MULTIDISCIPLINARY ACCIDENT INVESTIGATION TEAM NARRATIVE/DIAGRAM

DATE OF COLLISION (MONTH-DAY-YEAR)	TIME (2400)	NCIC	OFFICER I.D.	NUMBER	MAIT CASE NUMBER	PAGE
07-22-2010	0214	9435	15751	2010-07-0219	CF-023-10	i

Central Division

CF-023-10

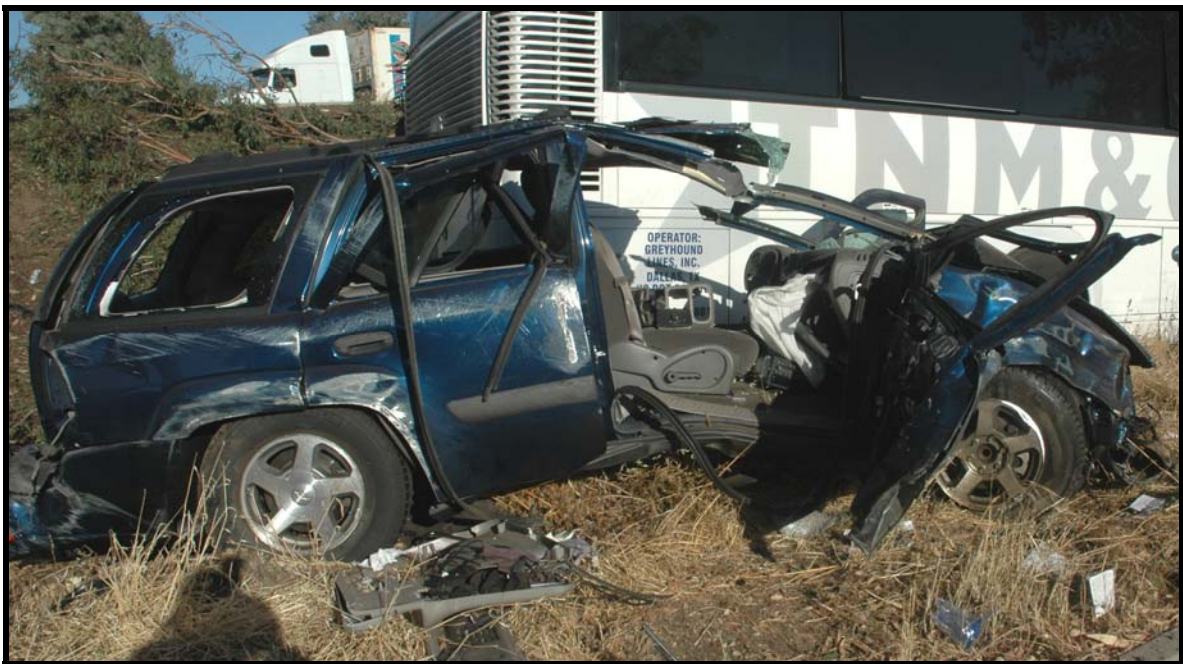
All references to direction are oriented from the driver's seat of the vehicle looking forward through the windshield. This vehicle sustained major front end and rollover damage. The principle direction of force was from front to rear and from right to left. There was a secondary impact with a principle direction of force from bottom to top. The following damage description is not inclusive of all the damage sustained by Vehicle 1 (Chevrolet).

Vehicle 1 (Chevrolet) at point of rest.
CF-023-10 07-22-10 MS-B (6) cropped

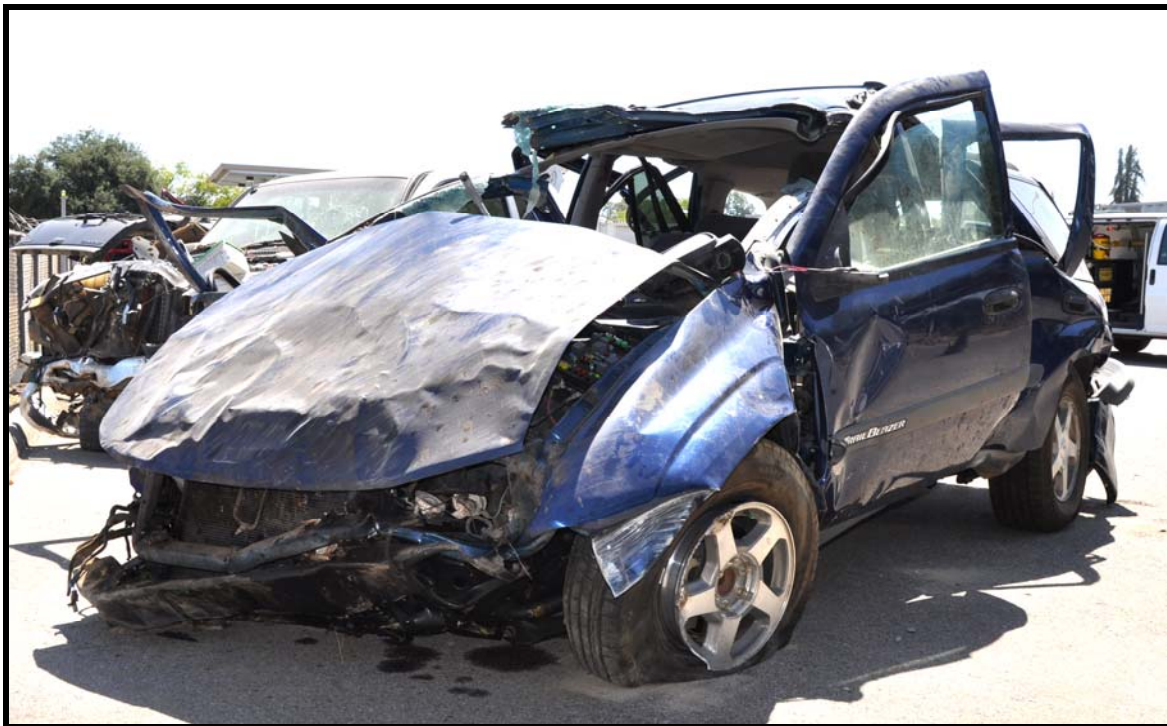
The bumper cover was displaced and missing. The grille was detached and missing. Both headlamps were detached. The bumper was displaced downward and rearward on the left. The radiator support was bent downward and displaced rearward. The left side of the bumper, grille and hood were displaced rearward. The hood was deformed and the leading edge of the hood was displaced downward. The rear of the hood was buckled upward. There were diagonal scrapes along the hood. The windshield was displaced and shattered. The top of the A-pillars were separated from the roof and the A-pillars were bent downward.

Front damage to Vehicle 1 (Chevrolet).
CF-023-10 07-29-10 DH-B (7) cropped

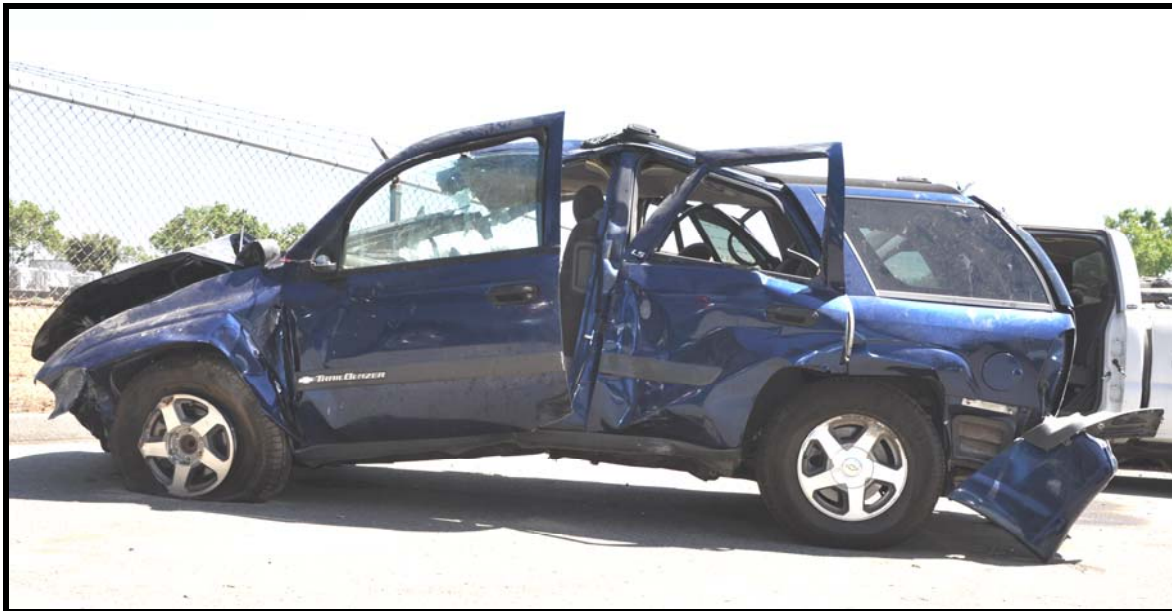
There was contact damage to the leading edge of the fender. The leading edge of the fender was displaced rearward and the trailing edge of the fender was displaced into the leading edge of the driver's door. Above the wheel well, the fender was flared outward. The side rearview mirror was broken and was detached from its mount. The top of the driver's door was separated from the roofline. There were scrapes along the top of the driver's door window frame. The driver's side window was positioned slightly open. The lower portion of the trailing edge of the driver's door was bent inward. There was a dent on the driver's door below the side rearview mirror bracket. The rear passenger's door was displaced rearward. The entire rear passenger's door was dented below the window sill. The window frame on the rear passenger door was twisted rearward and outward. The rear passenger's door window glass was broken and missing, and the window regulator was in the raised position. The top edge of the rear wheel well was displaced upward. The rear bumper cover was detached, and the tail lamp assembly was detached and missing. The rocker panel was displaced upward below the B-pillar. The B-pillar was displaced upward. The roof above the B-pillar was displaced upward.

Left side damage to Vehicle 1 (Chevrolet).
CF-023-10 07-29-10 DH-A (8) cropped

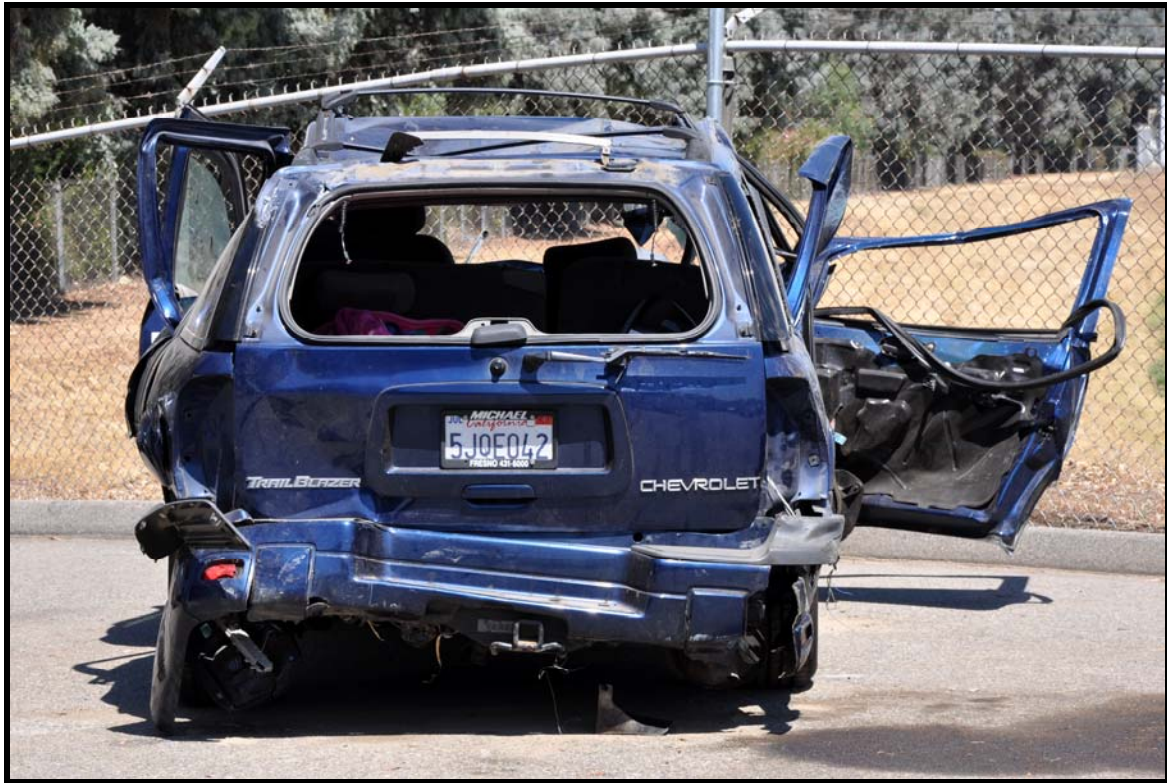
The lift gate glass was shattered and missing. The lift gate was dented on the left side above the "Trail Blazer" logo. On the left side, the bumper was displaced upward and the bumper cover was detached. On the right side, the bumper cover was torn below the tail lamp assembly. The left rear tail lamp assembly was hanging by electrical wires. The right rear tail lamp assembly was missing. The left rear D-pillar had a downward dent with scratches which appeared to have been caused by asphalt.

Rear end damage to Vehicle 1 (Chevrolet).
CF-023-10 07-29-10 DH-B (1) cropped

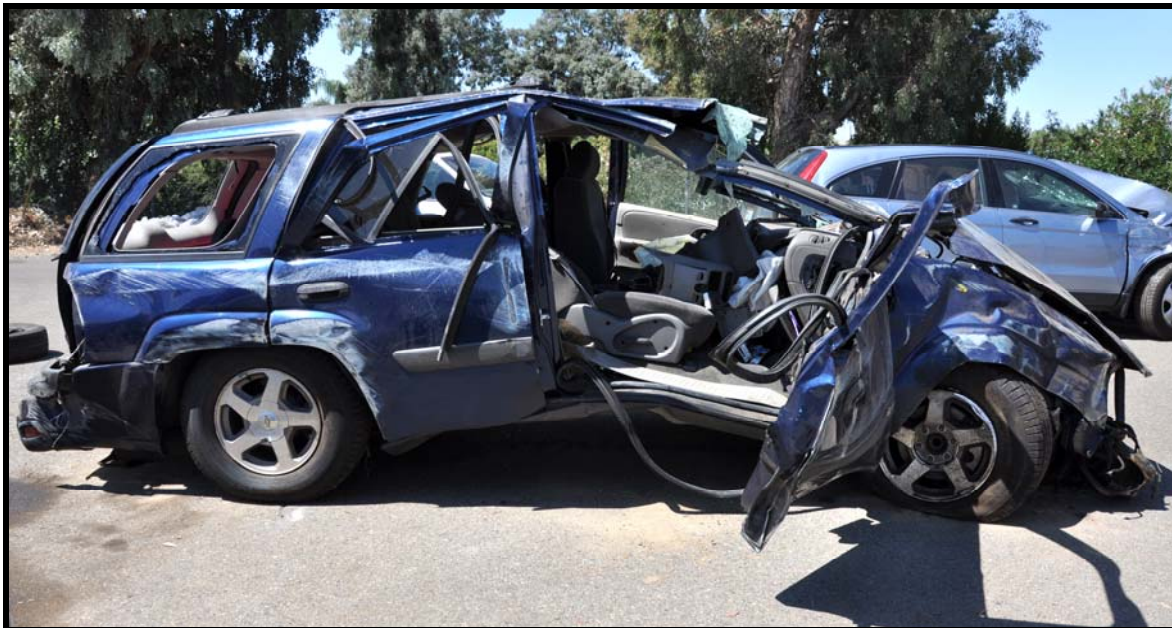
The majority of the right side was covered with scrapes and scratches that ran in multiple directions. The leading edge of the fender was displaced inward and rearward. The fender was displaced rearward into the leading edge of the front passenger door. The A-pillar was bent downward and was detached from the roof. The front wheel was displaced rearward. The bottom of the front passenger's door was displaced outward and would not latch. The front passenger door's window frame was displaced outward and twisted. The right front passenger door's window glass was shattered and the window regulator was in the raised position. The side rearview mirror was broken and missing. The rear passenger's door was displaced rearward and upward. The rear passenger door's window frame was displaced outward and twisted. The window glass was shattered and the window regulator was in the raised position. The quarter window in the rear passenger's door was present but was dislodged. The rear side window was shattered. There was a dent on the quarter panel below the window. The bumper cover was detached. The rocker panel was displaced upward below the B-pillar. The B-pillar was displaced upward. The roof above the B-pillar was displaced upward.

Right side damage to Vehicle 1 (Chevrolet).
CF-023-10 07-29-10 DH-B (4) cropped

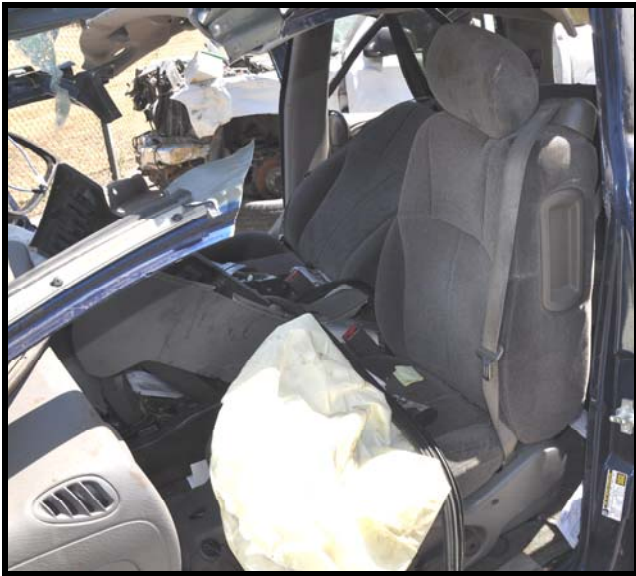
The dash was separated from the bulkhead by a distance of approximately one foot. The steering column was separated from the bottom of the dash. The center console was broken and detached. The driver's seat base was tilted forward and pushed upward. The right front passenger seat base was pushed upward. The rear seat base was tilted rearward. Blood was located on the headliner and other locations throughout the interior of the vehicle.

Front interior of Vehicle 1 (Chevrolet).
CF-023-10 07-29-10 DH-B (94) cropped

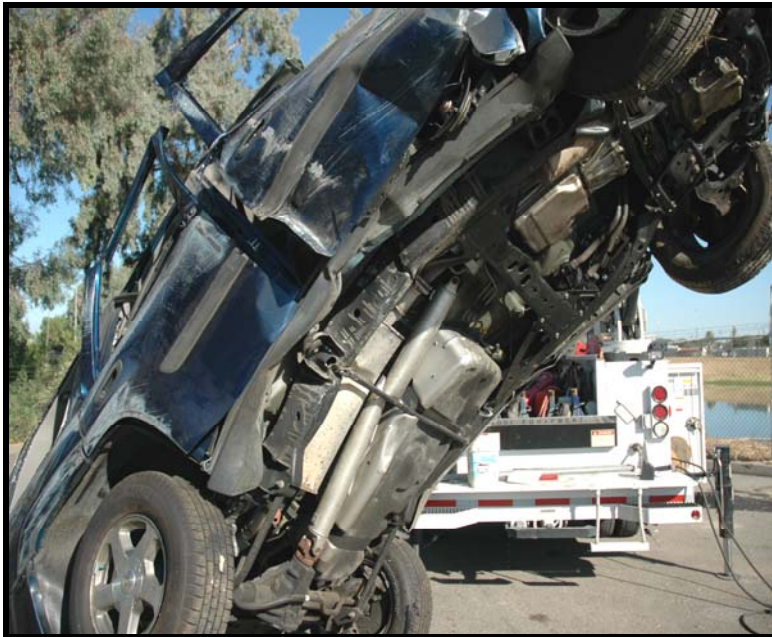
The left side frame rail was bent upward 3 inches. The right side frame rail was bent upward 6 inches. There were scrapes with white paint transfers along the crossmember near the right frame rail. The heat shield along the inboard side of the fuel tank was dented and there were black scuff marks in the area of the dent. There was a black scuff on the under side of the fuel tank to the rear of the mounting strap. Other damaged vehicle components from the undercarriage are described in the mechanical inspection of Vehicle 1 (Chevrolet).

Undercarriage of Vehicle 1 (Chevrolet).
CF-023-10 08-04-10 DN-B (17) cropped

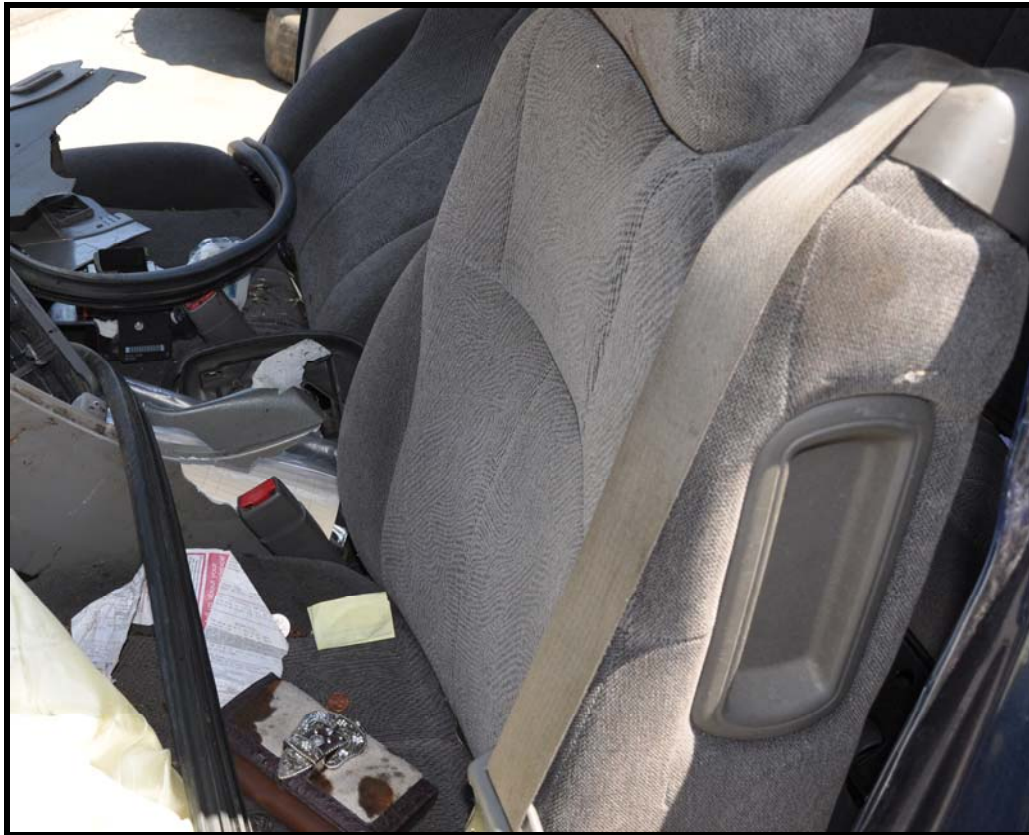
The driver's side supplemental inflatable restraint was deployed.

Driver's restraint for Vehicle 1 (Chevrolet).
CF-023-10 07-29-10 DH-C (32) cropped

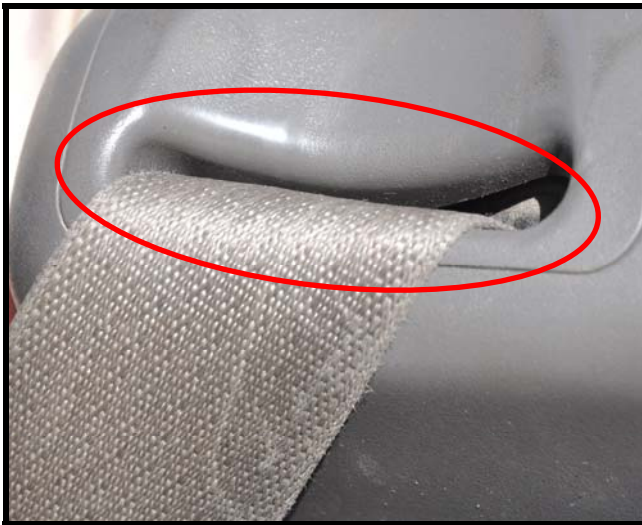
The plastic cover on the seat back mounted loop guide was displaced rearward and to the right. There was an angular, dark colored abrasion on the right side of the forward face of the loop guide cover. There was material transfer and imprinting on the loop guide cover (red oval in photograph). There were abrasions and minor fraying of the restraint webbing adjacent to the loop guide cover. Minor waviness of the webbing and a blue transfer (red circle in photograph) was observed in the vicinity of the abrasions and fraying. The abrasions, fraying, webbing waviness and the blue transfer were located approximately 2.6 feet from the left side restraint seat anchor, and corresponded to the latch plate position when it was installed into the buckle assembly. This position was determined via measurement from the fixed anchor on the left side of the seat to the buckle assembly.

Material transfer and imprinting on loop guide cover.
CF-023-10 08-02-10 DH (54) cropped

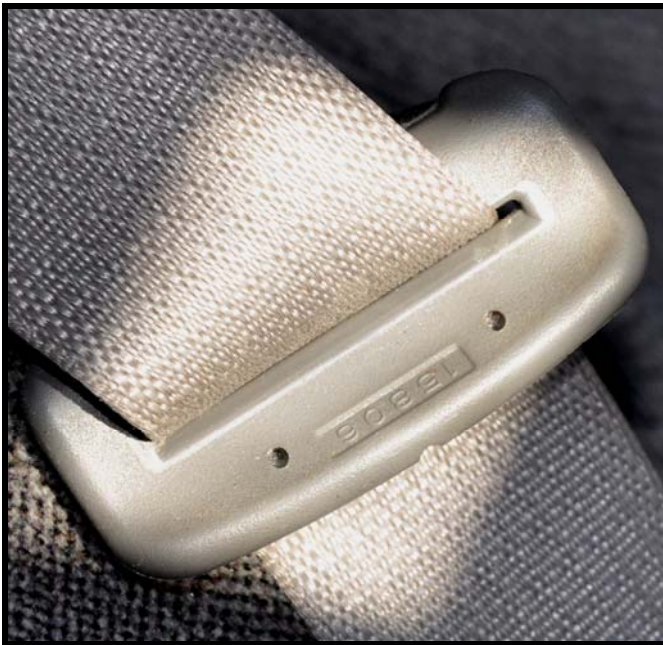
An inspection of the plastic coverings of the latch plate loop guide revealed there were material transfers and imprinting consistent with restraint webbing loading. An area of angular abrasions and material displacement was located on the edge of the latch plate loop guide. There were also angular material transfers, abrasions and imprinting consistent with restraint webbing loading on the upper concave surface of the plastic loop guide cover which was incorporated into the seat back.

Angular abrasions on latch plate loop guide.
CF-023-10 08-02-10 DH (58) cropped

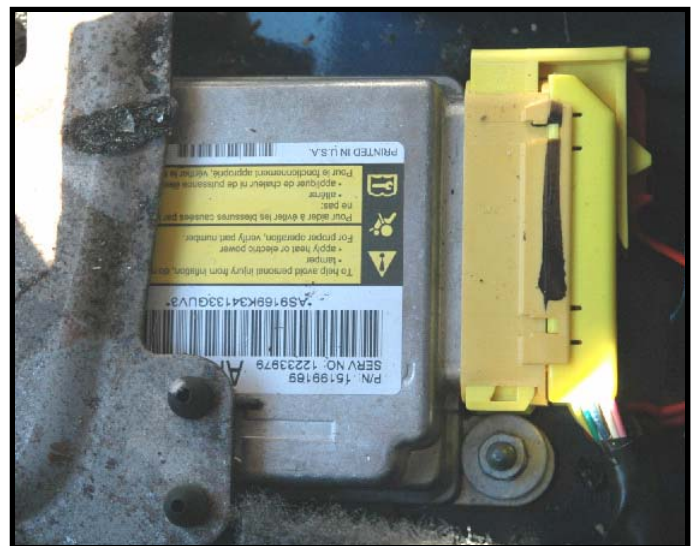
The SDM of Vehicle 1 (Chevrolet) was located under the center console, between the two front seats and was found securely bolted to the center tunnel with the directional arrow facing forward. The Bosch Crash Data Retrieval System (Version 3.5) was initially connected to Vehicle 1 (Chevrolet) via the underdash SAE J1962 Data Link Connector and an external power source. This method was unsuccessful. The Bosch Crash Data Retrieval System (CDR) was then connected to the SDM utilizing the appropriate direct to module interface cable (part number 2002829). The SDM remained securely mounted within Vehicle 1 (Chevrolet). The SDM was successfully imaged at 1707 hours, on Tuesday, August 3, 2010, by Investigator Kolter. The CDR data report from the SDM of Vehicle 1 (Chevrolet) is attached to this supplemental report as Annex B.

The SDM mounted in Vehicle 1 (Chevrolet).
CF-023-10 08-03-10 JK (7) cropped

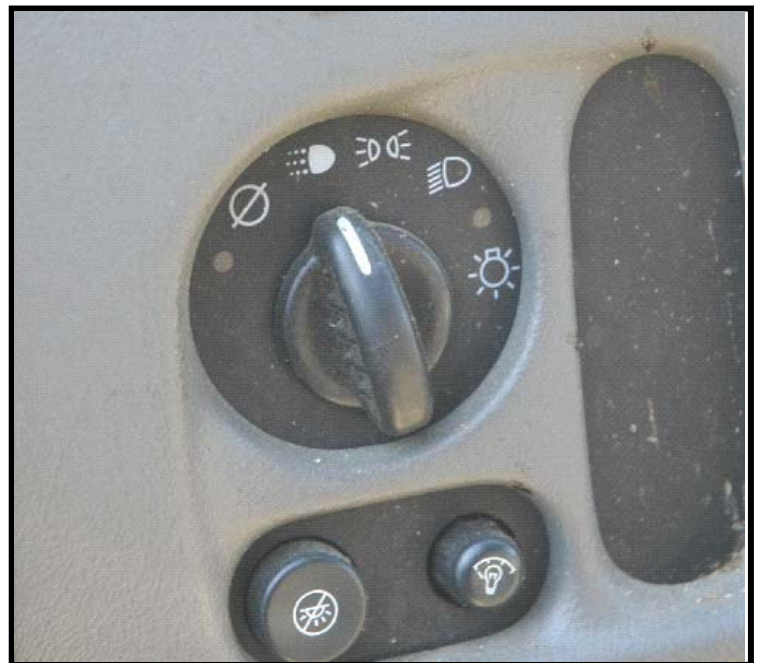
The headlamp switch was located in the dash panel to the left of the steering wheel. The switch was a rotary design and was found in the "Automatic DRL/AHS" position. With the headlamp switch in this position, the exterior illumination system of Vehicle 1 (Chevrolet) was in the "Automatic Daytime Running Lamp/Automatic Headlamp System" mode. This system utilized an ambient light sensor that was mounted at the top middle of the dash panel between the windshield defroster vents. The ambient light sensor is a light sensitive transistor that varies its voltage signal to the Body Control Module (BCM) in response to changes to the outside (ambient) light level. When the BCM receives this signal, it will either turn on the Daytime Running Lamps through the Headlamp Driver Module using a reduced output, or the BCM will turn on the headlamps at full intensity for auto headlamp operation. The BCM determines the desired lamp intensity utilizing the ambient light sensor. When the vehicle is placed in park or the ignition is turned off the Daytime Running Lamps will turn off. Any function or condition that turns on the headlights will cancel the Daytime Running Lamp's operation. The Daytime Running Lamps are the low beam headlights at a reduced intensity, nominally 70% of full low beam head lamp illumination.

Vehicle 1 (Chevrolet) headlamp switch.
CF-023-10 08-09-10 MS (41) (cropped)

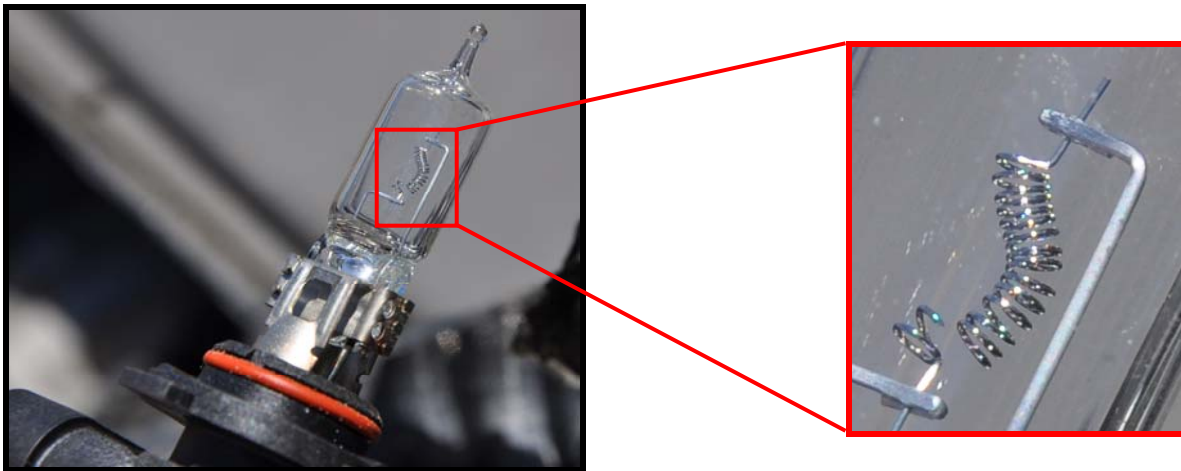
The glass envelope was intact. There was no continuity through the filament. The filament was fractured two coils above the lower support post. The filament was bright, shiny and silver in luster. The coils in the filament were stretched and bowed with uneven spacing and pitch.

Right high beam headlamp of Vehicle 1 (Chevrolet)
CF-0-23-10 07-29-10 DH-C (64) cropped

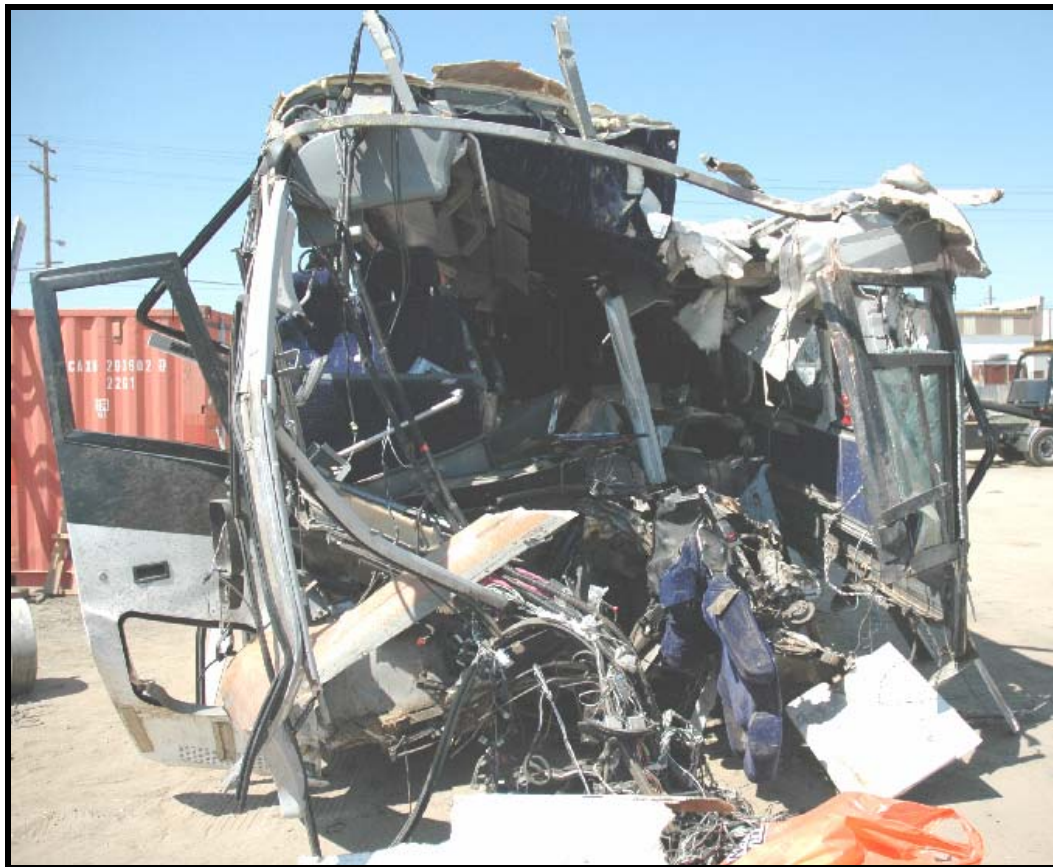
The front of Vehicle 2 (MCI) sustained major impact damage with significant intrusion into the passenger compartment. The majority of the intrusion was situated on the left side of the vehicle and extended rearward past the first three rows of seats. The leading edge of the roof was missing. The windshield was missing and its supporting framework was disfigured. The entire dash panel was shattered, exposing the underlying electrical components and the associated wiring. The floor at the front of Vehicle 2 (MCI) was shattered and was displaced rearward and upward. As a result, the passenger seats situated at the front of the vehicle displayed varying degrees of displacement. The center of the roof was pushed rearward and was angled to the left. The driver's seat was disfigured and was separated from its floor mount. The steering column was hanging loosely and was separated into several pieces. The overhead console was separated from the roof. The bumper, the bumper cover, and the headlamp assemblies were detached from the vehicle.

Damage to the front of Vehicle 2 (MCI).
CF-023-10 07-26-10 DN-B (51) (cropped)

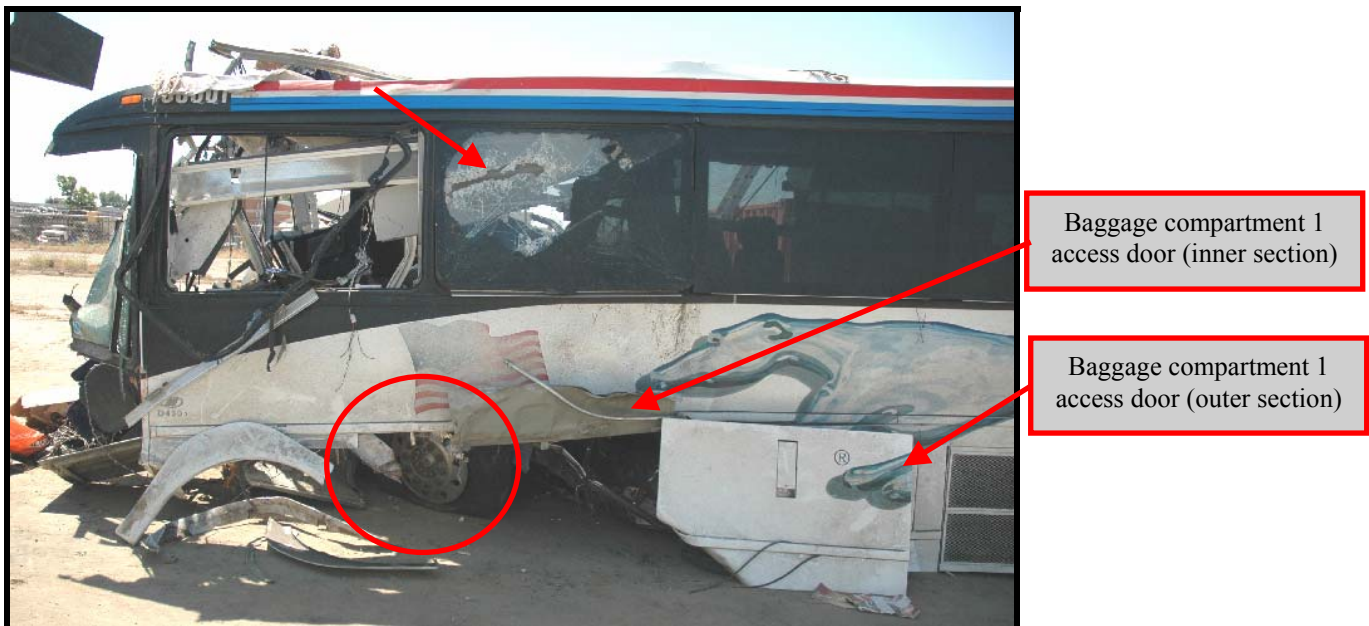
Window 1 was shattered and missing, with the associated frame was disfigured. The steer axle (axle 1) was displaced rearward and to the right (red circled area). The wheel house surrounding axle 1 was missing. The arched body flare that surrounded axle 1 was broken into two pieces, with one piece remaining fastened to the body of Vehicle 2 (MCI). The outer glass for window 2 was shattered and missing, while the inner glass was in place but broken. The inner glass also displayed a front to rear puncture (red arrow). The structure that encompassed baggage compartment 1 was disfigured and was pushed rearward. The inner section of the access door was bent and was in the open position. The outer section of the access door was separated from the inner part of the access door. An area of wood material transfers were located on the vehicle panel below the leading edge of the American flag decal, as well as the interior of the open access door of baggage compartment 1. The leading edge and the lower corner of the outer section of the access door of baggage compartment 1 displayed an angular fold and was displaced inward.

Left side damage to Vehicle 2 (MCI).
CF-023-10 07-26-10 DN-B (42) cropped

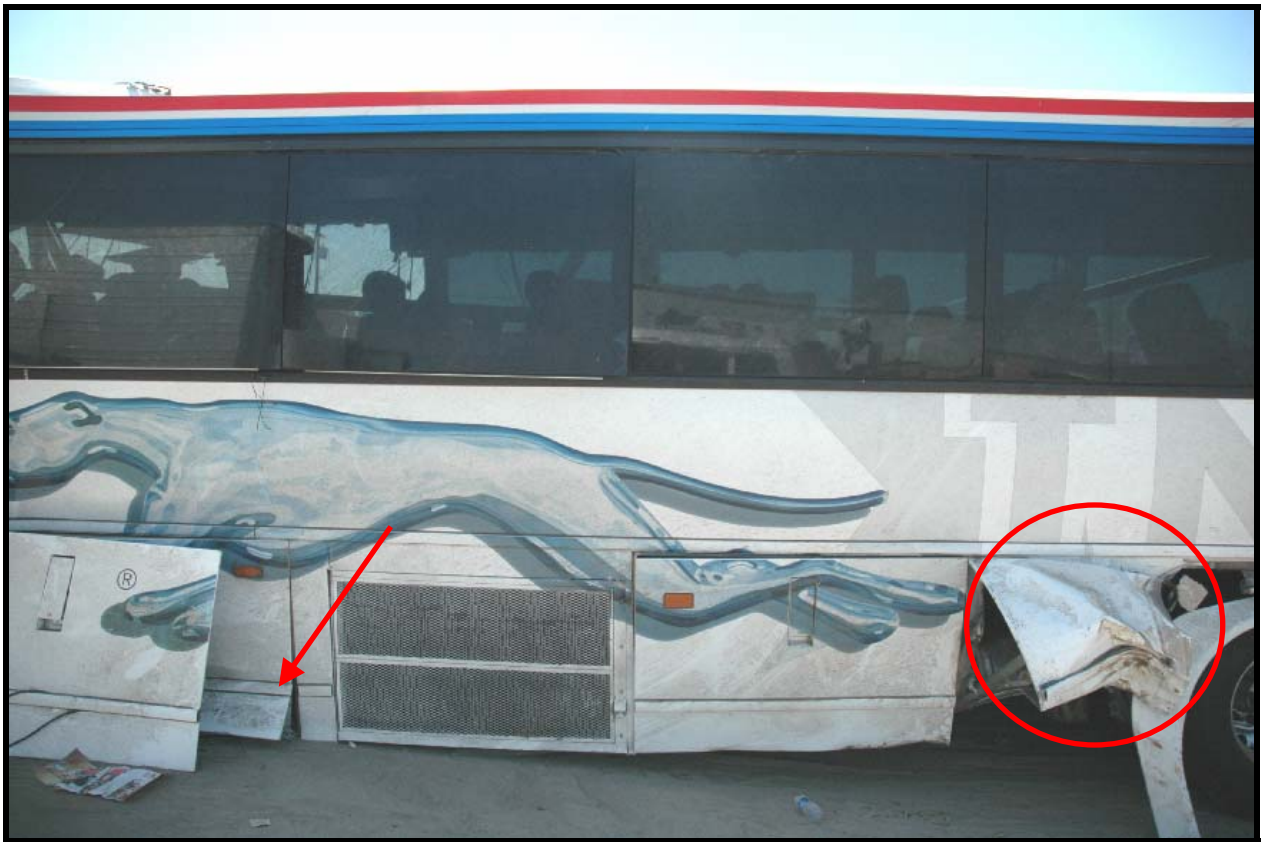
The glass within windows 3, 4, 5, 6, 7 and 8 were intact and undamaged. Windows 3, 4, 7 and 8 were in the “open” position. Windows 5 and 6 were in the “closed” position. The access door to baggage compartment 2 was displaced rearward, with the bottom of the door flared outward (red arrow). The air conditioning condenser compartment door behind baggage compartment 2 was intact, but the mesh grate within the door was displaced from the door. The access door to baggage compartment 3 was displaced outward, and the lower edge of the door was bent upward. The panel in front of axle 2 was displaced outward, and the lower edge of the panel was folded upward and rearward (red circled area). Wood material transfers were also noted in this area. The trim that encompassed the leading edge of the wheel well for axles 2 and 3 was fractured and broken from the associated side panels of the vehicle. Wood material transfers were observed about the leading edge of the trim.

Left side damage to Vehicle 2 (MCI).
CF-023-10 07-26-10 DN-B (37)

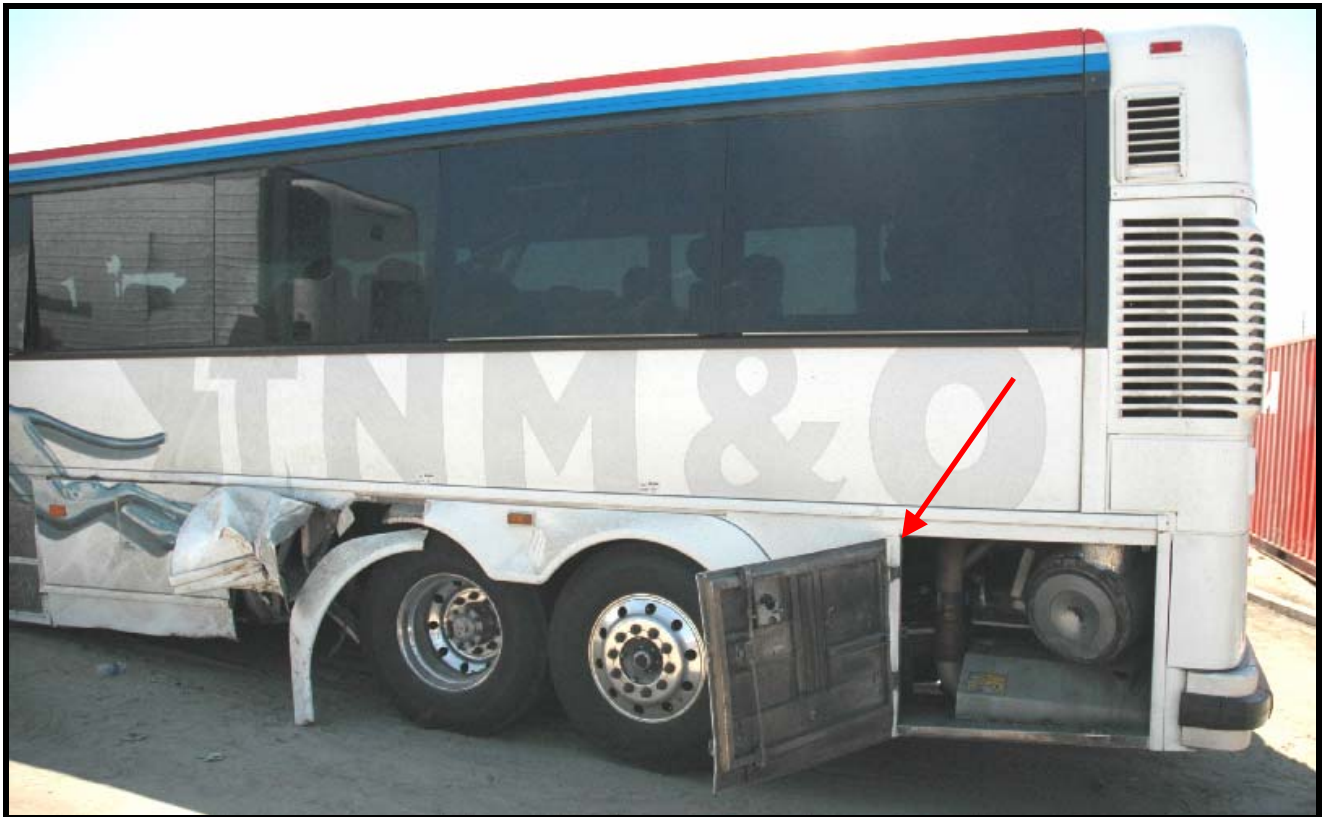
The air cleaner access door was sprung open and was bent downward (red arrow). The drive and tag axles exhibited minor displacement. The remainder of the left side of Vehicle 2 (MCI) appeared unremarkable.

Left side damage to Vehicle 2 (MCI).
CF-023-10 07-26-10 DN-B (30) cropped

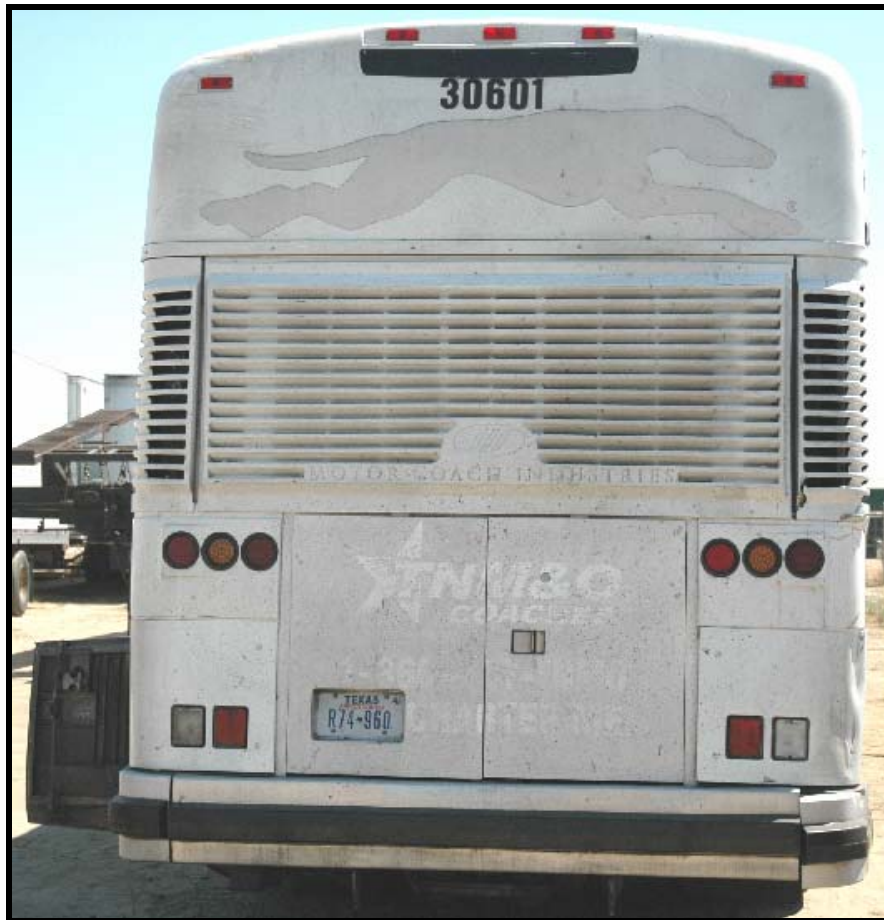
The majority of the rear of Vehicle 2 (MCI) that enclosed the power train and the radiators was intact and undamaged. Minor scuffs and scrapes were located on the left corner of the bumper cover, and the bumper cover was displaced slightly upward. The right side of the bumper cover was displaced downward and was not aligned with the remaining portions of the bumper cover. All of the lighting assemblies were intact and undamaged.

Damage to the rear of Vehicle 2 (MCI).
CF-023-10 07-26-10 DN-B (23) cropped

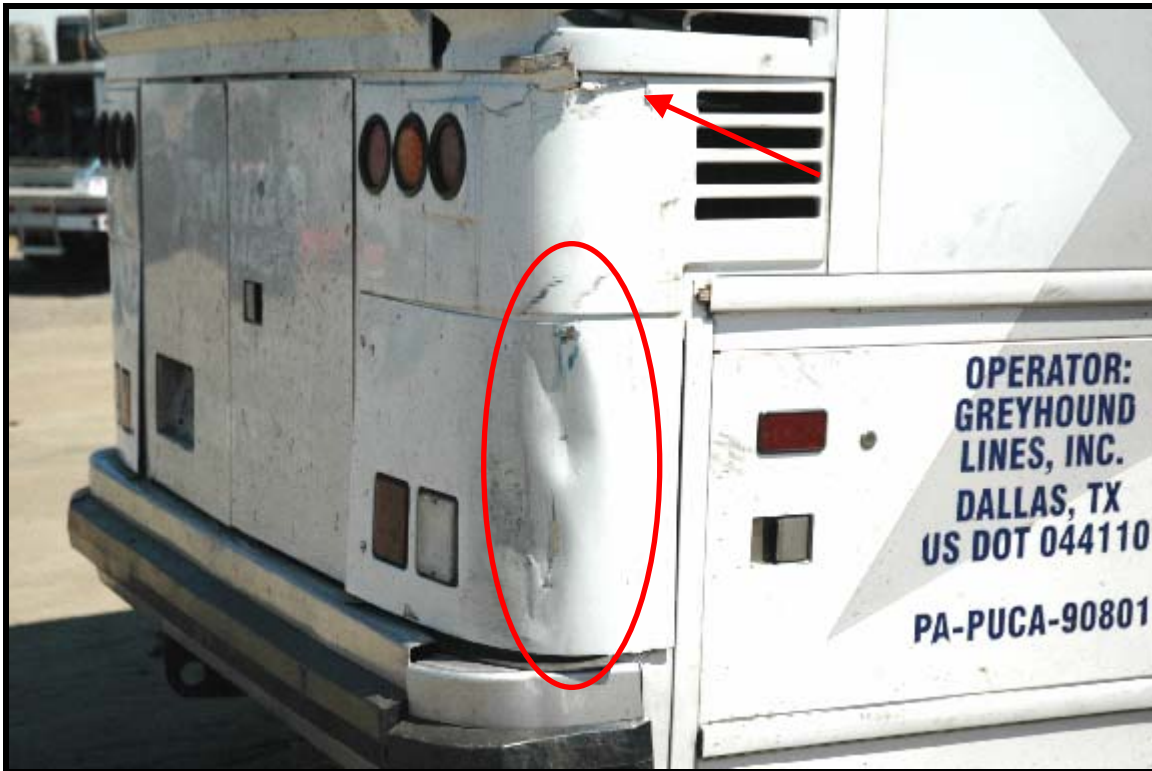
A series of vertical creases were observed at the right rear corner of Vehicle 2 (MCI), directly above the bumper cover. Blue paint transfers were also noted within the creases (red oval). The creased panel was slightly dislodged from its mounts. Two angular black transfers were located directly above the dislodged panel.

Damage to the right rear corner of Vehicle 2 (MCI).
CF-023-10 07-26-10 DN-B (19)

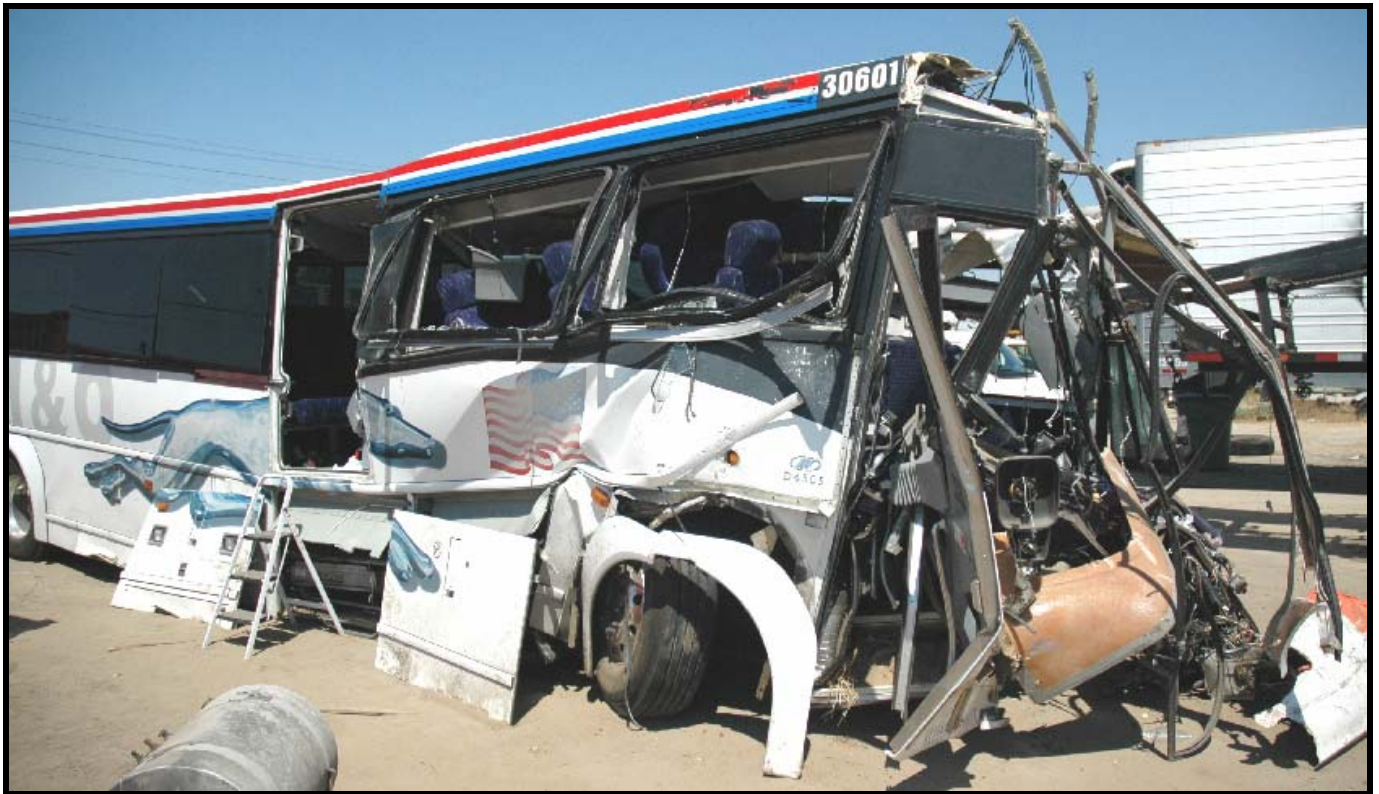
The passenger door was twisted inward and to the left. The door glass was broken, and the door hinge and operating mechanism were displaced rearward. The entire right front corner of the vehicle was missing. The glass for windows 1 and 2 was shattered and missing, and the associated frames were disfigured and pushed outward. The B-, C-, and D-pillars were displaced rearward. The panel below window 1 and window 2 exhibited several folds and creases, with an upward displacement of the panel, rearward of the front wheel well. The trim surrounding the front wheel well was dislodged and was fractured near its midpoint. Axle 1 was pushed rearward and displaced the rear of the front wheel well. Baggage access doors 1 and 2 were removed from Vehicle 2 (MCI) at the collision scene by rescue personnel. The wheelchair access door was detached from the vehicle, and the surrounding frame was pushed rearward and outward.

Right side damage to Vehicle 2 (MCI).
CF-023-10 07-26-10 DN-B (3) cropped

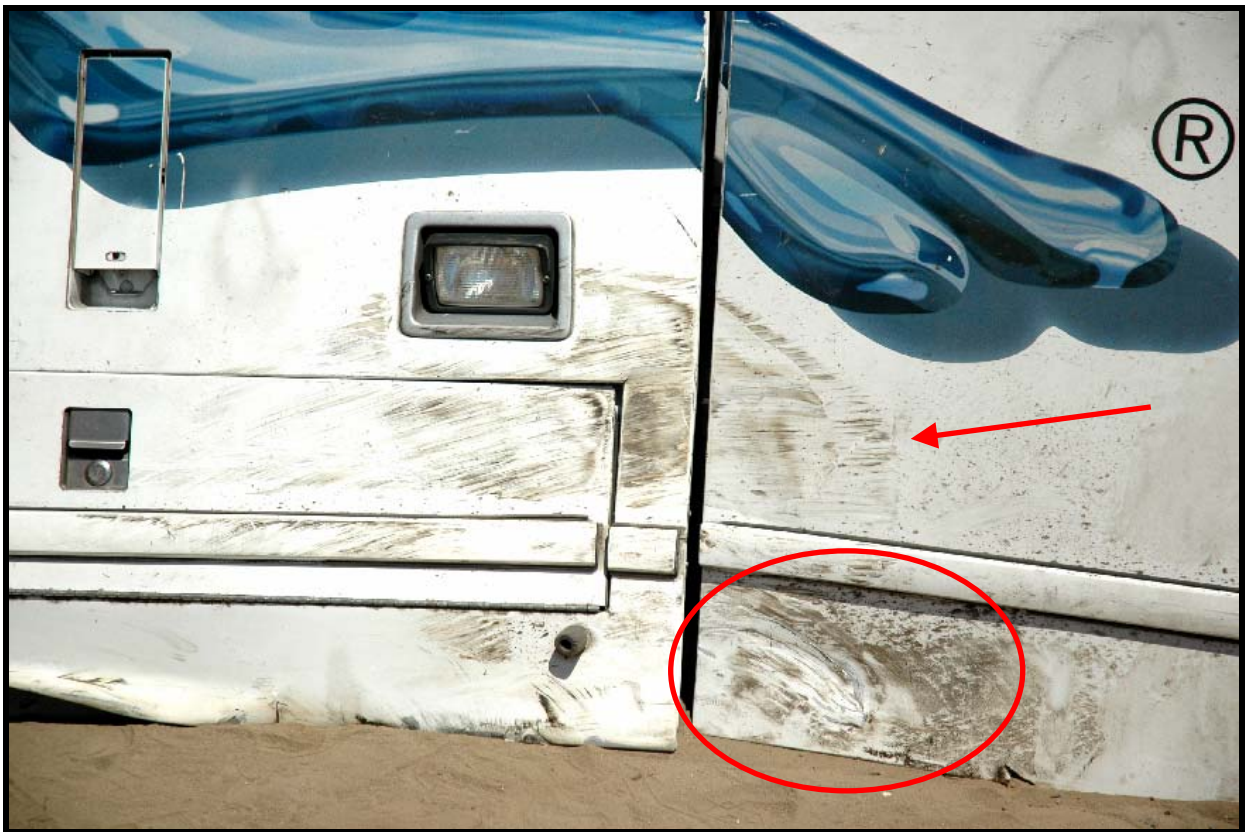
The bottom edge of baggage access door 2 was cracked and was pushed upward. Baggage access doors 1 and 2 displayed black transfers (red arrow), and the lower rear corner of the baggage access door exhibited semi-circular contact damage (red oval) which consisted of an indentation of the door material.

Black transfers and contact damage to baggage access doors 1 and 2 of Vehicle 2 (MCI).
CF-023-10 07-26-10 DN-B (5)

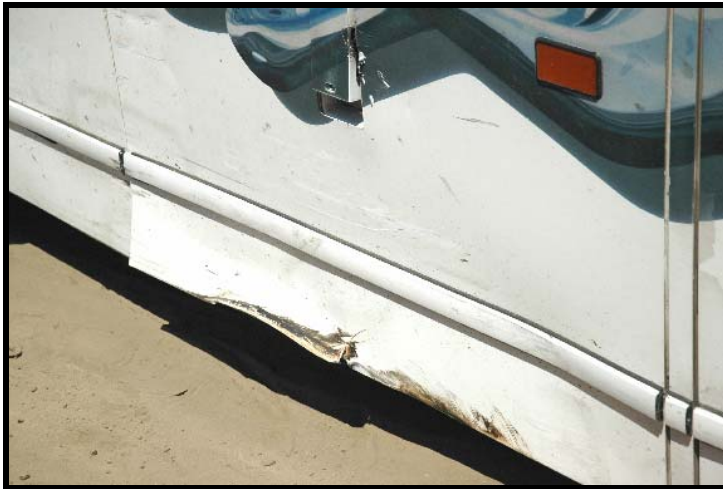
The lower edge of the fuel filler door and the battery compartment access panel exhibited minor folding, however the panels remained in place. The lower edge of baggage access door 3 was fractured and pushed upward, with the trailing section of the bottom edge of the panel flared outward. Two blue and red horizontal transfers were located at the trailing edge of baggage access door 3 (red oval). A horizontal crease was located adjacent to the upper transfer.

Fractured lower edge of baggage access door 3.
CF-023-10 07-26-10 DN-B (10)

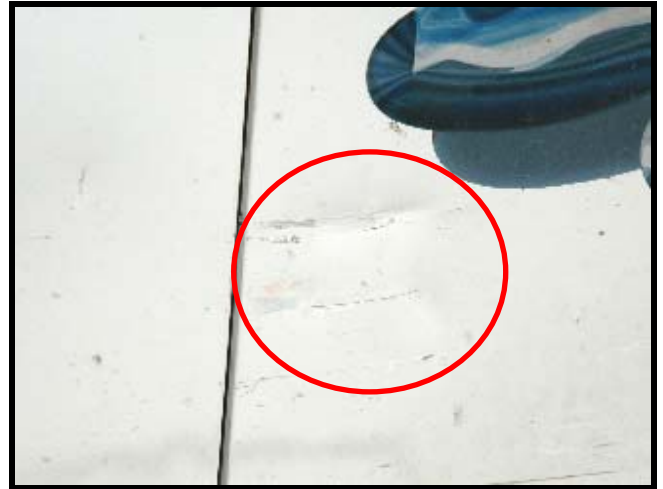
Blue and red transfers on baggage access door 3.
CF-023-10 07-26-10 DN-B (12) cropped

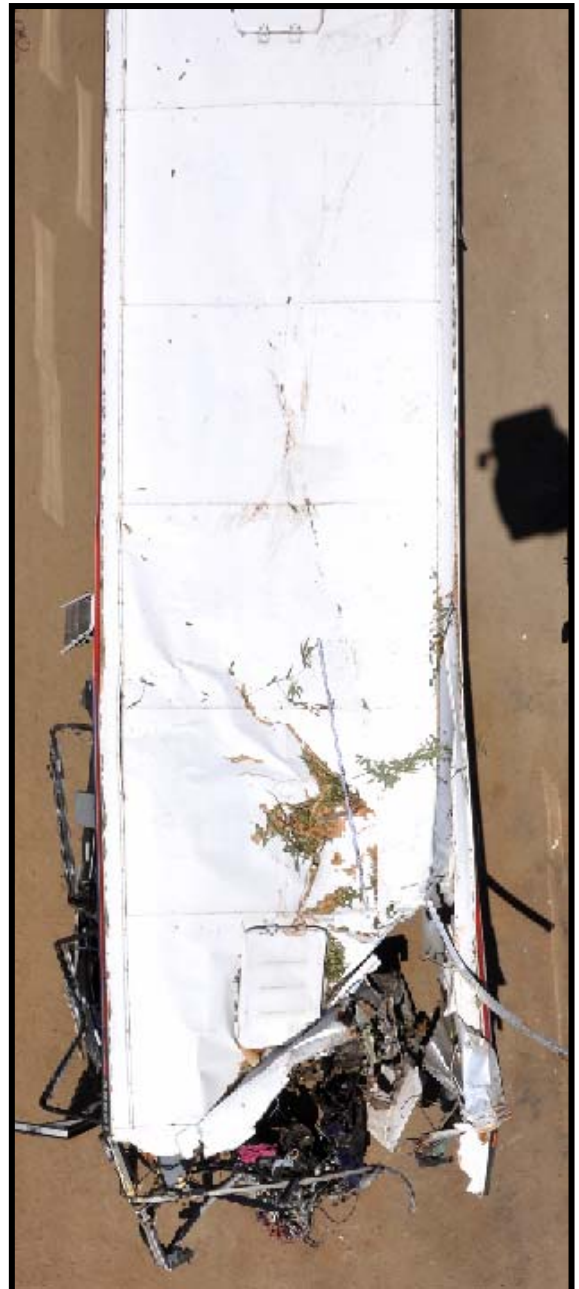
The rear passenger escape hatch was intact. The trailing edge of the hatch door was folded upward. Its locking mechanism operated properly and the hatch opened adequately. The remainder of the roof appeared unremarkable.

Roof of Vehicle 2 (MCI).
CF-023-10 07-23-10 RK (14) cropped

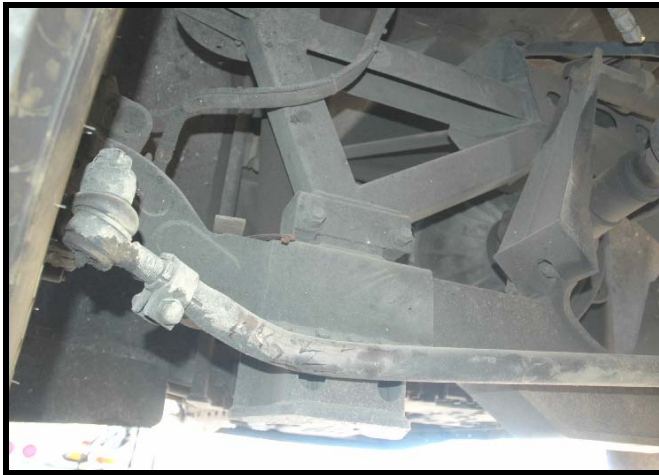
The frame to which the upper diagonally positioned radius rods were attached was displaced. As a result, axle 2 was displaced in a counterclockwise direction within the chassis. The drag link of axle 3 was bent rearward and upward near the tie rod end. There were several gouges perpendicular to the axis of the tie rod. The marks appeared to be fresh tool marks from J-hooks utilized by recovery crews moving Vehicle 2 (MCI) from the scene of the collision. This caused the alignment of axle 3 to be different than axle 2. This change in alignment appeared to have been caused by recovery efforts. The left rear shock absorber lower mount was pulled from its suspension mount. The shock absorber lower mount stud was bent.

Bent right side drag link of Vehicle 2 (MCI).
CF-023-10 08-06-10 MS (41)
