MULTIDISCIPLINARY ACCIDENT INVESTIGATION TEAM NARRATIVE/DIAGRAM

DATE OF COLLISION (MONTH-DAY-YEAR)	TIME (2400)	NCIC	OFFICER I.D.	NUMBER	MAIT CASE NUMBER	PAGE
07-22-2010	0214	9435	15751	2010-07-0219	CF-023-10	i

Central Division

CF-023-10

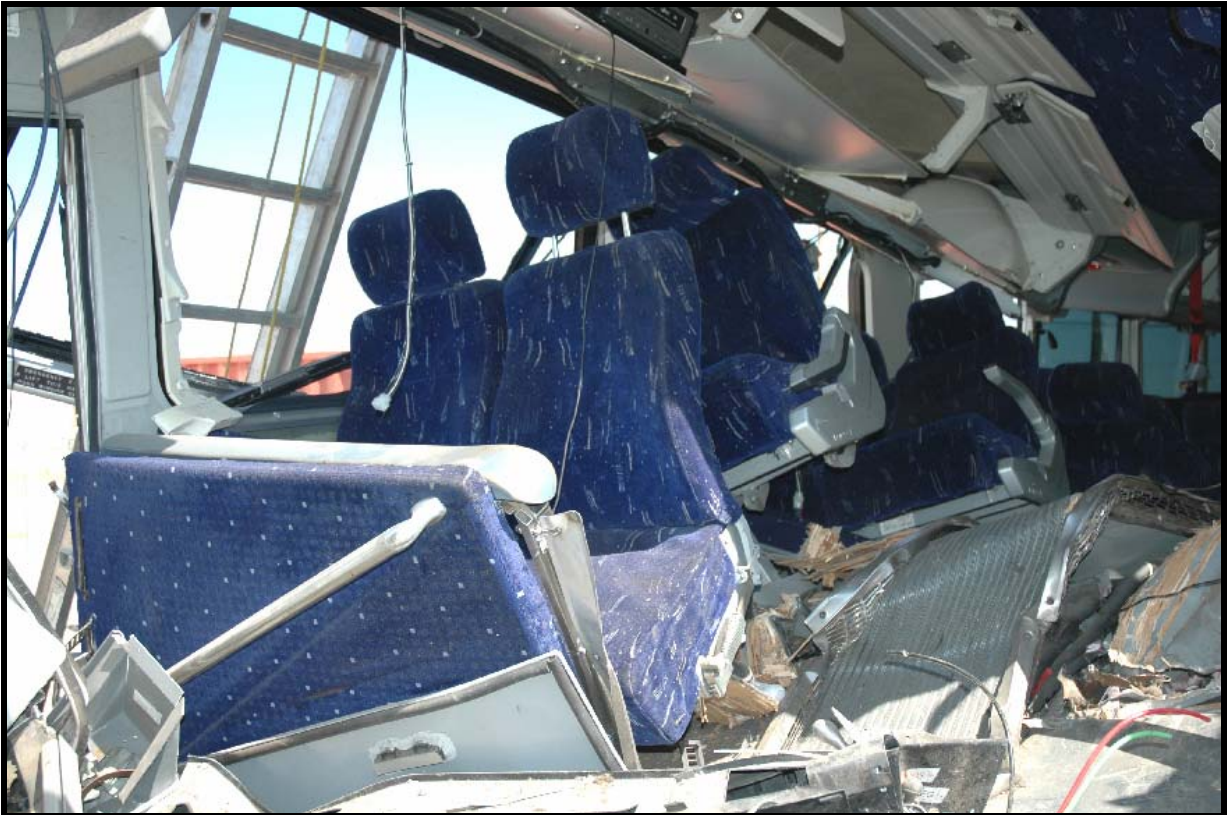
The passenger stair well was compressed rearward and downward, and the underlying stair structure was fractured. The left passenger hand rail was intact and appeared undamaged; however the modesty panel which the hand rail was attached to was tilted forward. The leading edge of the center aisle was disfigured and pushed downward. The center aisle, adjacent to passenger seats 3 and 4 and passenger seats 7 and 8, was pushed upward.

Passenger entry stair well area and center aisle.
CF-023-10 07-26-10 DN-A (3)

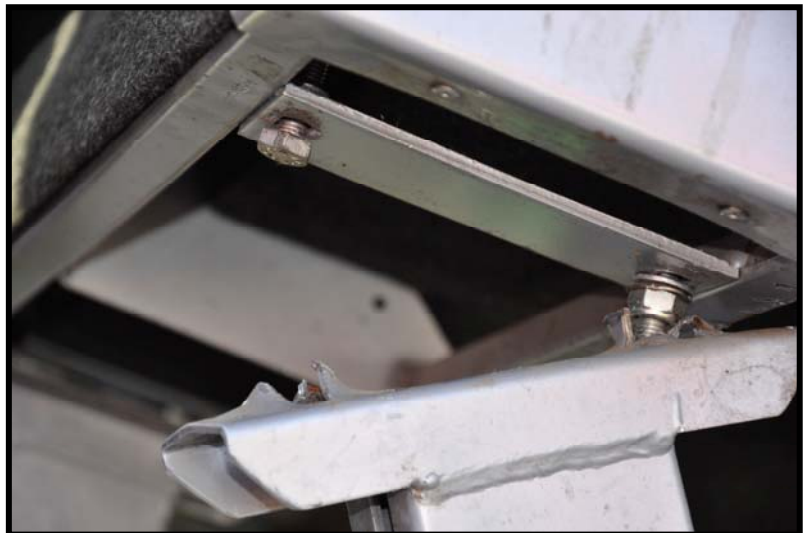
Seat separation from the outboard pedestal.
CF-023-10 07-29-10 DH-A (7) cropped

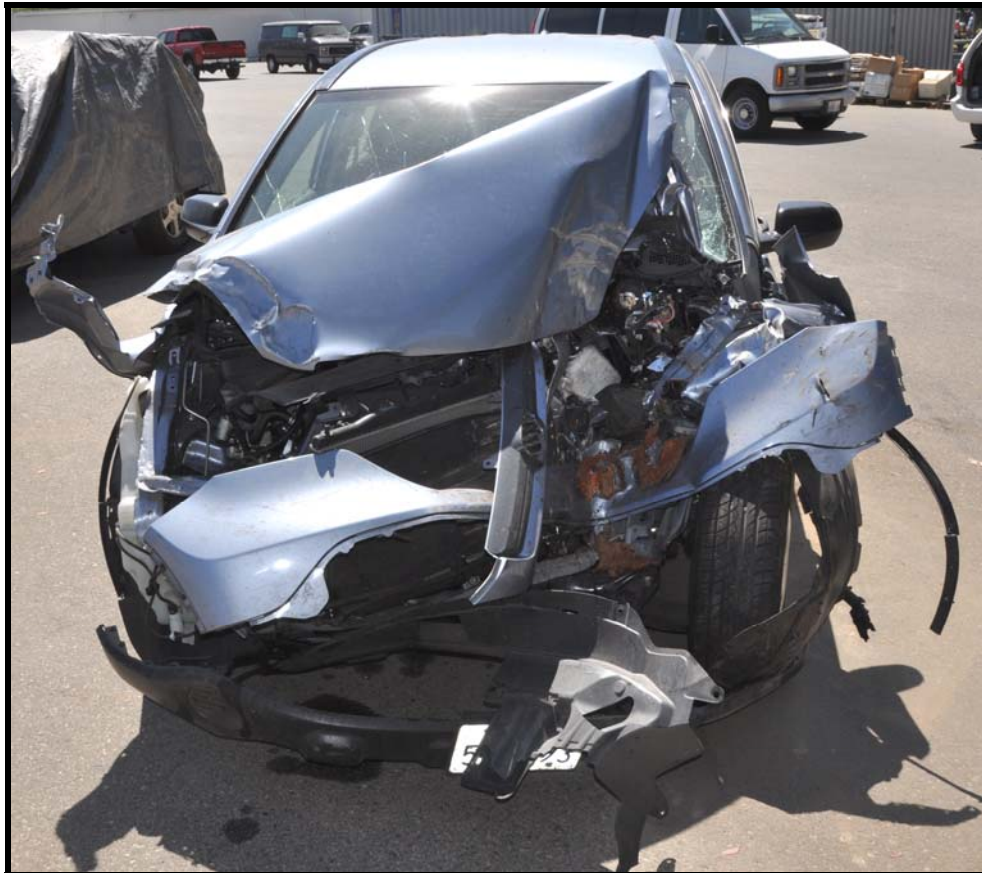
Front damage to Vehicle 3 (Honda).
CF-023-10 07-27-10 DH-A (6) cropped

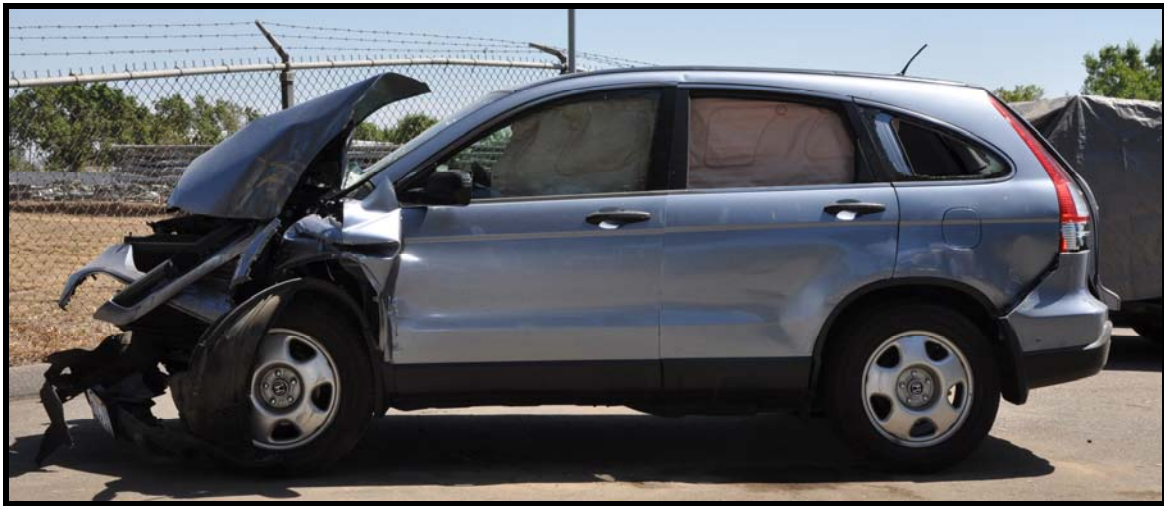
Left side damage to Vehicle 3 (Honda).
CF-023-10 07-27-10 DH-A (8) cropped

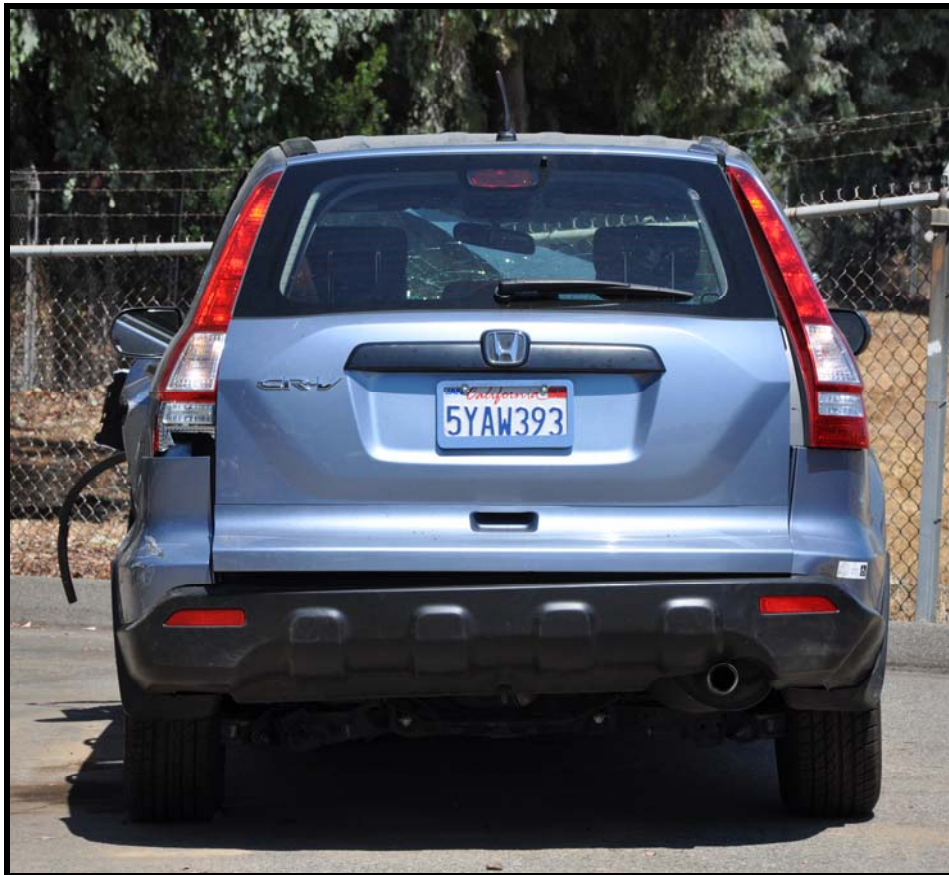
Rear end damage to Vehicle 3 (Honda).
CF-023-10 07-27-10 DH-A (1) cropped

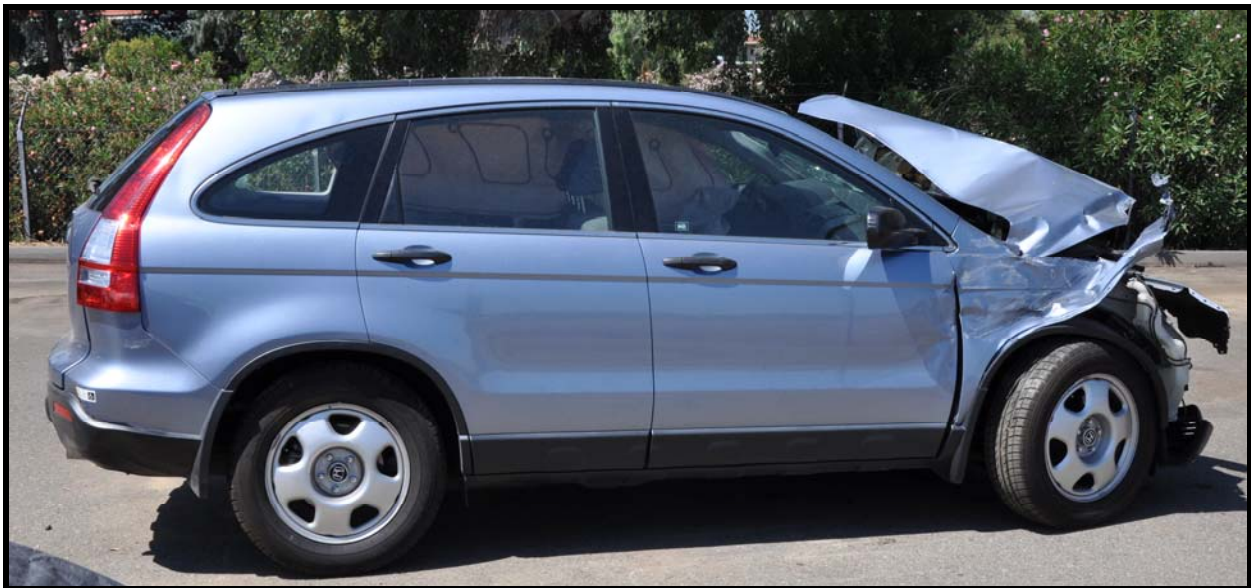
Right side damage to Vehicle 3 (Honda).
CF-023-10 07-27-10 DH-A (4) cropped

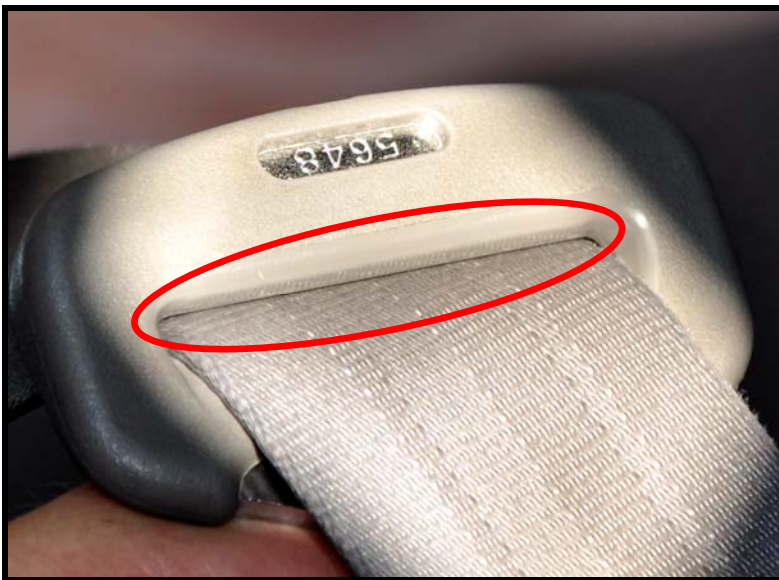
Latch plate imprinting.
CF-023-10 07-27-10 DH-B (6) (cropped)

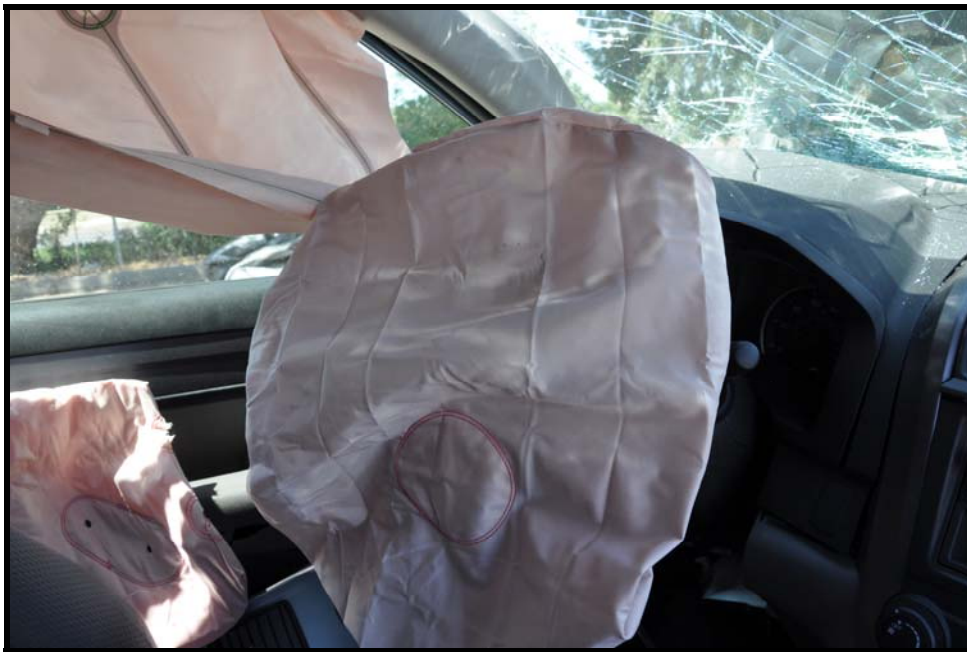
Deployed airbags of Vehicle 3 (Honda).
CF-023-10 07-27-10 DH-B (14)

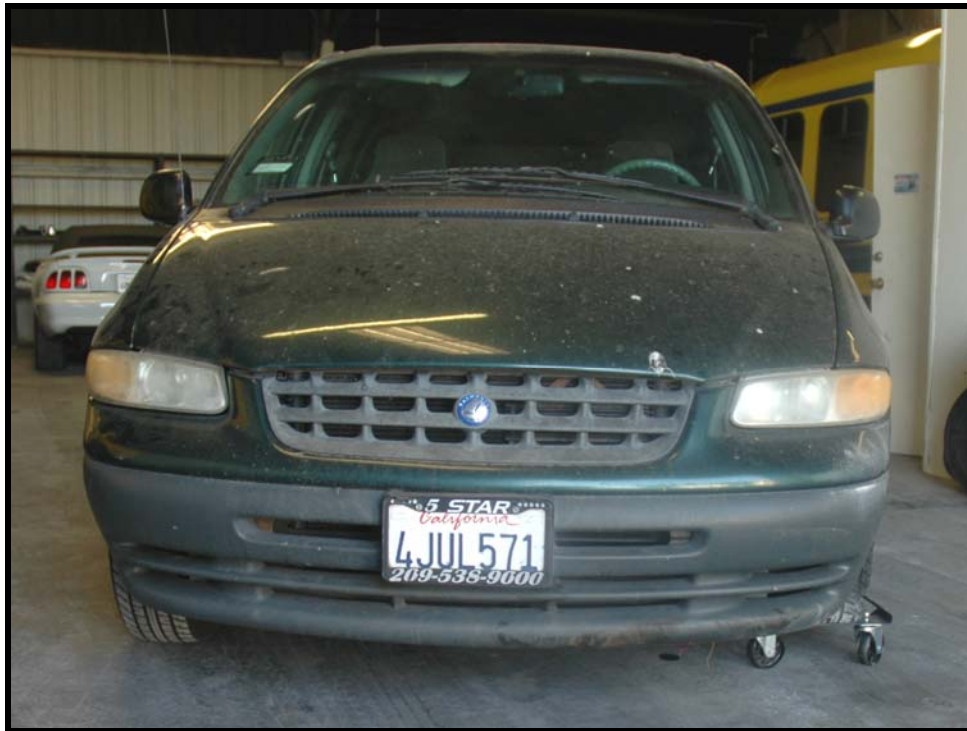
Front damage to Vehicle 4 (Plymouth).
CF-023-10 07-28-10 DN (12) cropped

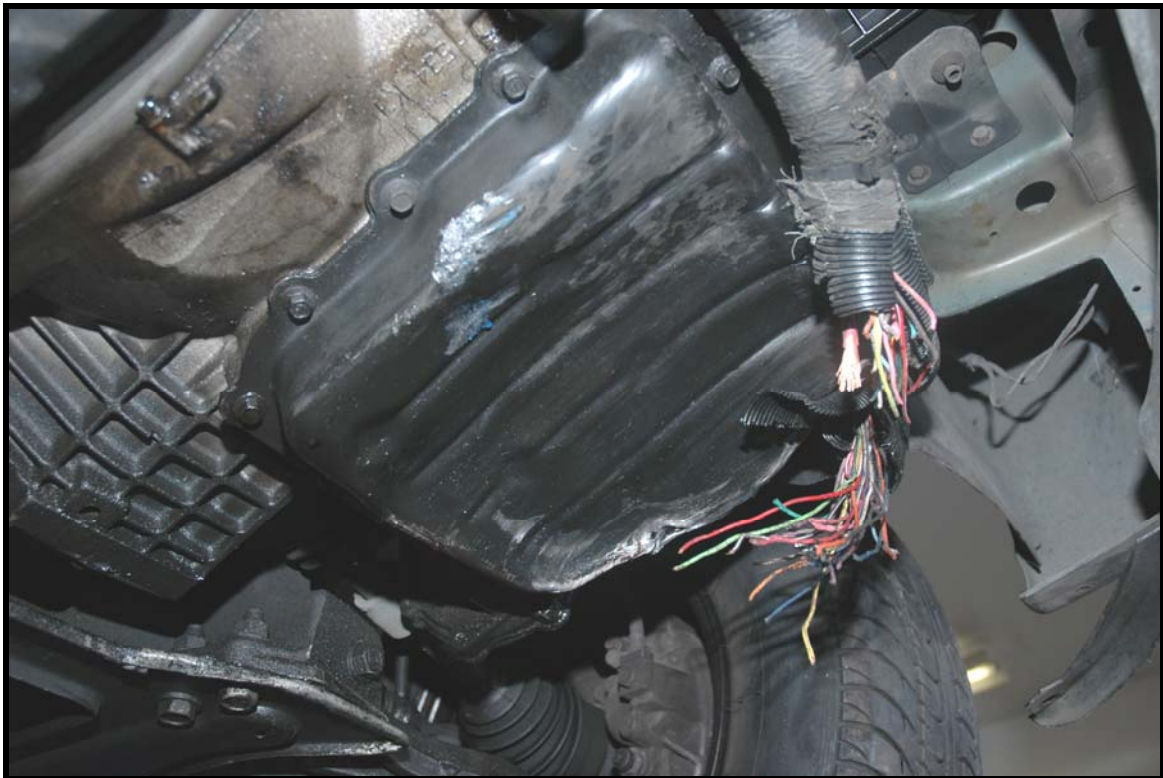
Undercarriage damage to Vehicle 4 (Plymouth).
CF-023-10 07-28-10 DN (31)
