NATIONAL TRANSPORTATION SAFETY BOARD

Attachment 1 – Flight Crew Interview Summaries

OPERATIONAL FACTORS/HUMAN PERFORMANCE

DCA17IA148

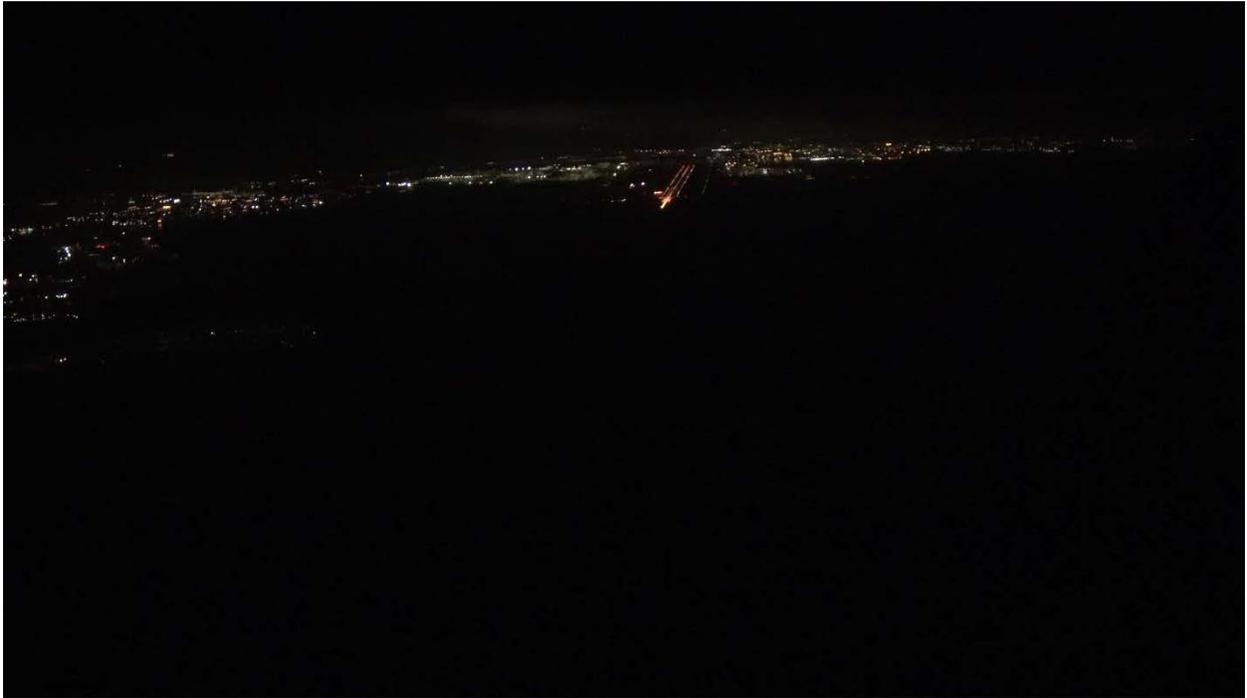
Photo 1: Taken from about F101D

When asked to clarify what he meant by the line of lights he observed on the runway, he stated that the lights were stationary type of lights. Further described the lights as a line of lights perpendicular across the runway. The lights he observed were green in color. He was not sure when he saw the lights but he thought that he observed them when the flight was inside the F101D fix. He saw a lot of green lights and was not sure why. At one time, he looked to his left and saw a runway lit up. He asked if that was runway 28L and had a horrible feeling in his stomach. When he figured out that something was wrong he commanded the go around. The approach was designed to come in at an angle, when compared to the airport. He could see runway lights before they were at F101D. He could not recall how many sets of runway lights he saw.

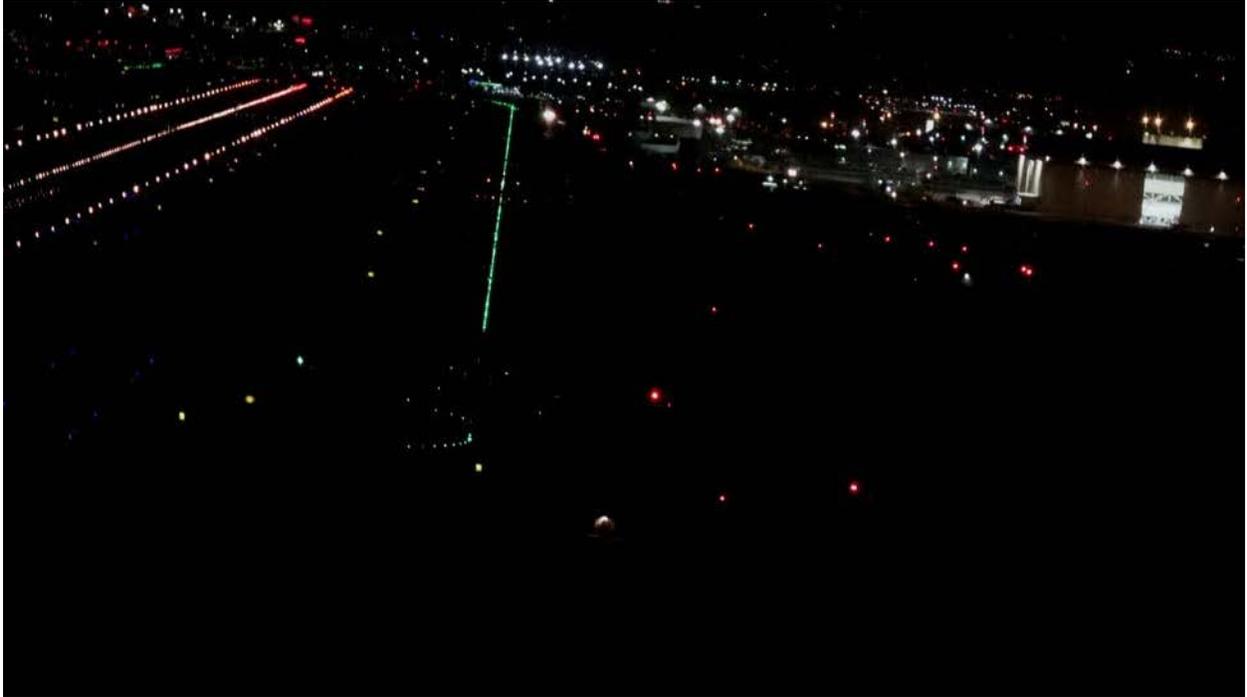
Photo 3: Approximate Go Around Location

When asked what altitude or distant from the perceived threshold he was when he initiated a go-around, he stated that he felt that he was about 400 feet above ground level and about one-half mile from what he thought was runway 28R.
