# ***Columbia* Crew Survival Investigation Report**

NASA/SP-2008-565

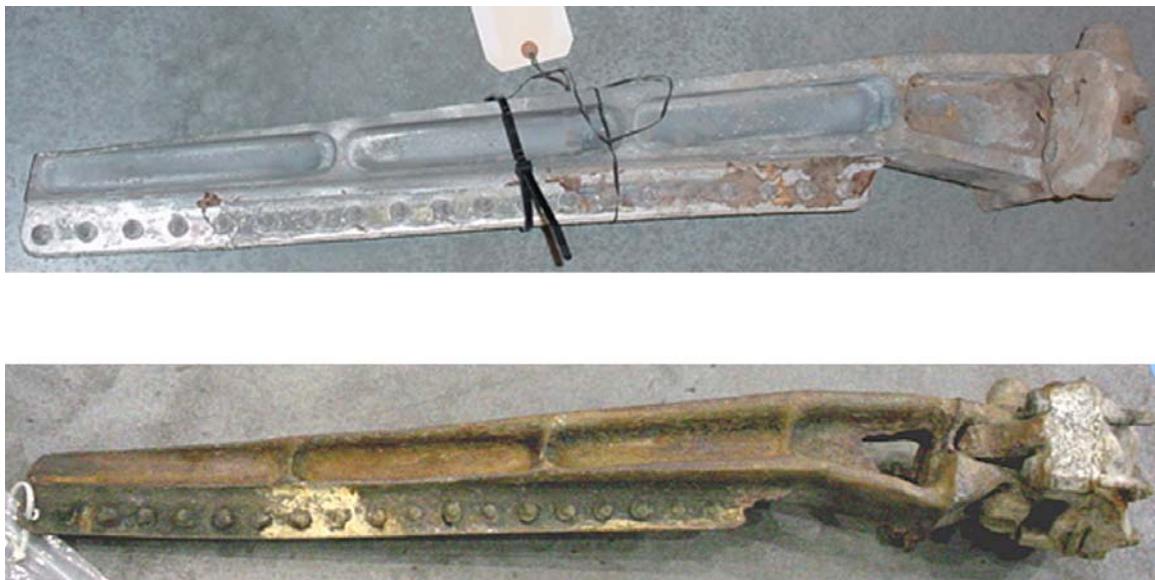
sill, and was likely from a combination of thermal degradation and structural loads. The forebody probably separated from the midbody from starboard to port. Based on structural evidence and the debris field, the crew module remained with the forward fuselage indicating that the links attaching the two structures remained intact. The remaining orbiter structure separated into aft and midbody/right wing segments. See Chapter 2. Figure 1.1-25 shows the recovered x-links.

Figure 1.1-25. Port x-link, debris item no. 1678 (top), and starboard x-link, debris item no. 1765 (bottom), from the Columbia Reconstruction Database.

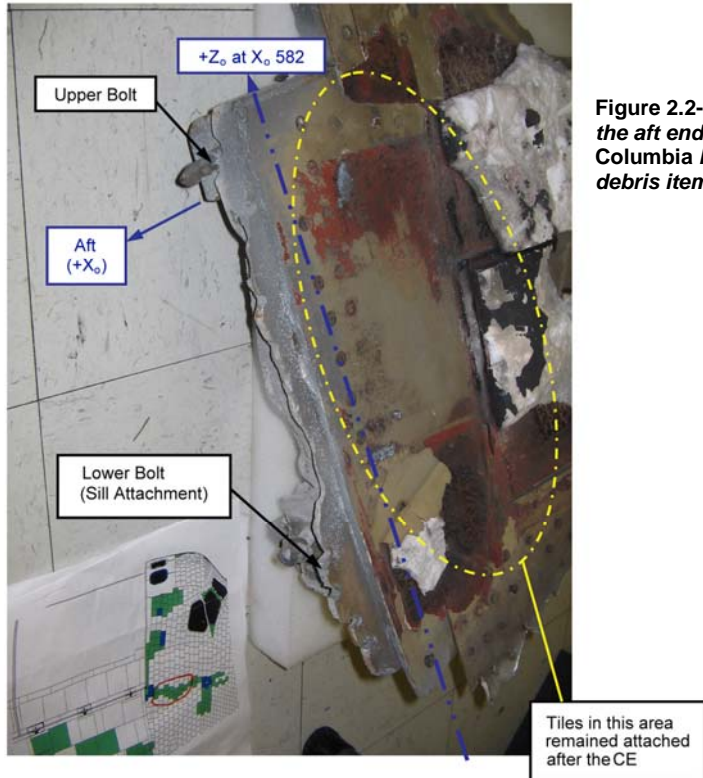
Figure 2.2-33. Thermal erosion on the aft end of the starboard-side skin, Columbia Reconstruction Database debris item no. 2436.

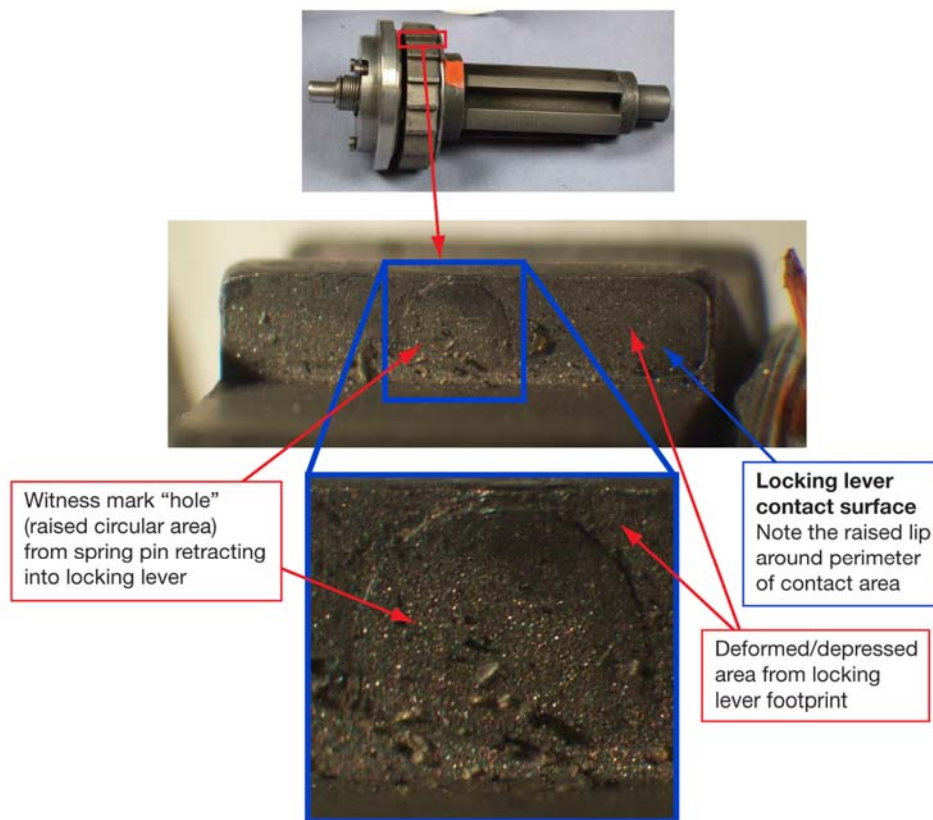
**Figure 3.1-33. Inertial reel locking gear witness mark.**
