**J. W. Jones Elementary School
Microbial Remediation Protocol
Classrooms 101, 109, & 206
Removal Date: TBA
Clearance Date: TBA**

SUBJECT: **INDOOR AIR QUALITY (IAQ) INVESTIGATION – J. W. JONES ELEMENTARY SCHOOL – CLASSROOMS 206, 109, 110, 101, AND 202**

**J. W. Jones Elementary School
 Classrooms 206, 109, 110, 101, and 202
 Indoor Air Quality (IAQ) Investigation
 August 14, 2007**

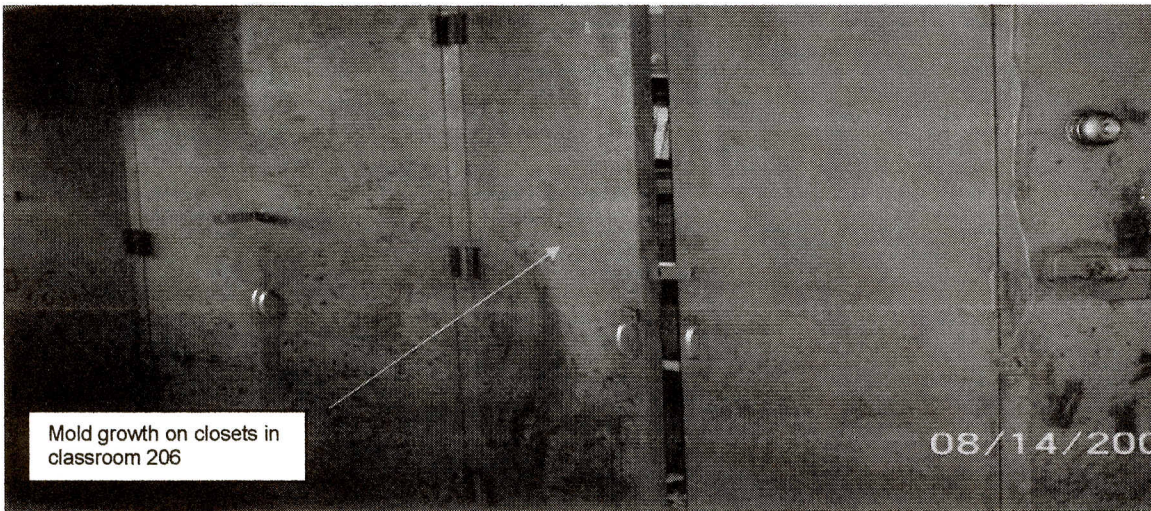
Photo 1

- The initial source of moisture appears to be high relative humidity in the building caused by in improperly-working Heating, Ventilation, Air Conditioning (HVAC) system which is not removing humidity from the indoor air.

1. At the time of the investigation, in classroom 206, visible microbial (mold) growth was observed on the closet doors, bulletin boards, and insulated pipes. The mold was in excess of 25 contiguous square feet on the bulletin boards and on the closets. (See photos 1-3 on page 4)

Mold growth on closets in classroom 206

1. The recommended course for classroom 206 is have licensed mold remediation personnel remove the mold on the closet doors, bulletin boards, and insulated pipes since the mold is in excess of 25 contiguous square feet.

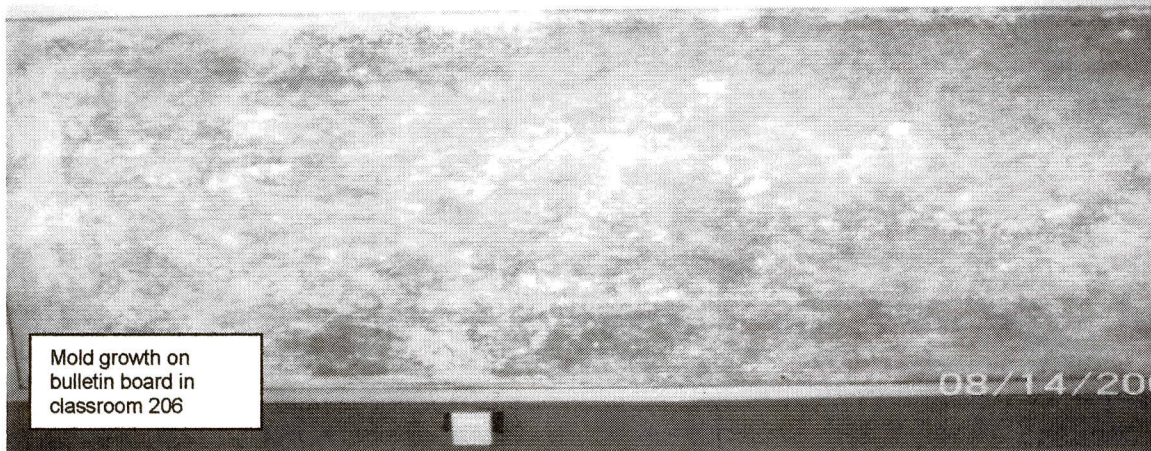
Photo 2

Mold growth on bulletin board in classroom 206

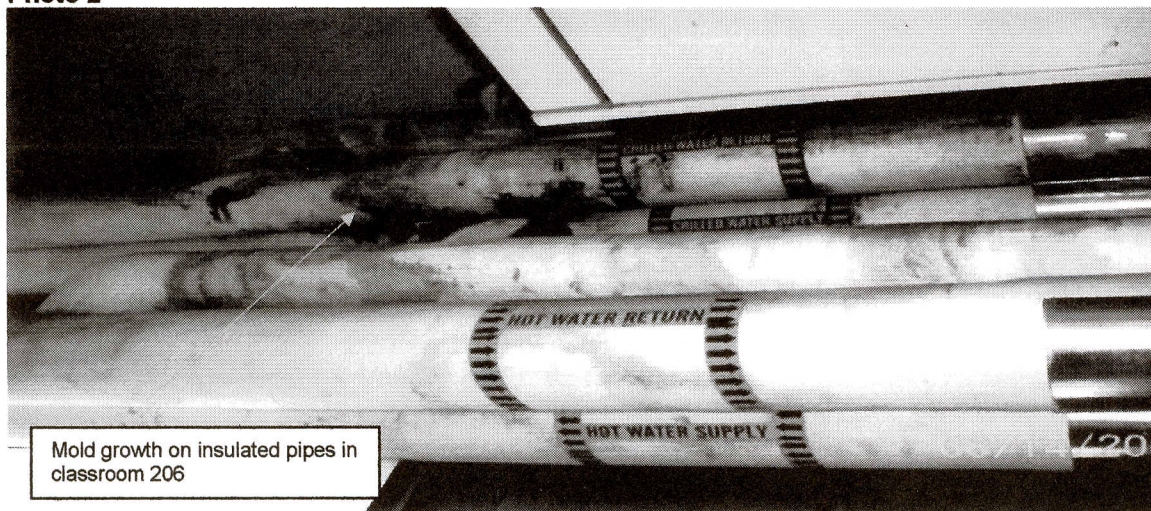
Photo 3

Mold growth on insulated pipes in classroom 206

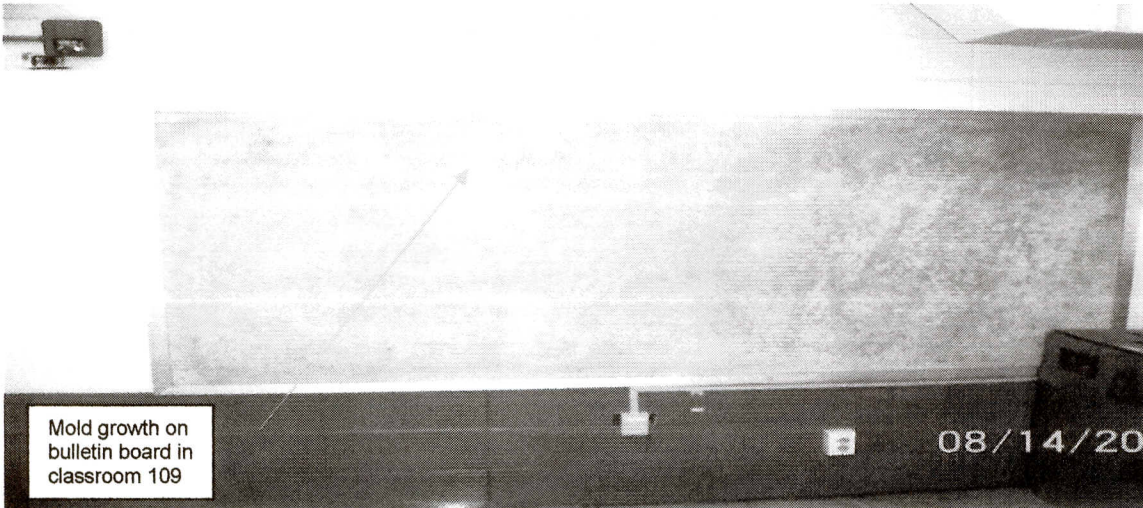
Photo 4

2. At the time of the investigation, in classroom 109, visible mold growth on the bulletin board was in excess of 25 contiguous square feet. (See photo 4 on page 5)

Mold growth on
bulletin board in
classroom 109

2. The recommended course of action for classroom 109 is to have licensed mold remediation personnel remove the mold on the bulletin board since the mold is in excess of 25 contiguous square feet.

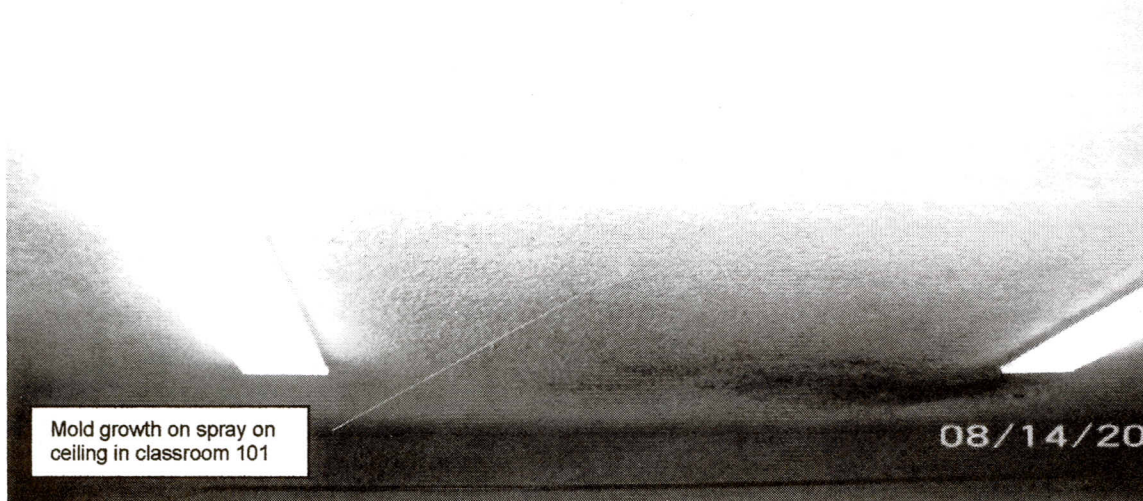
Photo 5

4. At the time of the investigation, in classroom 101, visible mold growth was observed on the spray on ceiling and on the closets. The mold was in excess of 25 contiguous square feet on both the spray on ceiling and the closets. (See photos 5-6 on page 5)

Mold growth on spray on
ceiling in classroom 101

4. The recommended course of action for classroom 101 is to have licensed mold remediation personnel remove the mold on the spray on ceiling and on the closets since the mold is in excess of 25 contiguous square feet.

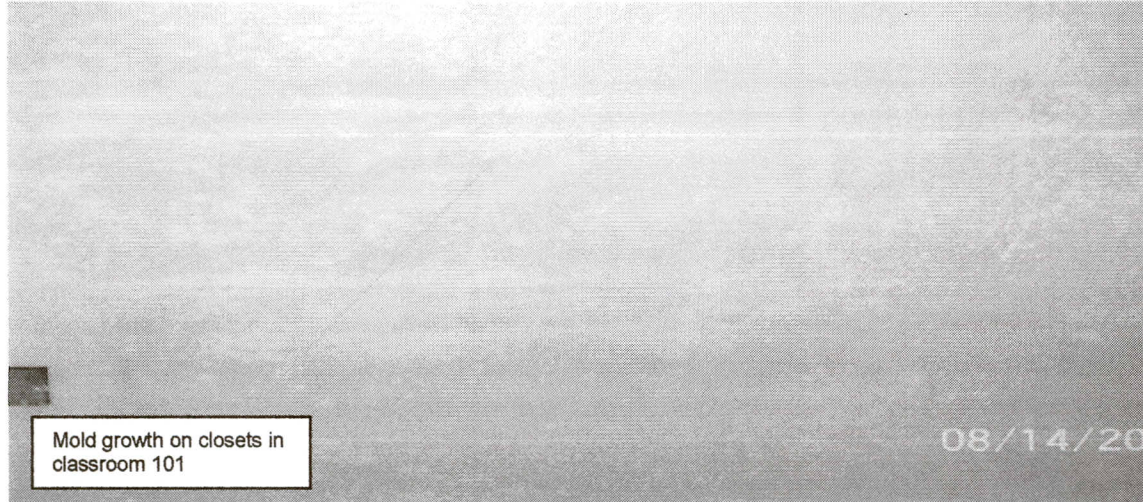
Photo 6

Mold growth on closets in
classroom 101
