Safety Study - Transport of Hazardous Materials by Rail

**NATIONAL
TRANSPORTATION
SAFETY
BOARD**

SAFETY STUDY

TRANSPORT OF HAZARDOUS MATERIALS BY RAIL

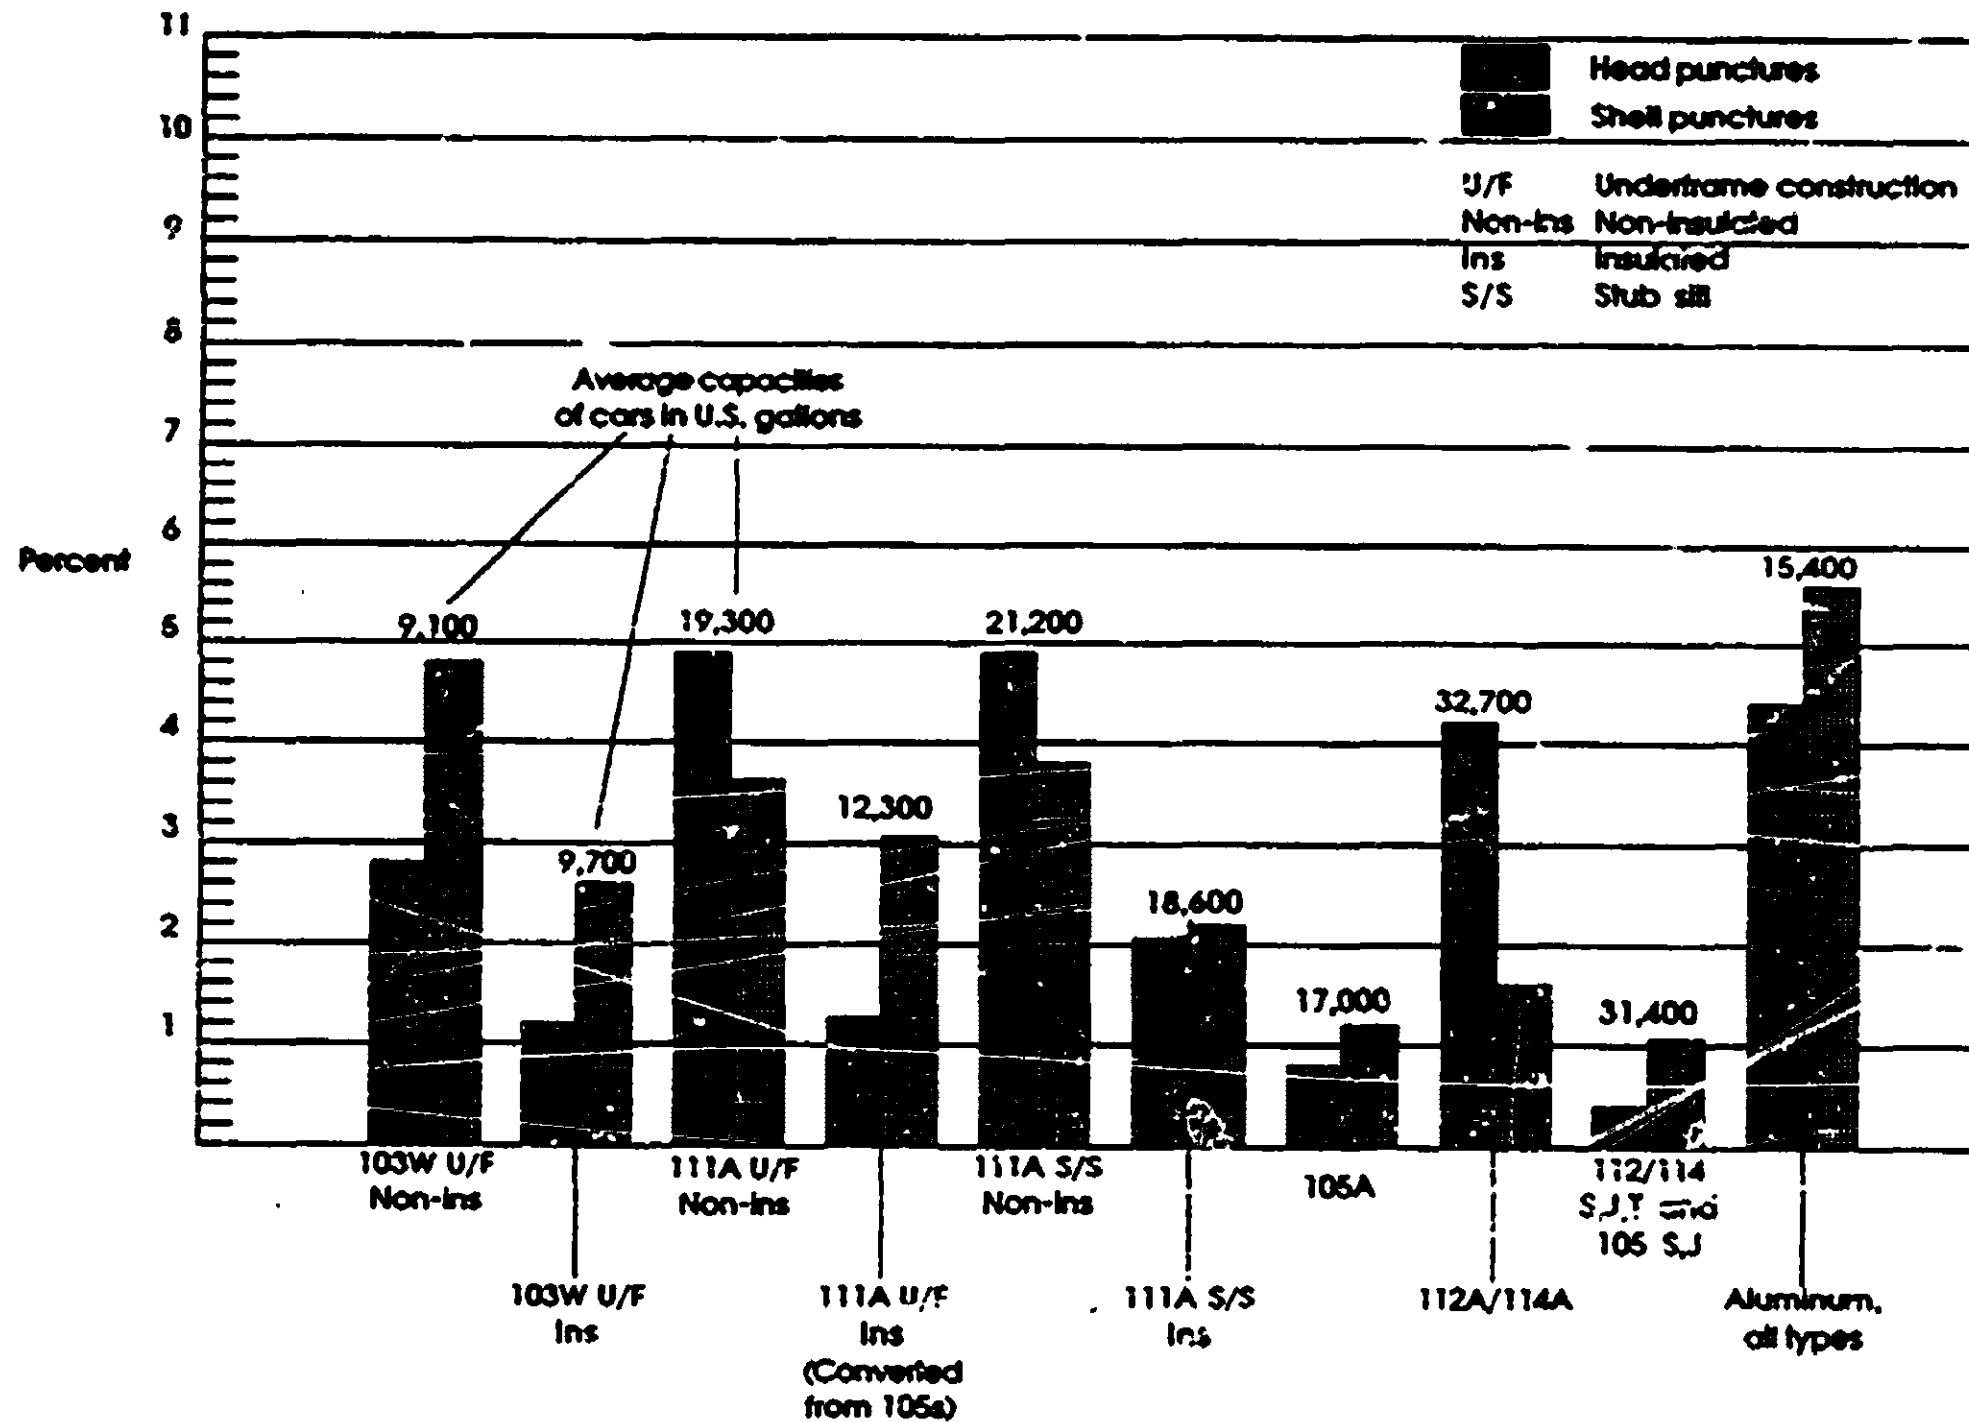
The RPI and AAR, in their 1990 study that analyzed the performance of the DOT-111A tank cars and other tank cars (RPI and AAR 1990a), reported a greater incidence of head and shell punctures in DOT-111A (insulated and non-insulated), DOT-112A/114A, and aluminum tank cars (fig. 1)--none of which have the improved tank head resistance protection and/or thermal protection as required for the DOT-112S, J, and T tank cars, the DOT-114S, J, and T tank cars, and for the DOT-105S, J, and T tank cars (see footnote 5). The incidence of head and shell punctures in tank cars damaged in accidents to the total number of tank cars damaged in accidents during a 22-year period (1965-86) is also shown in figure 1.

Figure 1.--Incidence of head and shell punctures to total number of tank cars damaged in accidents, 1965-86. (Source: Railway Progress Institute and Association of American Railroads 1990a.)
