**DEPARTMENT OF TRANSPORTATION**

01-262004  
MEN-101-R69.4/R78.9KP  
CONSTRUCT WILLITS BYPASS  
Sent via E-mail

**RE: Letter of Response to NCRWQCB April 2, 2014 Inspection Report**

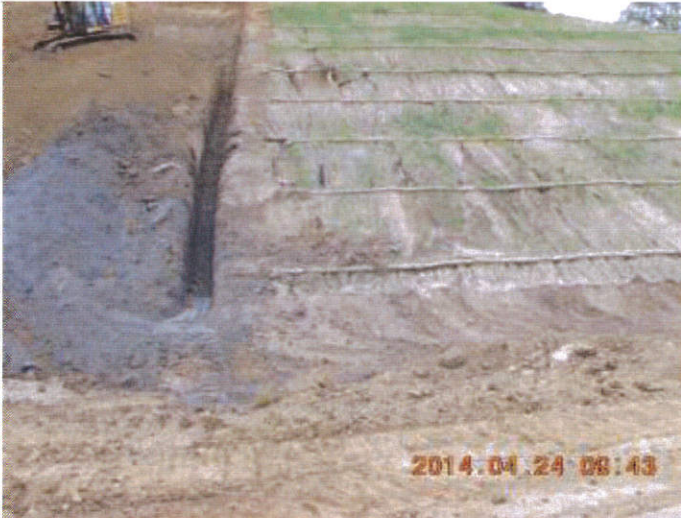
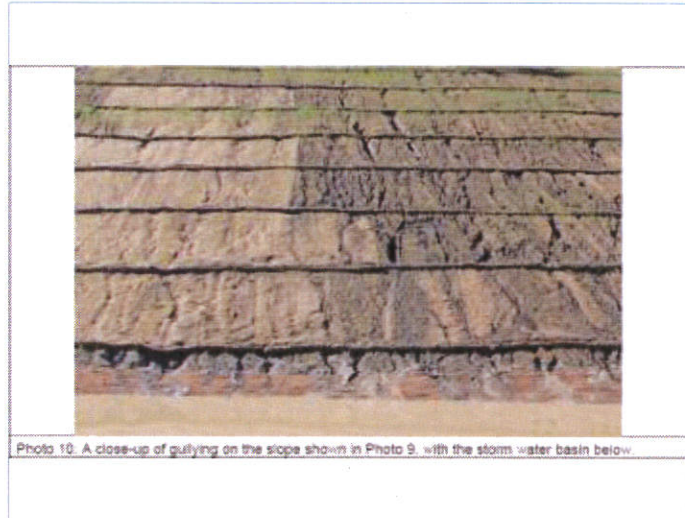
11

"U1, Line," Photo 1 through Photo 19, West of Hwy 101, Southern-Most Project Limits, South Haehl Creek Watershed, Water Quality Monitoring Stations WQ01 and WQ03

Description: Repair in progress for permanent slope.

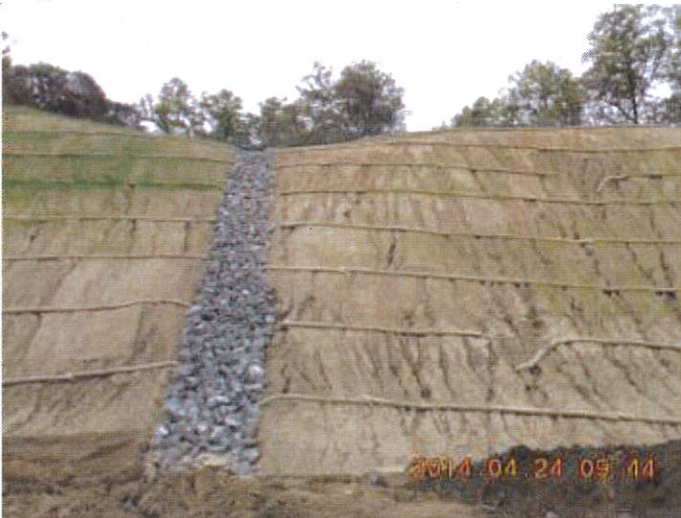
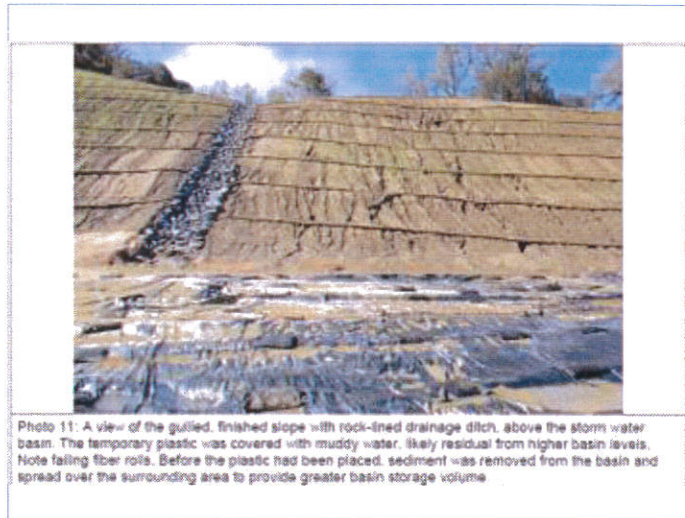
12

"U1, Line," Photo 1 through Photo 19, West of Hwy 101, Southern-Most Project Limits, South Haehl Creek Watershed, Water Quality Monitoring Stations WQ01 and WQ03

Description: Repair in progress for permanent slope.

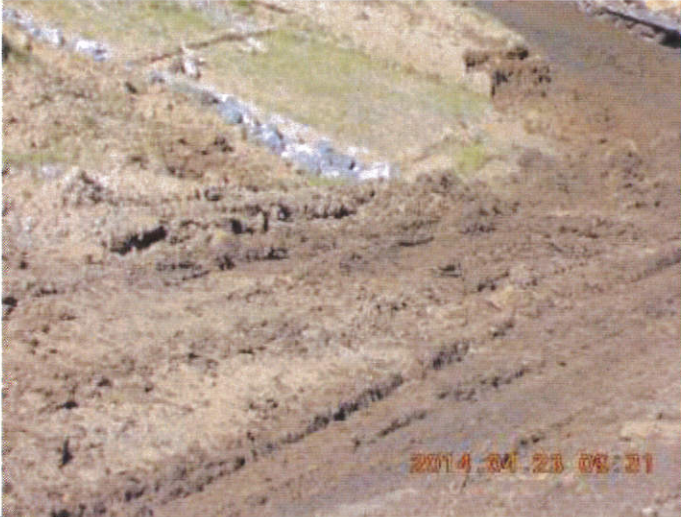
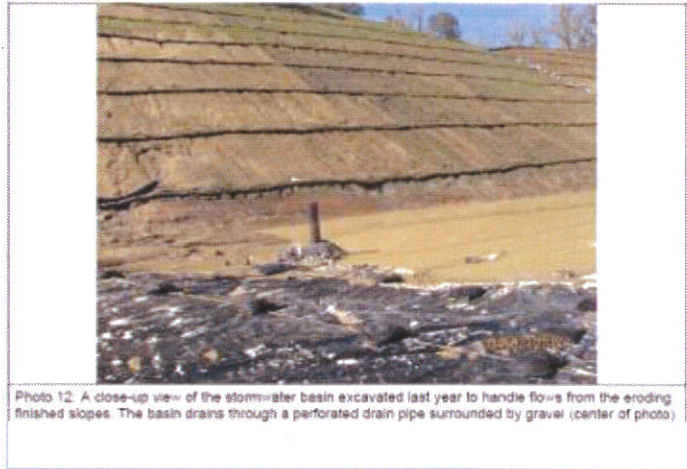
Photo 12: A close-up view of the stormwater basin excavated last year to handle flows from the eroding finished slopes. The basin drains through a perforated drain pipe surrounded by gravel (center of photo)

Description: Inlet capped and removed, Repair in progress for permanent slope. "U1" area bermed with temp cover where necessary.

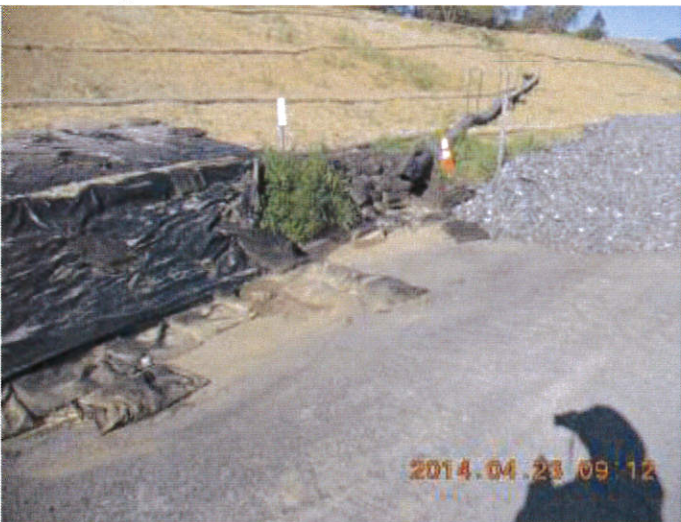
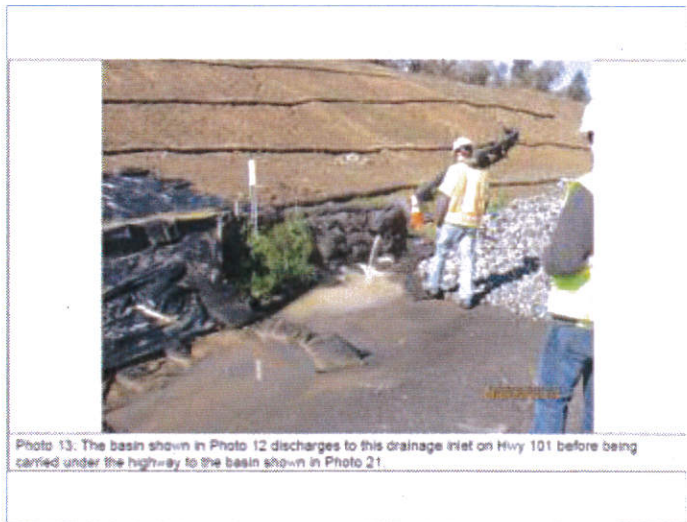
Photo 13: The basin shown in Photo 12 discharges to this drainage inlet on Hwy 101 before being carried under the highway to the basin shown in Photo 21

Description: Inlet capped and removed, Repair in progress for permanent slope. "U1" area bermed with temp cover.

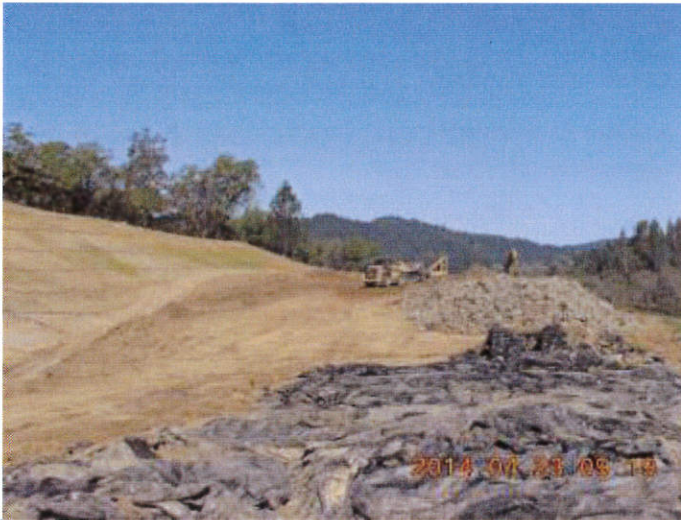
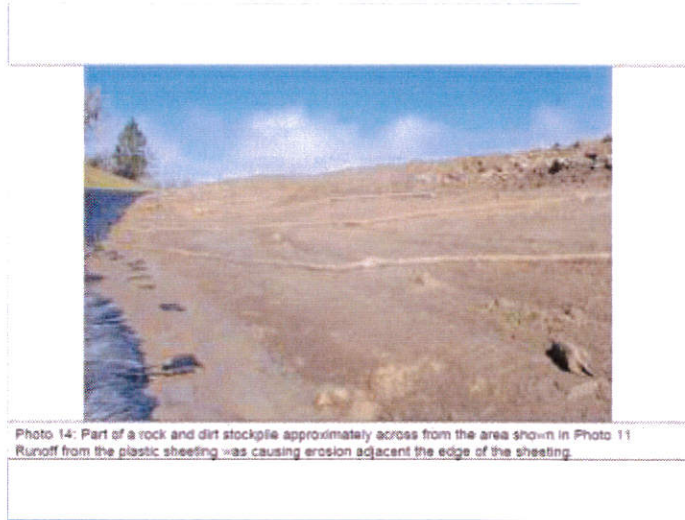
15

"U1, Line," Photo 1 through Photo 19, West of Hwy 101, Southern-Most Project Limits, South Haehl Creek Watershed, Water Quality Monitoring Stations WQ01 and WQ03

Description: Repair in progress for permanent slope. "U1" area bermed with temp cover where necessary.

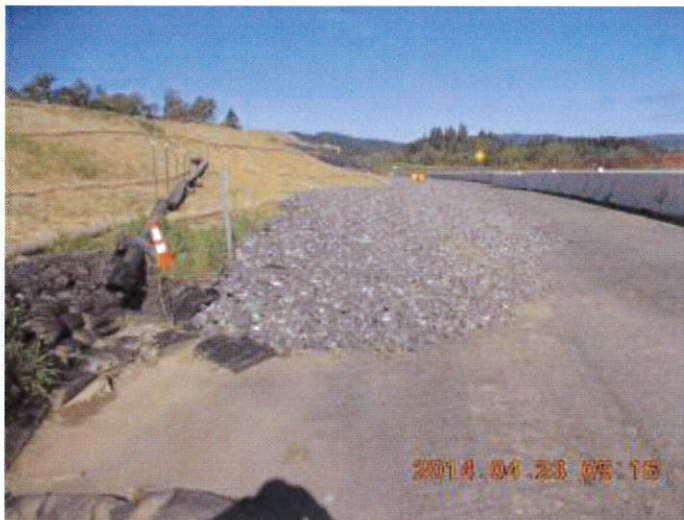
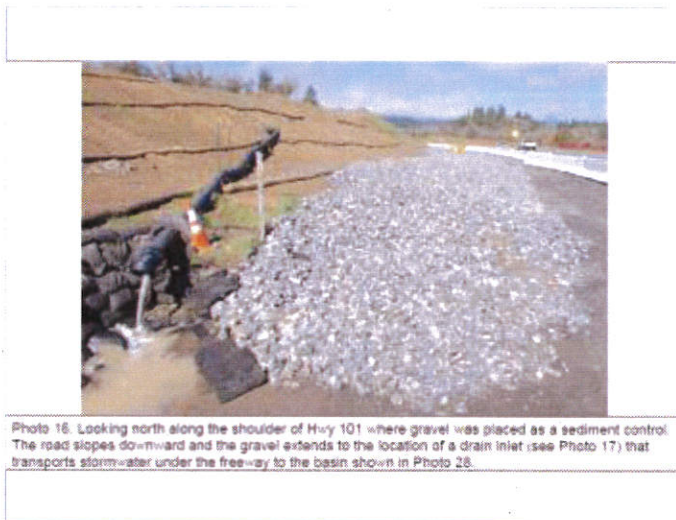
Photo 16. Looking north along the shoulder of Hwy 101 where gravel was placed as a sediment control. The road slopes downward and the gravel extends to the location of a drain inlet (see Photo 17) that transports stormwater under the free-way to the basin shown in Photo 28.

Description: Inlet capped and removed, Repair in progress for permanent slope. "U1" area bermed with temp cover.

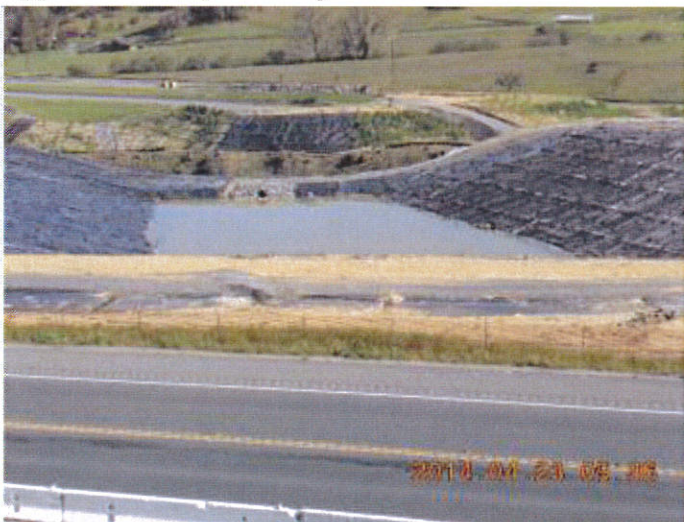
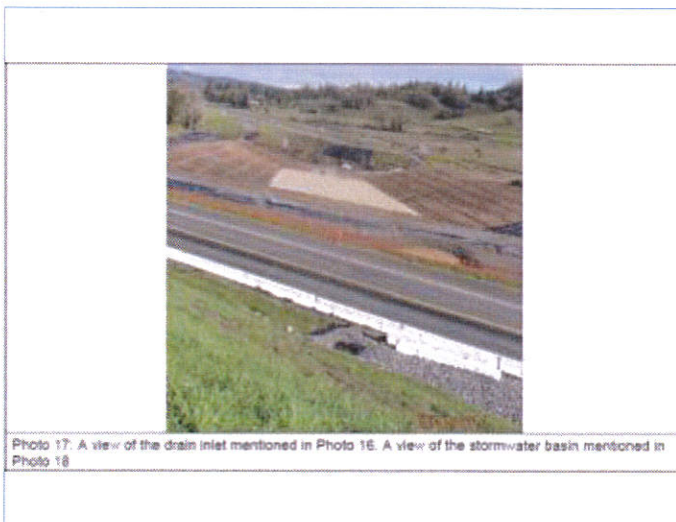
Photo 17. A view of the drain inlet mentioned in Photo 16. A view of the stormwater basin mentioned in Photo 16

Description: Temporary cover applied to slopes on Basin 4. Area between Basin 4 and "H" had BFM applied due to proximity to the Basin.

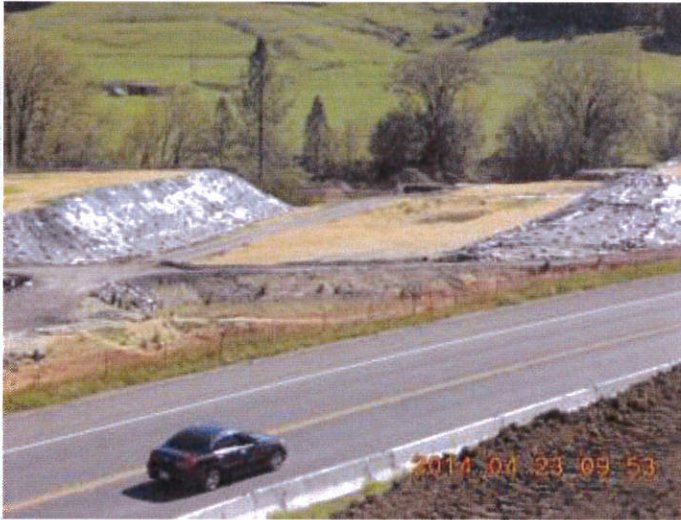
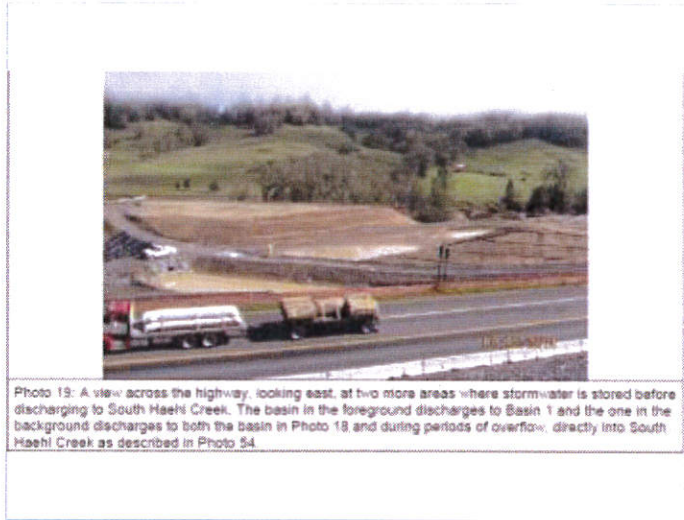
Photo 19: A view across the highway, looking east, at two more areas where stormwater is stored before discharging to South Haehl Creek. The basin in the foreground discharges to Basin 1 and the one in the background discharges to both the basin in Photo 18 and during periods of overflow directly into South Haehl Creek as described in Photo 54

Description: Temp cover applied on abutment slopes. Straw mulch applied on the exposed soil along the "H" alignment.

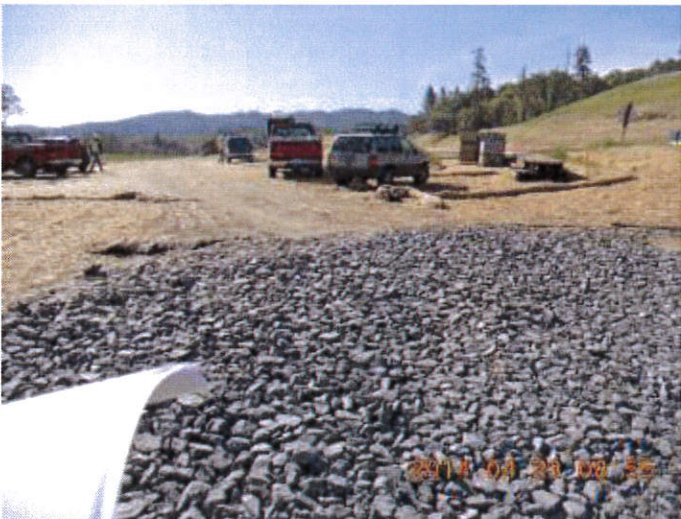
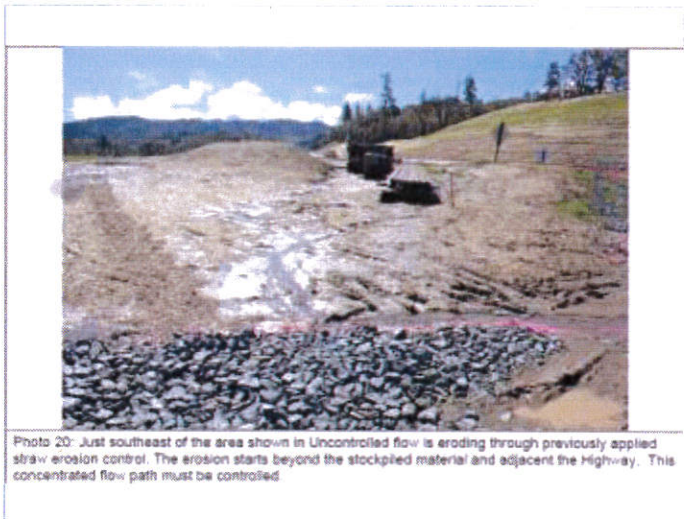
Just southeast to the area shown Uncontrolled flow is eroding through previously placed applied straw erosion control. The erosion starts beyond the stockpiled material and adjacent the highway. This concentrated flow path must be controlled.

Photo 20: Just southeast of the area shown in Uncontrolled flow is eroding through previously applied straw erosion control. The erosion starts beyond the stockpiled material and adjacent the highway. This concentrated flow path must be controlled.

Description: Fiber rolls installed and straw mulch applied. Fiber rolls displaced as necessary access for repair the "U2" slip out. Fiber rolls to be replaced at end operation.

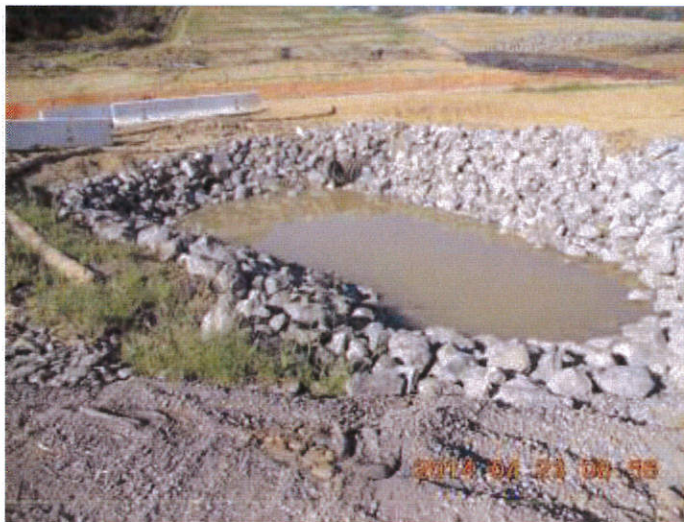
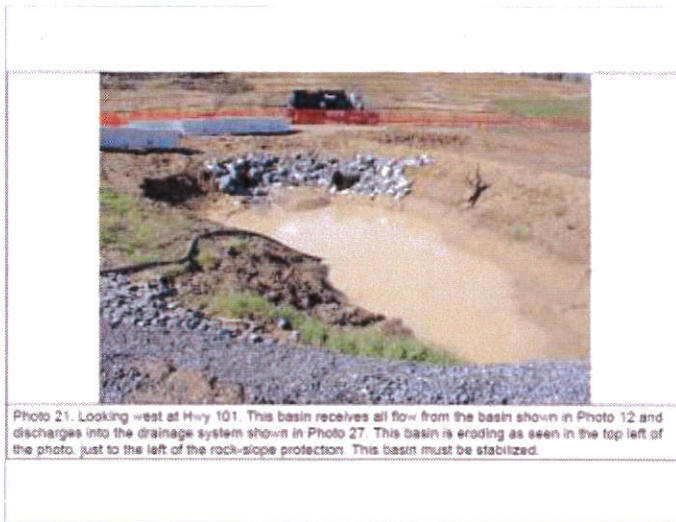
This Basin must be stabilized.

Photo 21. Looking west at Hwy 101. This basin receives all flow from the basin shown in Photo 12 and discharges into the drainage system shown in Photo 27. This basin is eroding as seen in the top left of the photo, just to the left of the rock-slope protection. This basin must be stabilized.

Description: RSP installed to stabilize slopes. Sediment at outflow of culvert from "U1" basin removed. Fiber rolls placed in perimeter areas to control run-on.

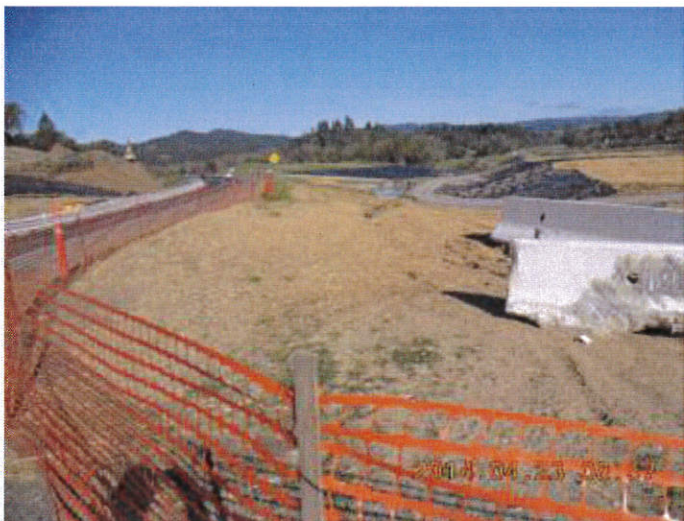
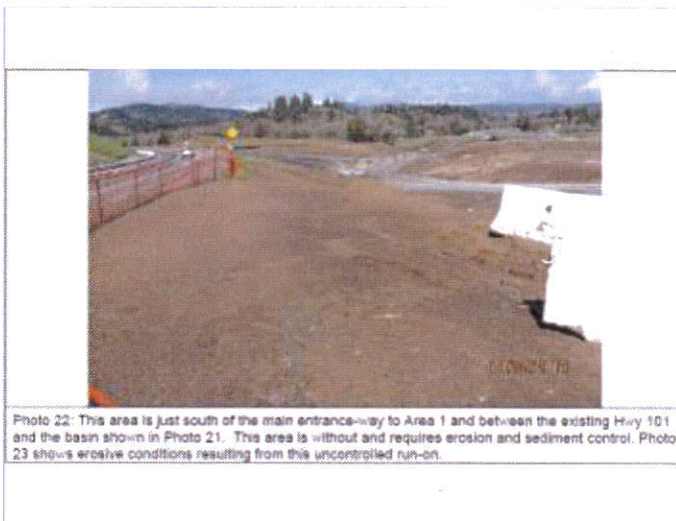
Area requires sediment and erosion control BMPs to treat stormwater run-on.

Photo 22: This area is just south of the main entrance-way to Area 1 and between the existing Hwy 101 and the basin shown in Photo 21. This area is without and requires erosion and sediment control. Photo 23 shows erosive conditions resulting from this uncontrolled run-on.

Description: Straw mulch applied. Fiber rolls to be installed to directionalize run-on away from the basin.

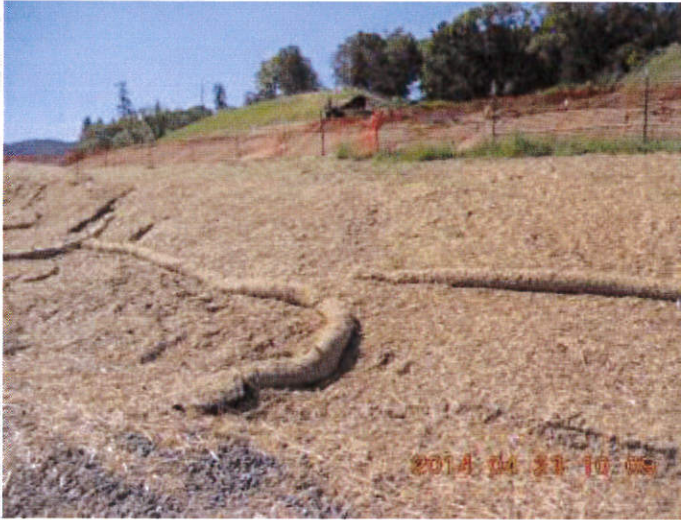
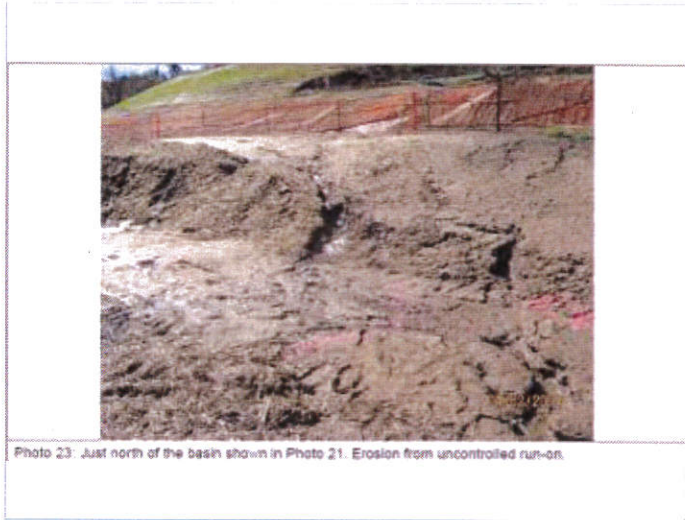
Water Board Comment:  
Erosion from uncontrolled run-on.

Photo 23: Just north of the basin shown in Photo 21. Erosion from uncontrolled run-on.

Description: area hand raked, straw mulch and fiber rolls installed. Minor adjustment in fiber roll alignment addressed.

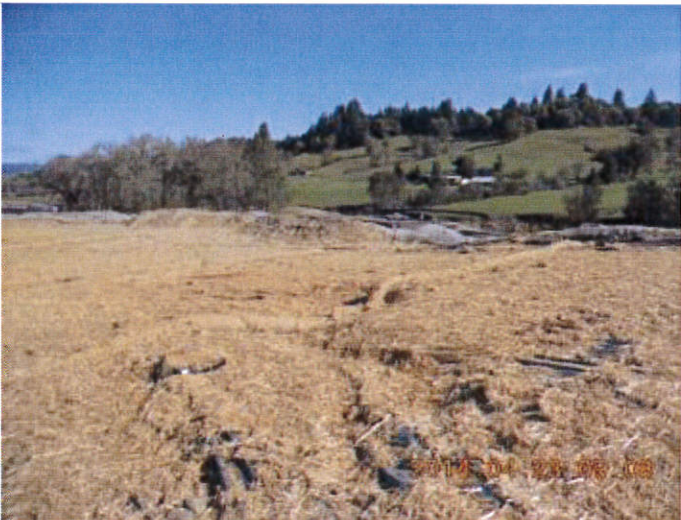
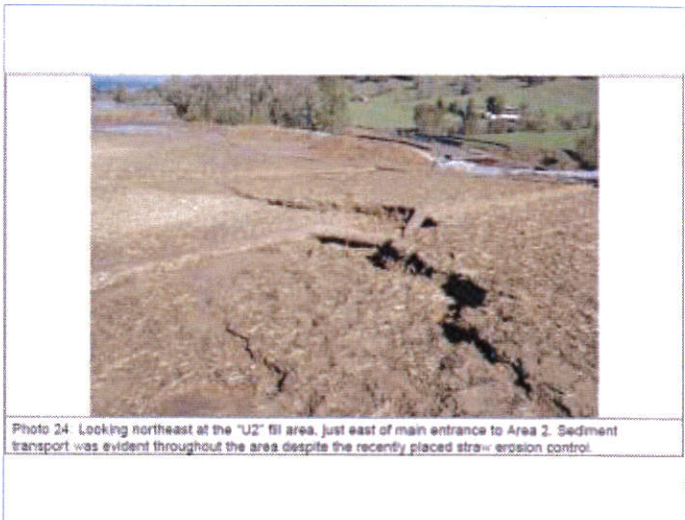
Water Board Comment:  
Sediment transport evident throughout the area despite the recently placed straw.

Photo 24: Looking northeast at the "U2" fill area, just east of main entrance to Area 2. Sediment transport was evident throughout the area despite the recently placed straw erosion control.

Description: Temporary cover placed on rilled location. Fiber rolls installed then straw mulch applied

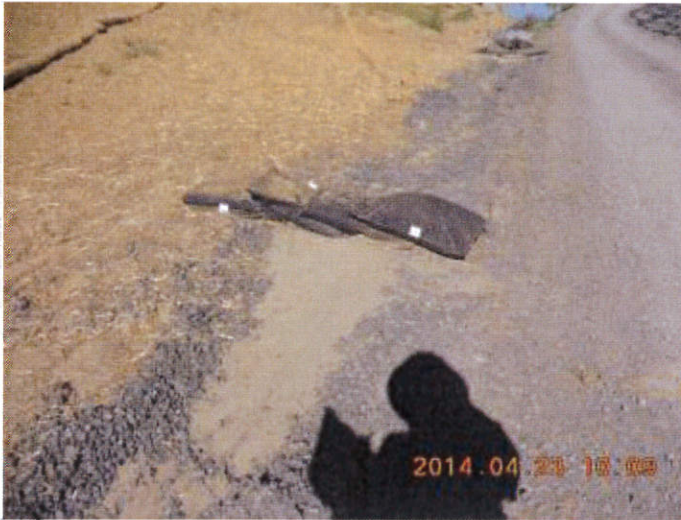
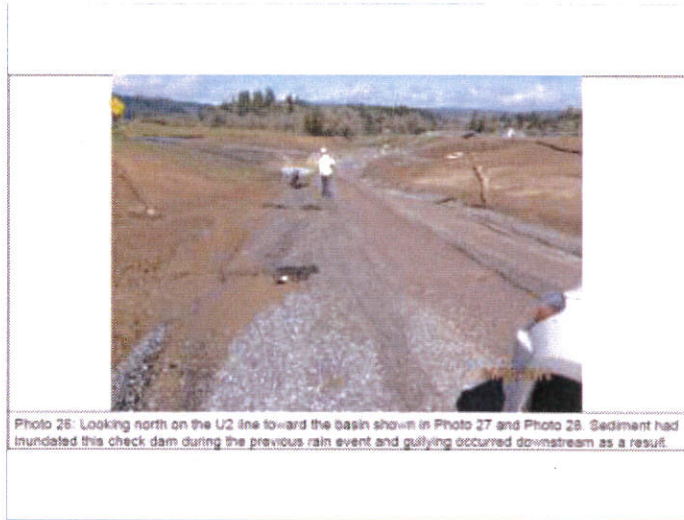
Sediment inundated this check dam during previous storm which caused gullying .

Photo 26: Looking north on the U2 line toward the basin shown in Photo 27 and Photo 28. Sediment had inundated this check dam during the previous rain event and gullying occurred downstream as a result.

Description: Maintenance and readjustment of gravel bag check dams added to 2035, corrective action summary sheet.

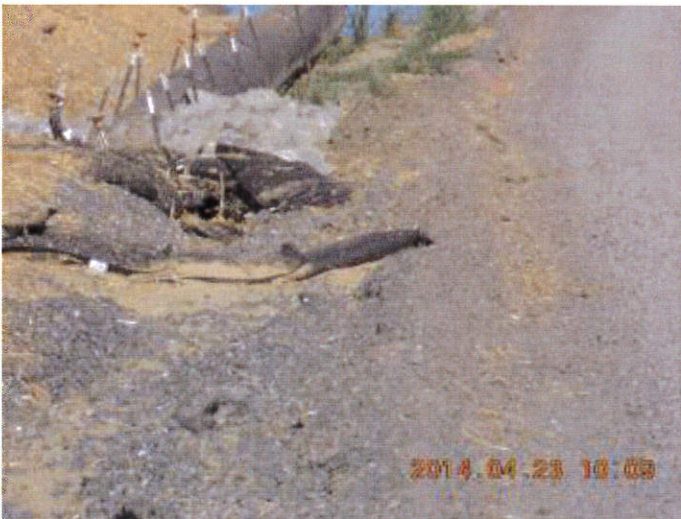
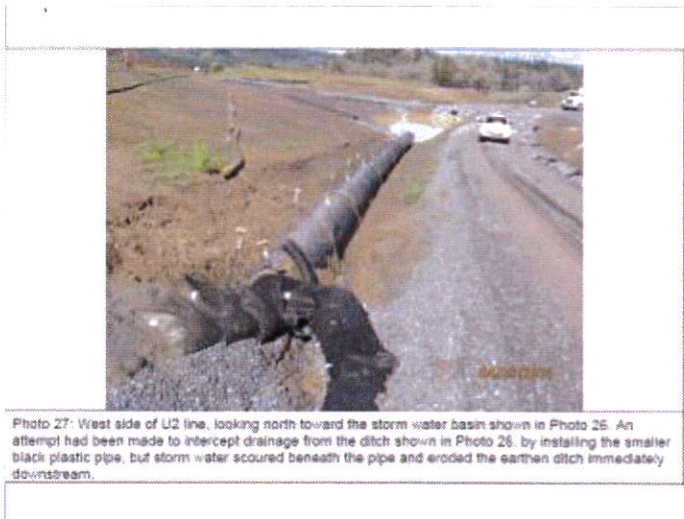
An attempt was made to intercept drainage from the ditch shown in Photo 26 by installing the smaller plastic pipe, but storm water scoured beneath the pipe and eroded the earthen ditch immediately downstream.

Photo 27: West side of U2 line, looking north toward the storm water basin shown in Photo 26. An attempt had been made to intercept drainage from the ditch shown in Photo 26, by installing the smaller black plastic pipe, but storm water scoured beneath the pipe and eroded the earthen ditch immediately downstream.

Description: Maintenance and readjustment of gravel bag check dams added to 2035, corrective action summary sheet. RSP and light backing placed to prevent scour under HDPE culvert.

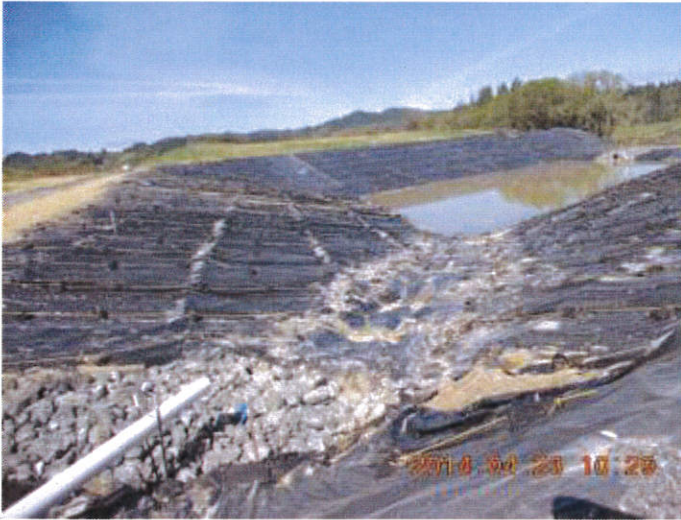
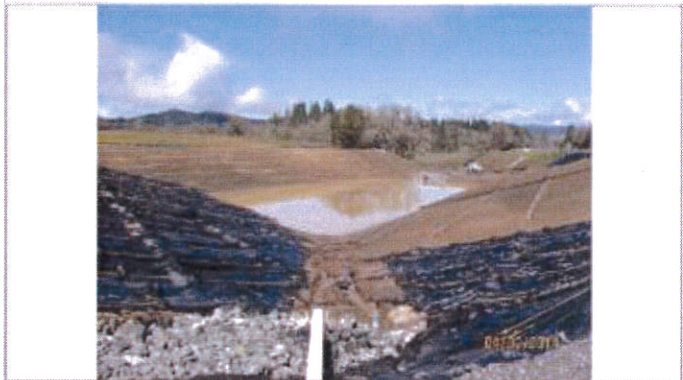
Stabilize channel to accommodate concentrated flows.

Photo 31: A view of Basin 1, looking north. The channel was eroding/eroded below the outlet seen in the foreground. This channel must be appropriately stabilized to accommodate concentrated flow.

Description: Temporary basin 4 has all slopes covered. Maintenance of temporary cover added to 2035, corrective action summary sheet.

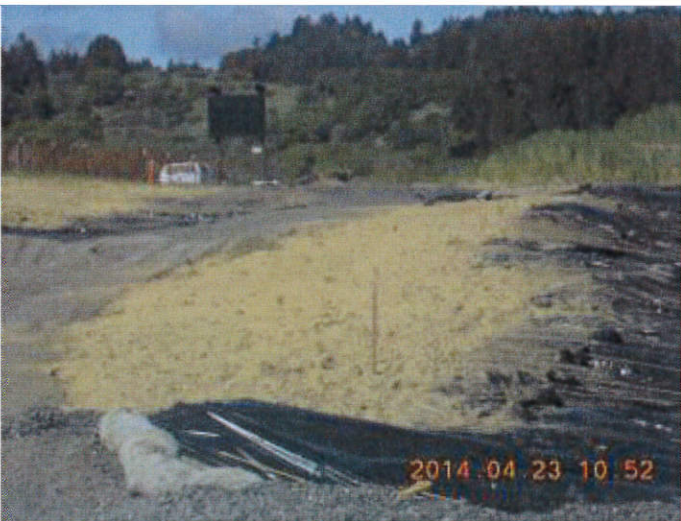
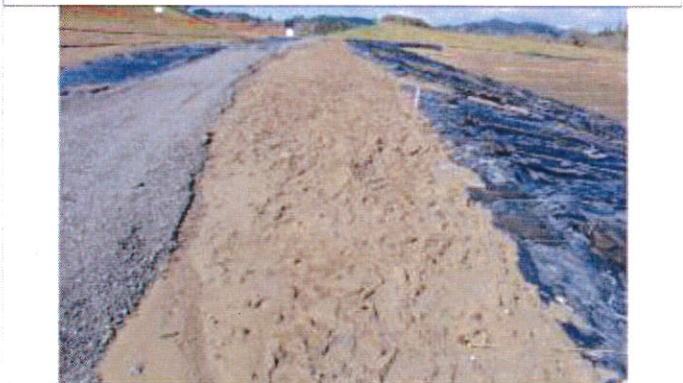
This area must be stabilized.

Photo 33: At the top of Basin 1, southern side, looking west. This dirt area was unstabilized and eroding. This area and others around the basin must be stabilized.

Description: BFM sprayed at location of exposed soil between Basin 4 and TC-2 "H" alignment

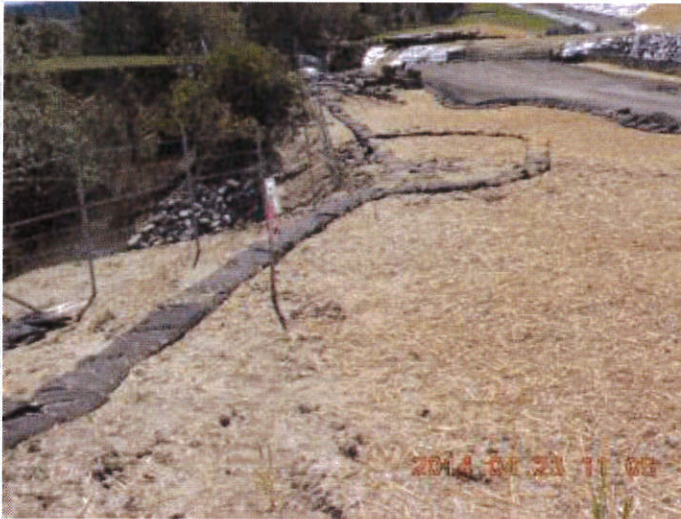
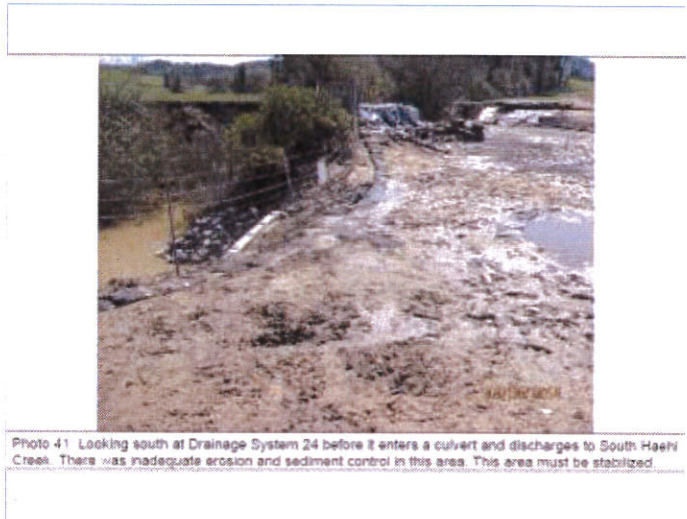
Inadequate erosion and sediment control. This area must be stabilized.

Photo 41 Looking south at Drainage System 24 before it enters a culvert and discharges to South Haehi Creek. There was inadequate erosion and sediment control in this area. This area must be stabilized.

Description: Straw mulch applied. Rilling inside temporary construction easement will be hand raked and temp cover placed. Work will be performed only while Water Quality Monitor on site.

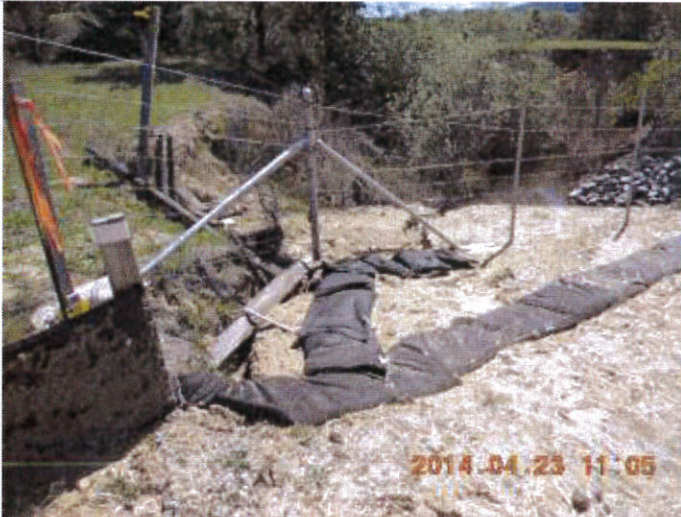
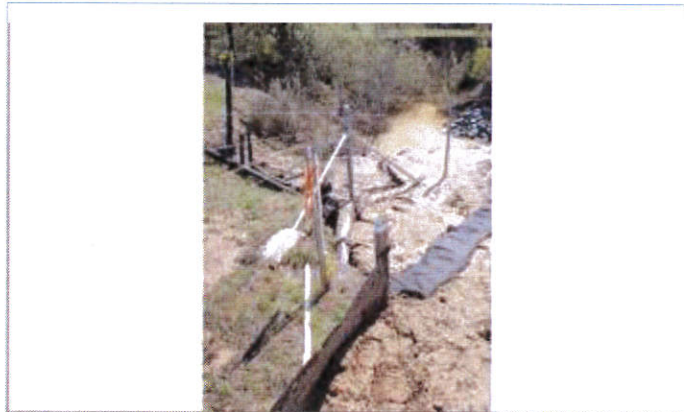
Stabilize soil disturbance within the temporary construction easement area.

Photo 42. Looking southeast at Drainage System 24 before it enters a culvert and discharges to South Haehl Creek. A large gully has formed developed into the channel, as seen in the center of the photo. The steel fence is the Caltrans right-of-way fence. Caltrans staff said they were limited to fixes within their right-of-way; however, the disturbance on the other side of the fence was created by Caltrans and is Caltrans's responsibility to stabilize.

Description: Straw mulch applied. Rilling inside temporary construction easement will be hand raked and temp cover placed. Work will be performed only while Water Quality Monitor on site.

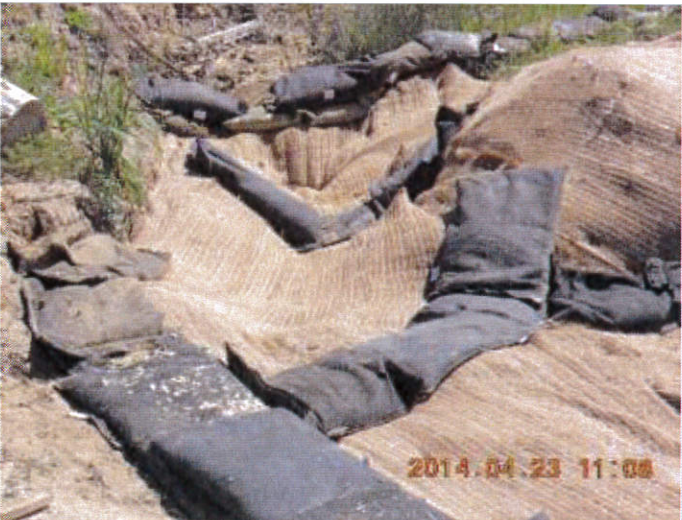
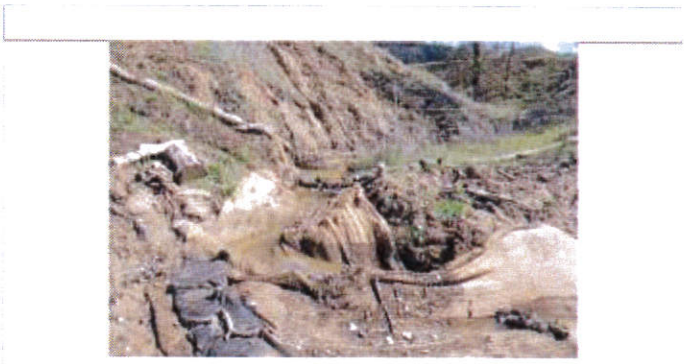
Water Board Comment:  
Provide a stable drainage path. The final drainage configuration must be approved by the Regional Water Board.

Photo 45: A closer view of the area shown in Photo 44, upper right. This watercourse runs into Caltrans's project limits from the Schmidbauer property, just before discharging to South Haehl Creek. Because a stable drainage path to South Haehl Creek was not planned for and provided, drainage has eroded the creek bank and transported sediment to South Haehl Creek. A stable drainage path must be provided. Plans for the final drainage configuration must be approved by the Regional Water Board. Biotechnical elements should be incorporated as appropriate.

Description: New Temporary cover and gravel bag check dams installed. Corrections to the implementation on 2035, corrective action form.

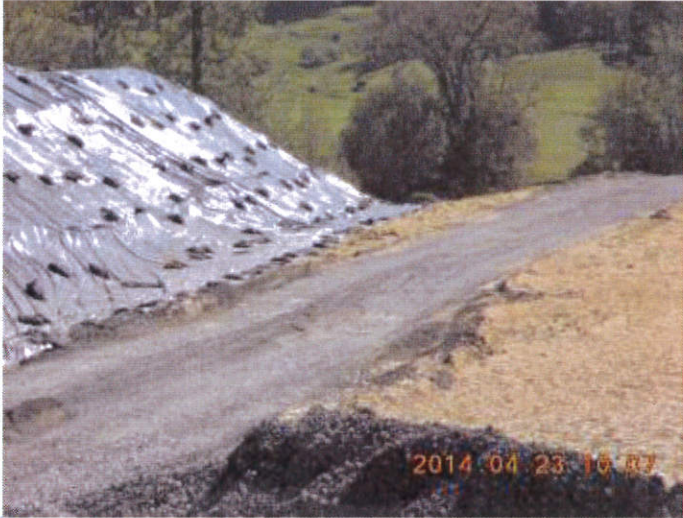
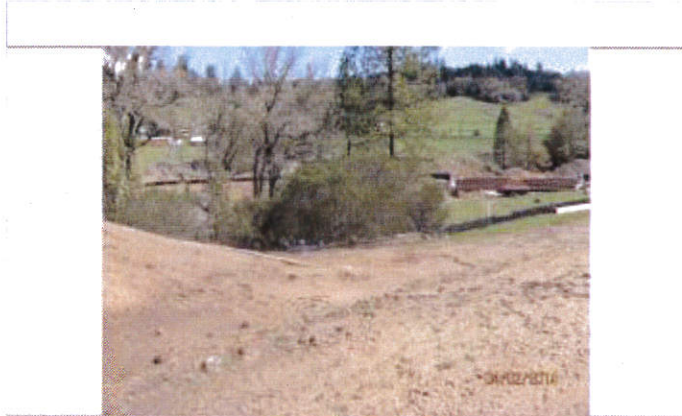
Address uncontrolled run-off to S. Haehl CR. Replace damaged silt fence.

Photo 54: There was evidence that the basin shown in Photo 19 and Photo 55 overflowed down this slope, through the silt fence, and into South Haehl Creek. Erosion can be seen in the center-right of the photo. The silt fence shown in the distance was worn and requires replacement.

Description: Exposed soil areas have been stabilized with plastic cover, road base, and straw. Silt fence repair completed.

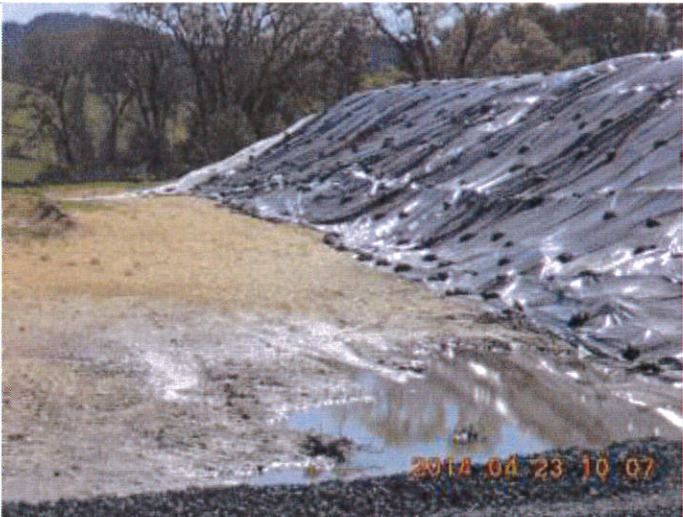
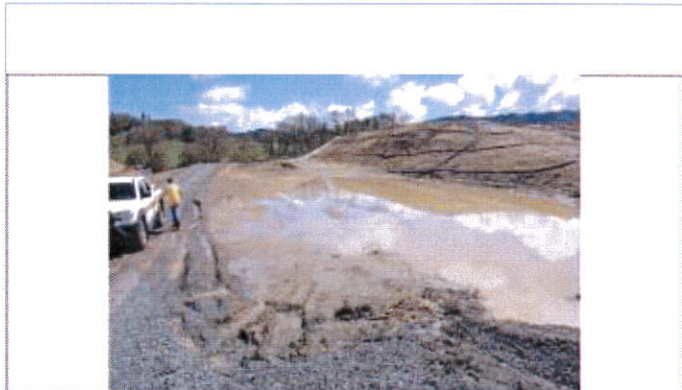
Basin overflow drains directly to S. Haehl Creek.

Photo 55: This basin primarily drains to Basin 1 through an inlet just to the lower right of the photo (see Photo 56), but will overflow directly to South Haehl Creek at the location in the upper left of the photo and as shown in Photo 54.

Description: Plastic cover placed on slopes to reduce sediment delivery to basin. Straw mulch applied between TC-2 and Temporary cover.

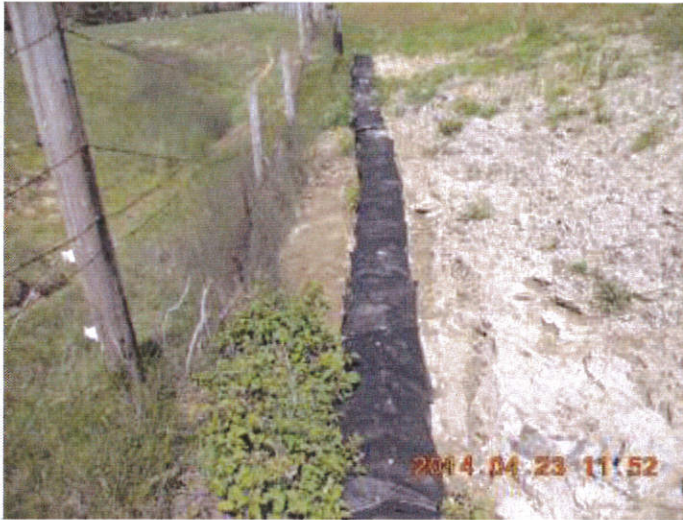
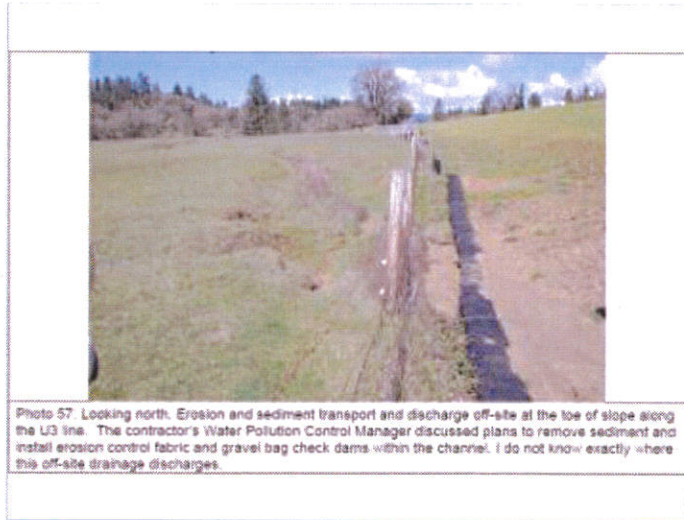
WPCM discussed plans to remove sediment and install EC fabric and gravel bag check dams within the channel.

Photo 57: Looking north. Erosion and sediment transport and discharge off-site at the toe of slope along the U3 line. The contractor's Water Pollution Control Manager discussed plans to remove sediment and install erosion control fabric and gravel bag check dams within the channel. I do not know exactly where this off-site drainage discharges.

Description: Gravel bag berm maintained. Netting to be installed on area of exposed soil as listed on 2035, corrective action summary.

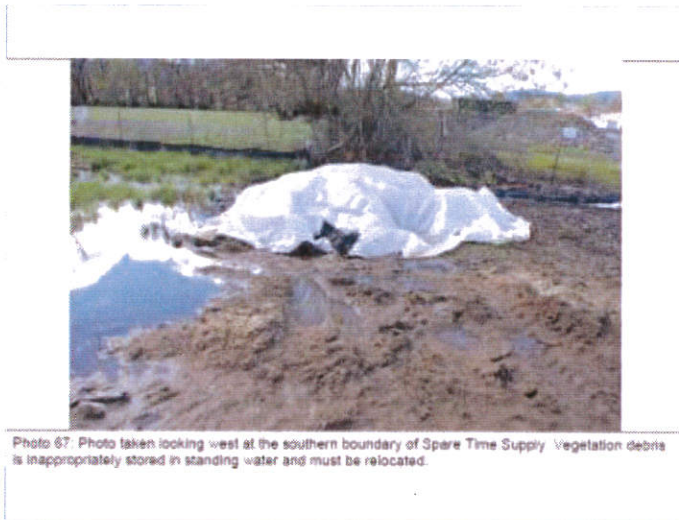
Photo 67: Photo taken looking west at the southern boundary of Spare Time Supply. Vegetation debris is inappropriately stored in standing water and must be relocated.

Description: Debris has been removed. Straw mulch to be applied per 2035, corrective action summary form.

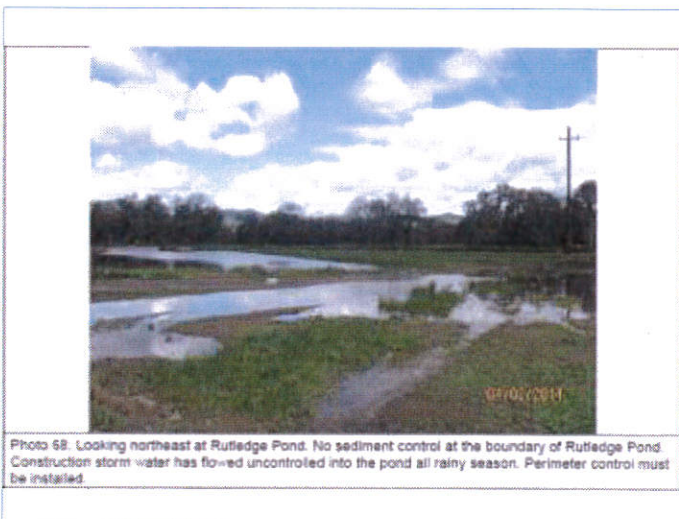
Photo 68: Looking northeast at Rutledge Pond. No sediment control at the boundary of Rutledge Pond. Construction storm water has flowed uncontrolled into the pond all rainy season. Perimeter control must be installed.

Description: Silt fence installed. Straw mulch applied to exposed soil area between pond and DS 48.

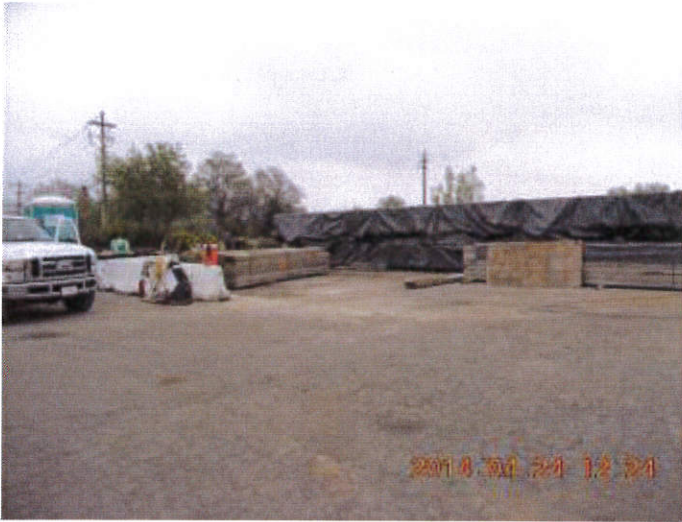
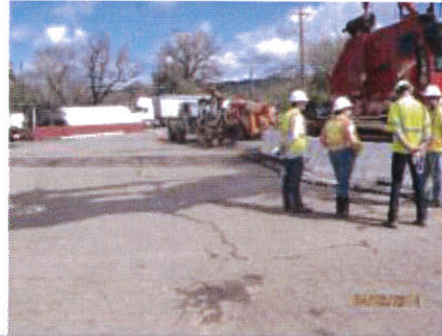
Photo 71: It appeared that fluid had drained from the spill area as indicated by the water mark on the asphalt. We communicated that the material, including the gravel bags must be disposed of immediately subject to appropriate hazardous waste disposal protocol. Caltrans had not been notified of the incident and potential discharge.

Description: Clean up method provided by WPCM, Jim Montgomery. Area of oil spill was covered with absorbent, swept up and then vacuumed to remove as much of the contaminated absorbent as possible. All contaminated absorbent, pads, and gravel bags were disposed of in 55 gallon hazmat barrels provided by Safety Kleen, Inc. JV continuing to monitor location. Additional information on notifications, clean-up timelines is provided in Enclosure 1.

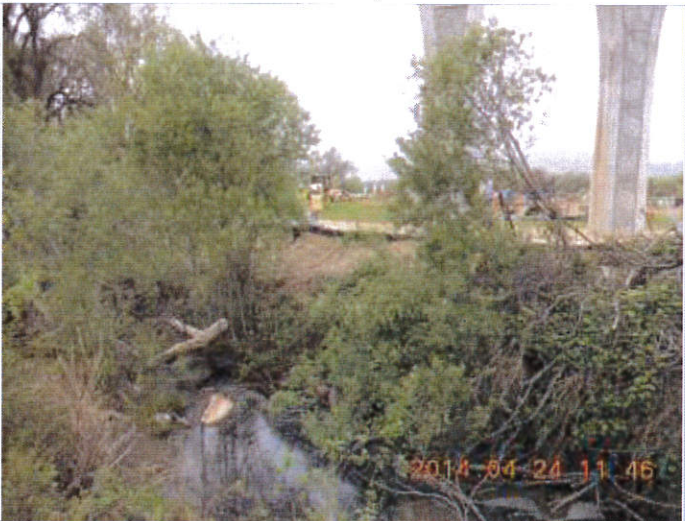
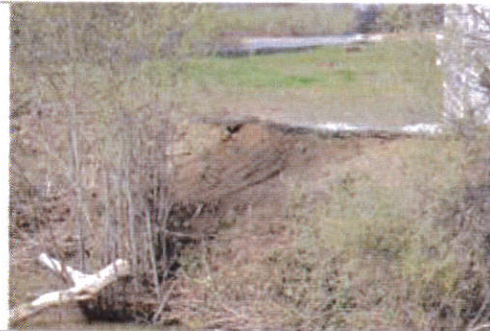
Photo 72: Looking north-west. Sediment discharge to Baechtel Creek at Pier 4 as a result of inadequate erosion control and failed sediment control. Erosion and sediment control must be provided.

Description: Erosion control blanket placed on exposed soil. Gravel bag check dam maintenance performed and additional layer of bags installed.
