GHOST SHIP FIRE STARTED IN ADJACENT BUILDING

Was Ghost Ship fire caused by inadequate Utility Wiring?

1305 – 31st Avenue, Oakland, CA 94601

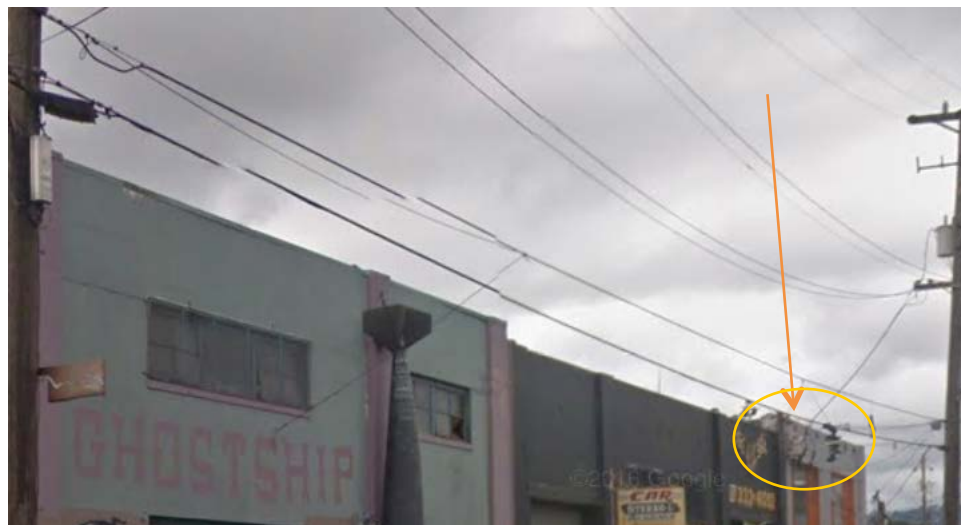
- 1) No apparent direct utility drop to the building segment (Ghost Ship Unit) in question.
- 2) There are TWO apparent Utility drops to the complex as the buildings are adjacent and abutting to each other.
 - a. One at the Boost Mobile entrance

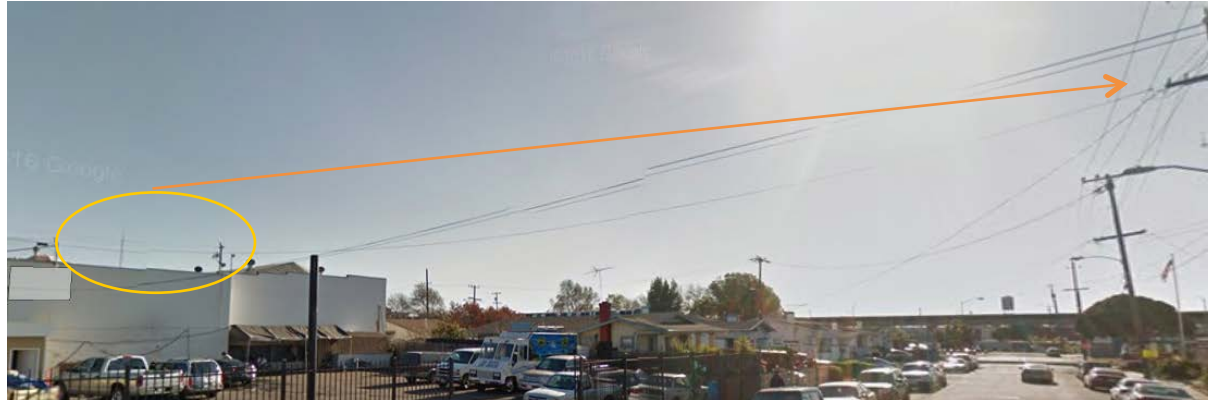
- b. The second appears to go to center building via drop line from rear on Derby Street to a roof mounted Weatherhead:

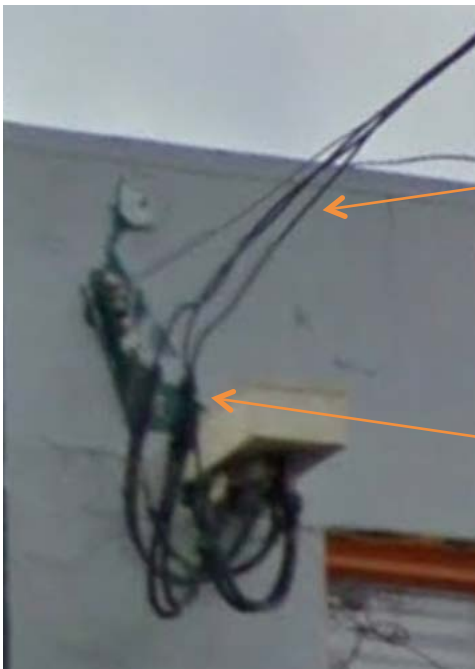
The Boost Mobile front side connection shows a clearly undersized PG&E drop when compared to the building services wires emerging from the weatherhead.

PG&E Drop wires. Undersized when compared to building wire.

Boost Mobile - Building service wires.
2x 4/0 copper wires per phase.
Capacity of 400Amps within the building

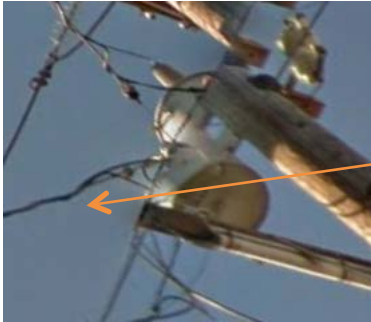
The Line drop from Derby Street is similarly small.

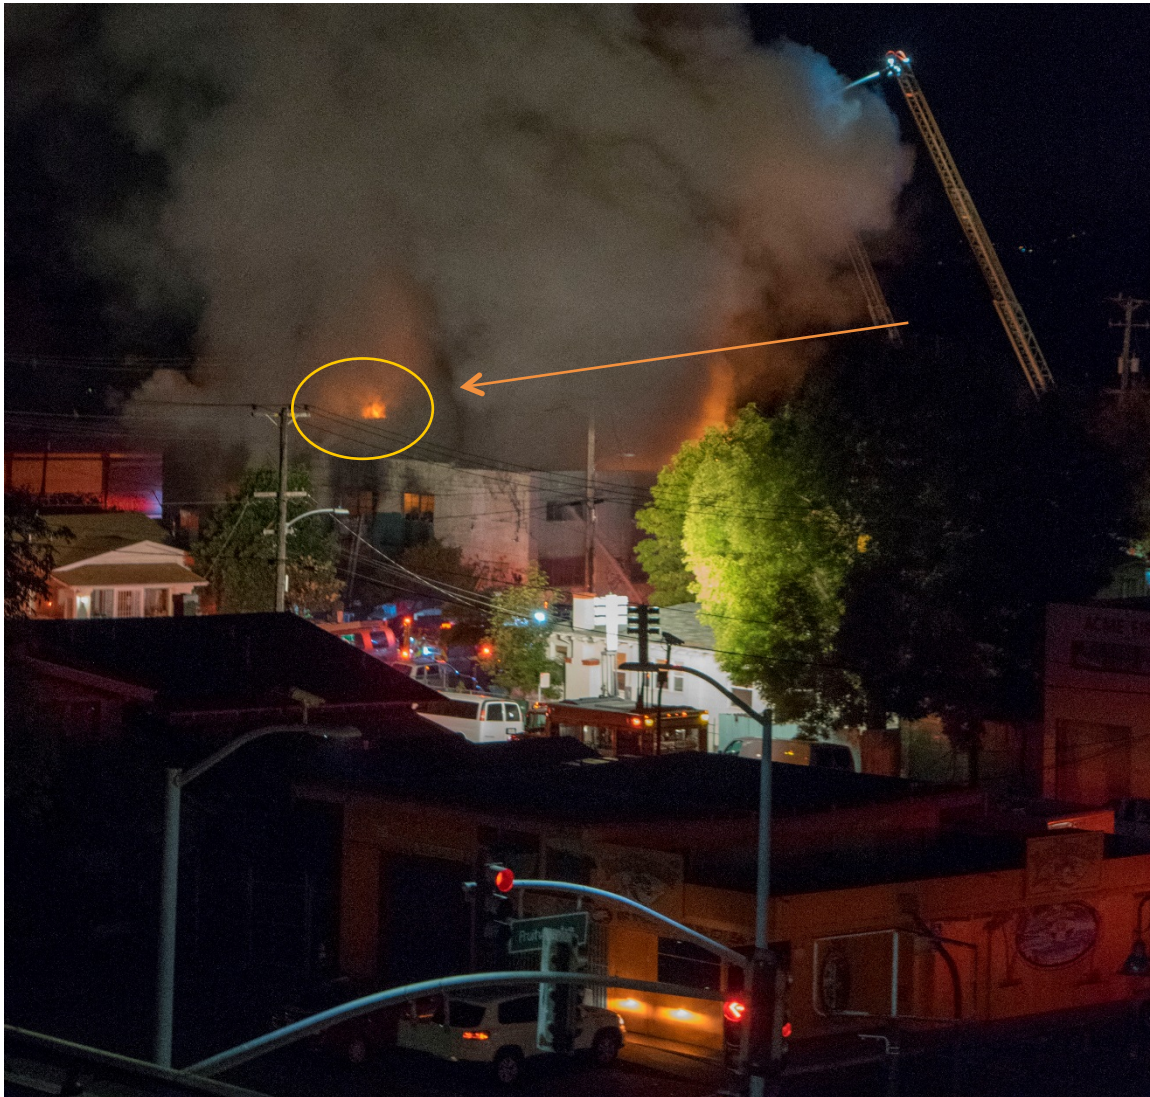
- 1) Fire seen on adjacent building:

Photographs drawn from Wikipedia Page on fire show fire hot spot on adjacent building DURING fire.
<https://www.flickr.com/photos/54485353@N05/30595918003/in/photostream/>

- 1) the fire was NOT constrained to the Ghost Ship Unit alone
- 2) damage was extensive enough inside the adjacent building to have the fire department removing the roof that was near but NOT directly adjacent to the Ghost Ship building.

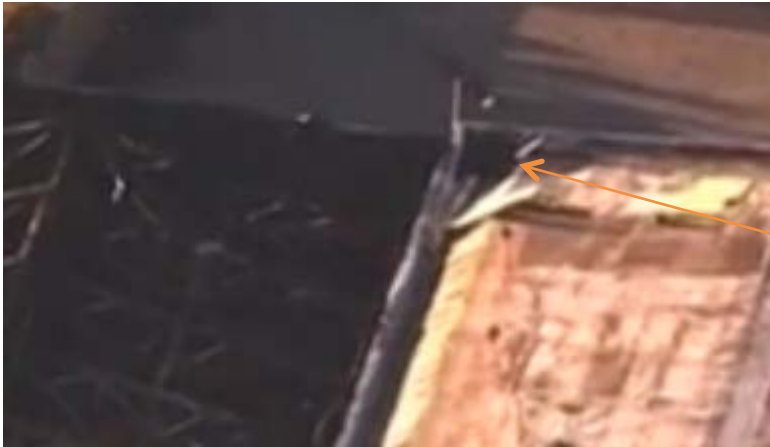
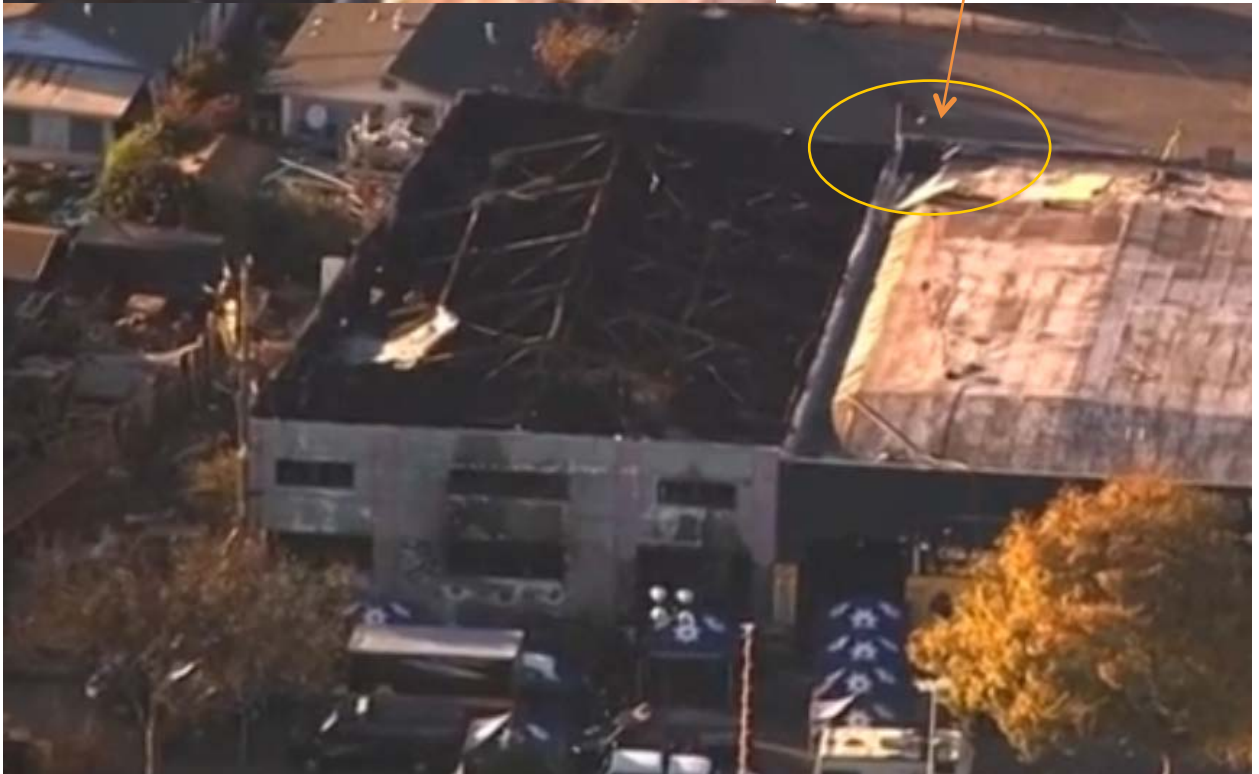
- 2) Drone images from Reuters show adjacent rooftop damage
<http://www.reuters.com/article/us-california-fire-idUSKBN13S0M9>

Roof peeled back on adjacent building and fire damage can be seen.

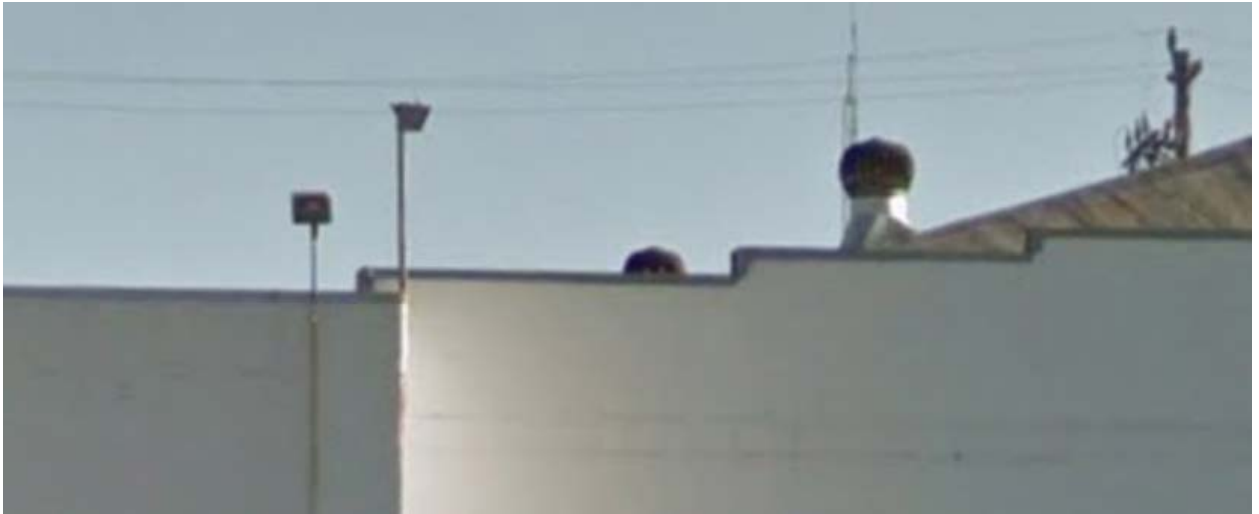
- 3) Pre-fire images from Google Streetview show rooftop pole extensions with electrical equipment at top: Lower left is a light. Other is unclear.

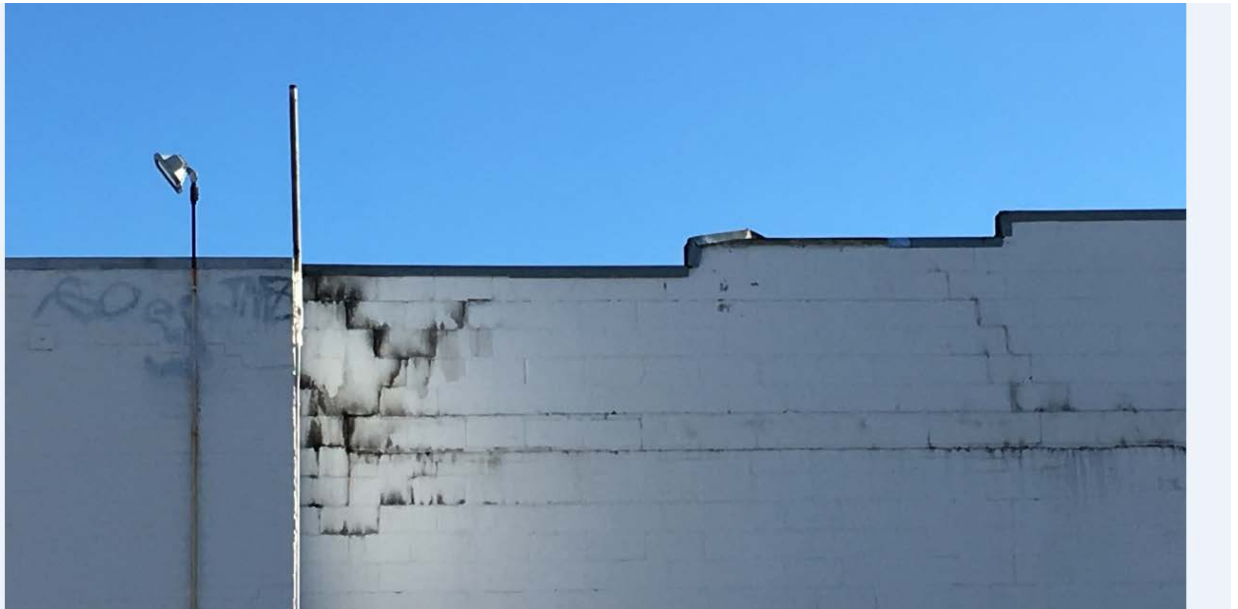
- 4) Post Fire shot show fire damage to Ghost Ship building and pole and one light with scorched fire damage. Other pole has equipment missing.

- 4) the fire was prolonged enough and hot enough to burn the paint and damage the conduit of the security light.
- 5) something electrical was present at the secondary tube (taller) and that it was removed post fire.

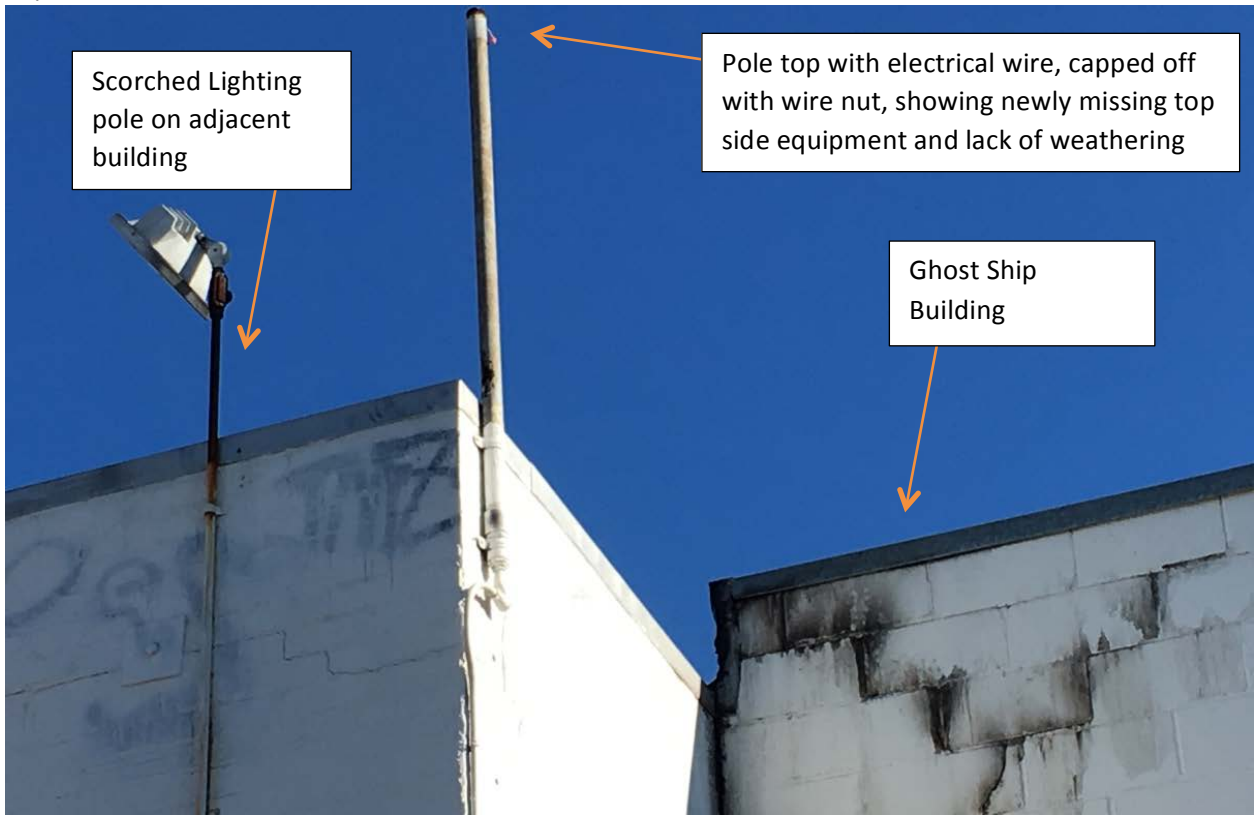
- 5) Close up clearly shows fire damage to poles. Also shows electrical wire and insulating wire nut in place.

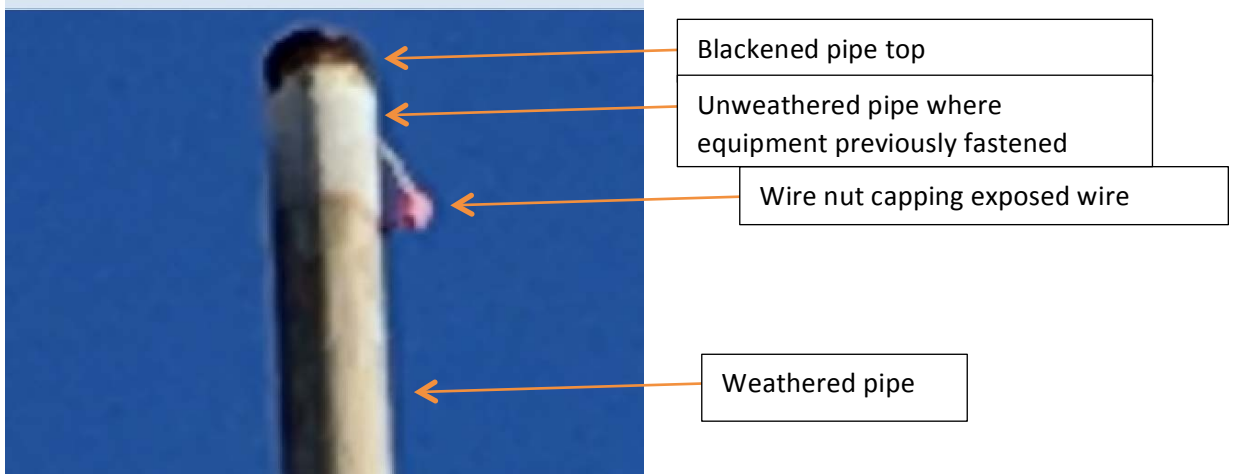
- 6) Close up of pole where top is missing. Shows three colorations bands: black as if scorched at top, white where equipment was fastened and removed, weathered where previously exposed

- 6) the top discoloration indicates the removed equipment from the taller tube may have been on fire due to the discoloration at the top of the tube.
- 7) Electrical distribution to the G.S. portion had to come from the inside of the second building as no other apparent power drop is present on the G.S. building itself.

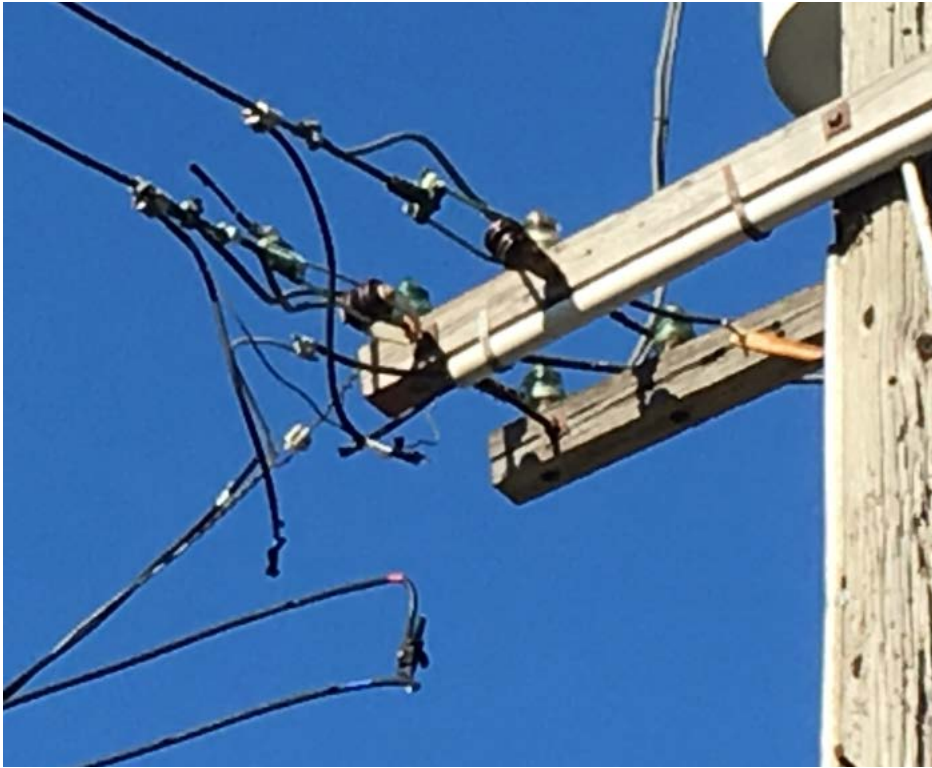
- 7) The fire department cut service wires at the what appears to be the main service entry to the set of buildings:
