Caltrans State Route 101 Willits Bypass April 2, 2014 Inspection Findings
Inspected by Brendan Thompson and Kason Grady, North Coast Regional Water Quality Control Board
Time of Inspection: ~9:00 a.m. to 3:30 p.m., clear weather, one day after rain
Caltrans EA No.: 01-262004, Risk Level 3, WDID No. 1B12045WNME
See "Willits Map" at end of document for Area locations.

Area 1, "U1 Line," Photo 1 through Photo 19, West of Hwy 101, Southern-Most Project Limits, South Haehl Creek Watershed, Water Quality Monitoring Stations WQ01 and WQ03

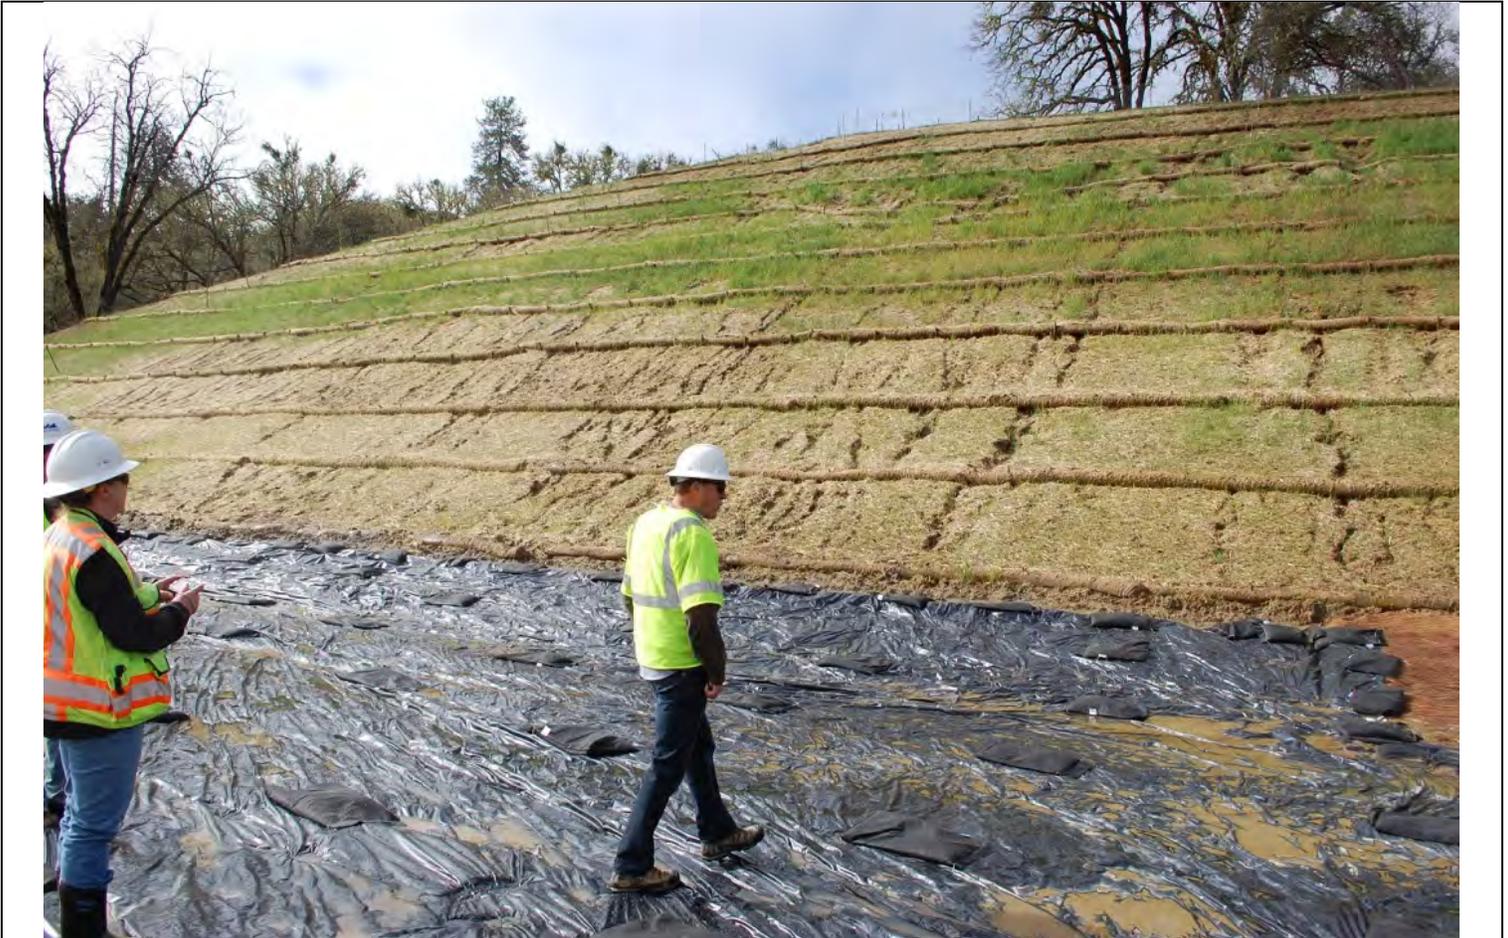
Photo 1: Final grade slope in "U1" area, west of 101, South Haehl Creek watershed. Rilling was evident. Fiber rolls and bonded fiber matrix with seed had been applied last year. Caltrans and contractor staff noted that the slopes could only be repaired by regrading, which has not been done due to the saturated soil conditions and lack of access.

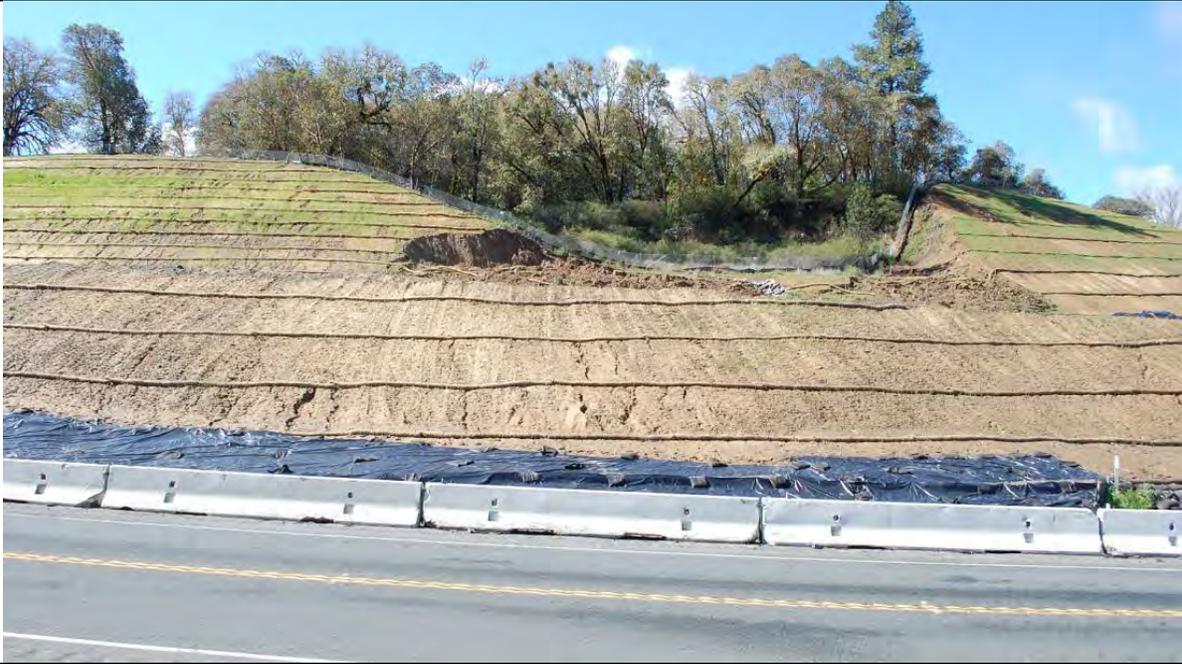
Photo 2: Final grade slope in “U1” area, west of 101, South Haehl Creek watershed. A large portion of the slope failed in an area that exhibits evidence of pre-project slope failure. According to Caltrans staff, this failure had started 2-3 weeks before the inspection. Caltrans staff also mentioned that their geotechnical engineers were working on a solution.

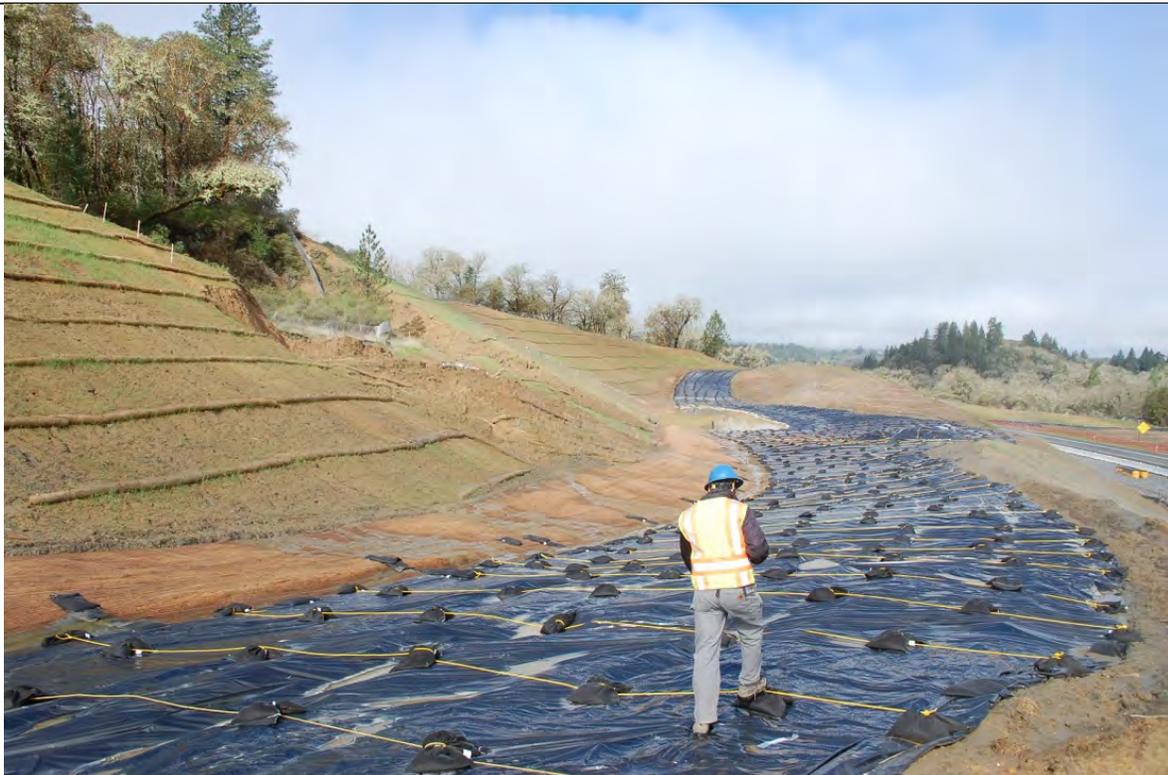
Photo 3: Looking north. The inactive roadway in the U1 area had been covered with plastic and gravel bags for erosion control. The plastic had been placed just before the previous rain event. The Flatiron representative said that placement of plastic resulted in an NTU decrease of “thousands” at the discharge point shown in Photo 13. The slopes to the left were finished to final grade last year, whereas the slopes on the right are still scheduled to be excavated. The slope failure shown in Photo 2 is on the middle-left of this photo.

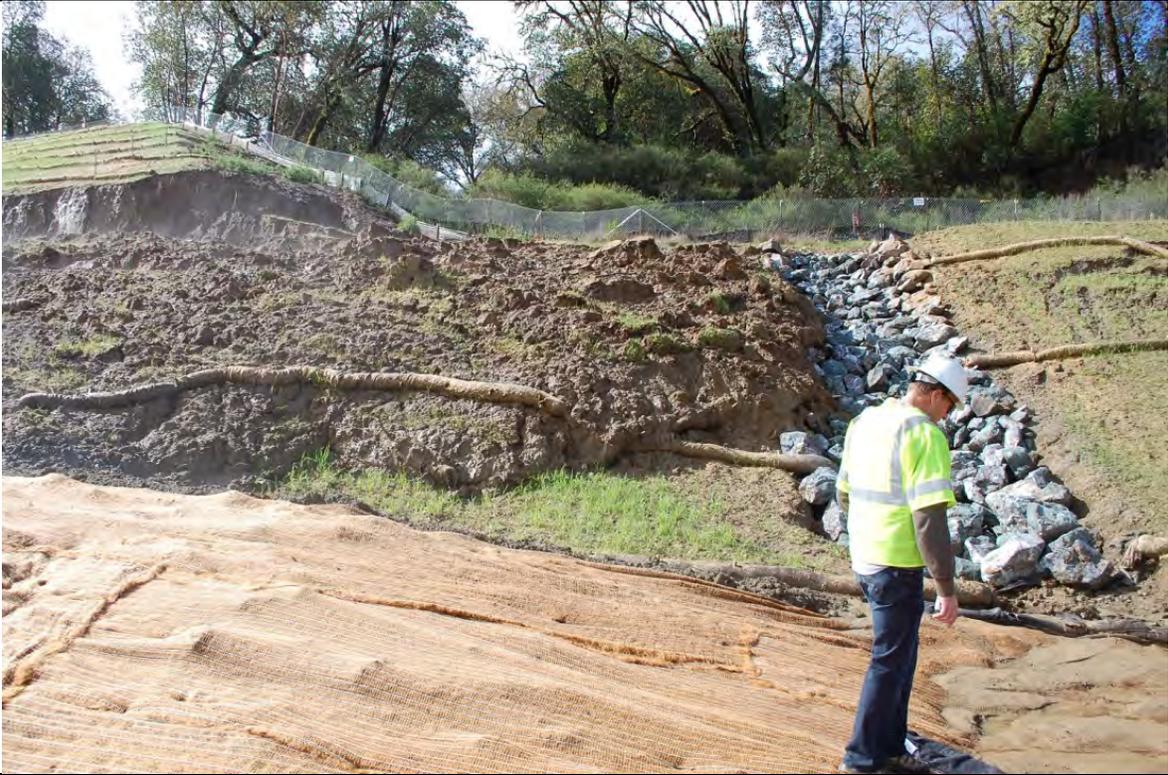
Photo 4: A close up of the slope failure shown in Photo 2. A rock-lined drainage ditch had been constructed to carry stormwater from the top of slope. Photo 5 shows disturbed conditions at the top of the slope.

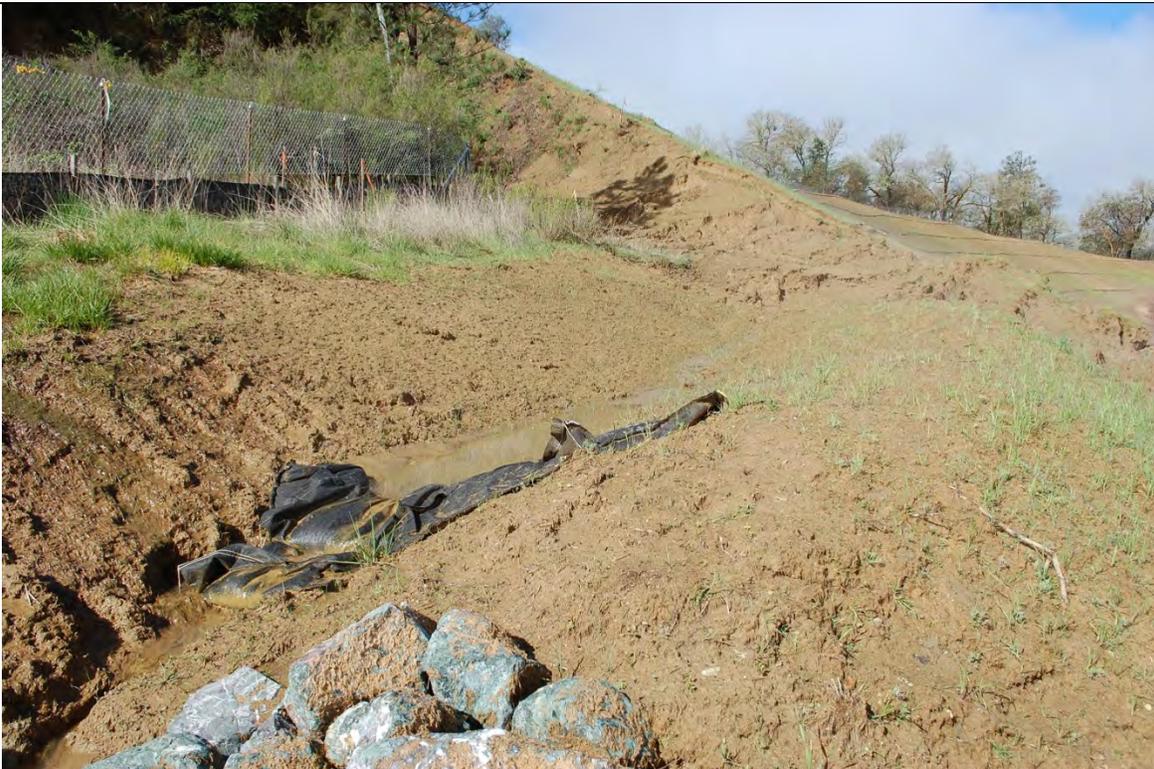
Photo 5: Top of disturbed slope shown in Photo 4. Only one gravel bag check dam and no effective erosion control was present. The rock in the bottom of the picture is the top of the rock-lined drainage ditch shown in Photo 4.

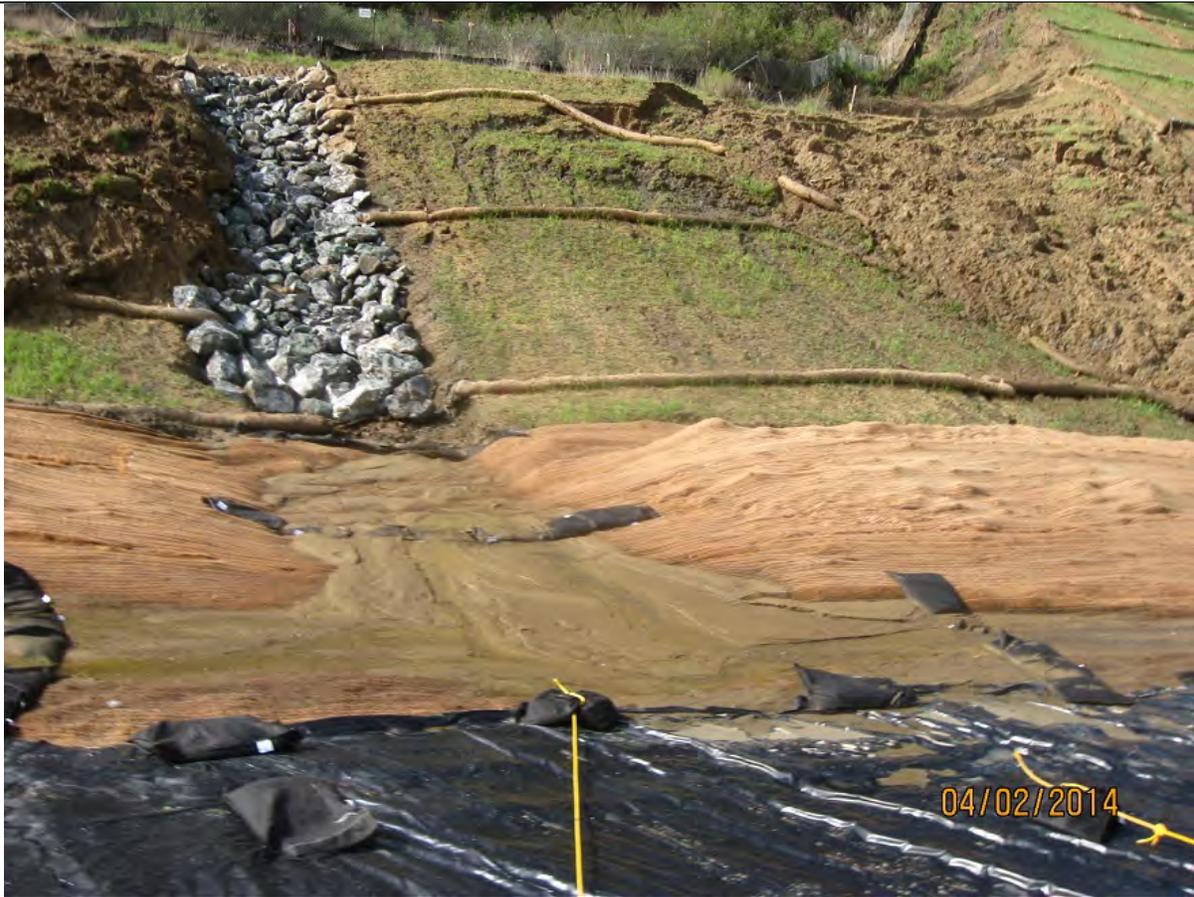
Photo 6: Significant amounts of sediment had been transported from the top of the slope and the failed slope area. This entire area drains to the basin shown in Photo 12.

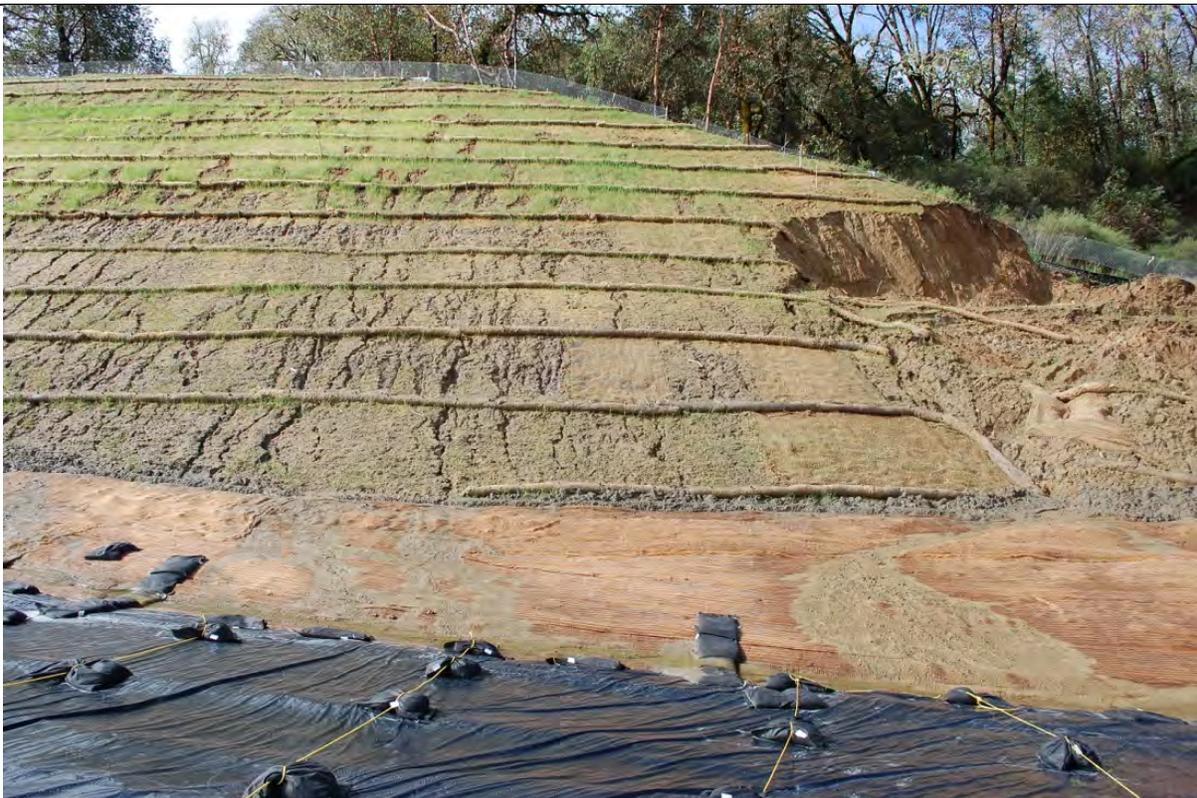
Photo 7: Just north of the slope area shown in Photo 1. Note rilling and associated sediment flows.

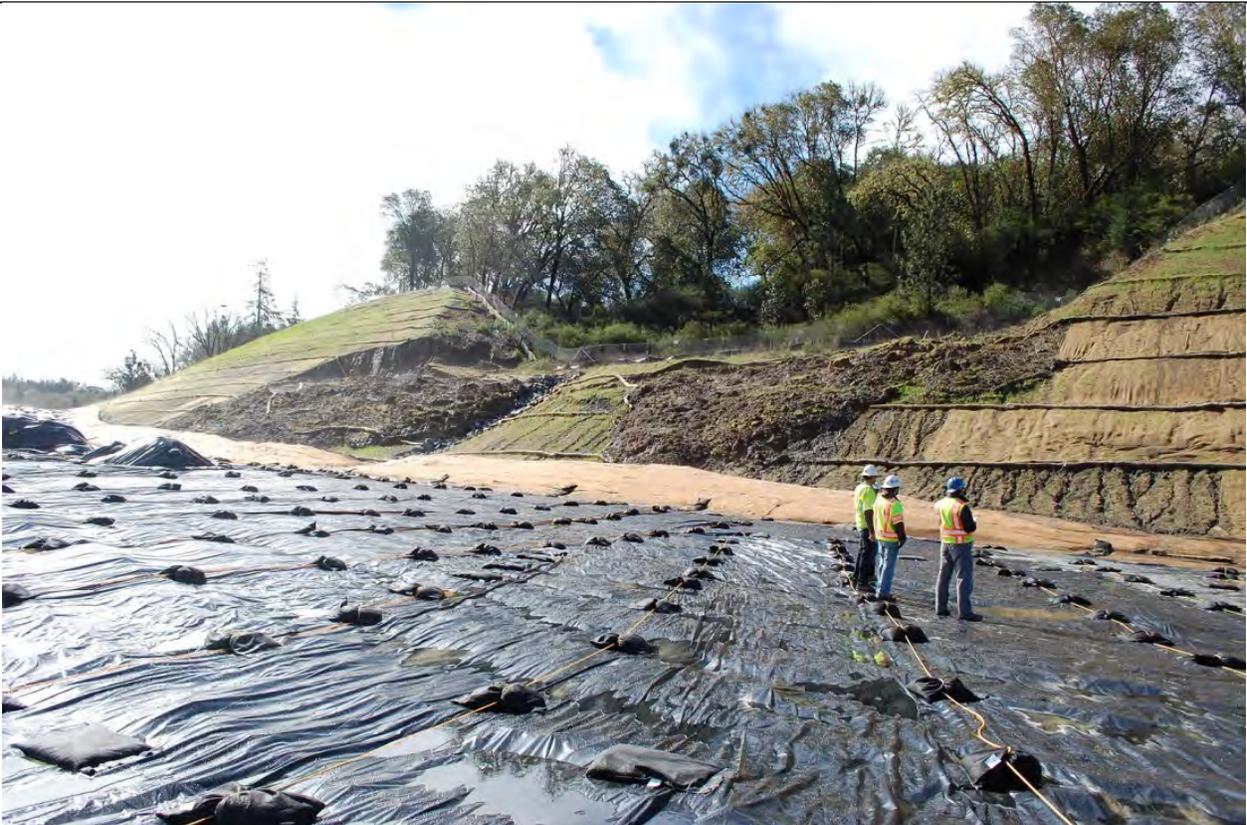
Photo 8: View of slope failure across a large area covered with plastic as a temporary erosion control fix.

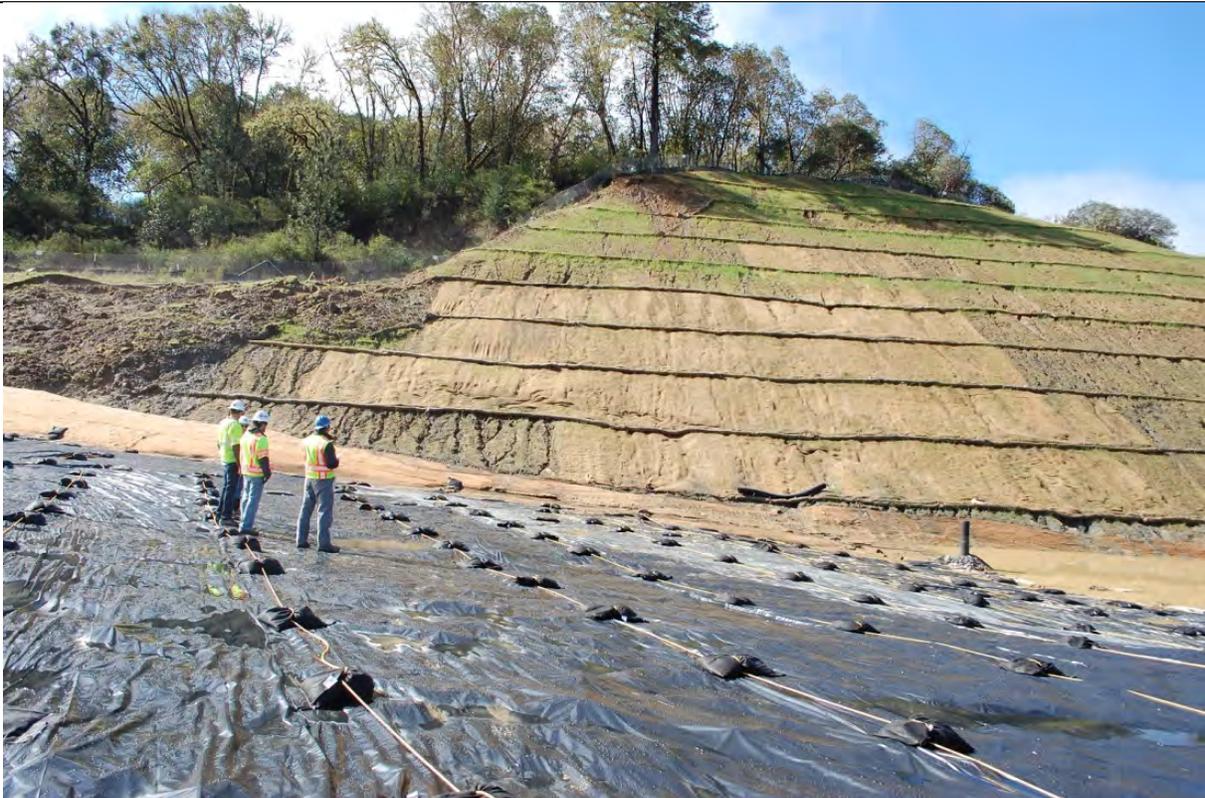
Photo 9: Finished slope just north of the slope failure. This is one of the few slope locations with rolled erosion control fabric. The fabric was placed sometime after the early February 2014 rain event. A new slope failure is starting at the top left of the slope where the tree shadow is. The ad hoc storm water basin is visible right center.

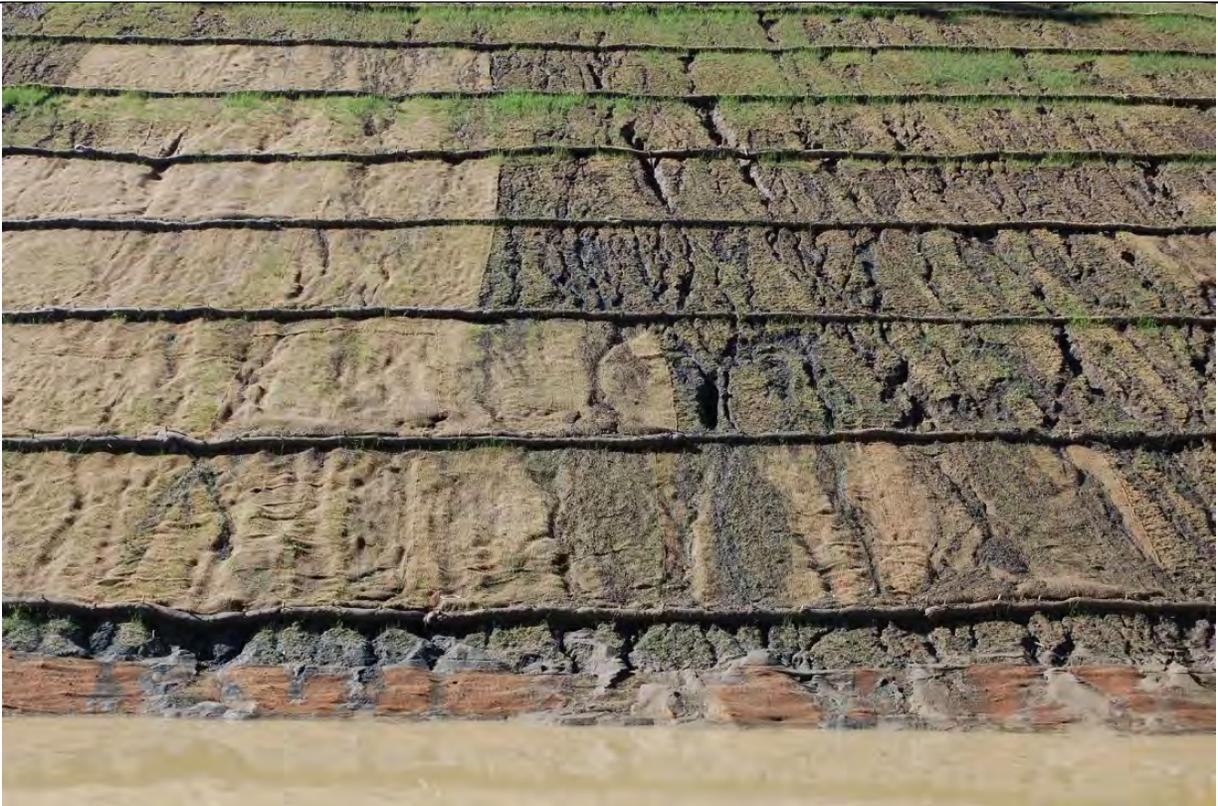
Photo 10: A close-up of gullying on the slope shown in Photo 9, with the storm water basin below.

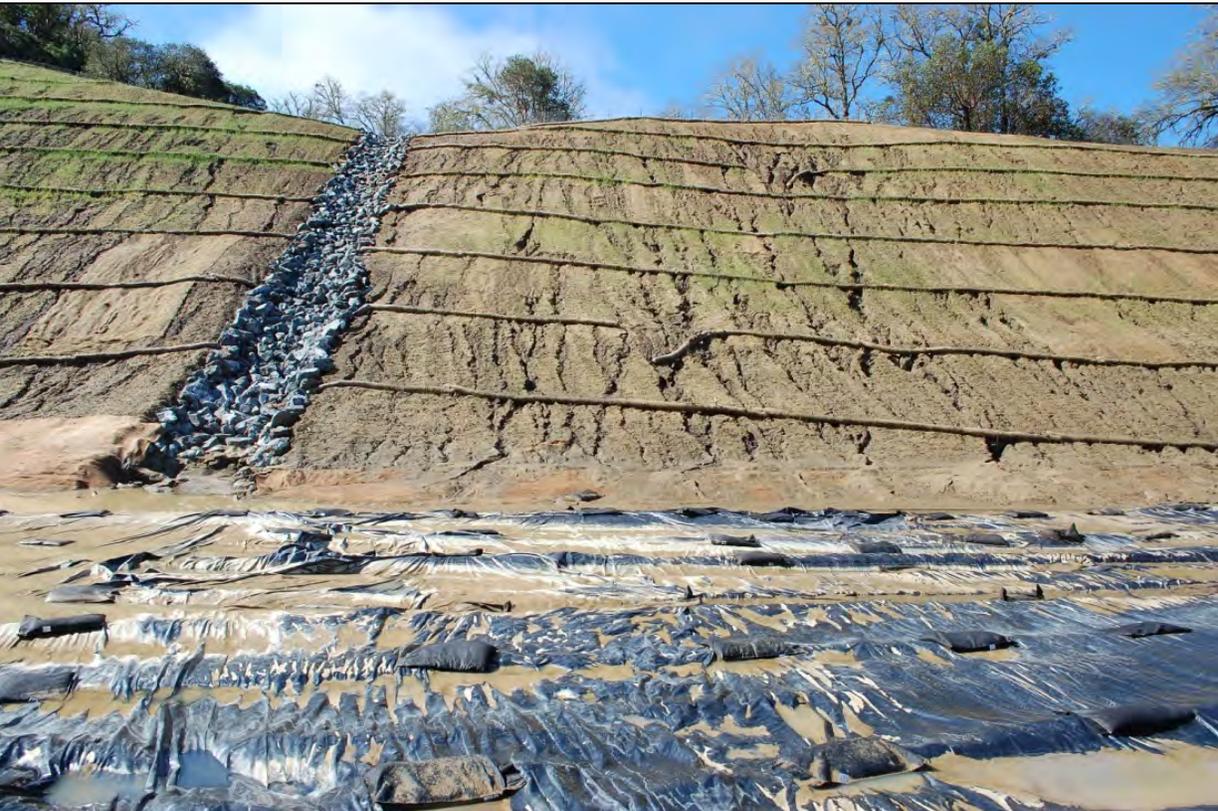
Photo 11: A view of the gullied, finished slope with rock-lined drainage ditch, above the storm water basin. The temporary plastic was covered with muddy water, likely residual from higher basin levels. Note failing fiber rolls. Before the plastic had been placed, sediment was removed from the basin and spread over the surrounding area to provide greater basin storage volume.

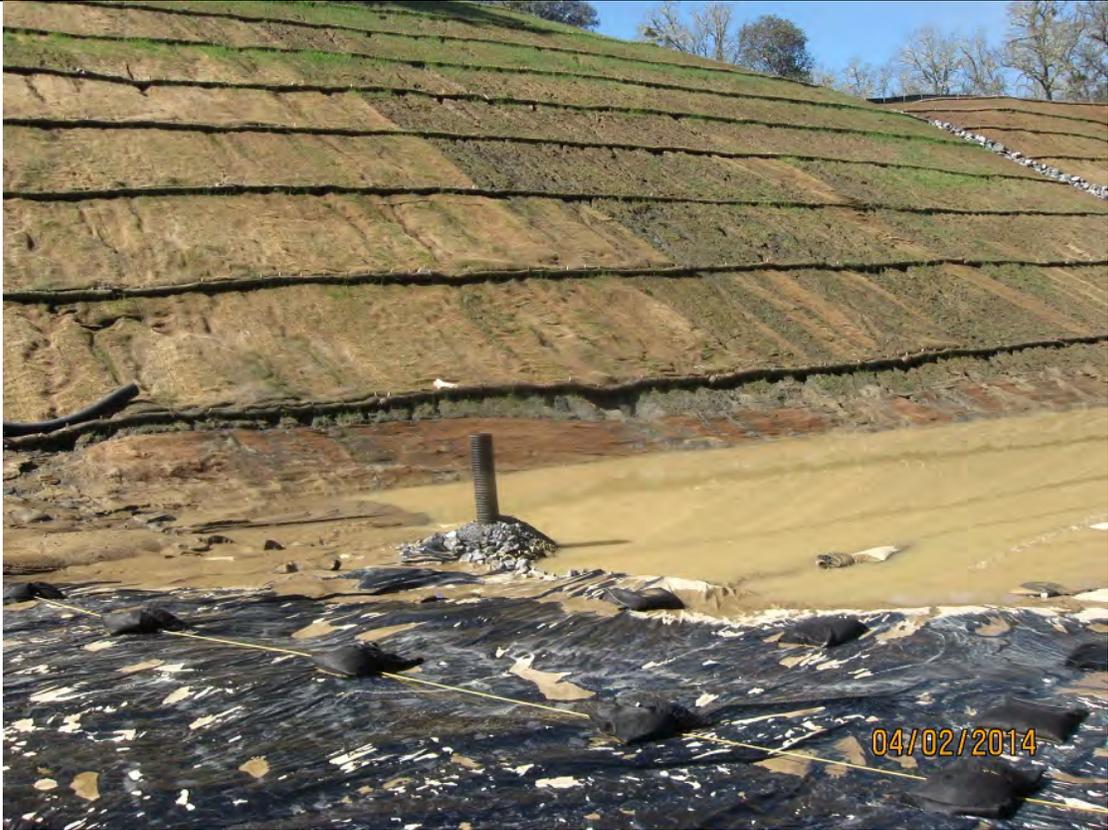
Photo 12: A close-up view of the stormwater basin excavated last year to handle flows from the eroding finished slopes. The basin drains through a perforated drain pipe surrounded by gravel (center of photo).

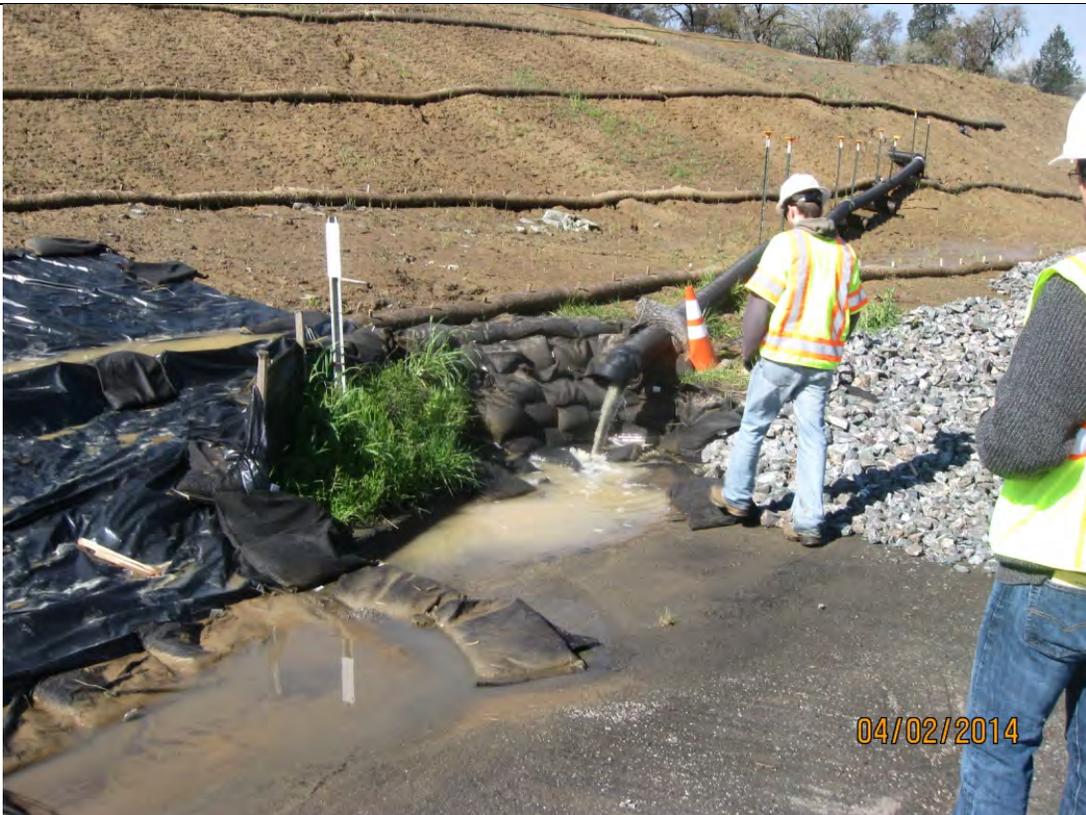
Photo 13: The basin shown in Photo 12 discharges to this drainage inlet on Hwy 101 before being carried under the highway to the basin shown in Photo 21.

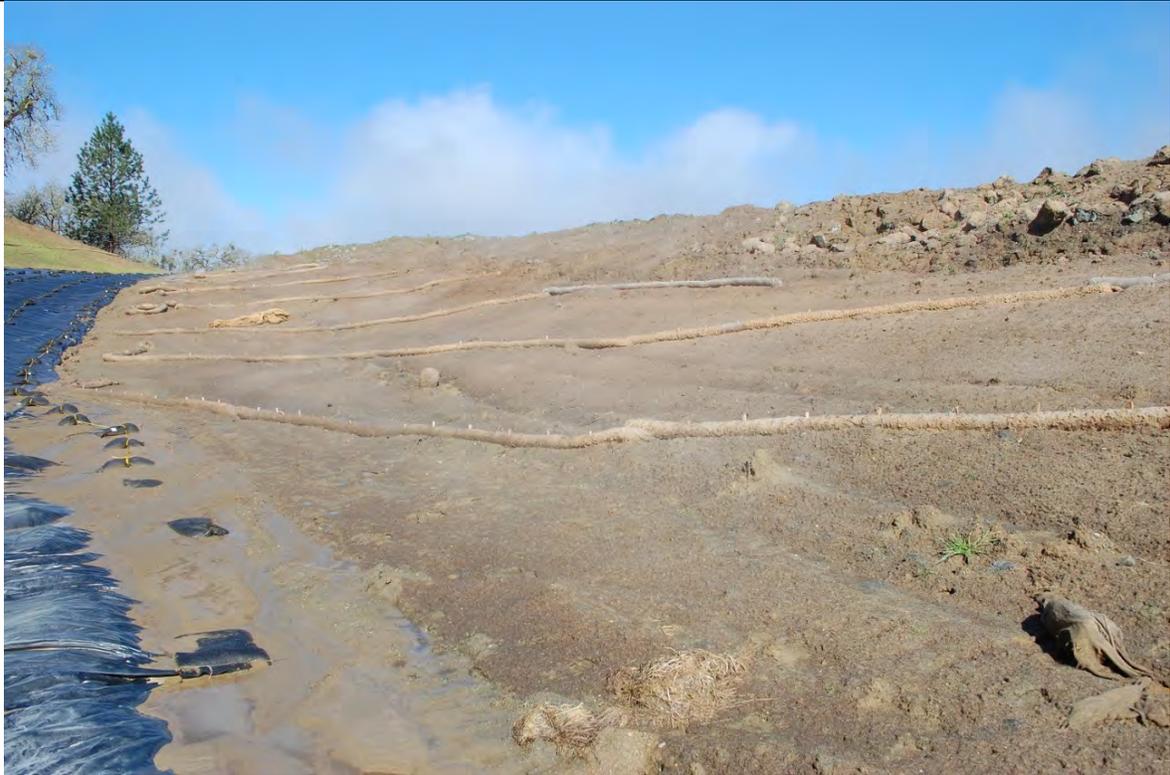
Photo 14: Part of a rock and dirt stockpile approximately across from the area shown in Photo 11. Runoff from the plastic sheeting was causing erosion adjacent the edge of the sheeting.

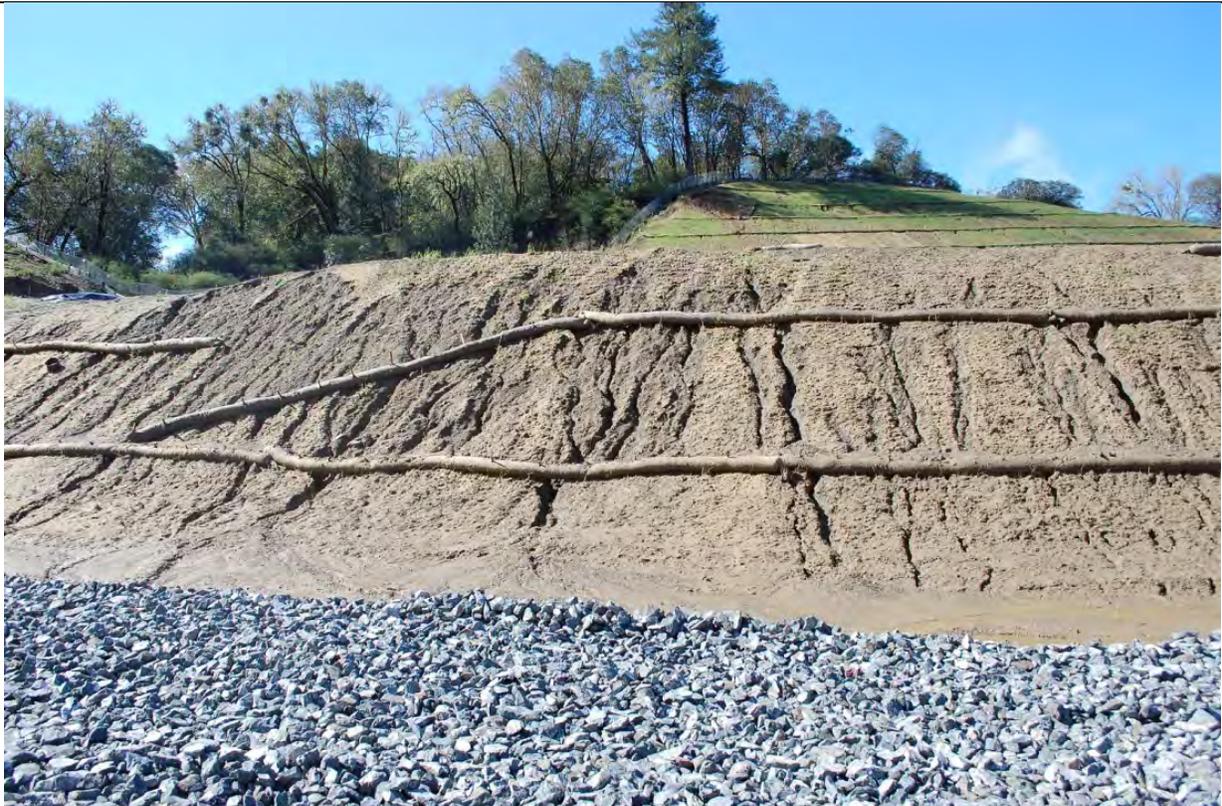
Photo 15: Standing on the shoulder of 101 looking west at the U1 line area. Failure of erosion and sediment control BMPs evident on the temporary slope. The gravel in the foreground was added after the early February 2014 rain event as a sediment control measure. This is part of the same gravel strip as shown in Photo 16.

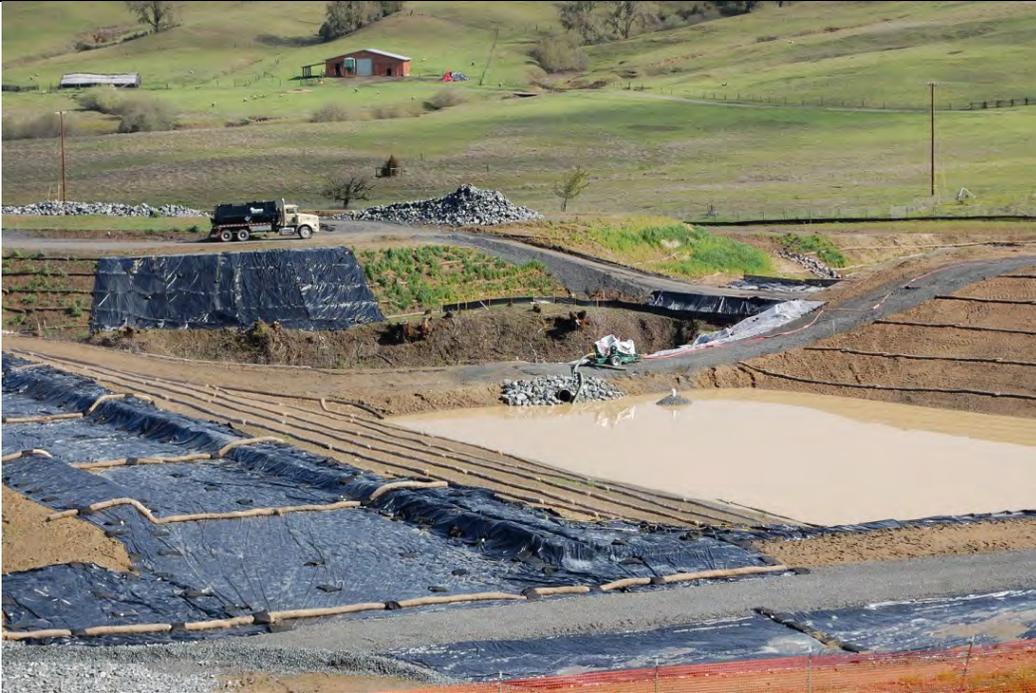
Photo 18: A view across the highway, looking east, at the largest stormwater basin (hereinafter "Basin 1." Water discharges directly from this basin into South Haehl Creek. Caltrans has been using water trucks, like the one seen in the distance, to pump and truck turbid water from this and other basins to the Willits Wastewater Treatment Facility. Contractor staff said that three, 5,000 gallon water trucks were being operated throughout the day (and 4 the previous day) and could transport approximately one load per hour.

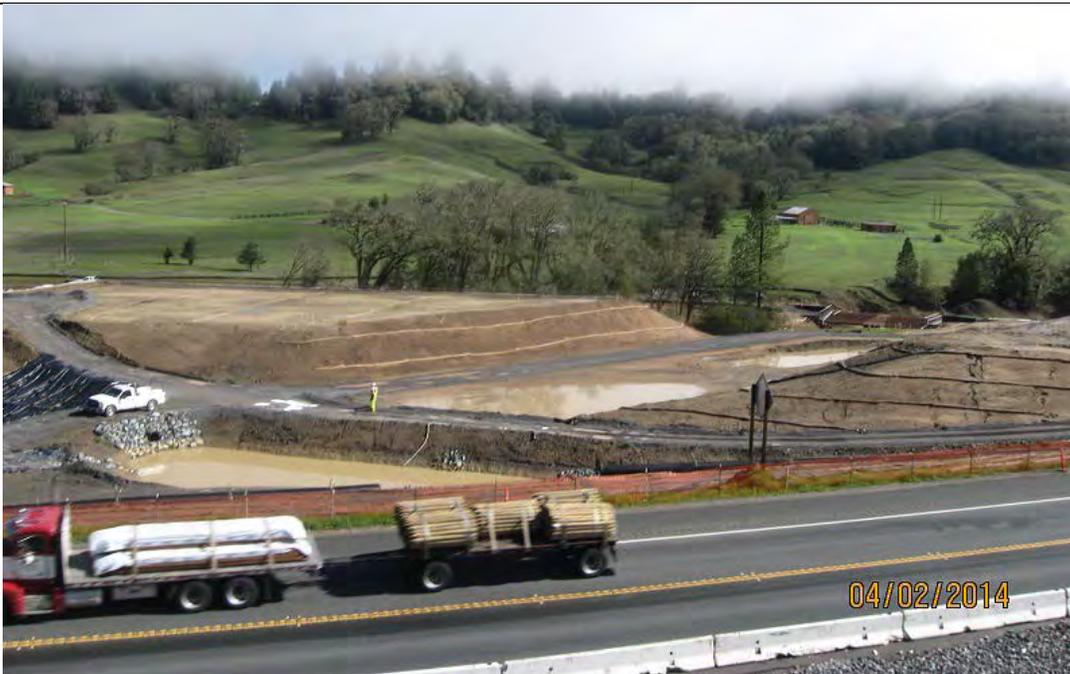
Photo 19: A view across the highway, looking east, at two more areas where stormwater is stored before discharging to South Haehl Creek. The basin in the foreground discharges to Basin 1 and the one in the background discharges to both the basin in Photo 18 and during periods of overflow, directly into South Haehl Creek as described in Photo 54.

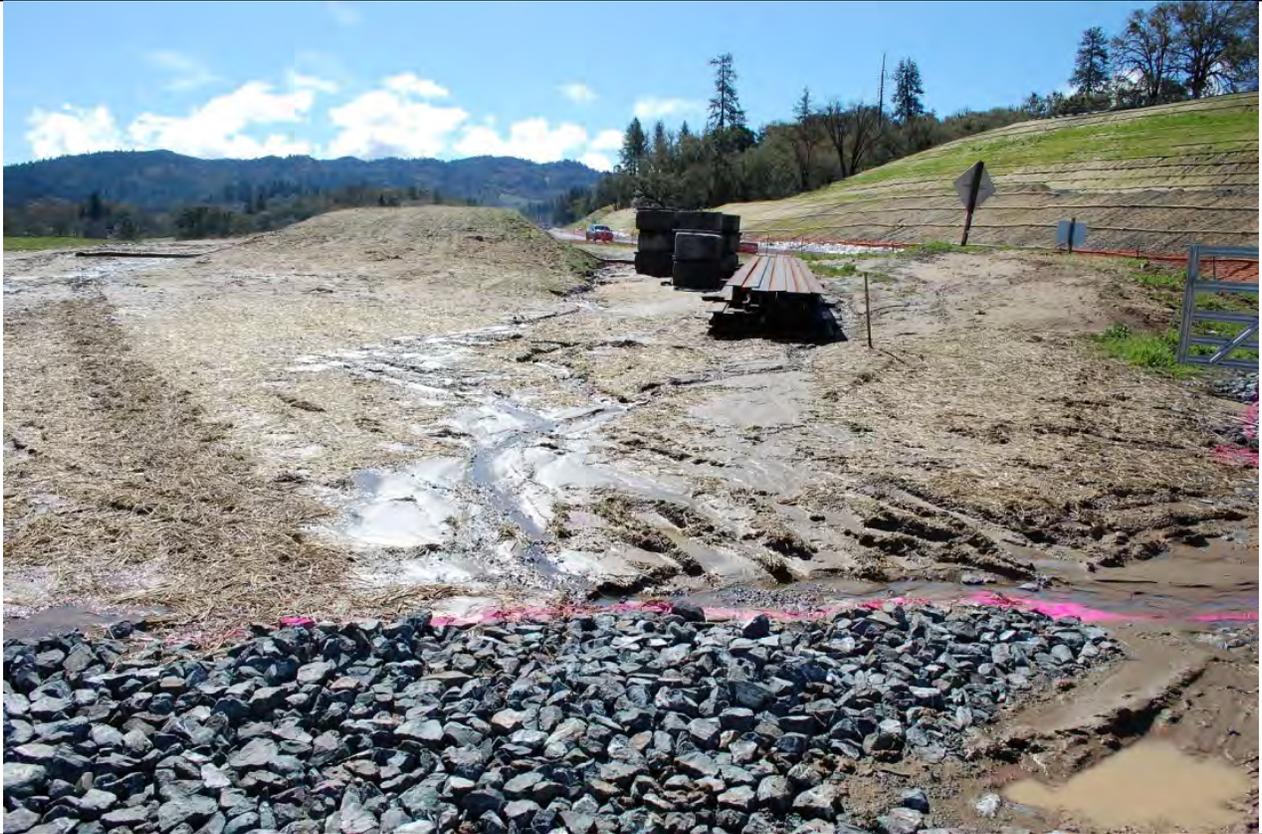
Photo 20: Just southeast of the area shown in Uncontrolled flow is eroding through previously applied straw erosion control. The erosion starts beyond the stockpiled material and adjacent the Highway. This concentrated flow path must be controlled.

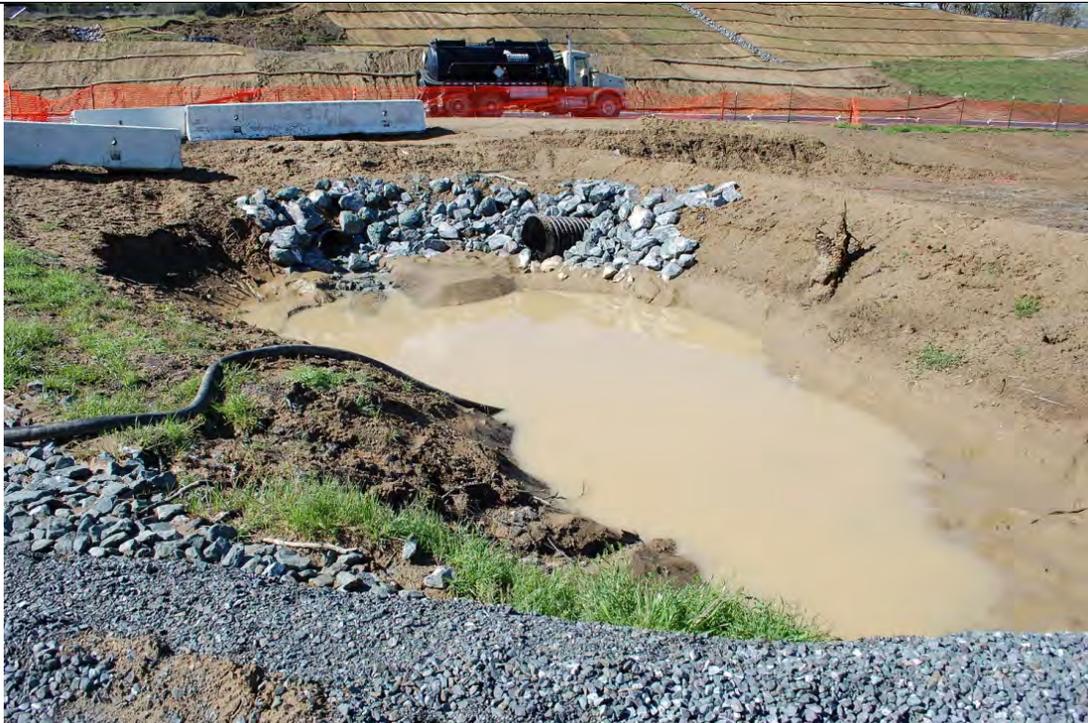
Photo 21: Looking west at Hwy 101. This basin receives all flow from the basin shown in Photo 12 and discharges into the drainage system shown in Photo 27. This basin is eroding as seen in the top left of the photo, just to the left of the rock-slope protection. This basin must be stabilized.

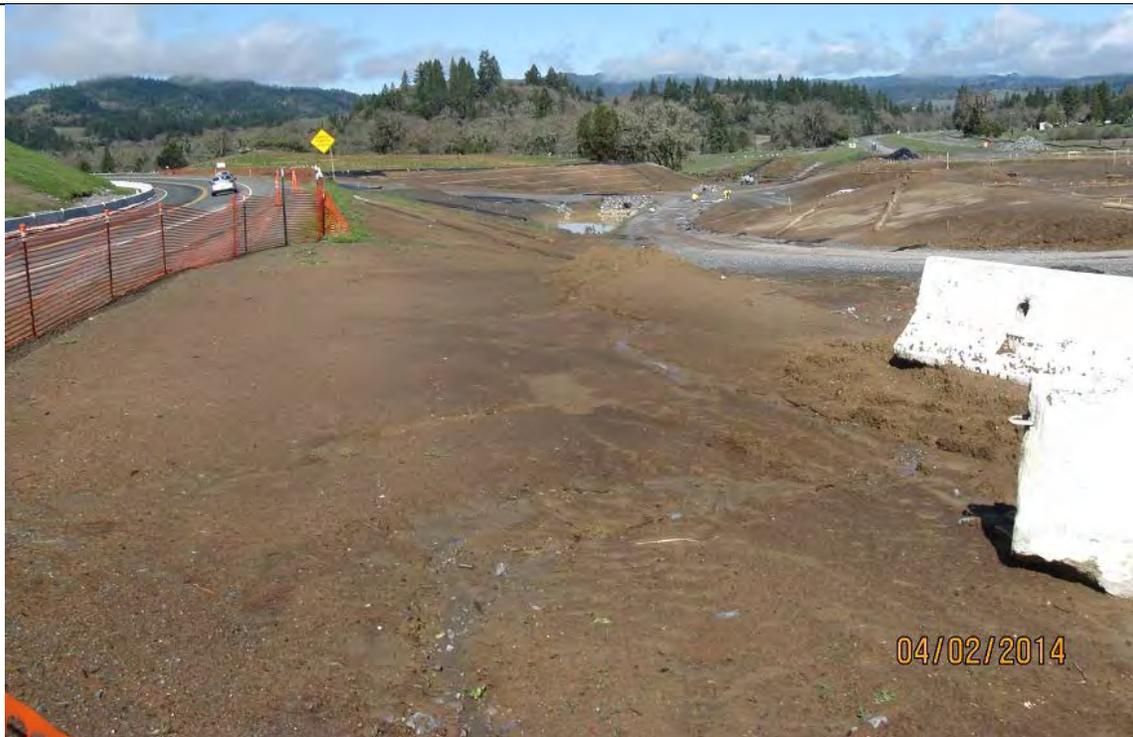
Photo 22: This area is just south of the main entrance-way to Area 1 and between the existing Hwy 101 and the basin shown in Photo 21. This area is without and requires erosion and sediment control. Photo 23 shows erosive conditions resulting from this uncontrolled run-on.

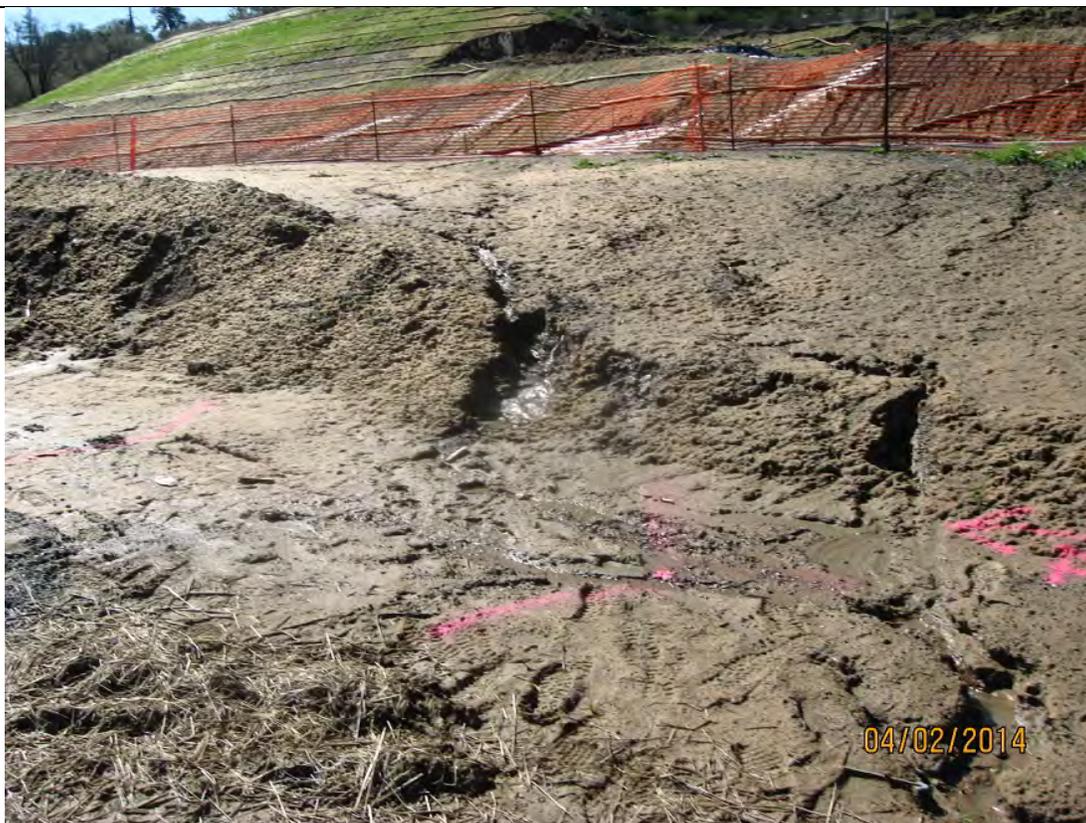
Photo 23: Just north of the basin shown in Photo 21. Erosion from uncontrolled run-on.

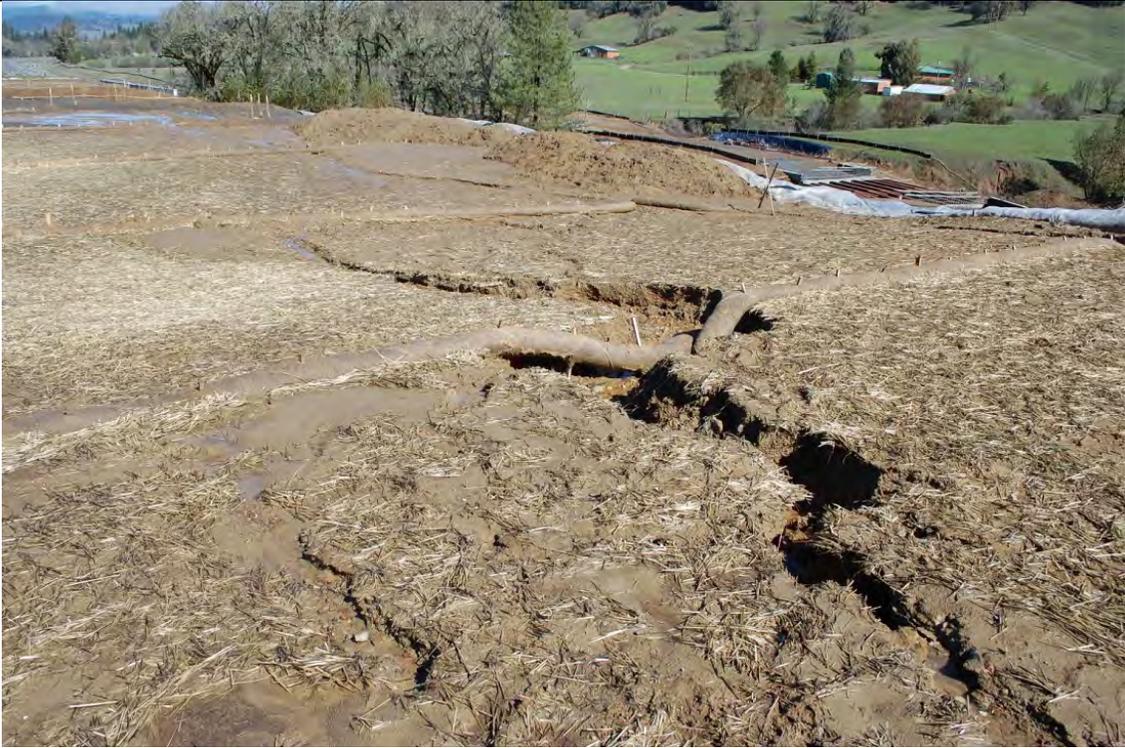
Photo 24: Looking northeast at the “U2” fill area, just east of main entrance to Area 2. Sediment transport was evident throughout the area despite the recently placed straw erosion control.

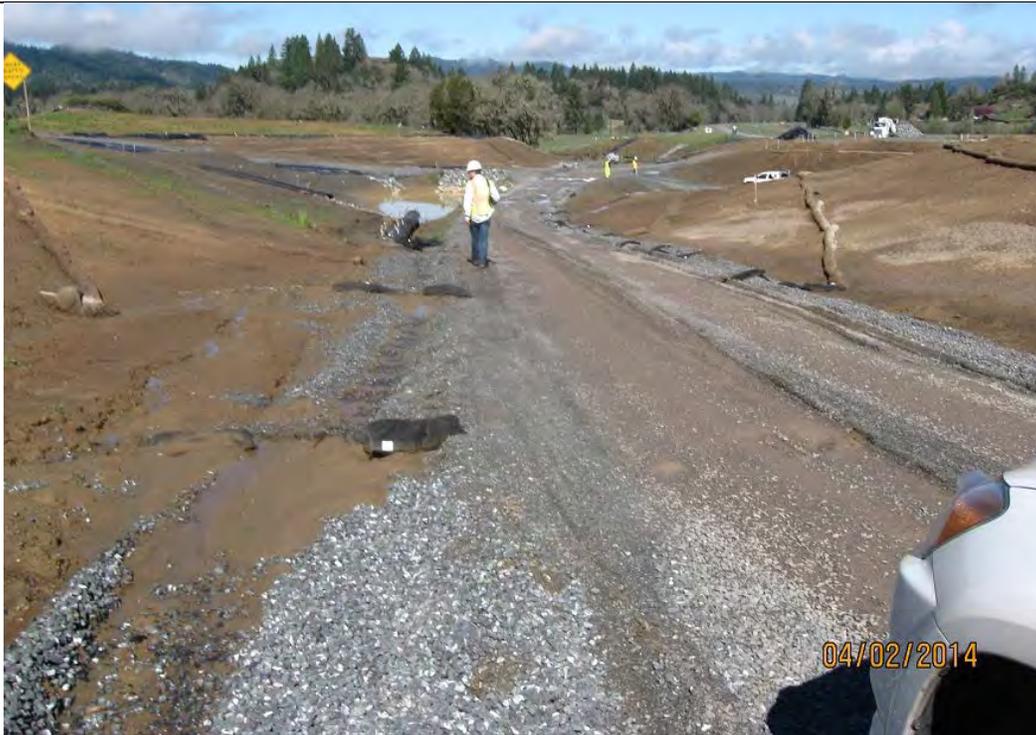
Photo 26: Looking north on the U2 line toward the basin shown in Photo 27 and Photo 28. Sediment had inundated this check dam during the previous rain event and gulying occurred downstream as a result.
