Caltrans State Route 101 Willits Bypass April 2, 2014 Inspection Findings
Inspected by Brendan Thompson and Kason Grady, North Coast Regional Water Quality Control Board
Time of Inspection: ~9:00 a.m. to 3:30 p.m., clear weather, one day after rain
Caltrans EA No.: 01-262004, Risk Level 3, WDID No. 1B12045WNME
See "Willits Map" at end of document for Area locations.

Area 1, "U1 Line," Photo 1 through Photo 19, West of Hwy 101, Southern-Most Project Limits, South Haehl Creek Watershed, Water Quality Monitoring Stations WQ01 and WQ03

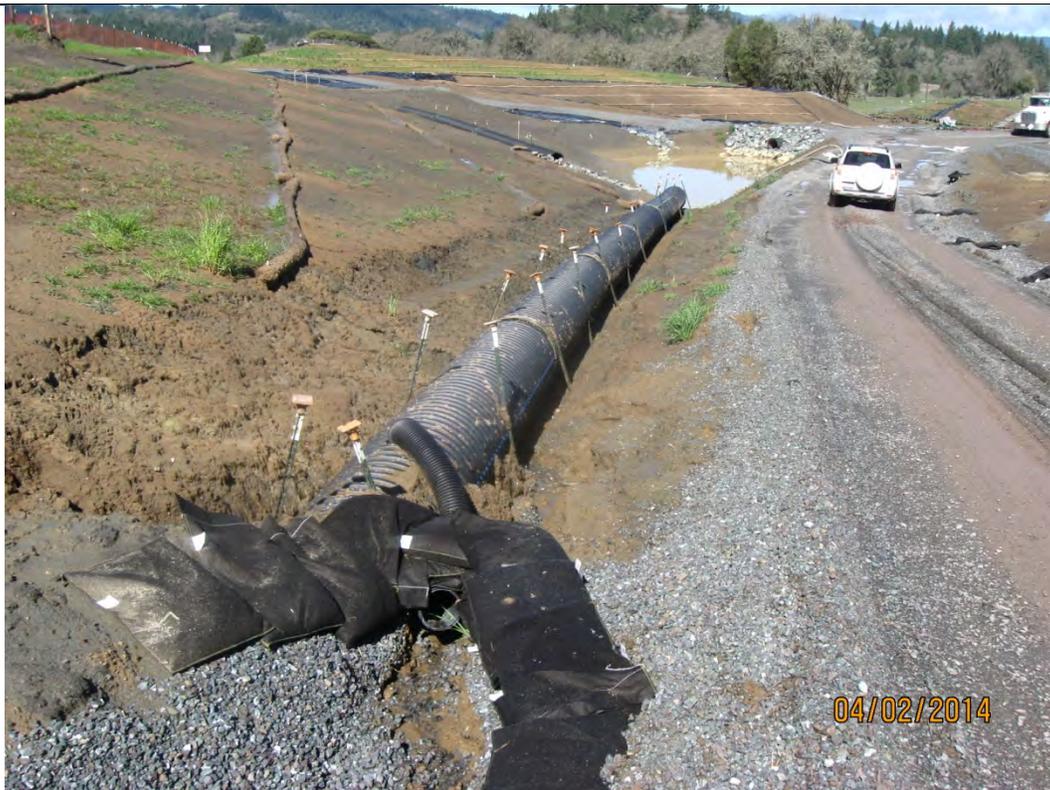
Photo 27: West side of U2 line, looking north toward the storm water basin shown in Photo 26. An attempt had been made to intercept drainage from the ditch shown in Photo 26, by installing the smaller black plastic pipe, but storm water scoured beneath the pipe and eroded the earthen ditch immediately downstream.

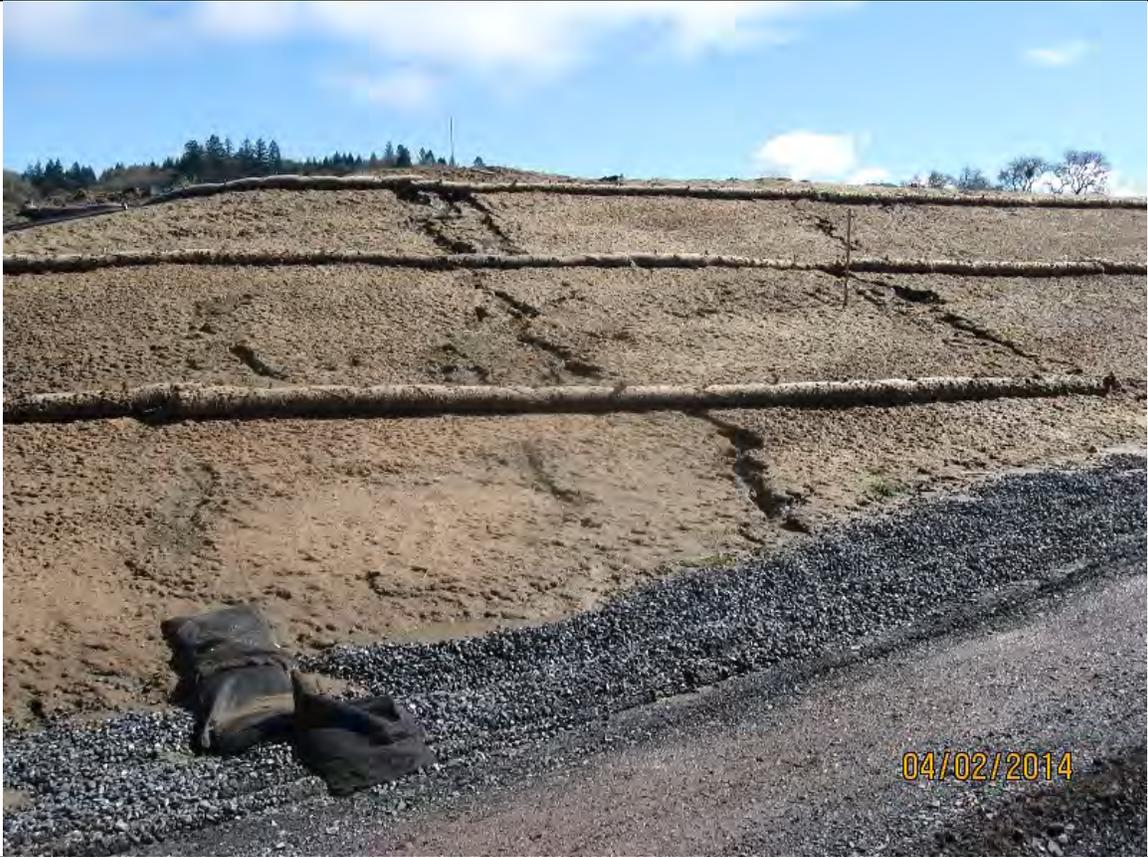
Photo 30: Ineffective erosion and drainage control and gullying on the west side of the U2 line.

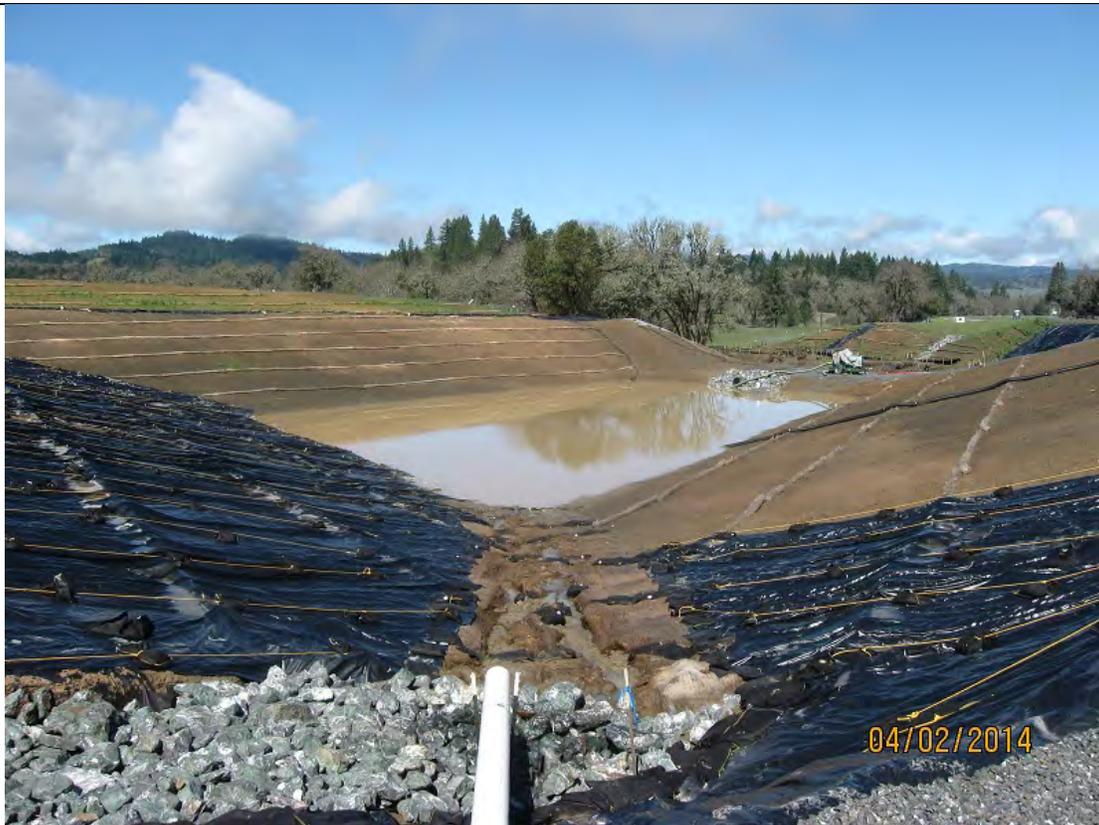
Photo 31: A view of Basin 1, looking north. The channel was eroding/eroded below the outlet seen in the foreground. This channel must be appropriately stabilized to accommodate concentrated flow.

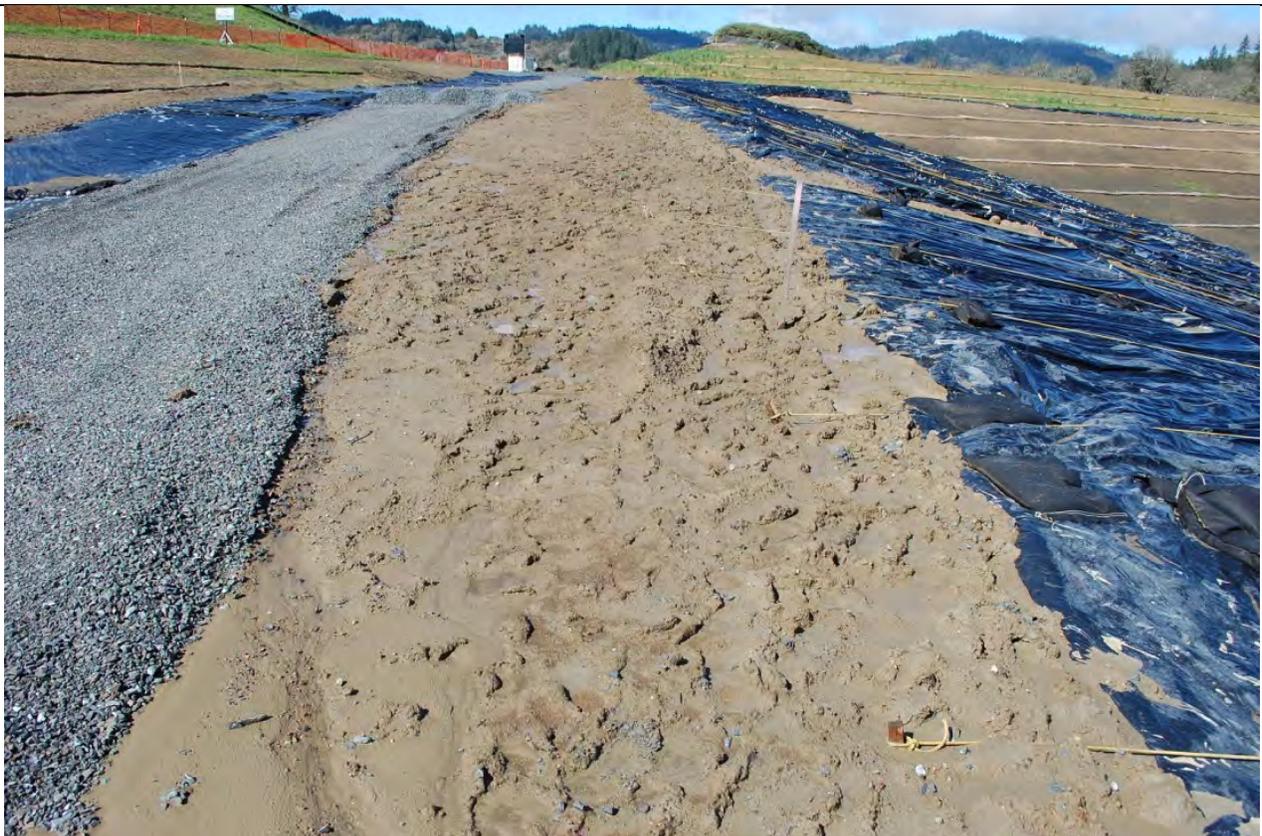
Photo 33: At the top of Basin 1, southern side, looking west. This dirt area was unstabilized and eroding. This area and others around the basin must be stabilized.

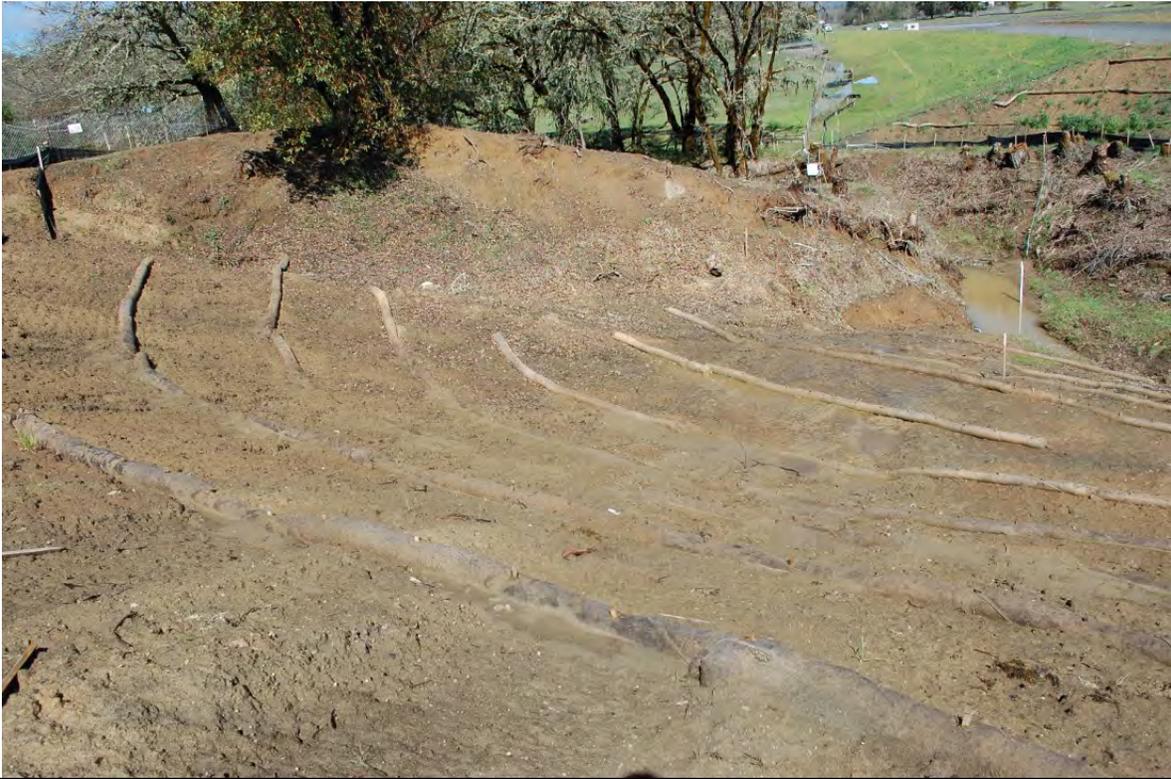
Photo 36: Standing at the top of Basin 1, looking at the south bank of South Haehl Creek. The top rows of fiber rolls were inundated with sediment.

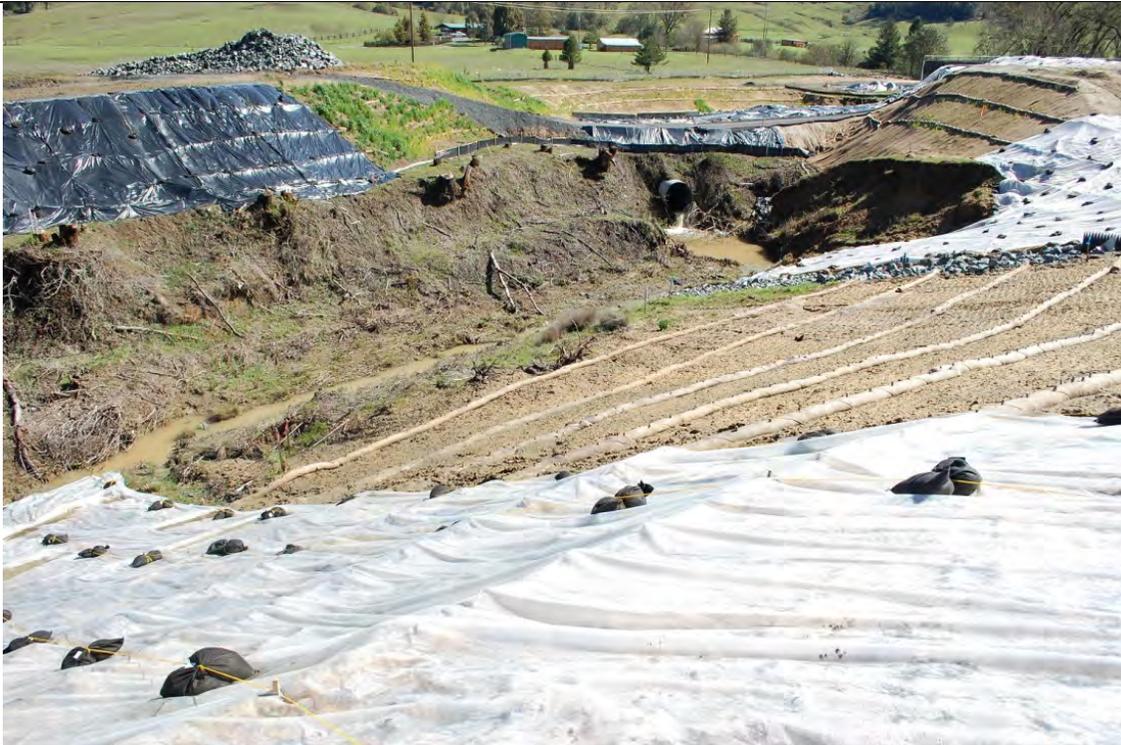
Photo 37: Standing at the top of Basin 1, looking at the south bank of South Haehl Creek. The area in the foreground with plastic sheeting is just upstream of the area shown in the previous photo. All plastic was recently placed to cover the eroding bank.

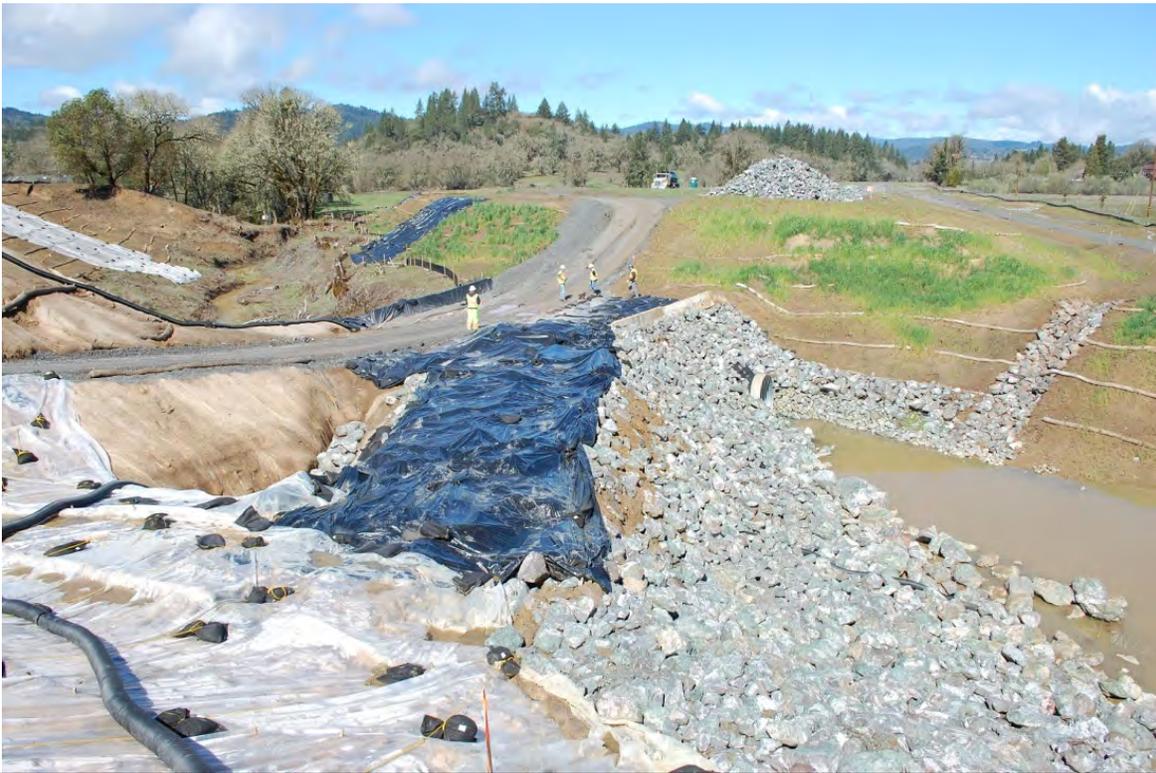
Photo 38: Standing just east of the previous photo, looking north at the temporary culvert for South Haehl Creek. The rock was placed after the early February 2014 rain event to protect the eroding the creek banks.

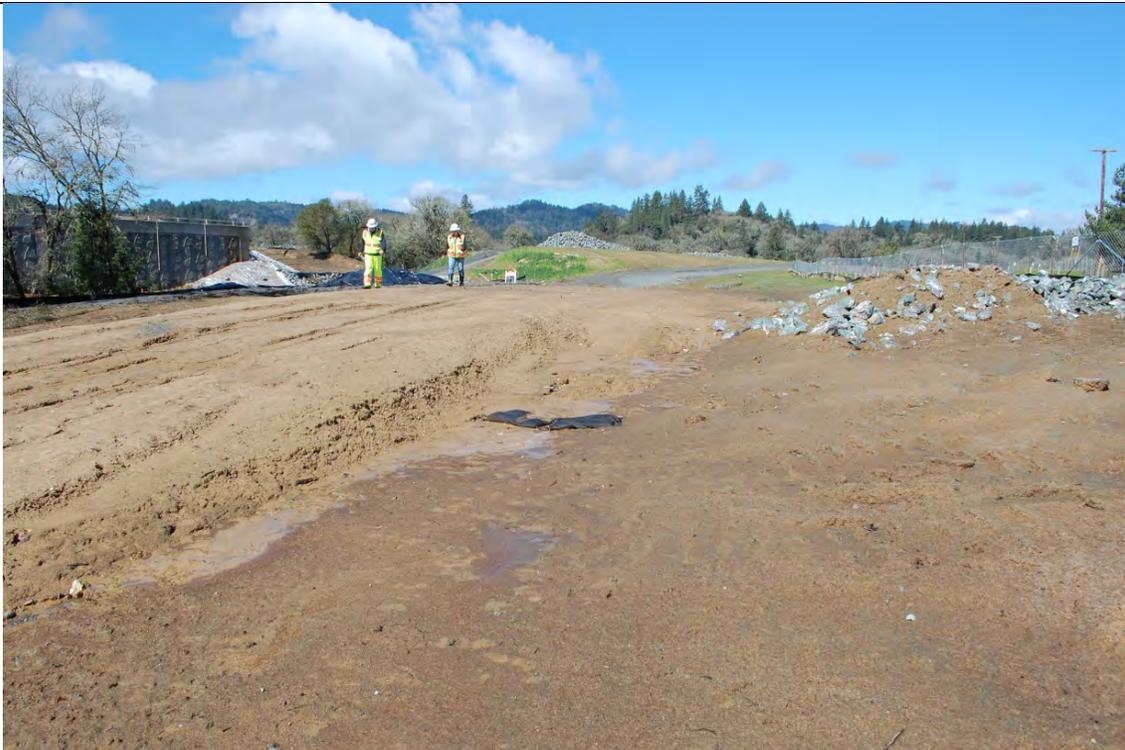
Photo 39: Inadequate erosion and sediment control on and adjacent to the roadway north of South Haehl Creek, looking north on the "U4" line.

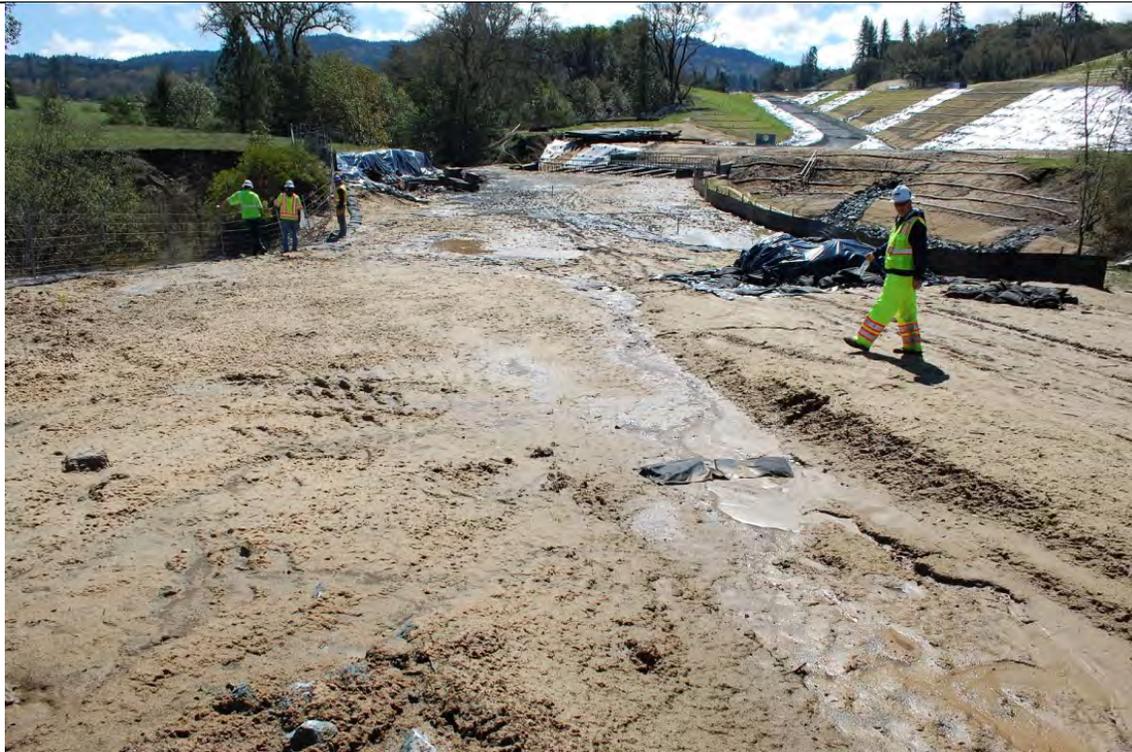
Photo 40: Looking south toward South Haehl Creek, standing at approximately the same position used in Photo 39. Inadequate erosion and sediment control.

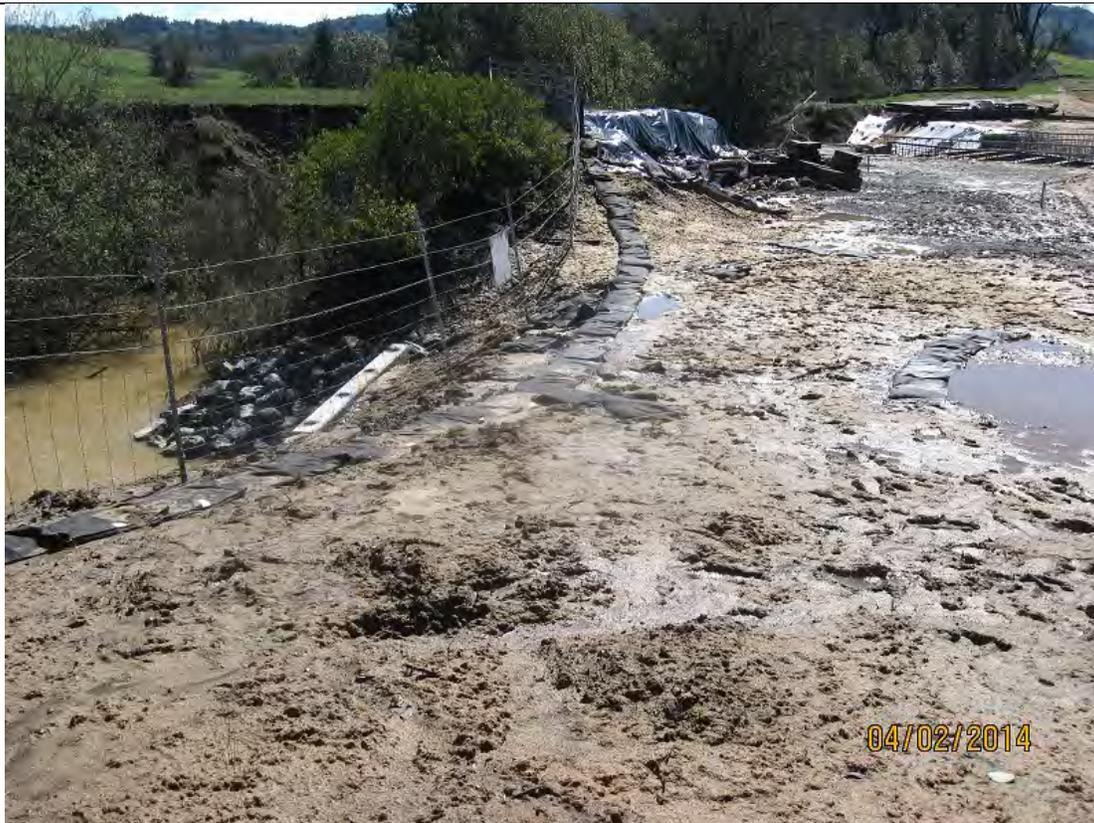
Photo 41: Looking south at Drainage System 24 before it enters a culvert and discharges to South Haehl Creek. There was inadequate erosion and sediment control in this area. This area must be stabilized.

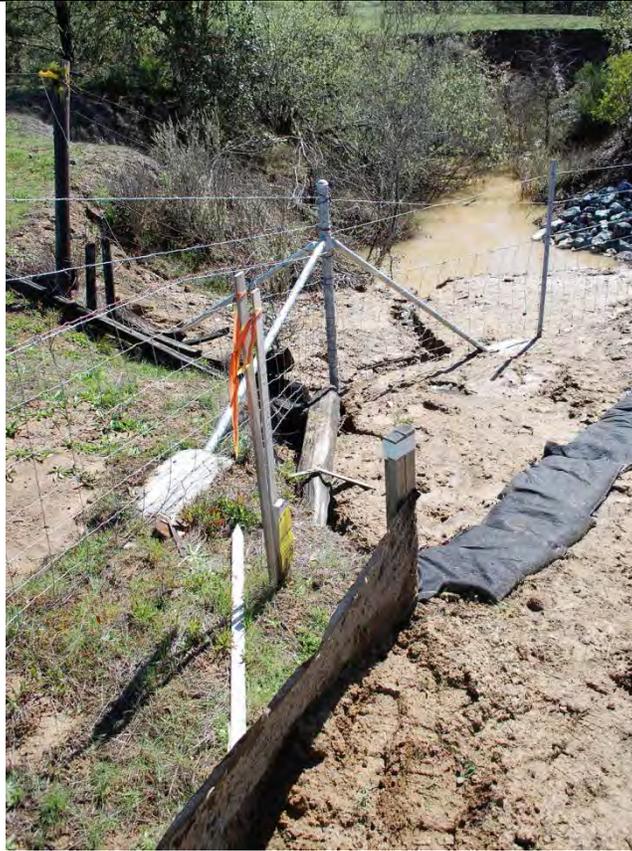
Photo 42: Looking southeast at Drainage System 24 before it enters a culvert and discharges to South Haehl Creek. A large gully has formed developed into the channel, as seen in the center of the photo. The steel fence is the Caltrans right-of-way fence. Caltrans staff said they were limited to fixes within their right-of-way, however, the disturbance on the other side of the fence was created by Caltrans and is Caltrans's responsibility to stabilize.

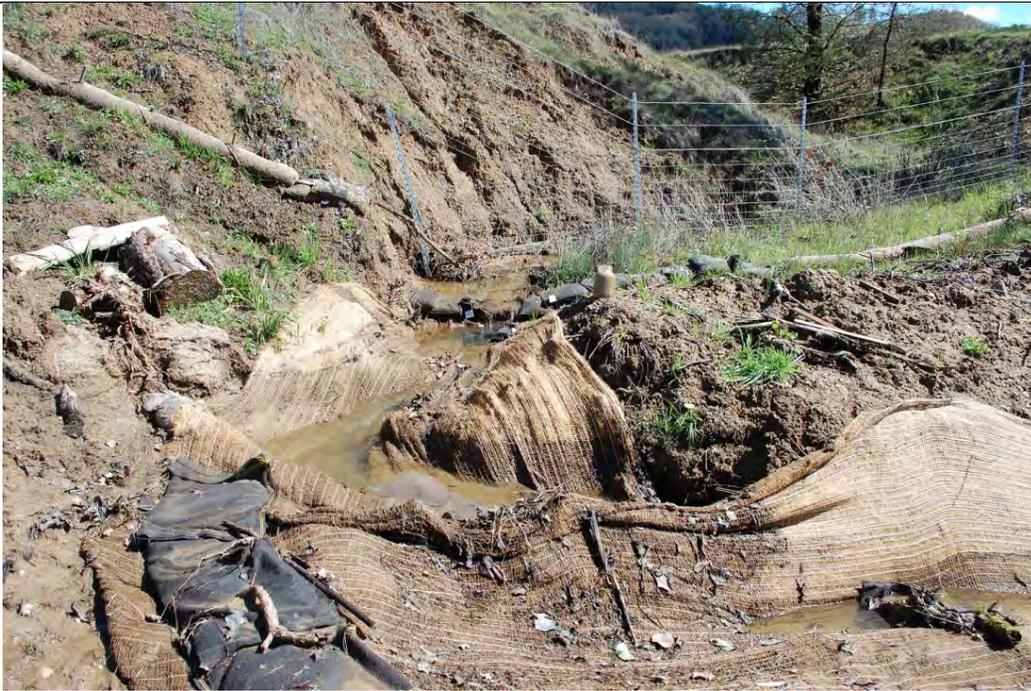
Photo 45: A closer view of the area shown in Photo 44, upper right. This watercourse runs into Caltrans's project limits from the Schmidbauer property, just before discharging to South Haehl Creek. Because a stable drainage path to South Haehl Creek was not planned for and provided, drainage has eroded the creek bank and transported sediment to South Haehl Creek. A stable drainage path must be provided. Plans for the final drainage configuration must be approved by the Regional Water Board. Biotechnical elements should be incorporated as appropriate.

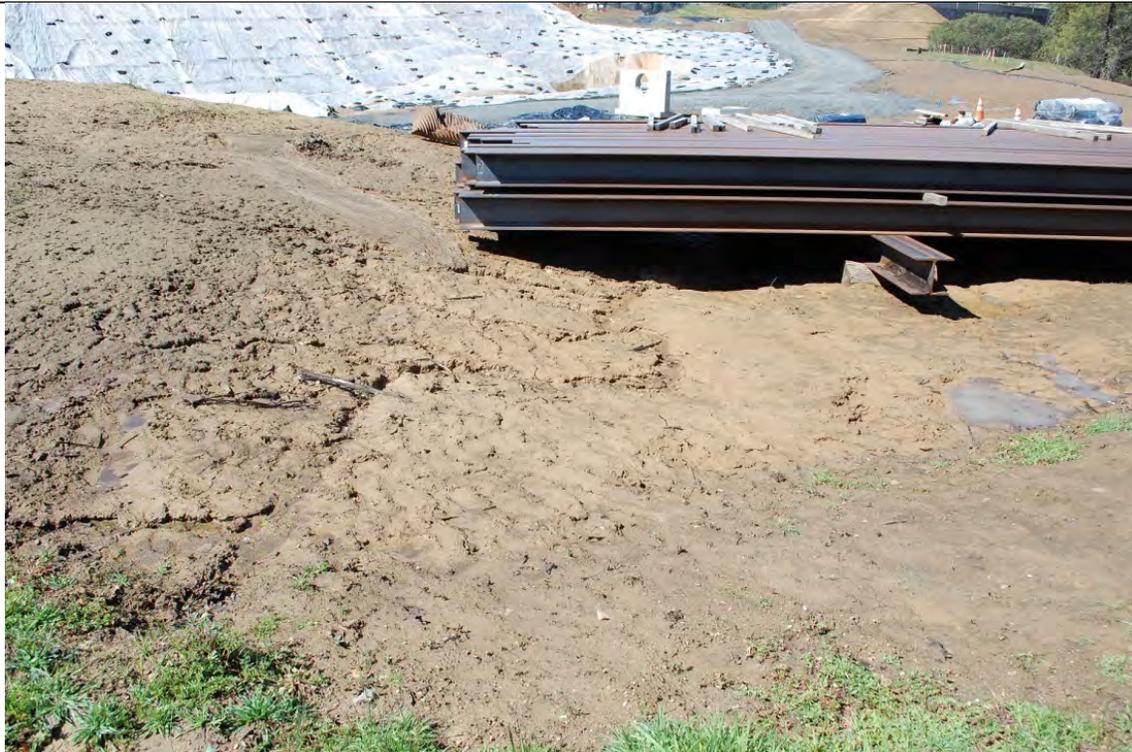
Photo 46: Looking west at a material storage area, just south of South Haehl Creek at the bridge 0129 abutment. Inadequate erosion and sediment controls.

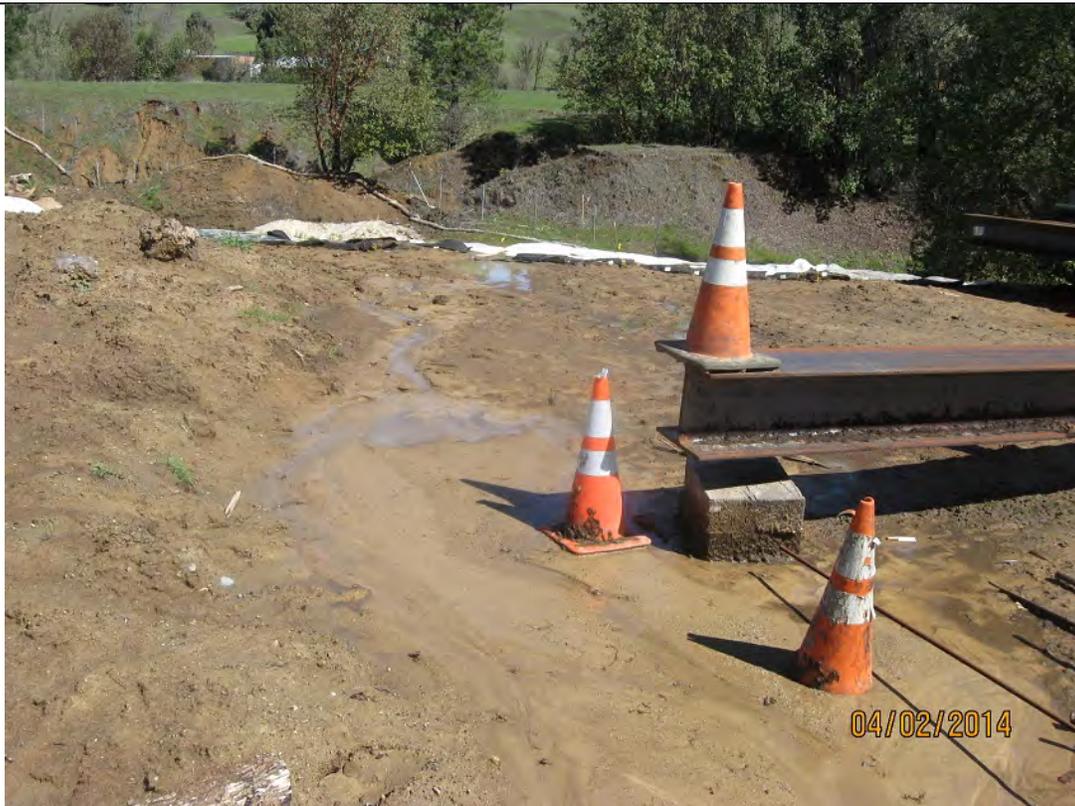
Photo 47: Looking east at a material storage area, just south of South Haehl Creek at the bridge 0129 abutment. Inadequate erosion and sediment controls. The concentrated flow path runs toward south Haehl Creek.

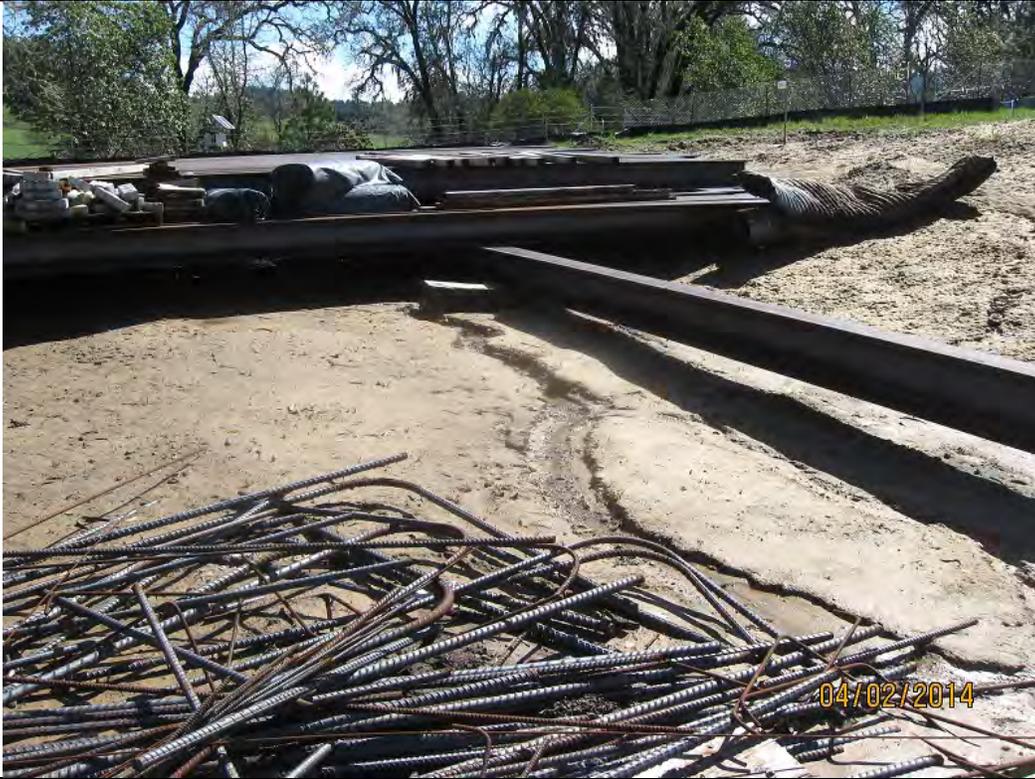
Photo 48: Looking east at a material storage area, just south of South Haehl Creek at the bridge 0129 abutment. Inadequate erosion and sediment controls. The eroding channel flows toward south Haehl Creek.

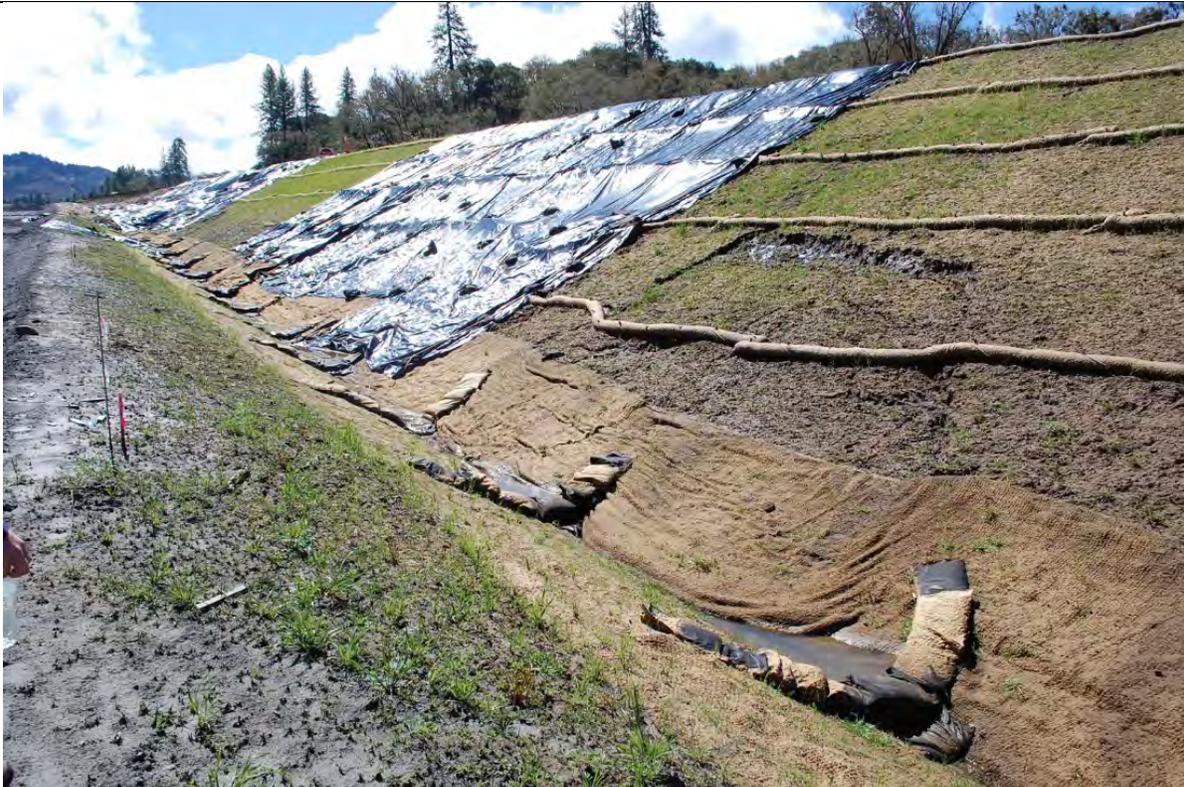
Photo 49: Drainage ditch on the west side of the U2 line, looking south. The slope was failing and eroding in several locations. Some of the slides are restricted to the top six inches, which corresponds to the depth of compost incorporation. This area drains to the basin shown in Photo 25.

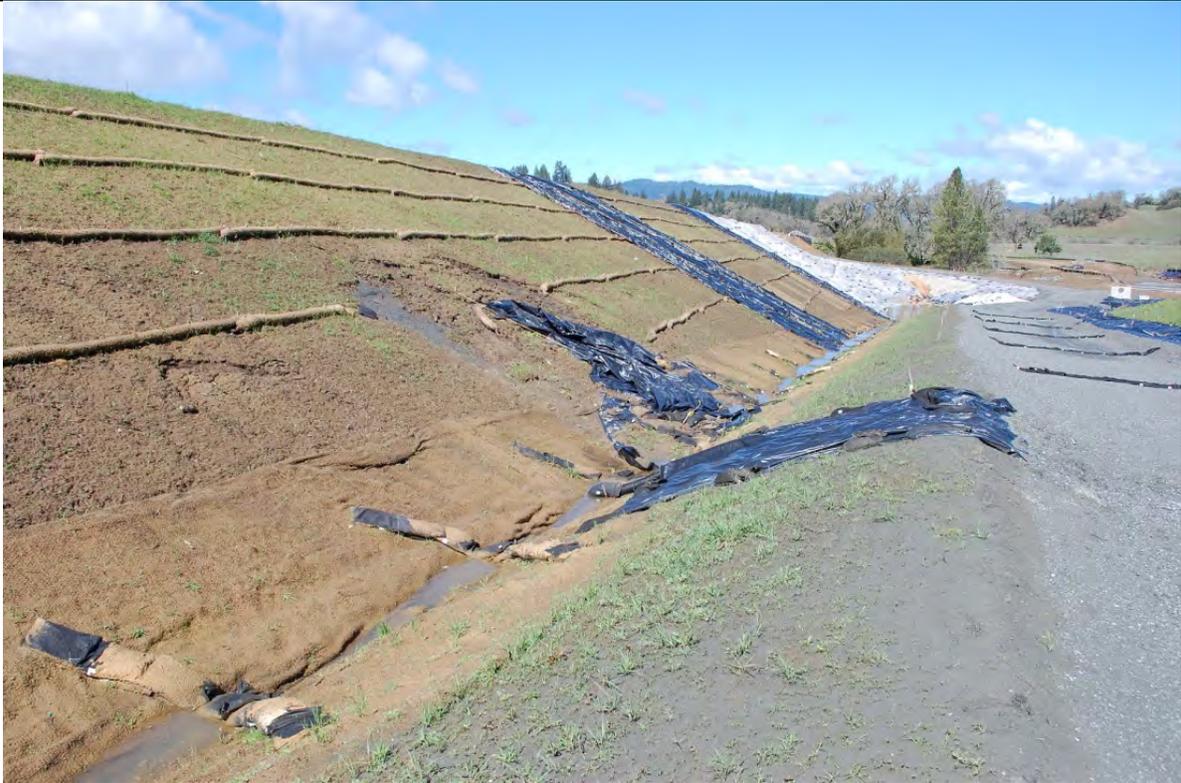
Photo 50: Drainage ditch on the west side of the U2 line, looking north. Ditch incision and sediment transport was evident in several locations.

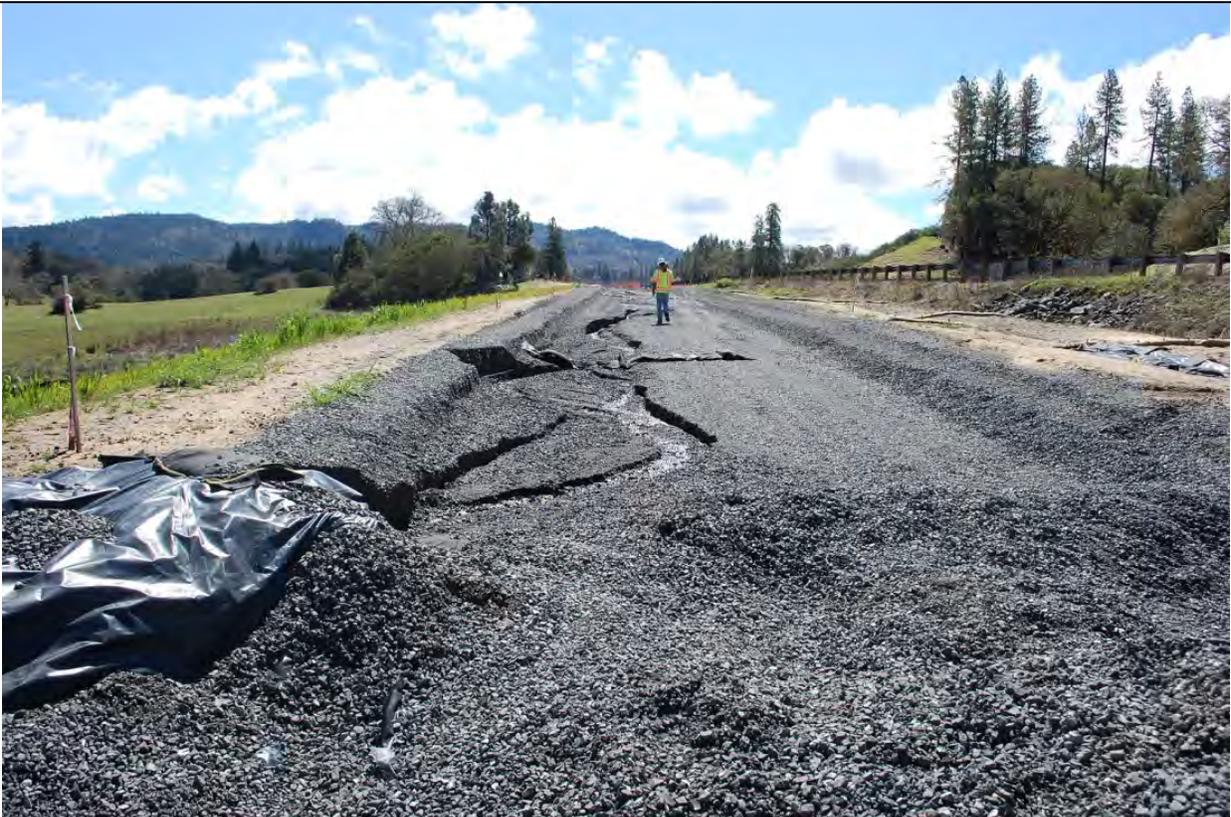
Photo 51: Looking north at the U2 line, south and upgradient of the area shown in Photo 50. The gravel road was significantly incised and sediment had been transported downstream to South Haehl Creek. The inlet is beneath the black plastic, shown in the lower left of the photo (see Photo 52).

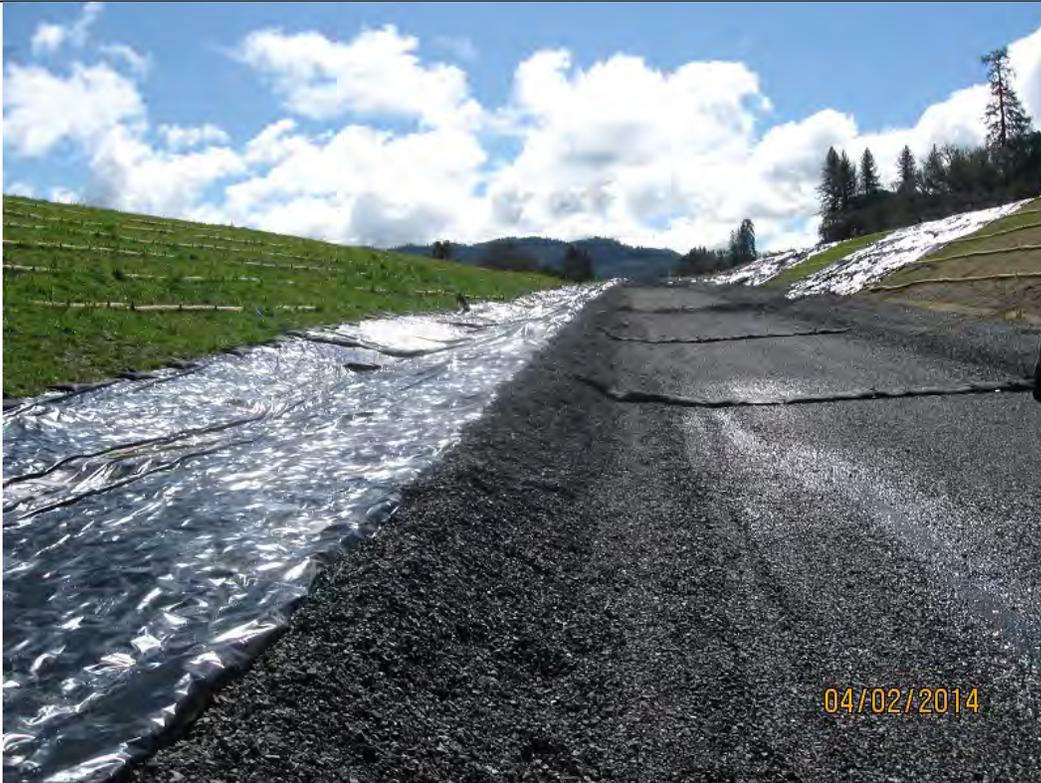
Photo 53: The U2 line downhill from the location shown in Photo 51. Caltrans staff noted that this segment of the gravel road had erosion problems similar to those shown above in Photo 51, but was recently fixed through installation of underdrains.

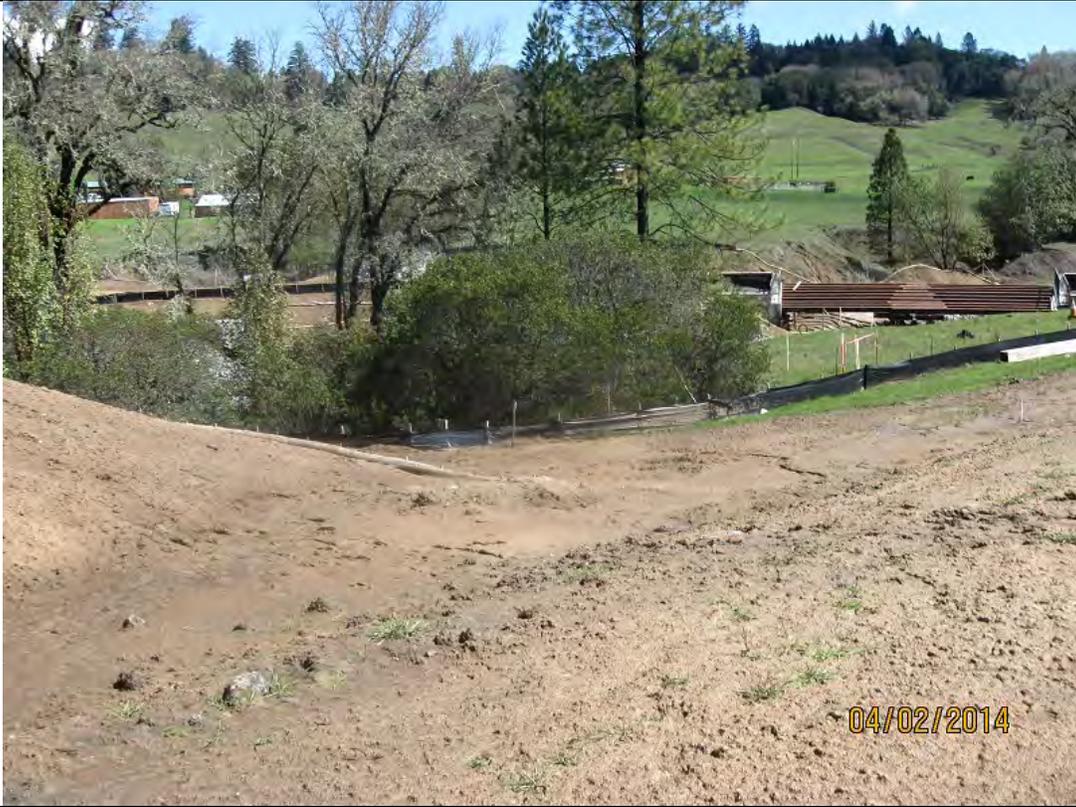
Photo 54: There was evidence that the basin shown in Photo 19 and Photo 55 overflowed down this slope, through the silt fence, and into South Haehl Creek. Erosion can be seen in the center-right of the photo. The silt fence shown in the distance was worn and requires replacement.

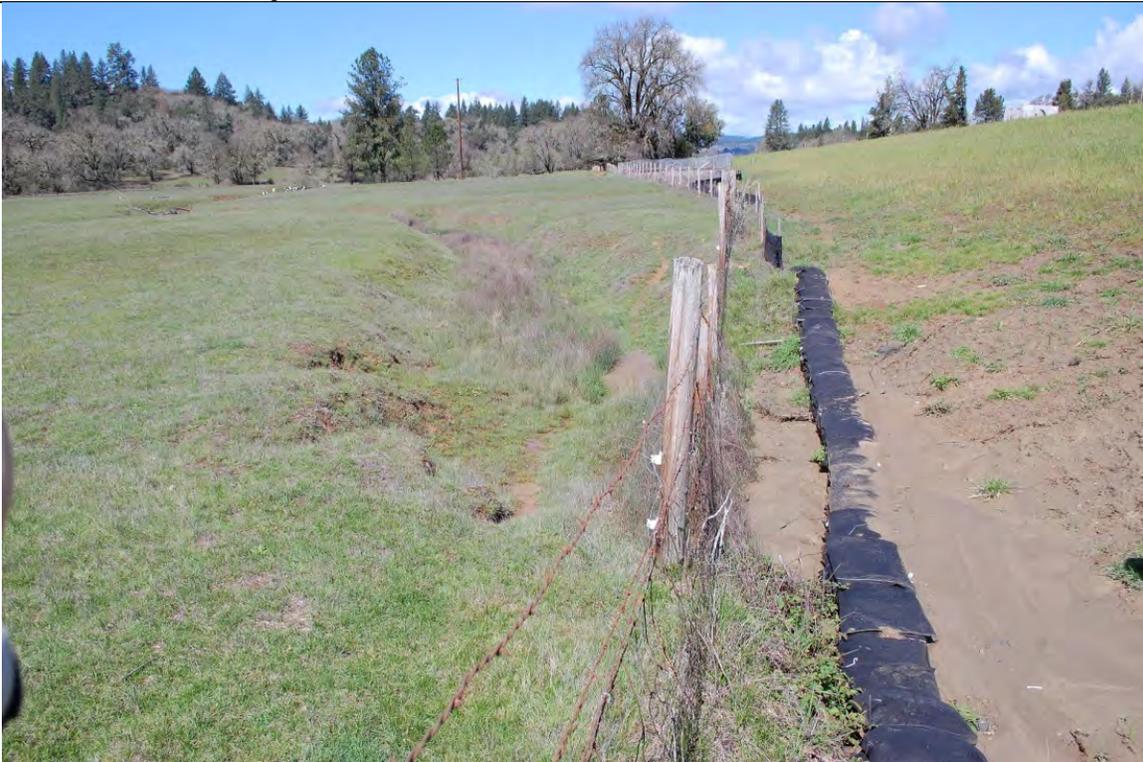
Photo 57: Looking north. Erosion and sediment transport and discharge off-site at the toe of slope along the U3 line. The contractor’s Water Pollution Control Manager discussed plans to remove sediment and install erosion control fabric and gravel bag check dams within the channel. I do not know exactly where this off-site drainage discharges.

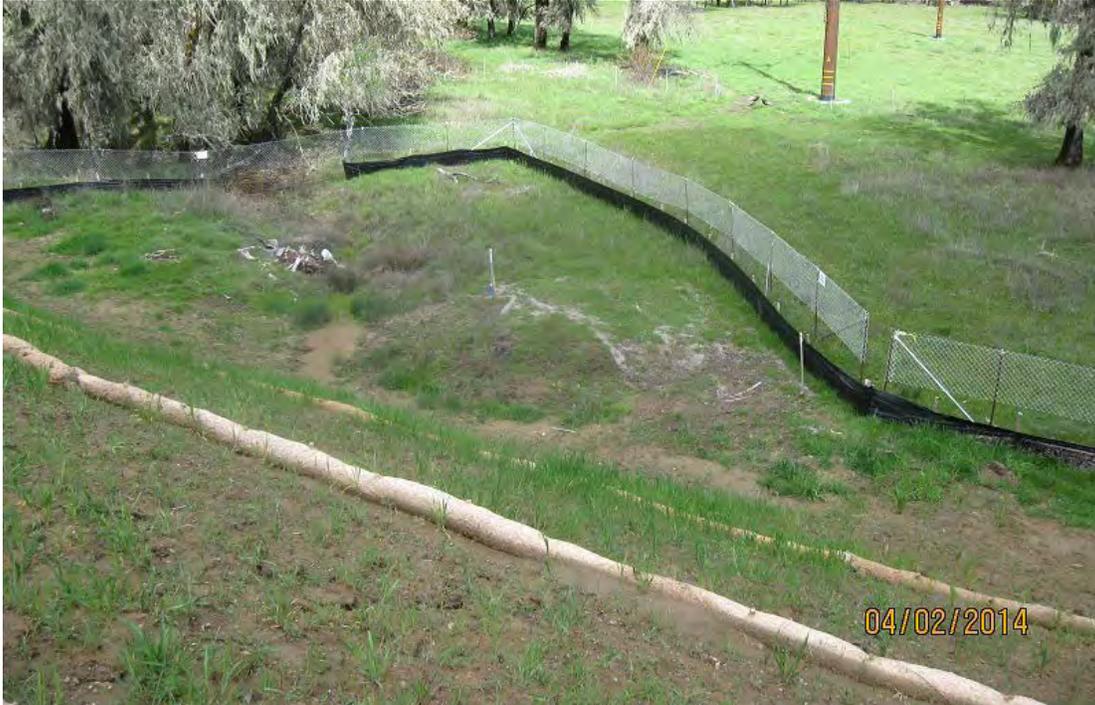
Photo 58: Sediment discharge seen in channel, center left, as a result of eroding embankment (see Photo 59)

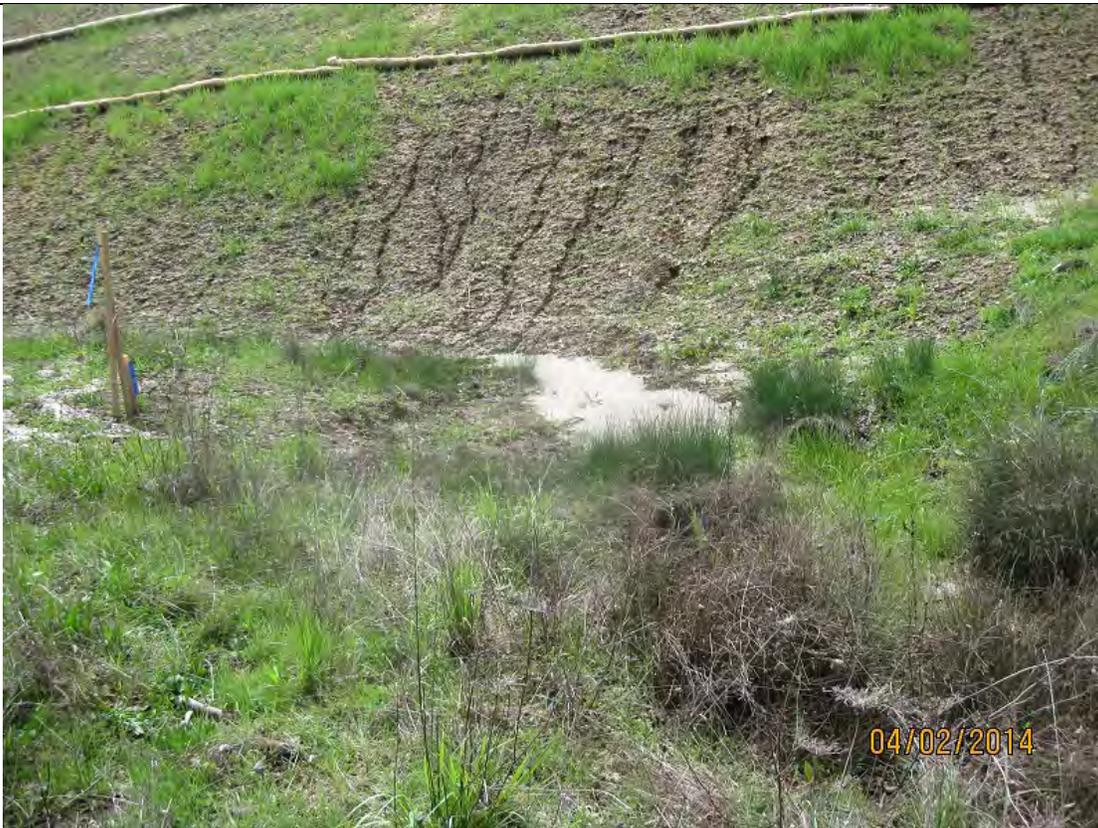
Photo 59: Erosion of embankment discussed above in Photo 58.

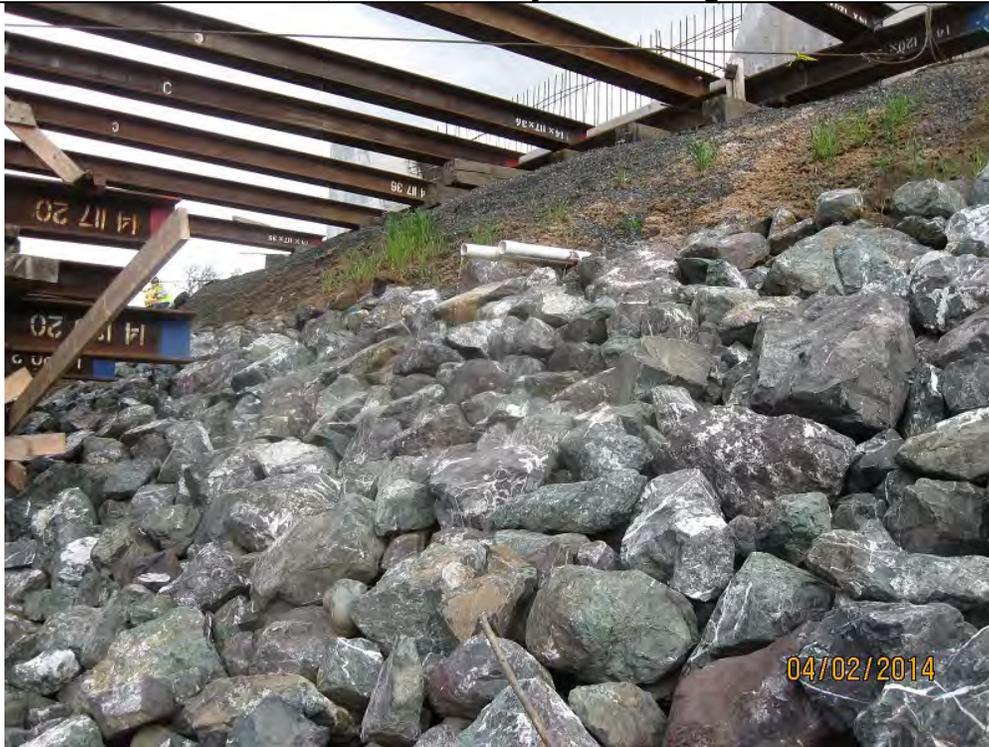
Photo 60: Discharge of high pH water from the North Haehl Creek southern abutment. High pH water had been discharging for an unknown period of time as a result of storm water infiltration through concrete base aggregate. The pipe has since been capped to prevent discharge.

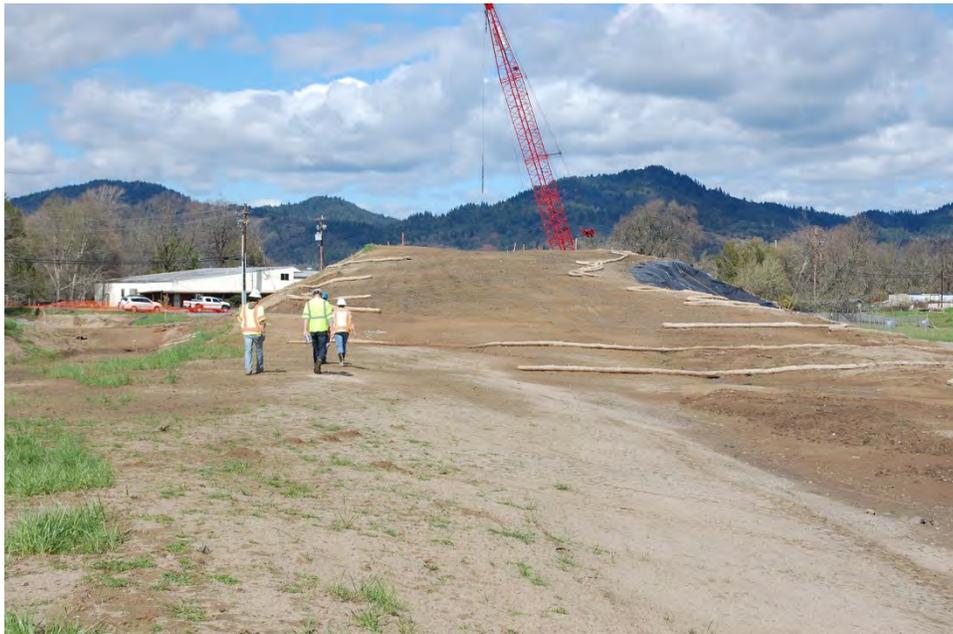
Photo 61: Looking north at Bent 1 at Center Valley Road. The abutment recently had fiber rolls removed and must be replaced.
