Caltrans State Route 101 Willits Bypass April 2, 2014 Inspection Findings
Inspected by Brendan Thompson and Kason Grady, North Coast Regional Water Quality Control Board
Time of Inspection: ~9:00 a.m. to 3:30 p.m., clear weather, one day after rain
Caltrans EA No.: 01-262004, Risk Level 3, WDID No. 1B12045WNME
See "Willits Map" at end of document for Area locations.

Area 1, "U1 Line," Photo 1 through Photo 19, West of Hwy 101, Southern-Most Project Limits, South Haehl Creek Watershed, Water Quality Monitoring Stations WQ01 and WQ03

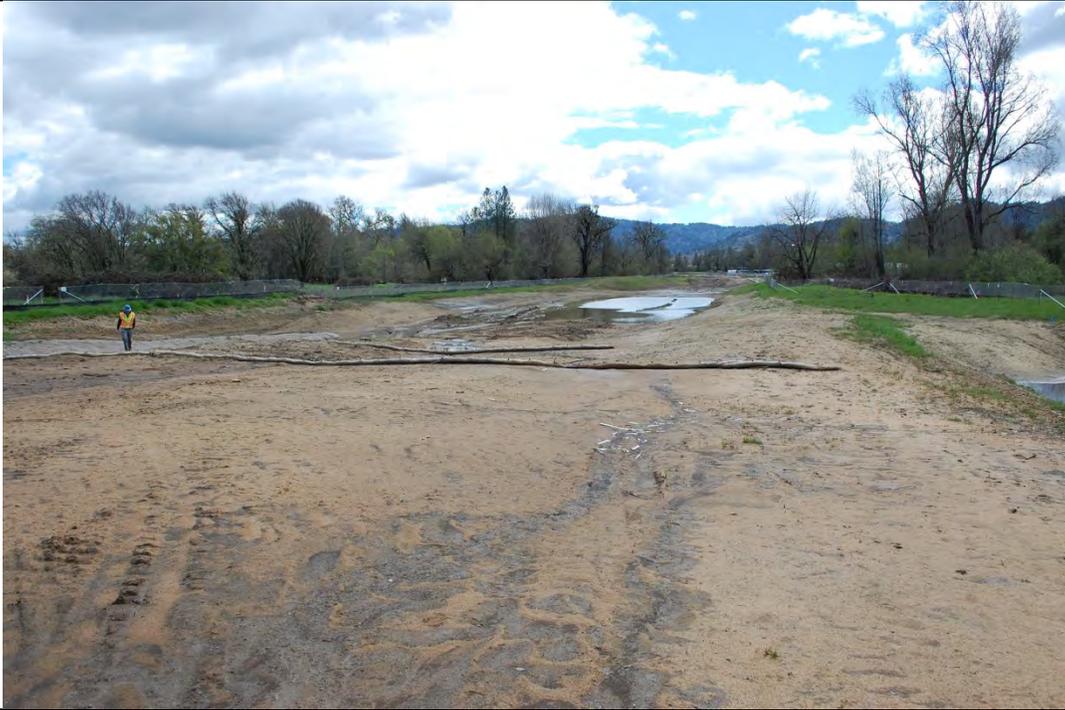
Photo 62: Looking south at disturbed area south of Bent 1. This large area has generally inadequate erosion and sediment controls. This area discharges to a tributary of Baechtel Creek at the location shown in Photo 63.

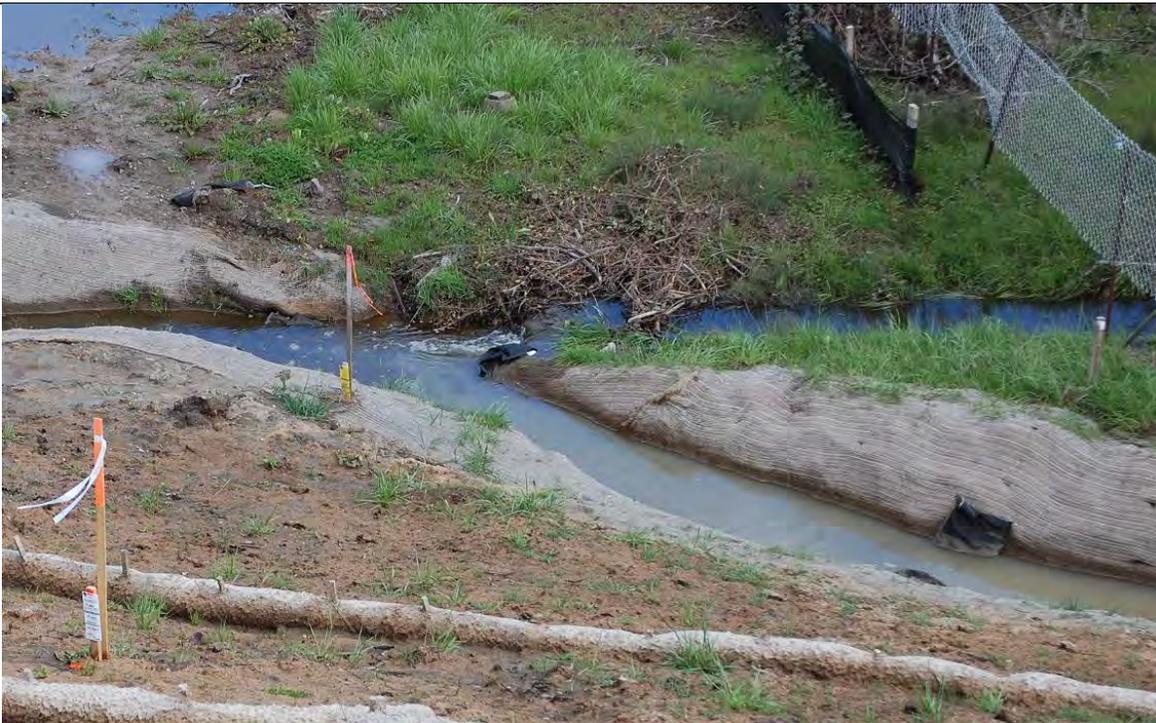
Photo 63: The lower drainage carries storm water from Caltrans disturbed soil areas shown in Photo 62, Photo 64, Photo 65, and Photo 66. It is visibly more turbid than the water from the adjacent drainage that is virtually unaffected by construction operations. Caltrans has been incorrectly representing site discharge by sampling at a location downstream of this confluence. Caltrans must capture representative site samples from a location upstream of this confluence.

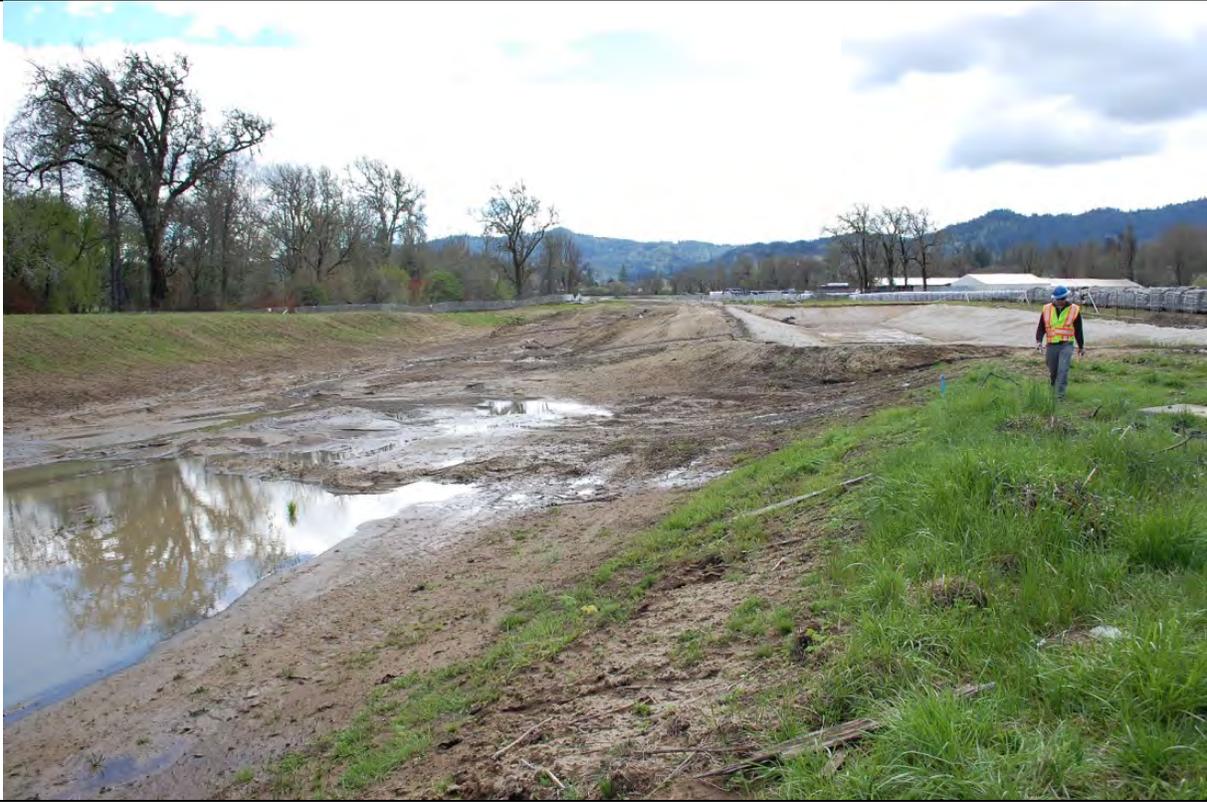
Photo 64: Inadequate erosion control south of Bent 1.

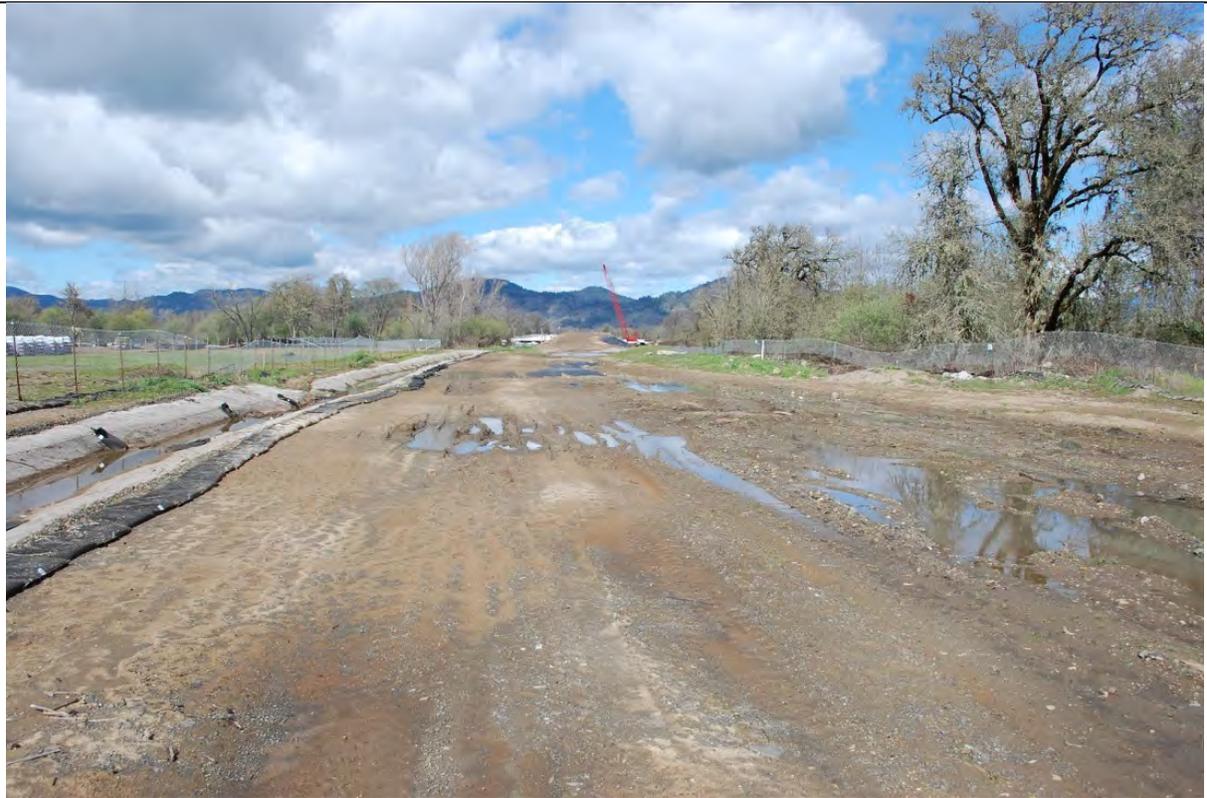
Photo 65: Inadequate erosion control south of Bent 1.

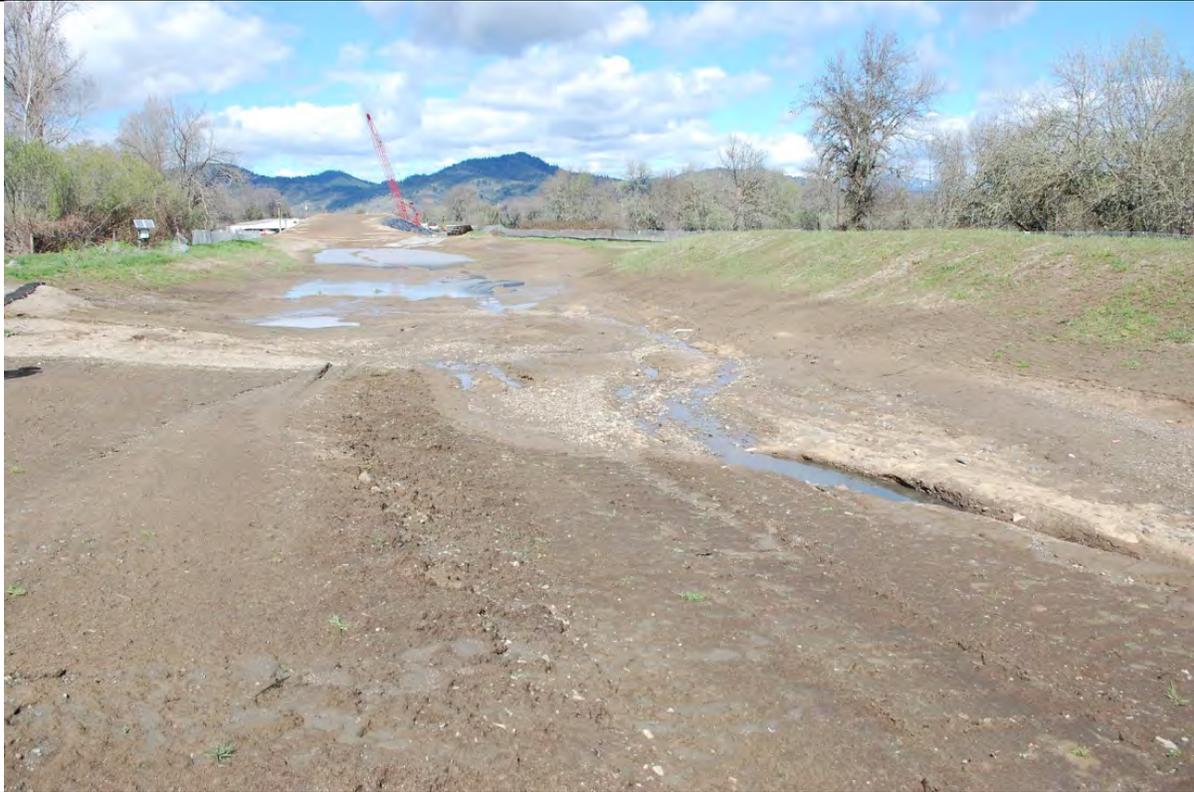
Photo 66: Inadequate erosion control south of Bent 1.

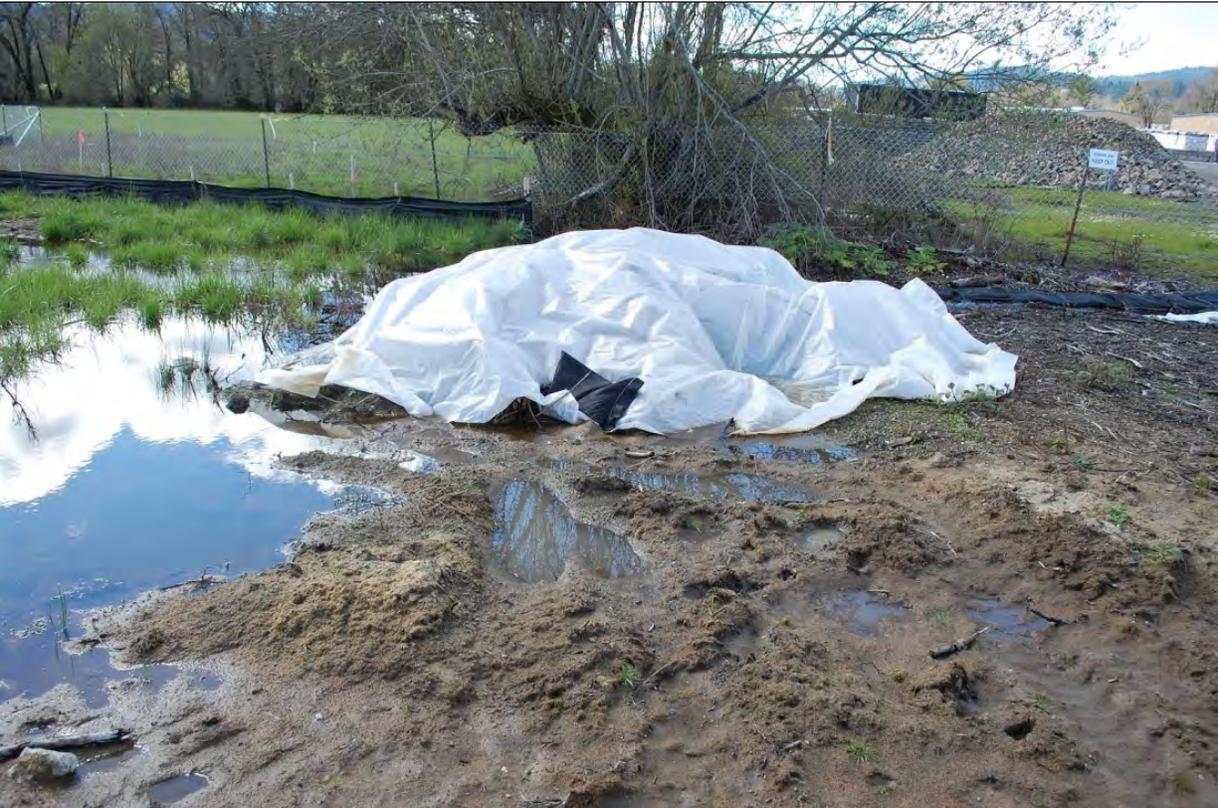
Photo 67: Photo taken looking west at the southern boundary of Spare Time Supply. Vegetation debris is inappropriately stored in standing water and must be relocated.

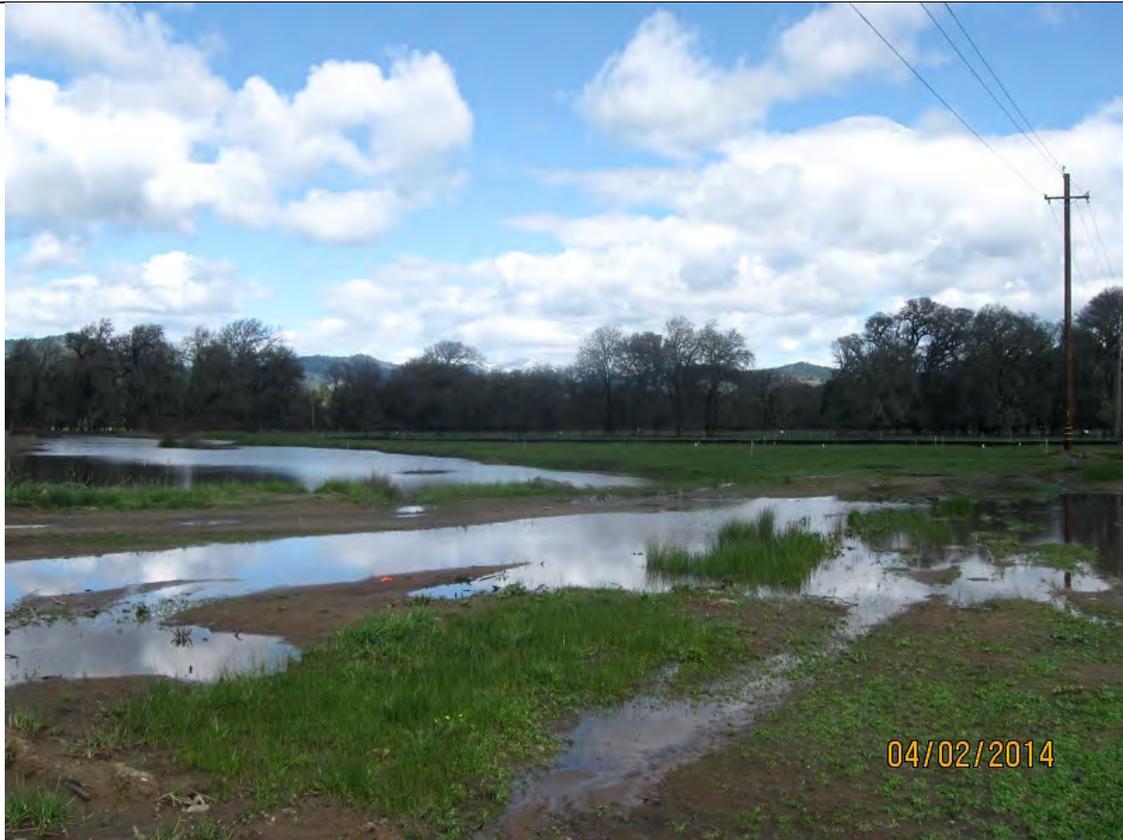
Photo 68: Looking northeast at Rutledge Pond. No sediment control at the boundary of Rutledge Pond. Construction storm water has flowed uncontrolled into the pond all rainy season. Perimeter control must be installed.

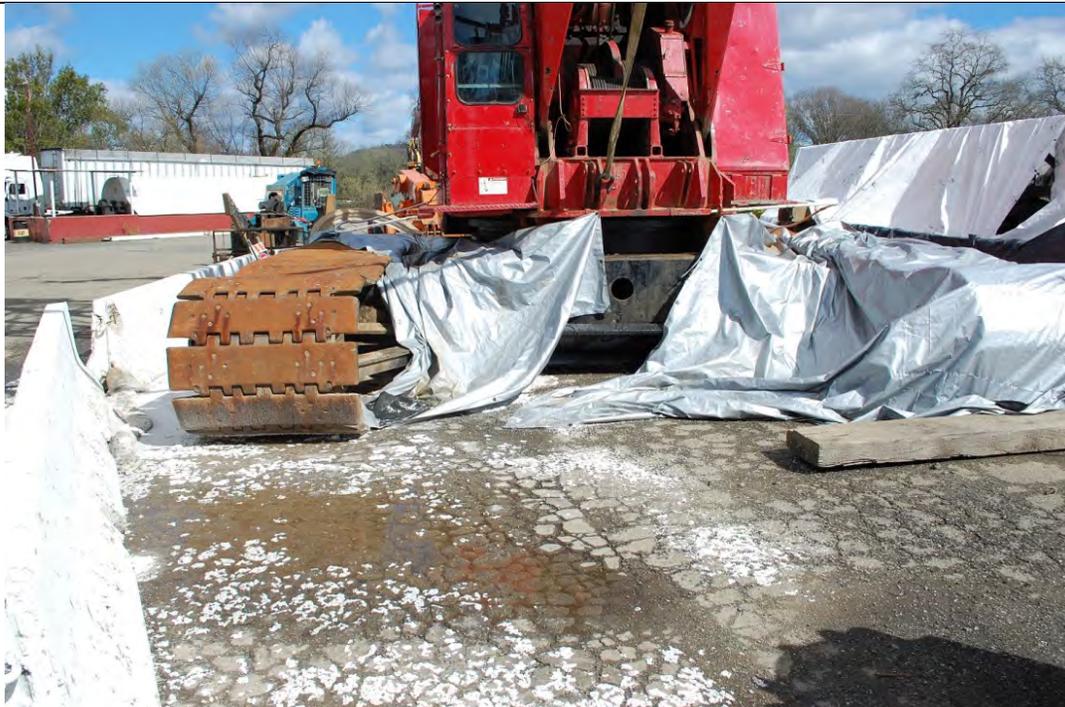
Photo 69: Flatiron's crane had been vandalized twice, resulting in hydraulic fluid spills. Absorbent material was distributed throughout the area. The smell of petroleum product was strong. It had rained the previous two days and the tarps onsite at the time were not large enough to cover the entire spill area.

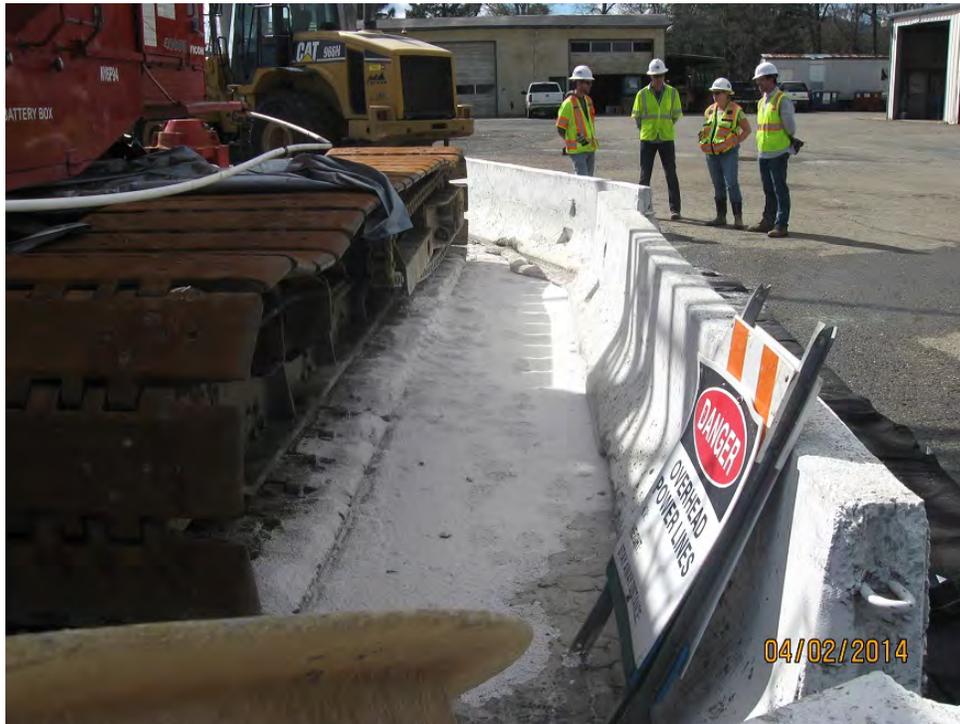
Photo 70: Absorbent material had been applied to absorb hydraulic fluid. Gravel bags along the perimeter appeared to have absorbed fluid. Caltrans must provide the Regional Water Board with information detailing the dates the hydraulic lines were cut as well as documentation of appropriate clean-up and disposal activities.

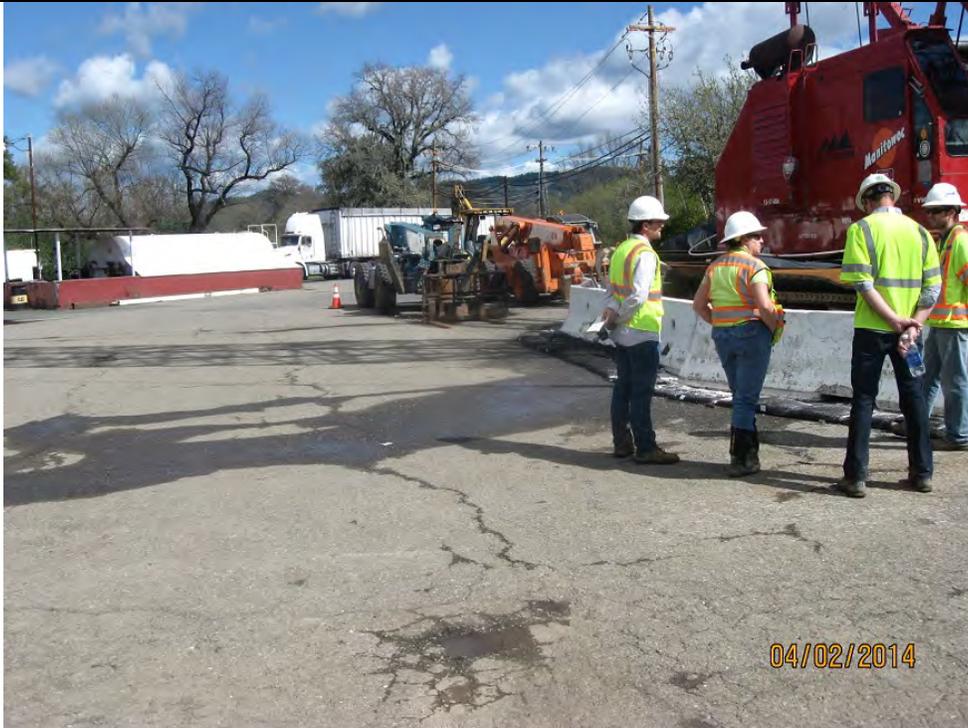
Photo 71: It appeared that fluid had drained from the spill area as indicated by the water mark on the asphalt. We communicated that the material, including the gravel bags must be disposed of immediately, subject to appropriate hazardous waste disposal protocol. Caltrans had not been notified of the incident and potential discharge.

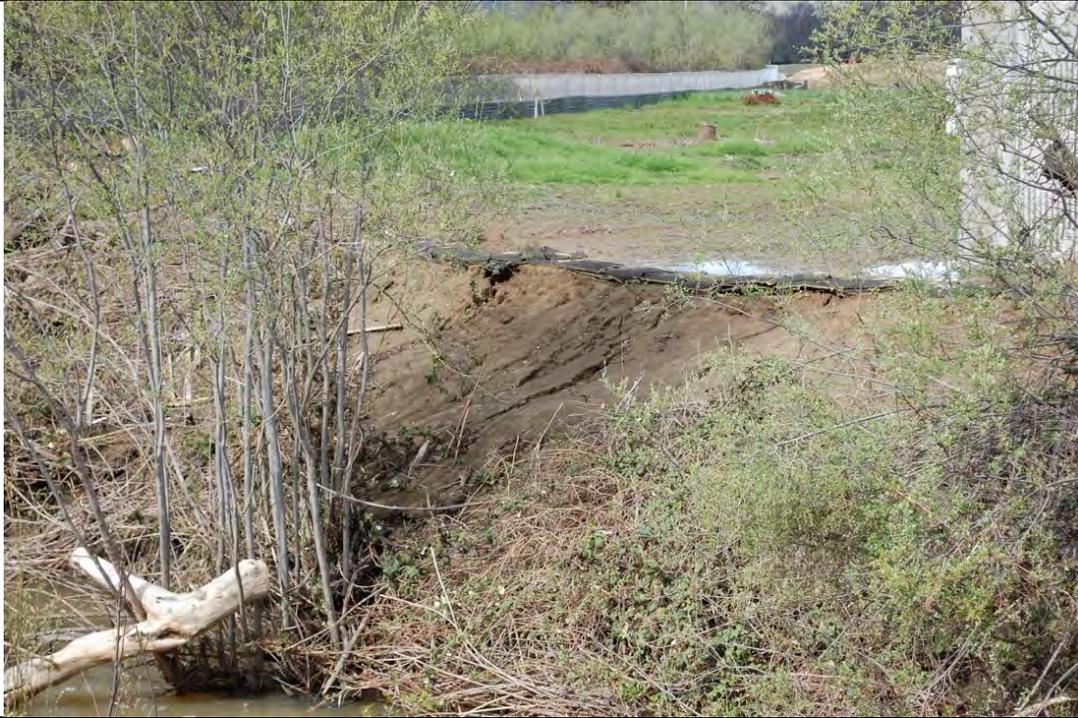
Photo 72: Looking northwest. Sediment discharge to Baechtel Creek at Pier 4 as a result of inadequate erosion control and failed sediment control. Erosion and sediment control must be provided.
