## SPECIAL AIRWORTHINESS INFORMATION BULLETIN

SAIB: SW-18-04  
Date: November 16, 2017

**SUBJ:** Engine Oil Drainage System

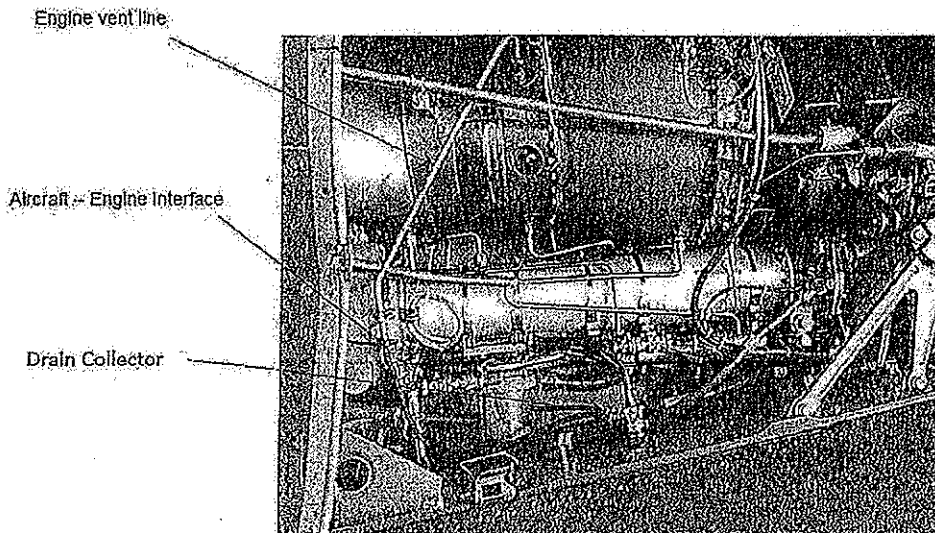
On January 26, 2017 an operator of a BK117 C-2 experienced an in-flight engine fire and made an emergency landing in Sioux Falls, South Dakota. Although still under investigation, the engine fire could be related to engine oil coke chips plugging the return scavenge line for the rear bearing of the gas generator. On September 8, 2017 a BK117 C-2 helicopter was destroyed when it crashed near Hertford, North Carolina. The NTSB preliminary investigation found that the number 2 engine rear turbine shaft bearing exhibited discoloration consistent with overheating and lack of lubrication. Through the course of inspecting the engine issue for scavenge line blockage, a BK117 C-2 operator discovered a separate, airframe-related issue. The operator detected various levels of coking blockage of engine drain lines. Airbus Helicopters prescribes a general visual inspection of the bearing compartment area. There are no prescribed inspections of the drain tube or drain collector to check for blockage. A blocked drain line may, under certain circumstances, present a risk for an engine fire and/or inflight shutdown of the affected engine.

The FAA recommends the actions below for all owners, operators, and maintainers of Airbus Helicopters BK117 C-2 helicopters. The actions should be performed for each engine at intervals not to exceed 100 hours time-in-service (TIS). Refer to Fig. 01 in Airbus Helicopters AMM 71-71-01, dated March 1, 2016 and to Figure 1 of this SAIB.

1. Disconnect the rear bearing lines part numbers AE709636-1 (hose), 117-600381.III (hose), and 117-600381.105 (hose) from the drain collector part number B717M1028801 or 117-602061 (drain collector) and disconnect the drain collector from the engine deck.
2. Visually check the drain collector and hoses for obstructions. These obstructions may include carbon and coke deposits. Contact Airbus Helicopters for recommended cleaning procedures if there are any obstructions.
3. If there are no obstructions or after performing the above actions, reconnect the drain collector to the engine deck and reconnect the drain/vent lines to the drain collector per approved maintenance instructions.
