National Transportation Safety Board Aviation Accident Final Report

Location:	Hertford, North Carolina	Accident Number:	ERA17MA316
Date & Time:	September 8, 2017, 11:20 Local	Registration:	N146DU
Aircraft:	EUROCOPTER DEUTSCHLAND GMBH MBB BK 117	Aircraft Damage:	Destroyed
Defining Event:	Loss of engine power (partial)	Injuries:	4 Fatal
Flight Conducted Under:	Part 135: Air taxi & commuter - Non-scheduled - Air Medical (Discretionary)

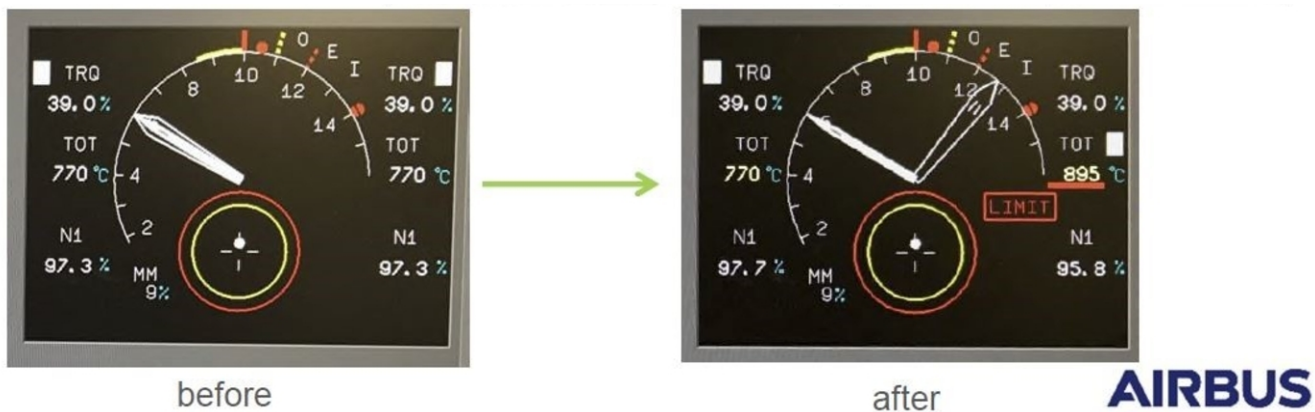
Figure 3 - Simulated FLI display before and during rear bearing seizure.

Specifically, as the bearing failed, the FLI needle for the No. 2 engine would have changed from indicating torque (TRQ), to indicating turbine outlet temperature (TOT) due to a sudden rise in TOT in the No. 2 engine. Such a switch would have been unusual, because the needles normally reflect TOT during engine start only. The change in the position of the No. 2 FLI needle would have resulted in a large split between both needles.

Airbus Helicopters performed a computer simulation to determine what the FLI might theoretically indicate in the event of a gas generator rear bearing seizure in the No. 2 engine. The simulation assumed that the gas generator continued to rotate momentarily with damage to the high-pressure turbines and without friction in the seized rear bearing. Figure 3 shows a representation of the FLI before and during such a rear bearing seizure. Airbus Helicopters noted that this simulation depicted a snapshot of the simulated conditions and that, during operations, the needles would move and numeric values would fluctuate based on the engine parameters, the power applied, and the evolution of the bearing failure.

The left image of figure 3 shows the FLI with the engine operating normally, prior to a bearing seizure. Both FLI needles should depict TRQ because that would be the first limiting parameter for both engines in the flight conditions on the day of the accident. The needles would both indicate the same or nearly the same value for TRQ because both engines should produce about the same power, as the engines are TRQ balanced by the VARTOMS system. The simulation showed that, with a rear bearing seizure in the No. 2 engine, the engine's turbine outlet temperature would be elevated such that the TOT limit would be reached before the torque limit. Thus, an elevated turbine outlet temperature would result in the FLI changing to TOT for the No. 2 engine, as denoted by the white box for the No. 2 engine moving from the TRQ label (in the left image) to the TOT label (in the right image) and the position of the needle for the No. 2 engine changing. In addition, because TOT reached its limit, the digital value appeared with a red bar underneath it. The No. 1 engine would remain limited by TRQ, as indicated by the white box for the No. 1 engine next to the TRQ label (in the right image). As a result, a large split in the needles would occur because they would no longer indicate the same parameter for each engine, even though both engines would still be initially producing the same torque (39% in the figure).
