Reference: Job 2087 – Highway 101 Willits Bypass
Caltrans – Contract: 01-262004

Subject: Corrections to Caltrans' Notice of Violation

NOV Attachment A Photo 1

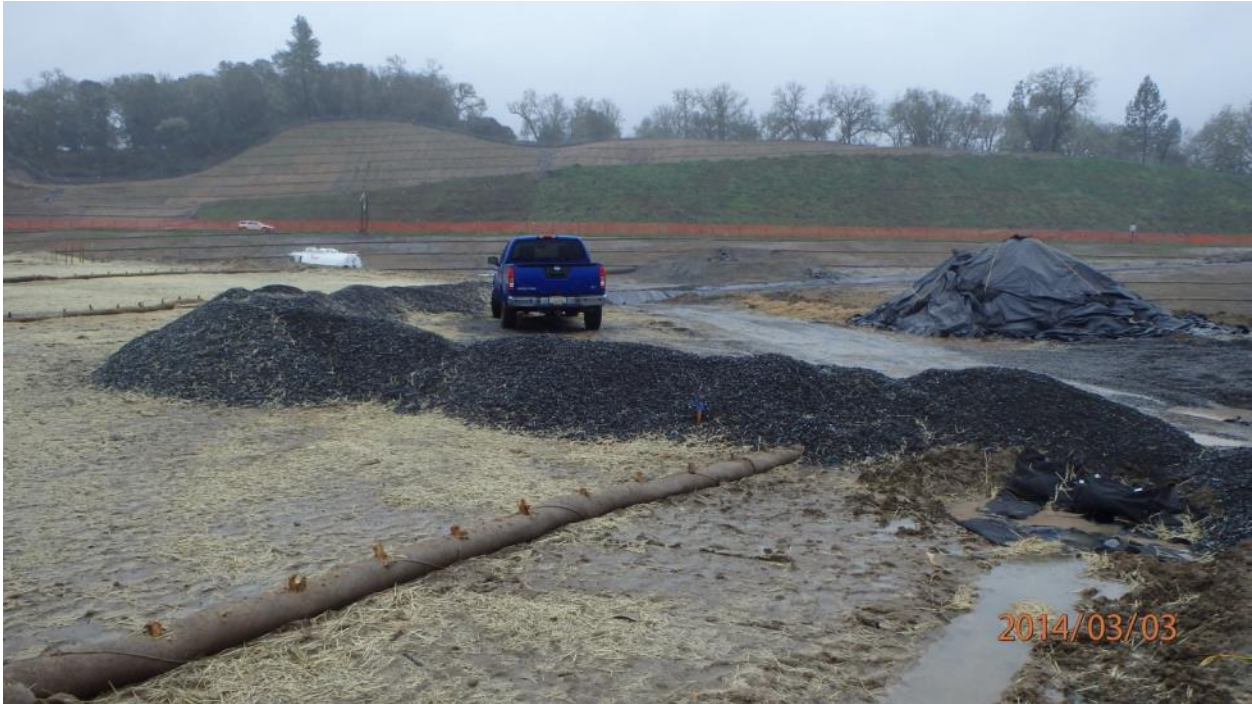
Corrective Action Photo 1A: Top of Bridge Number 10-0129 RL Northbound Abutment 1 with a $\frac{3}{4}$ " gravel berm to divert water into drain under road and straw to cover DSA

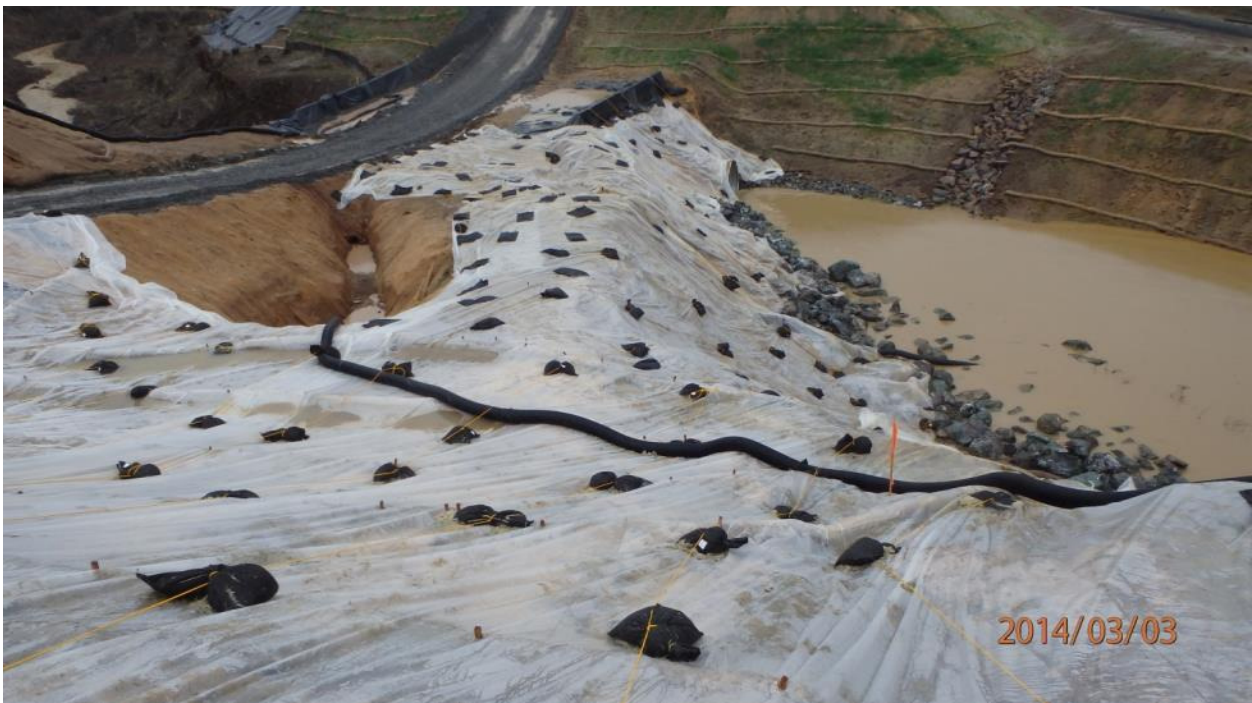
Corrective Action Photo 1B: View from top of Bridge Number 10-0129 RL Northbound Abutment 1. Looking north into South Haehl Creek and the culvert crossing

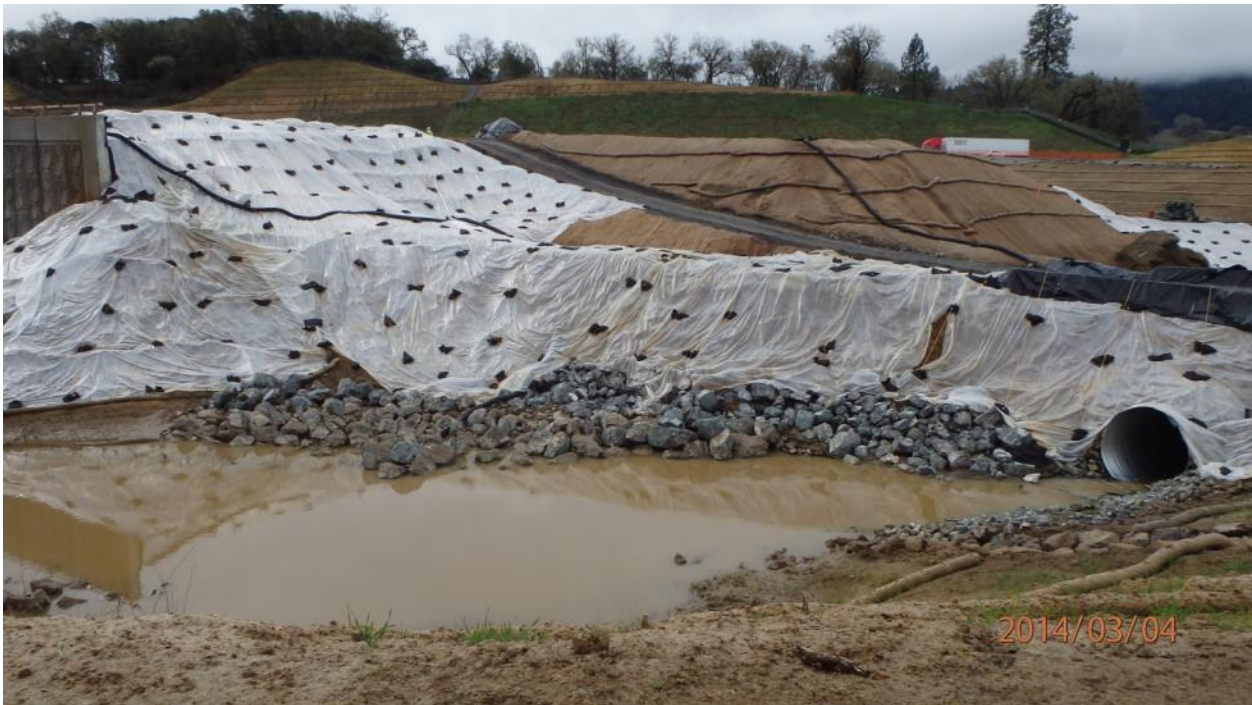
Corrective Action Photo 1C: Looking southwest at the culvert crossing and Bridge Number 10-0129 RL with filter fabric and ¼ ton RSP stabilizing the toe of slope

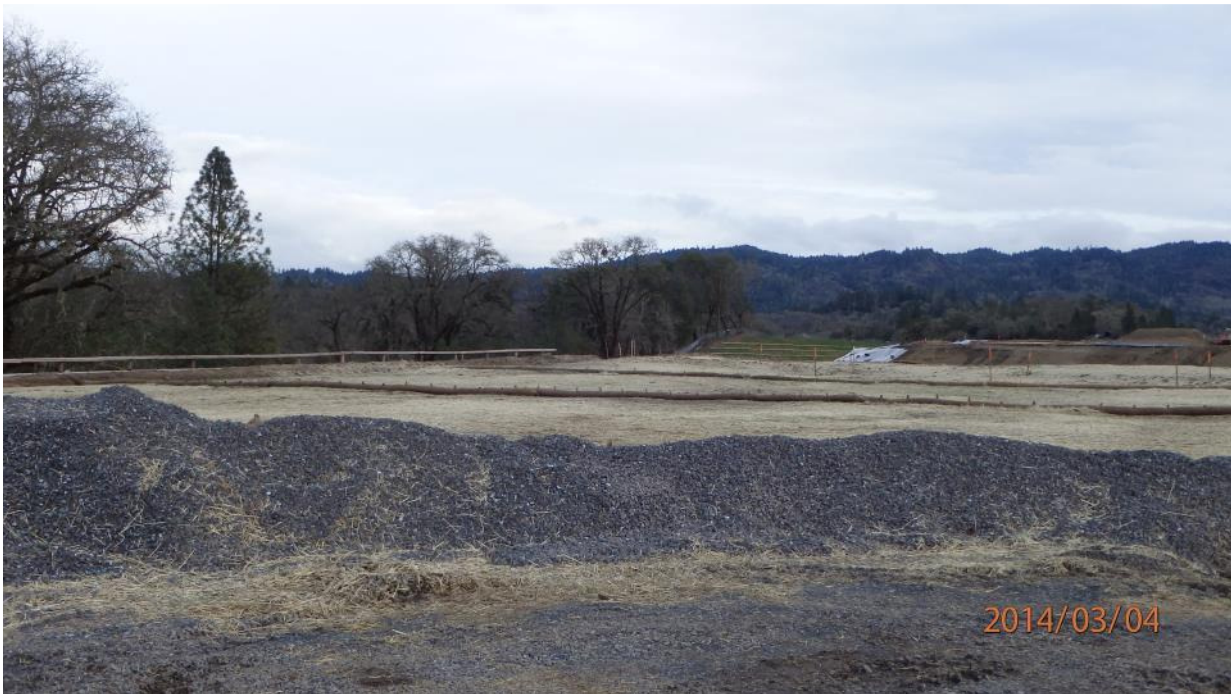
Corrective Action Photo 1D: DSA was stabilized with blown straw at the top of Bridge Number 10-0129 RL Northbound Abutment 1

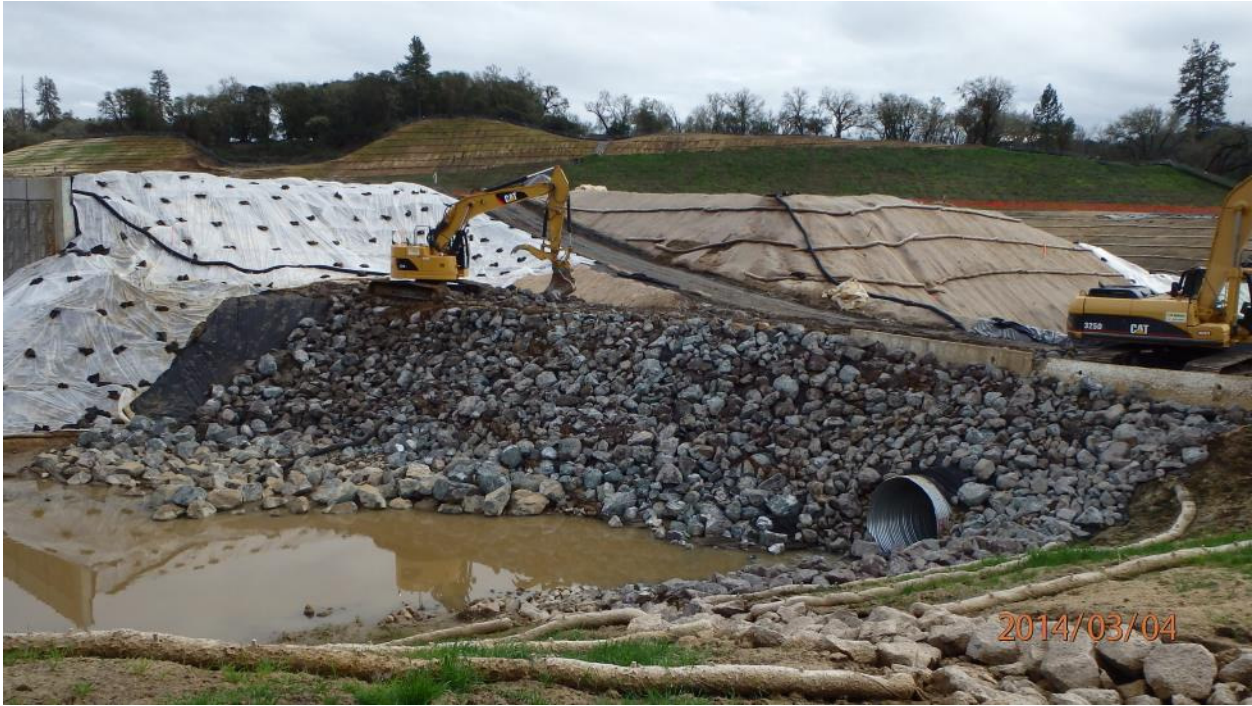
Corrective Action Photo 1E: Crew installing ¼ ton RipRap slope stabilization along eastern bank of the culvert crossing. Looking southwest at the culvert crossing and Bridge Number 10-0129 RL

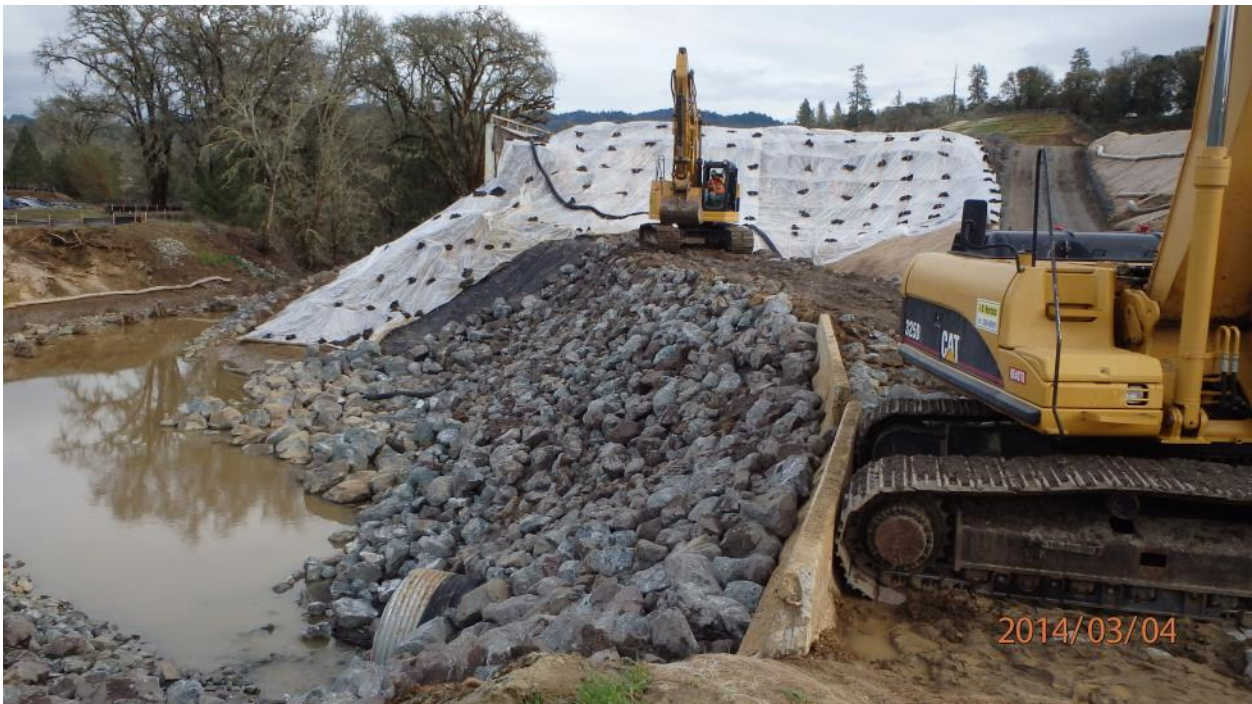
Corrective Action Photo 1F: Looking south at the culvert crossing and Bridge Number 10-0129 RL

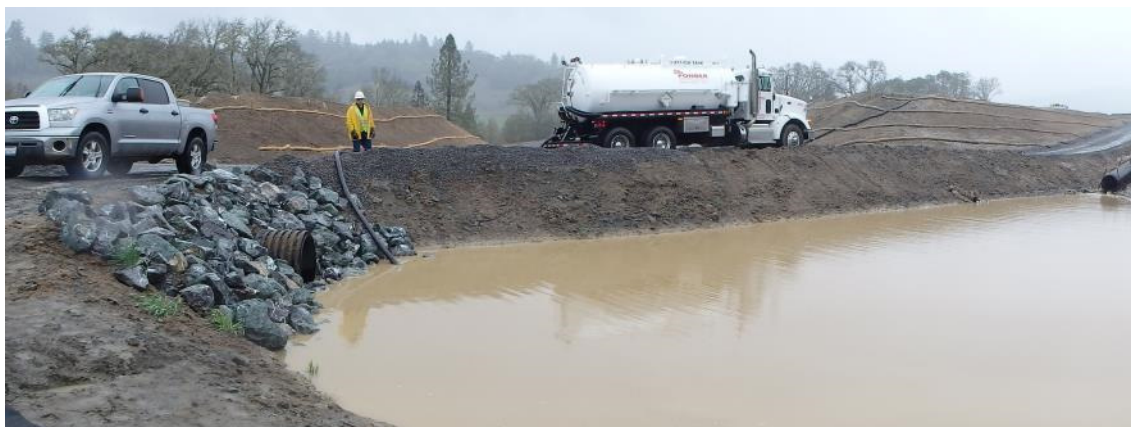
Corrective Action Photo 2A: Pumping water out of the Haehl Creek Interchange basins at the H-Line and winter access road intersection

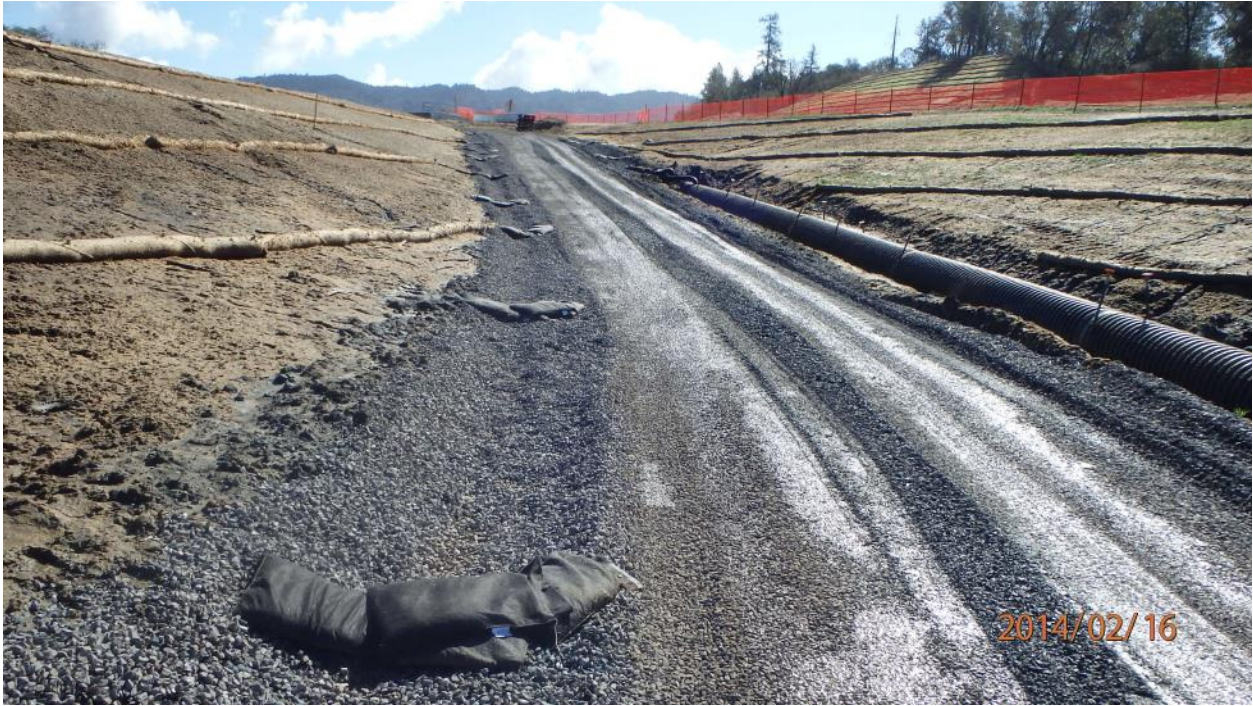
Corrective Action Photo 2B: Stabilized ditches along the winter access road at the South Haehl Creek Interchange

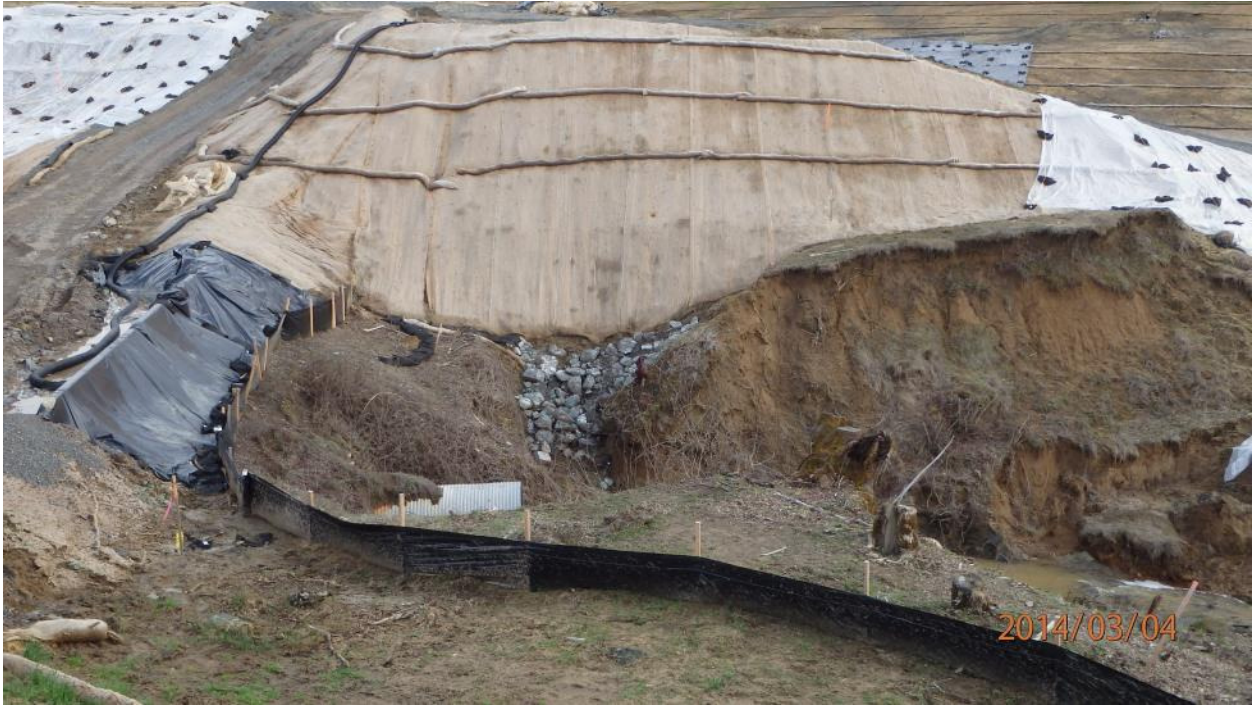
Corrective Action Photo 3A: Looking south at the southbound Bridge Number 10-0129 RL Abutment 1.

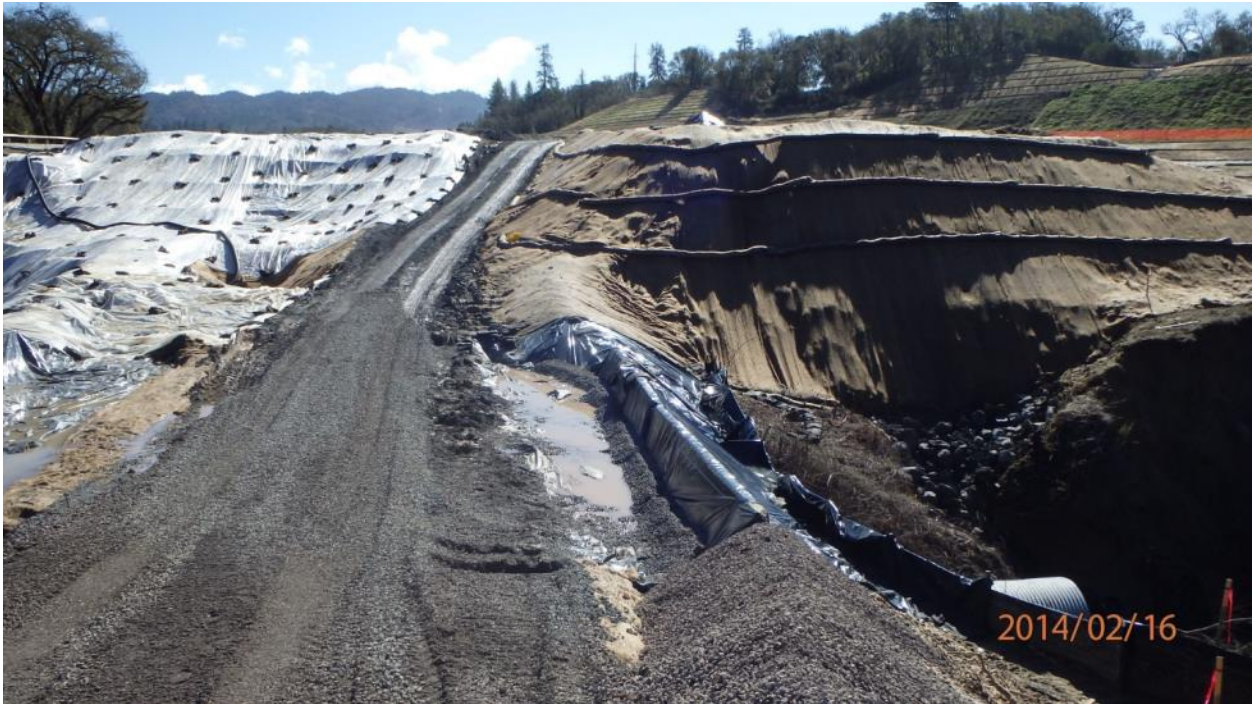
Corrective Action Photo 3B: Looking south at the Bridge Number 10-0129 RL southern abutments

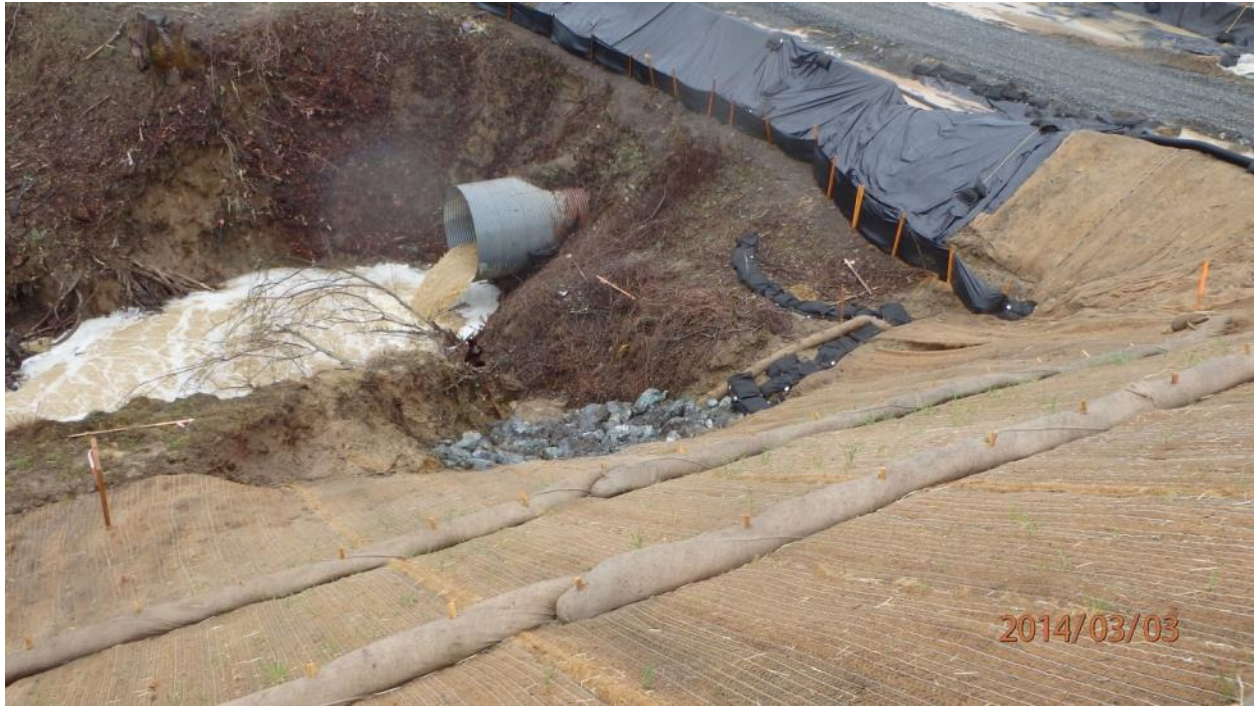
Corrective Action Photo 3C: View from above the southbound Bridge Number 10-0129 RL Abutment 1 at the culvert crossing and South Haehl Creek

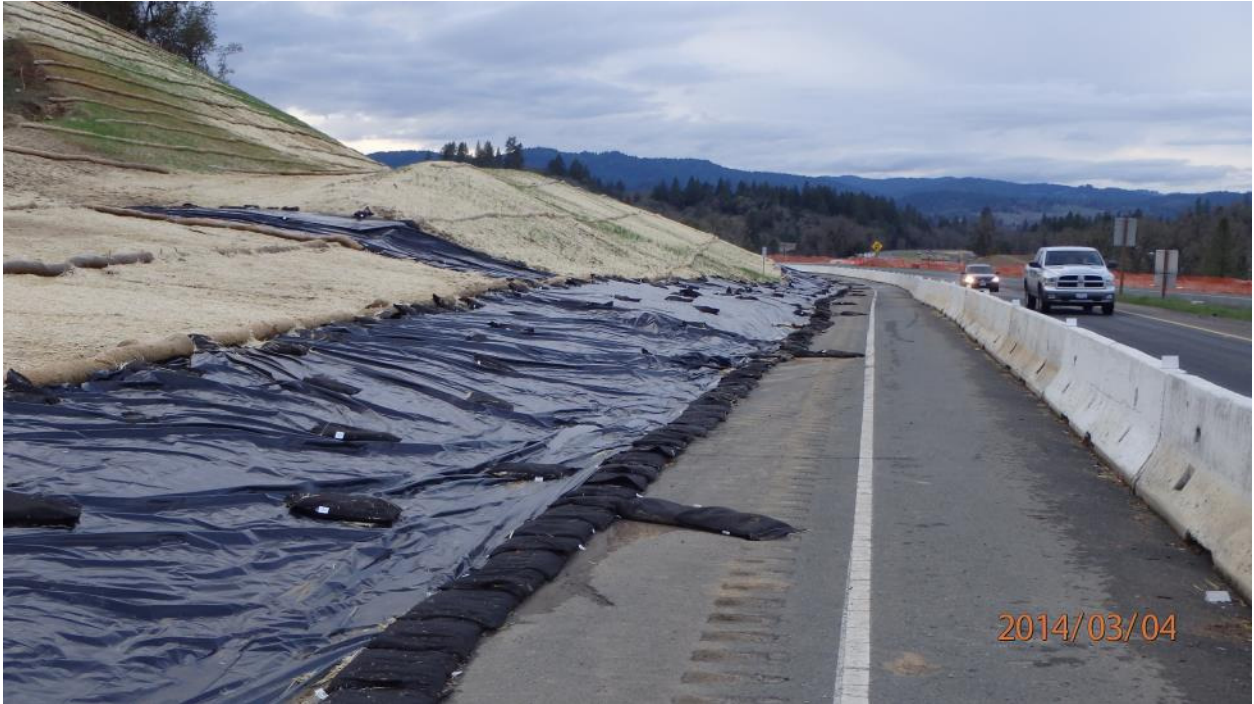
Corrective Action Photo 4A: DSA was stabilized with straw and plastic cover has been installed to convey water along the toe of slope to the drainage inlet. Looking north along Highway 101 at the base of the U1-Line

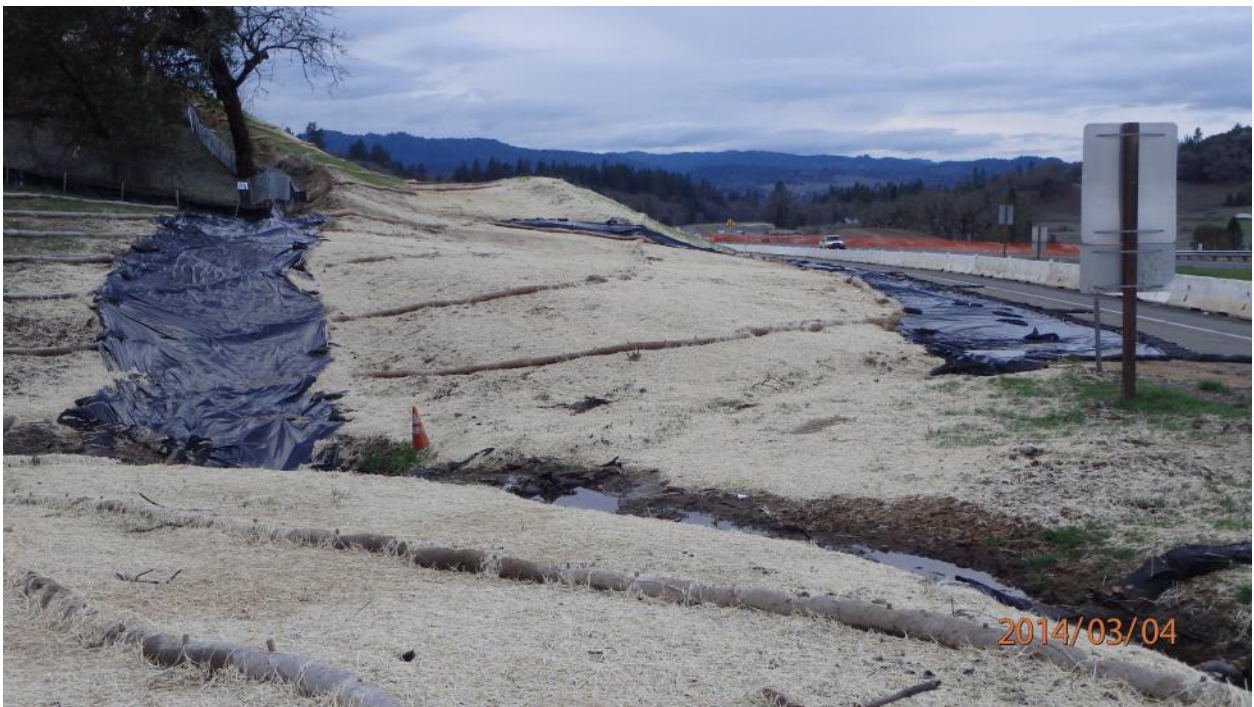
Corrective Action Photo 4B: Looking north along Highway 101 at the base of the U1-Line near the inlet for Drainage System 7

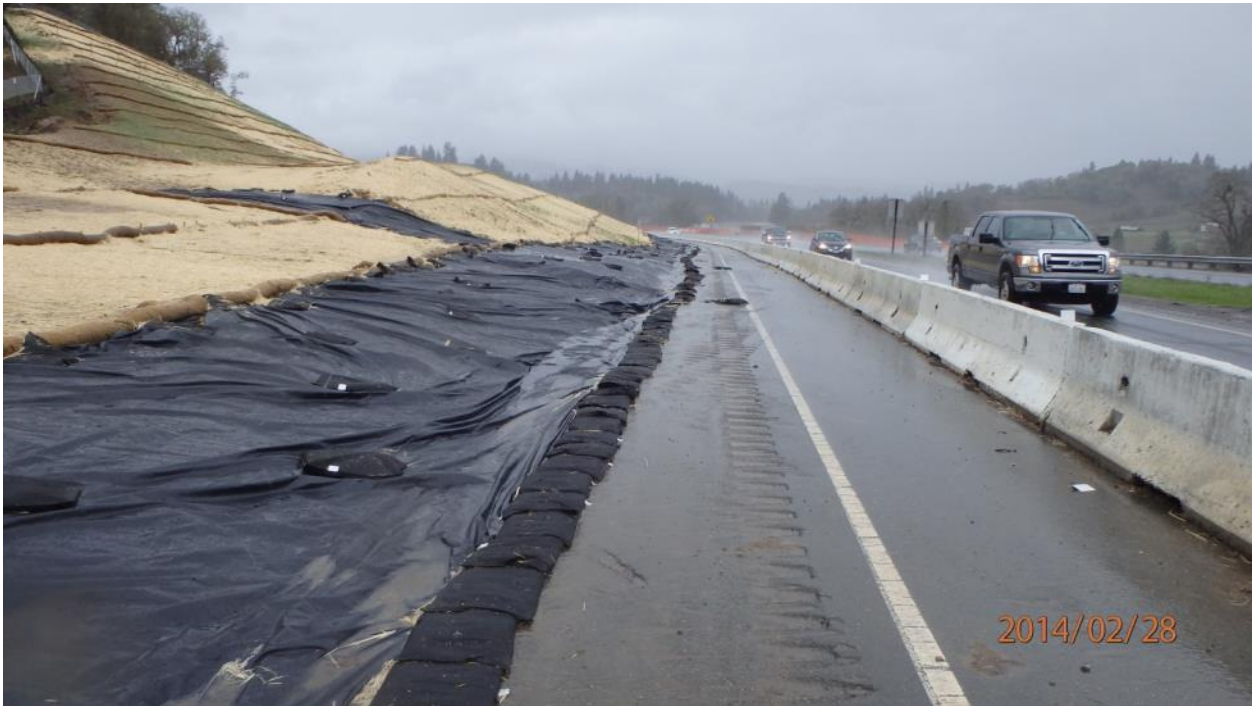
Corrective Action Photo 4C: Looking north along Highway 101 at the base of the U1-Line

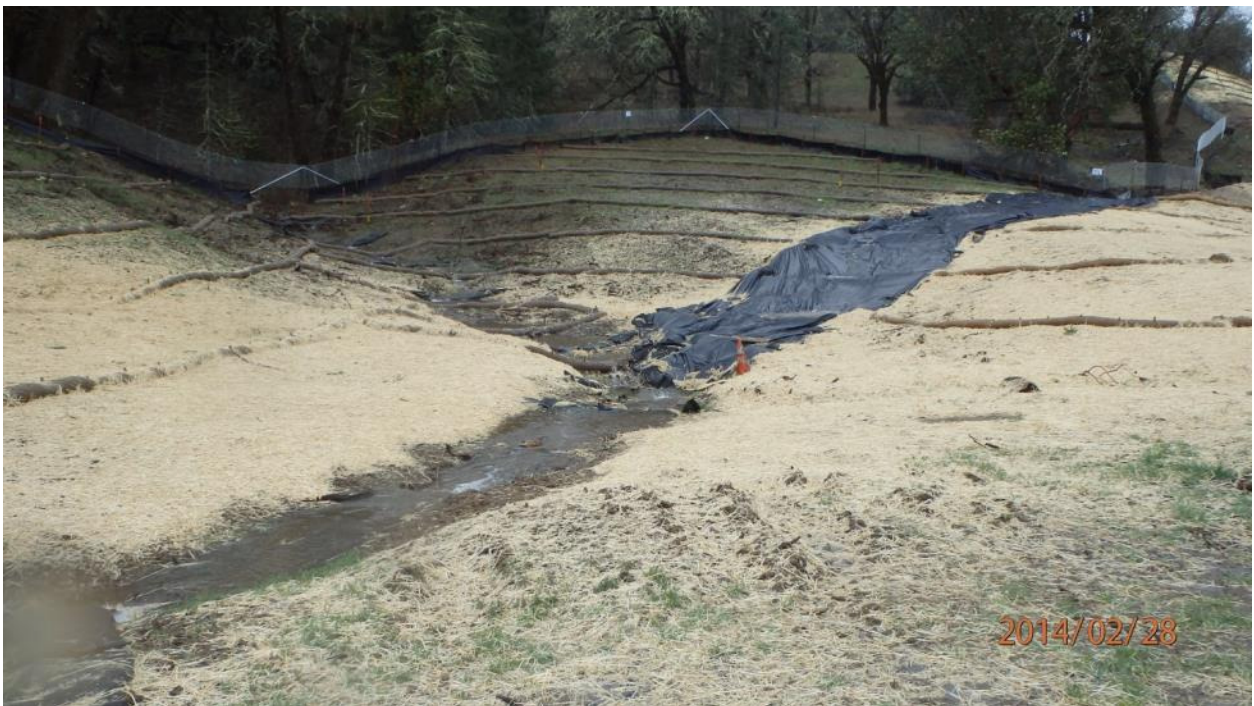
Corrective Action Photo 4D: Looking west at the inlet to Drainage System 7 at the base of the U1-Line

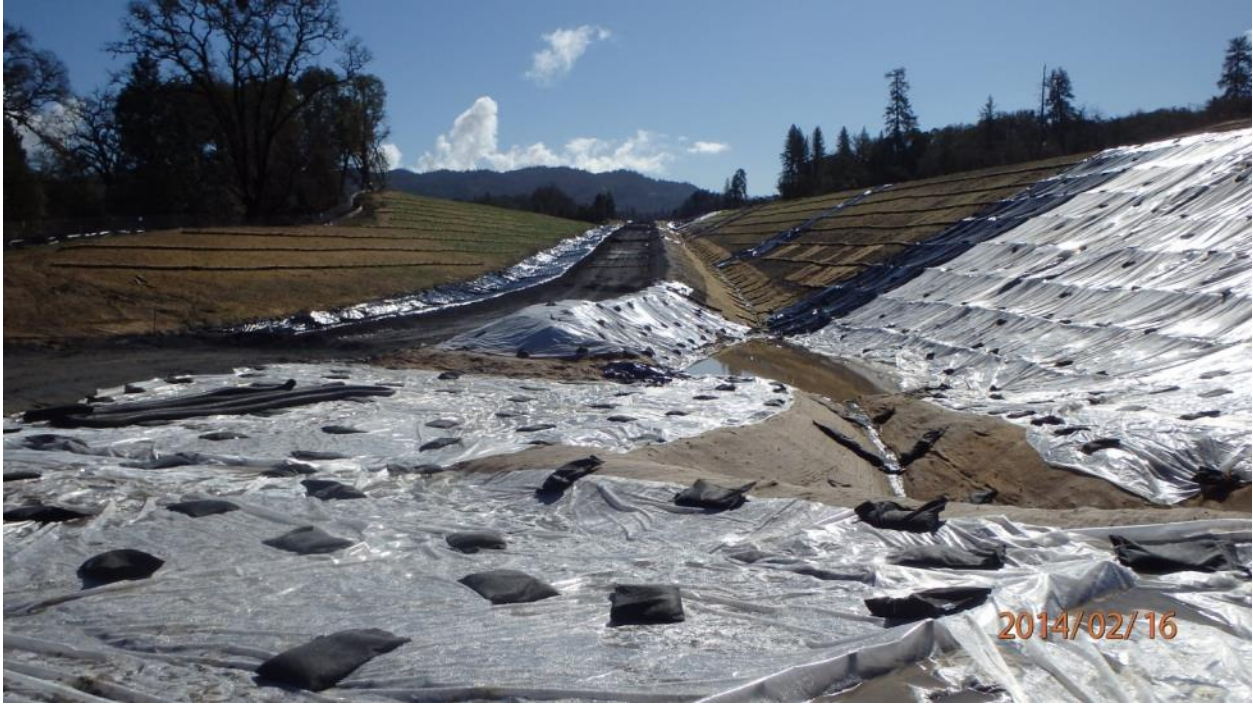
Corrective Action Photo 5A: Looking south at the U2-Line near the inlet to Drainage System 23

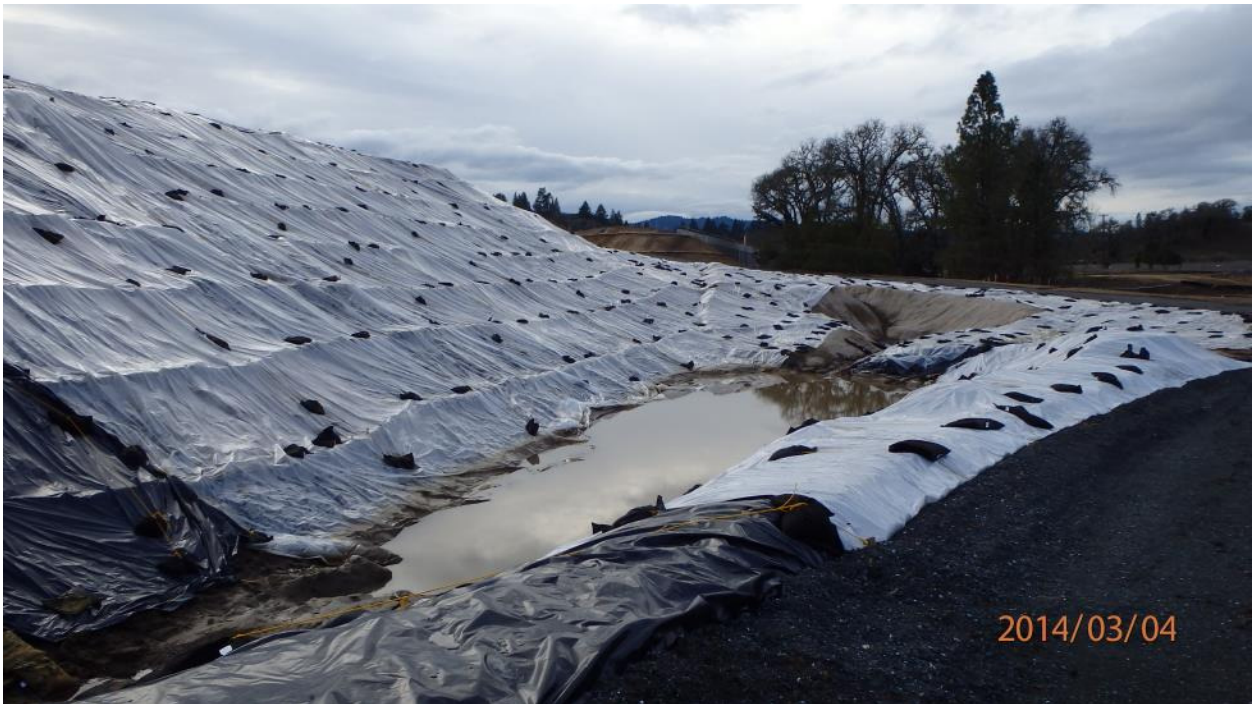
Corrective Action Photo 5B: Looking North along the U2-Line at the inlet to Drainage System 23

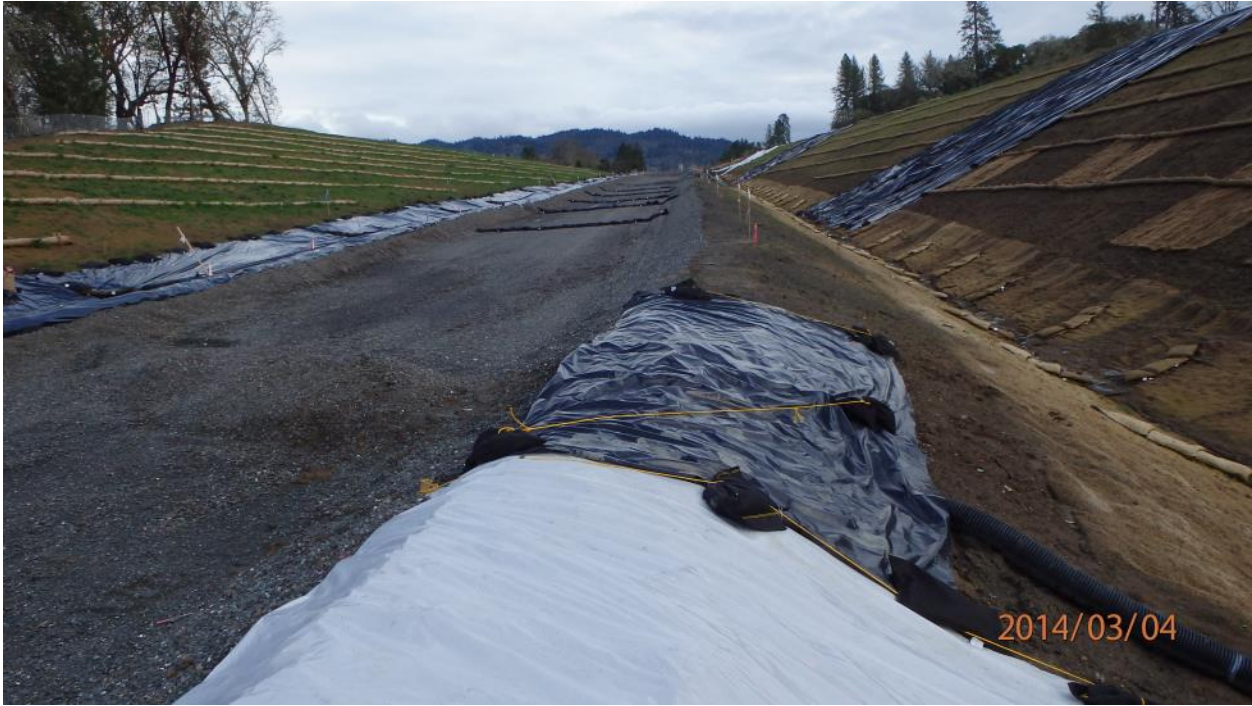
Corrective Action Photo 5C: Looking south along the U2-Line

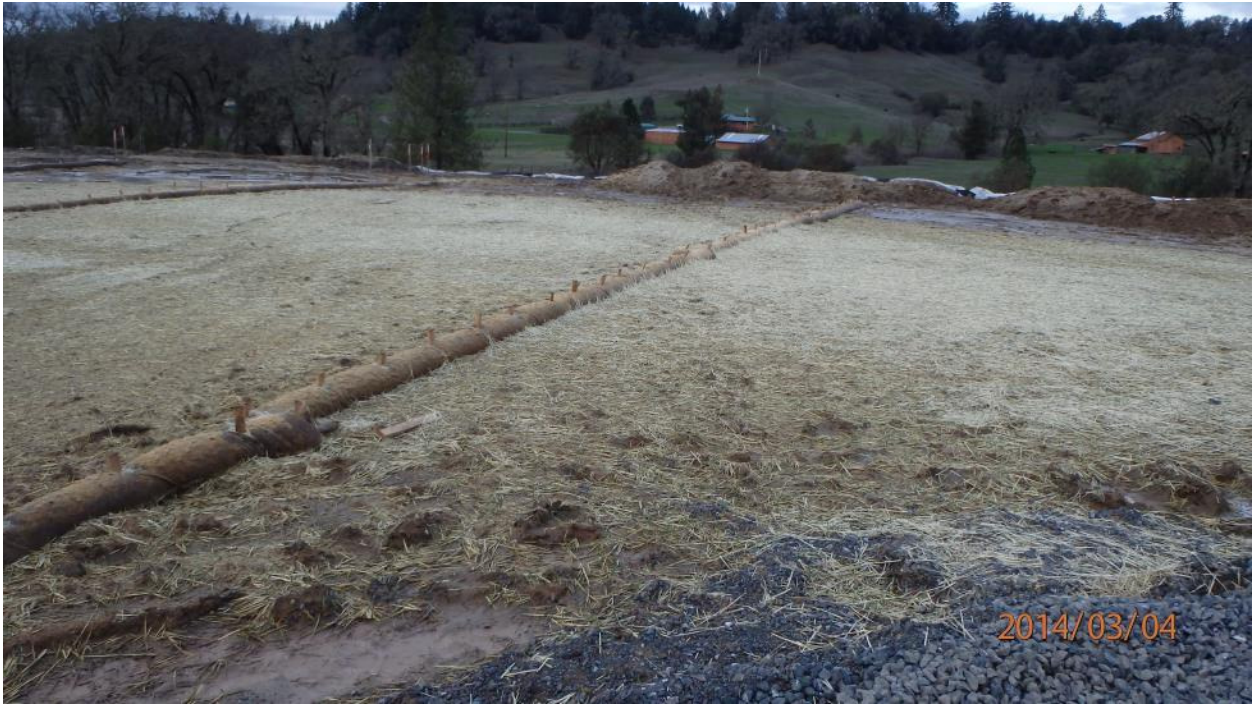
Corrective Action Photo 5D: Straw blown to cover DSA above the U2-Line

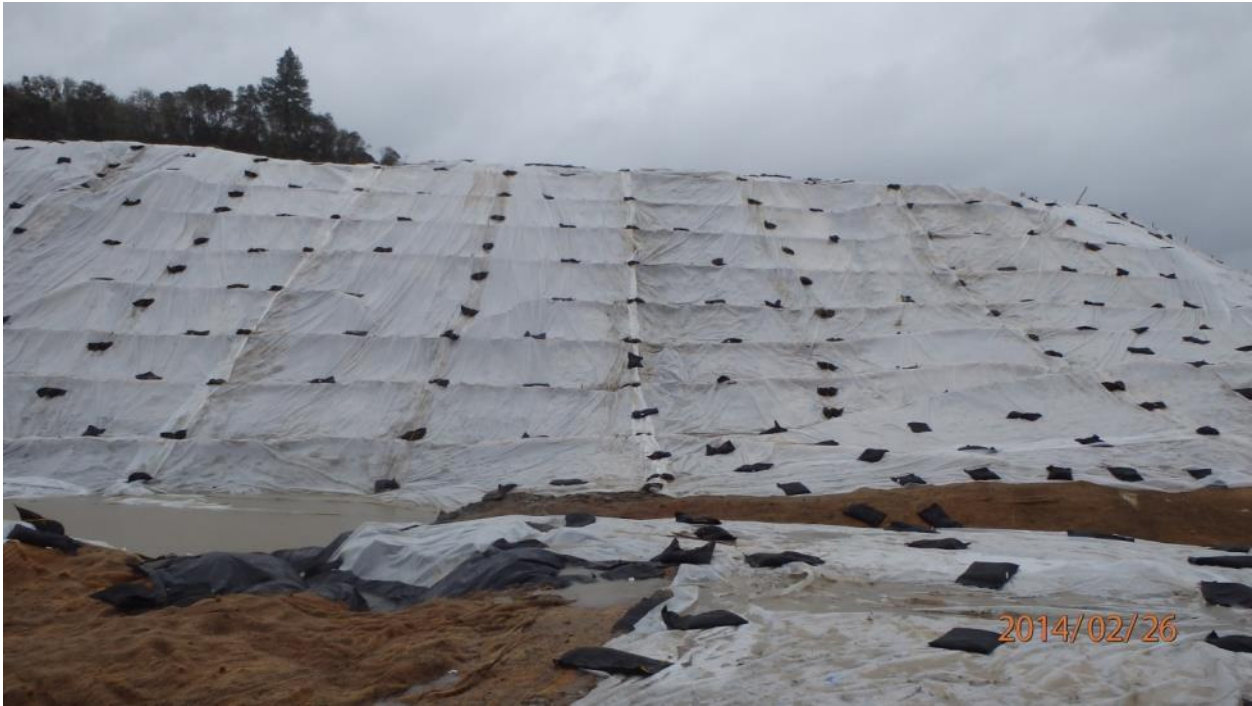
Corrective Action Photo 5E: Looking west at the U2-Line near the inlet to Drainage System 23

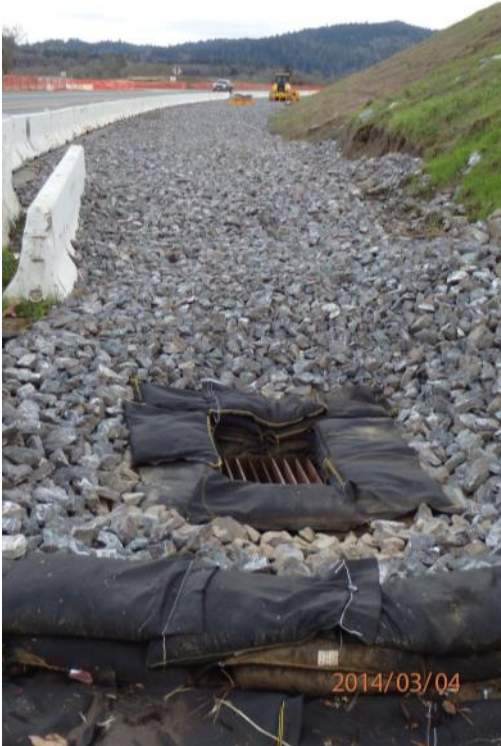
Corrective Action Photo 6A: Drainage inlet has been stabilized with 3-6" drain rock, filter fabric and gravel bags. Looking south along Highway 101 at the base of the U1-Line

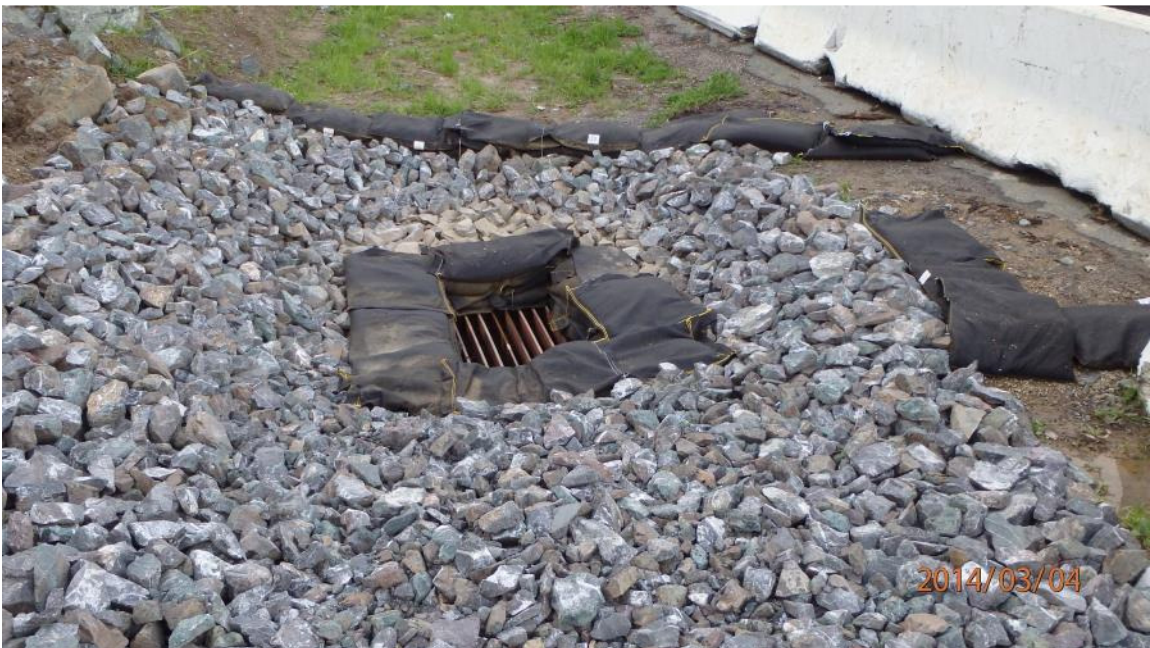
Corrective Action Photo 6B: Looking north along Highway 101 at the base of the U1-Line

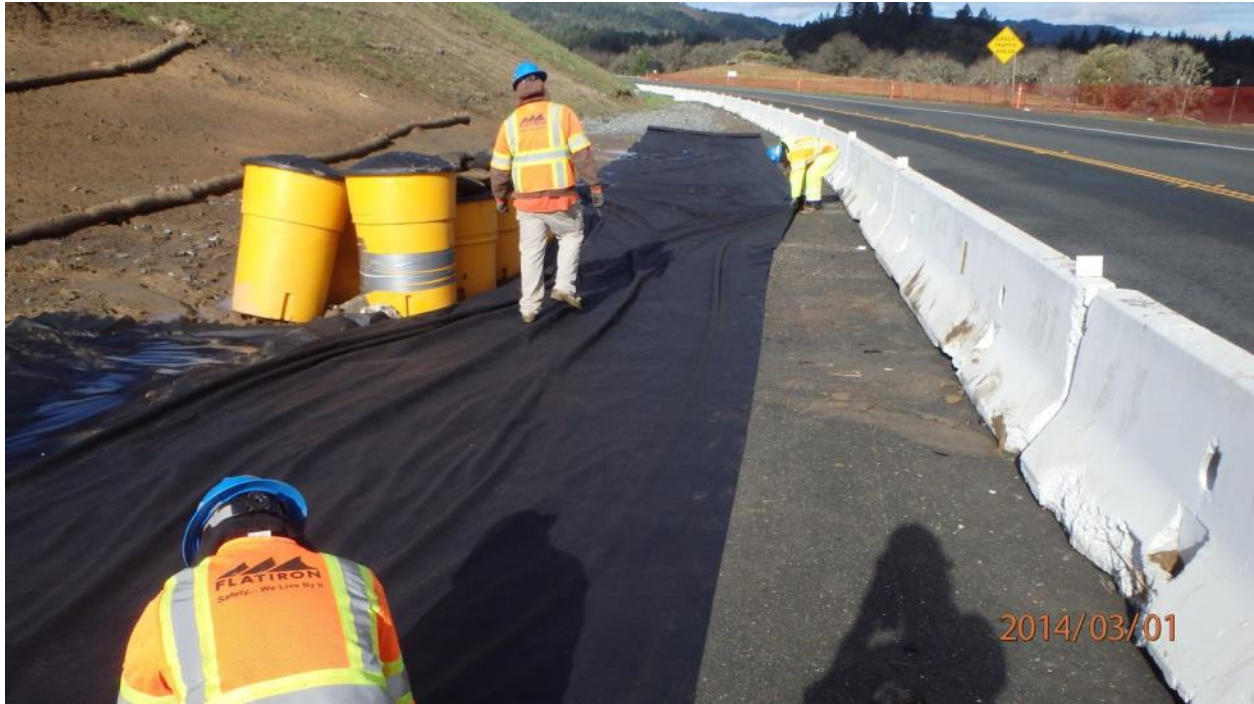
Corrective Action Photo 6C: Crew installing the filter fabric prior to the 3-6" rock installation. Looking north along Highway 101 at the base of the U1-Line

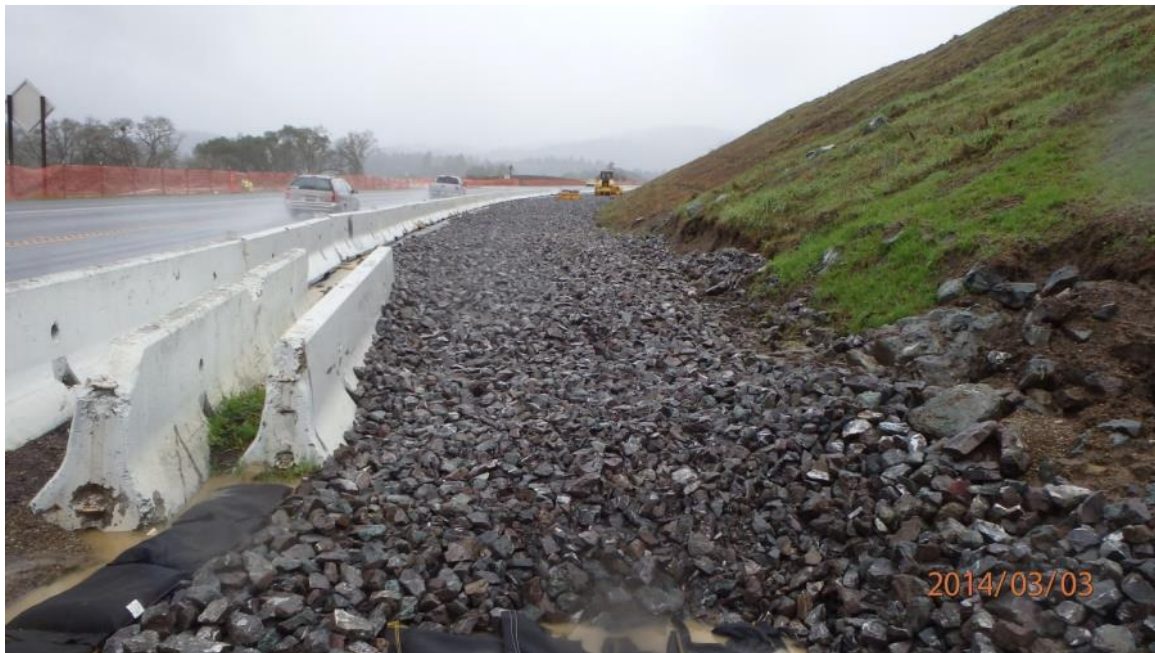
Corrective Action Photo 6D: Drainage inlet has been stabilized with 3-6" drain rock, filter fabric and gravel bags. Looking south along Highway 101 at the base of the U1-Line during the rain

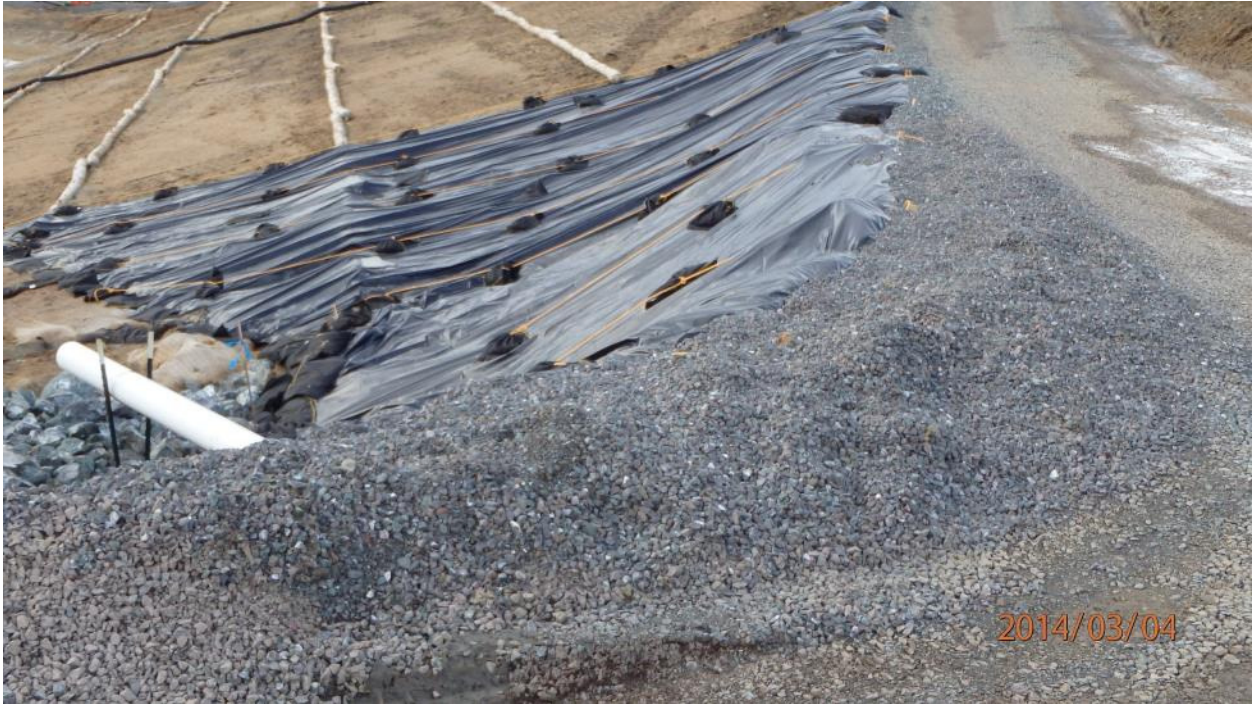
Corrective Action Photo 7A: Pictured is the same location in the NOV Attachment A Photo 7 with a ¾" gravel berm, temporary plastic cover and a drainage pipe installed. Looking north from the intersection of the H-Line and the winter access road at the South Haehl Interchange

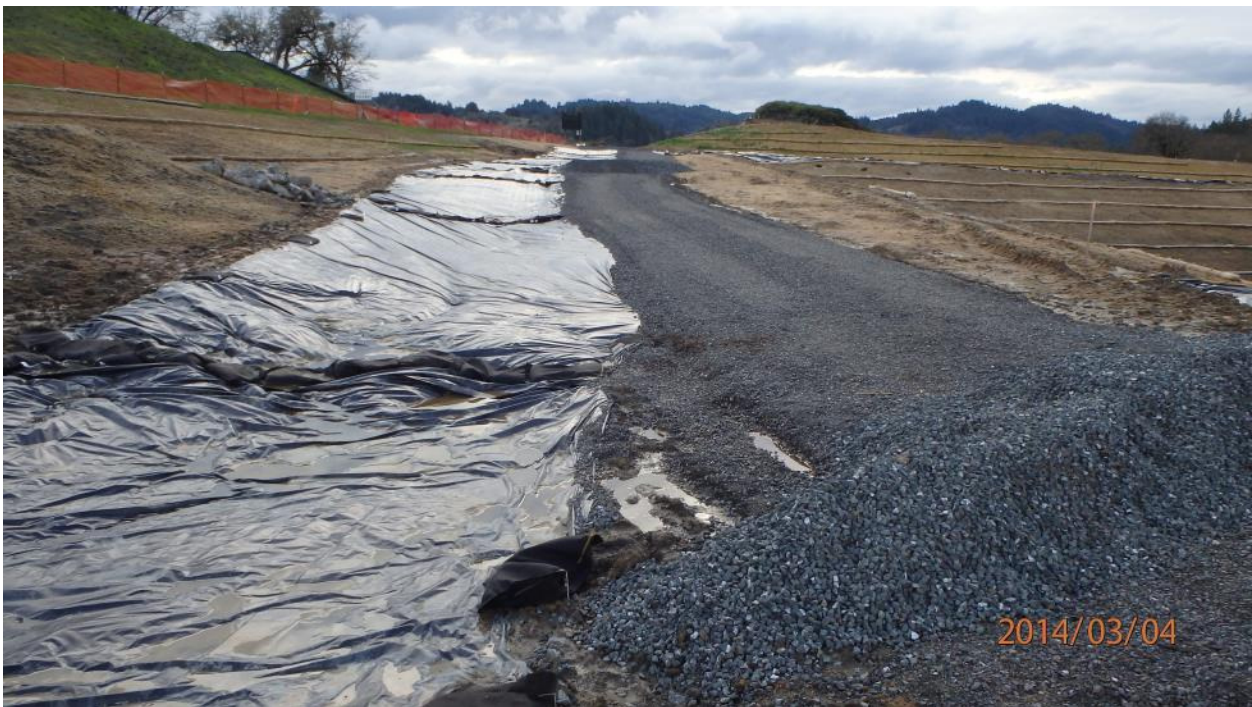
Corrective Action Photo 7C: Looking west at the H-Line with gravel berms and plastic cover conveying water off the road
