Reference: Job 2087 – Highway 101 Willits Bypass
Caltrans – Contract: 01-262004

Subject: Corrections to Caltrans' Notice of Violation

NOV Attachment A Photo 1

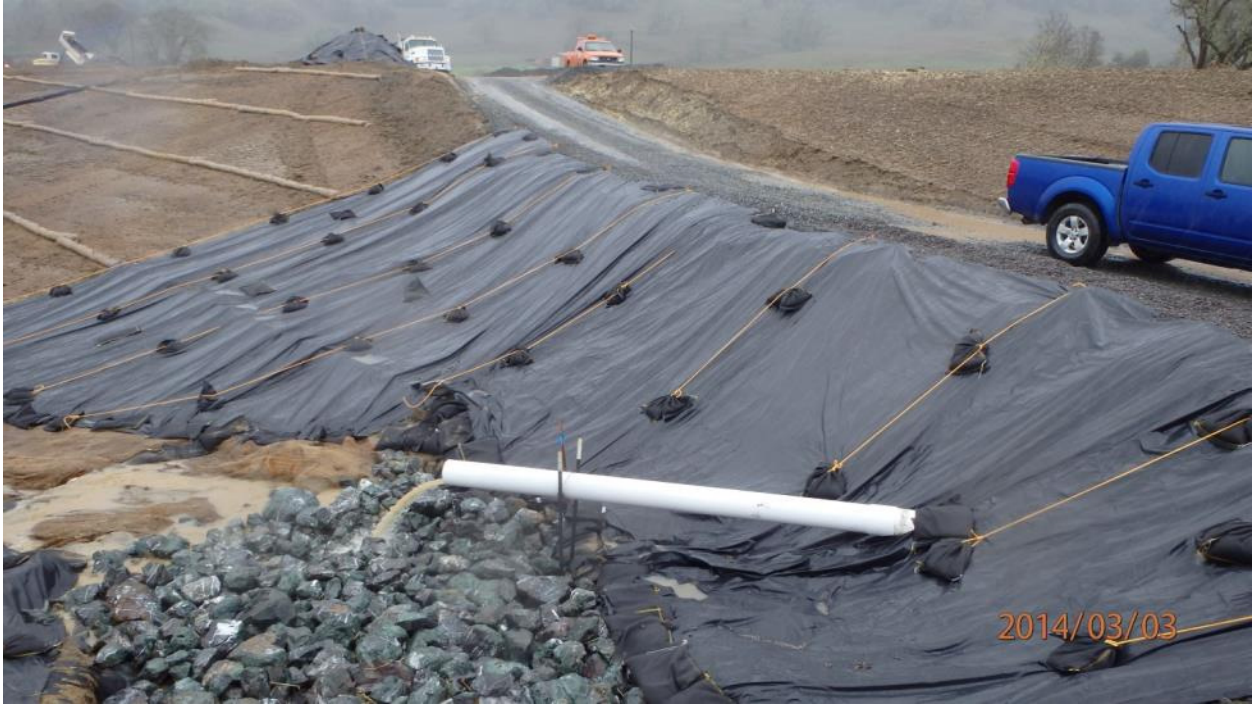
Corrective Action Photo 7C: Looking north from the intersection of the H-Line and the winter access road at the South Haehl Interchange

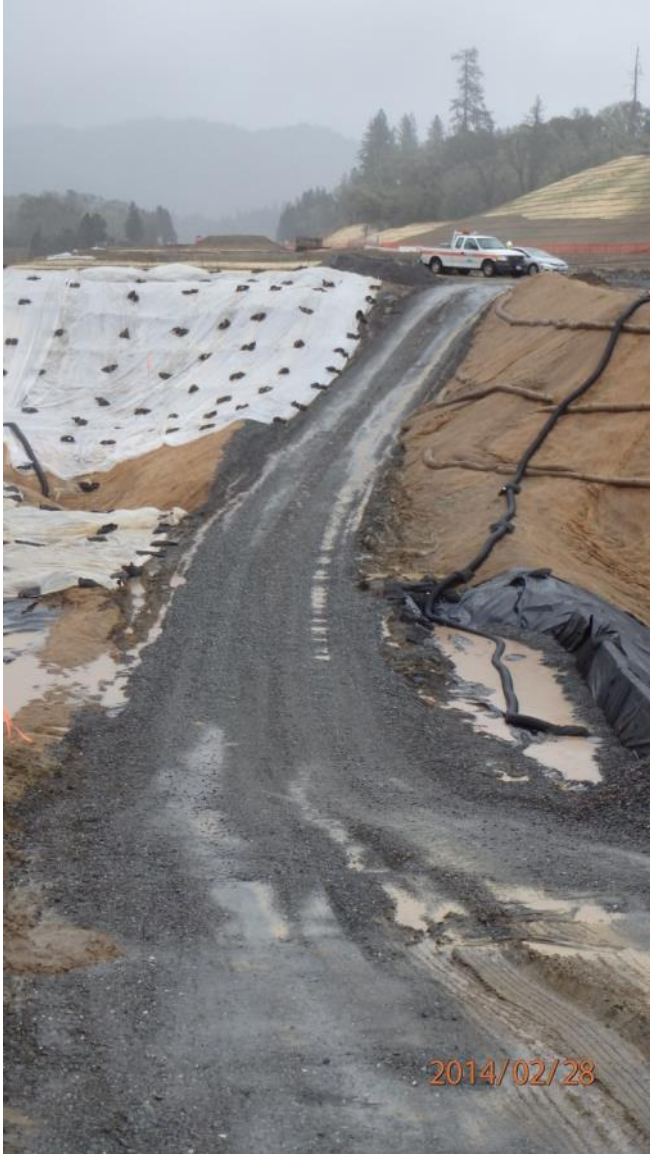
Corrective Action Photo 8A: Looking south at the culvert crossing winter access road at the South Haehl creek. Please refer to Corrective Action Photo 1A and 1D for further corrections

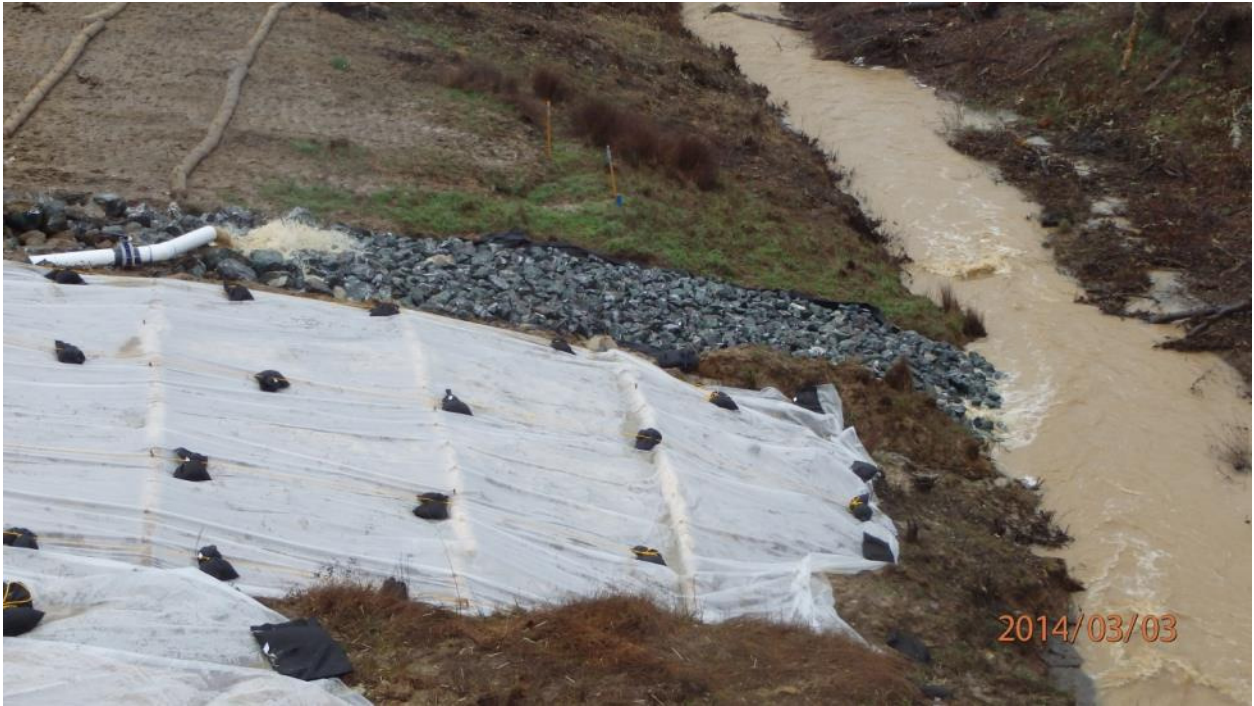
Corrective Action Photo 9A: Looking west along South Haehl Creek at Drainage System 27. RSP has been repositioned and a gravel bag berm has been installed to eliminate water bypassing the drainage

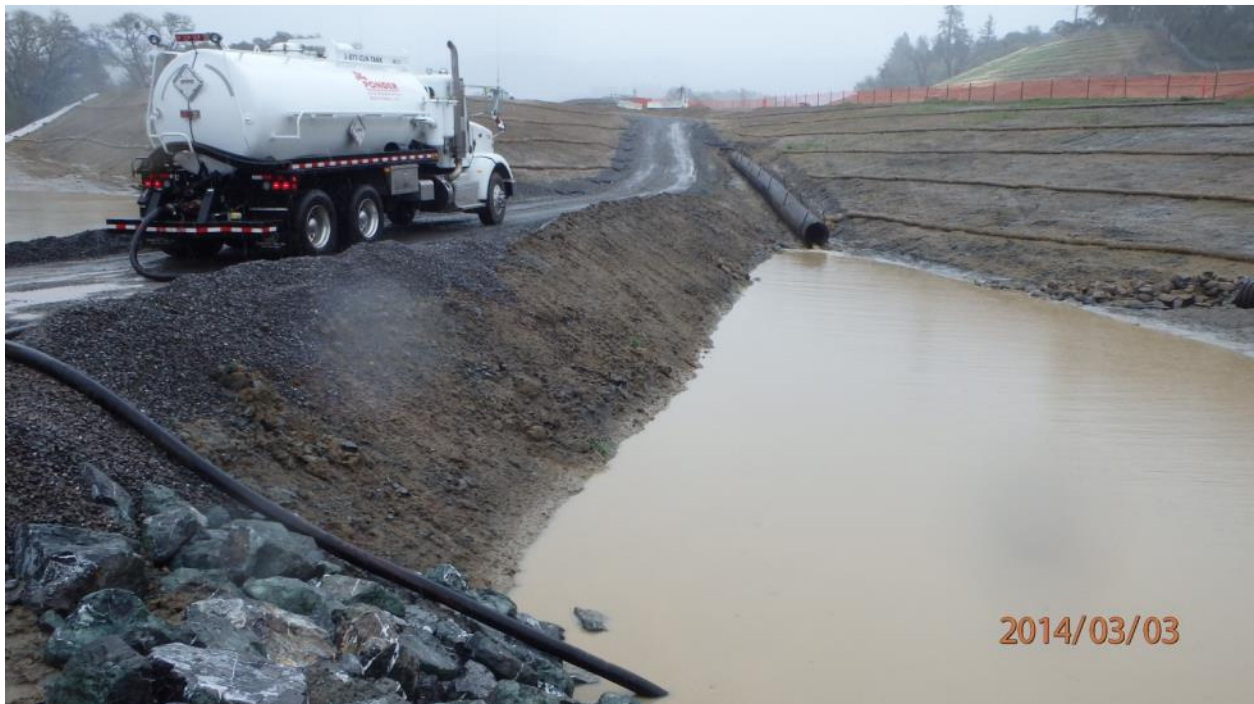
Corrective Action Photo 9B: Pumping water out of the Haehl Creek Interchange basins at the H-Line and winter access road intersection

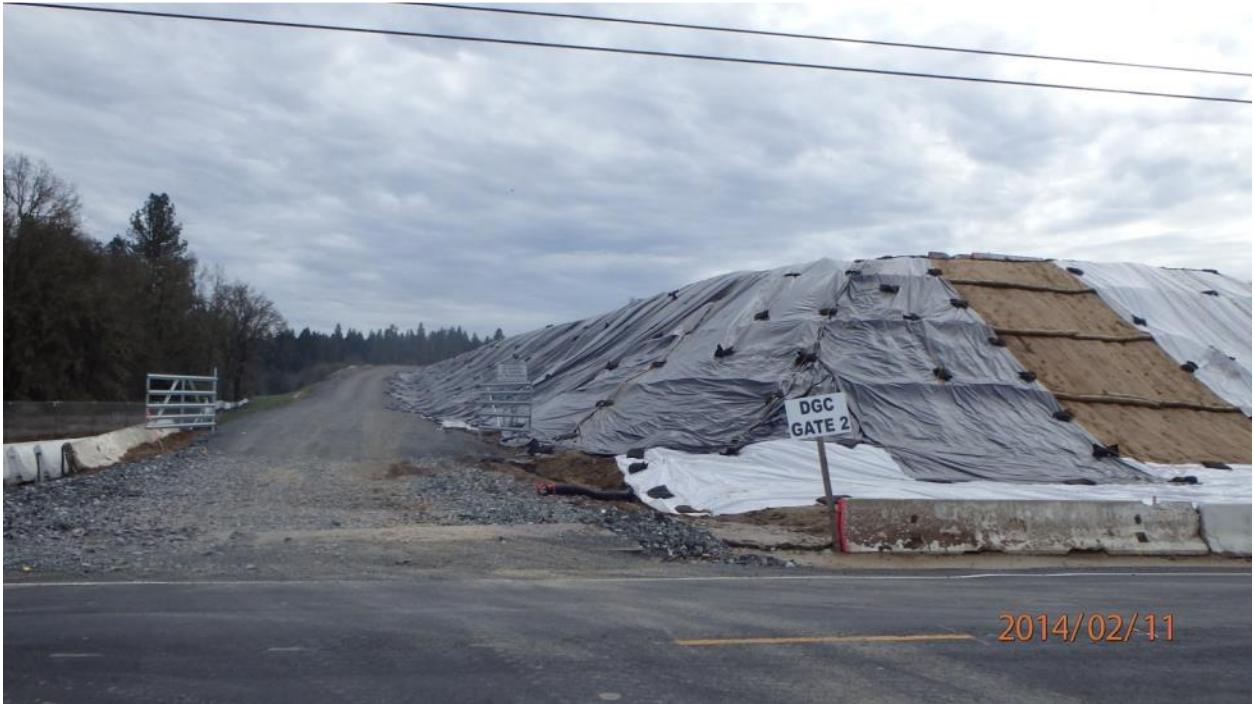
Additional Corrective Action Photo 1: Plastic cover at Bridge 10-0157 Abutment 1

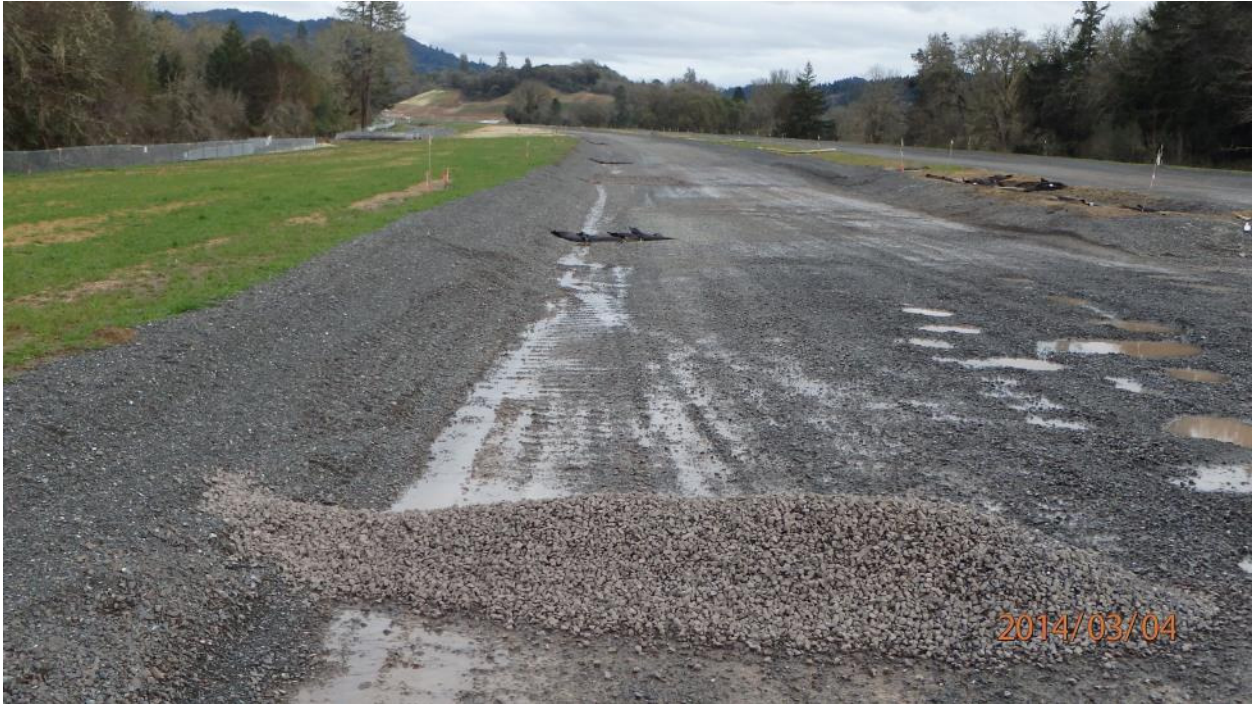
Additional Corrective Action Photo 2: Looking south at the AN-Line with gravel bars and gravel bag check dams. Photo at Station 36+40

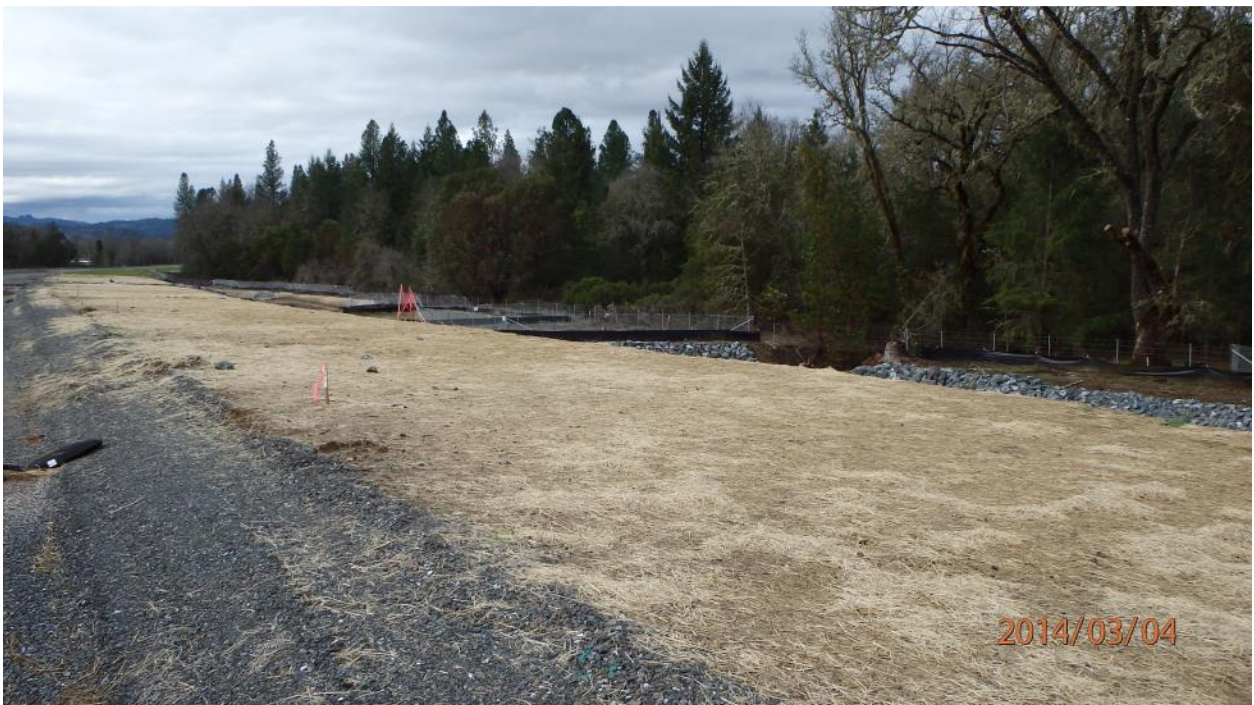
Additional Corrective Action Photo 3: Straw blown to cover DSA at Drainage System 37

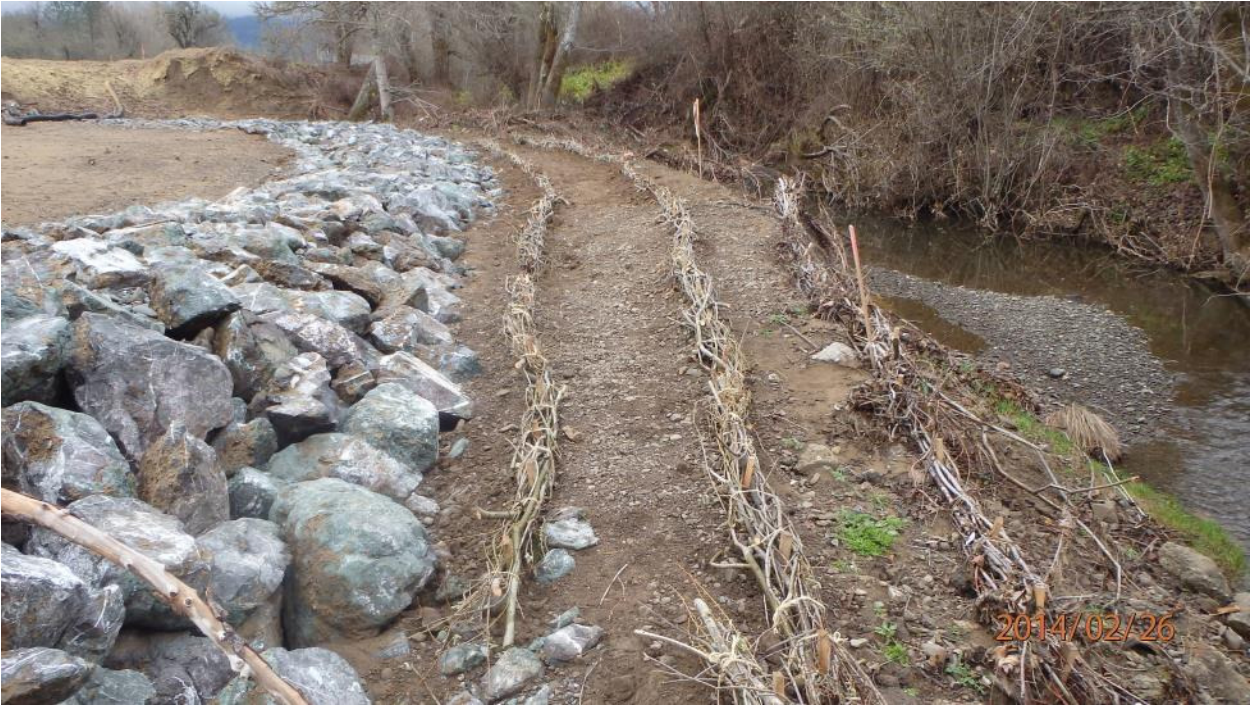
Additional Corrective Action Photo 4: Willow Wattles installed at Drainage System 51 at Baechtel Creek
