MATRIX

Subject: Limited Indoor Air Quality
Investigation Room 3320
Middle Creek High School
Apex, North Carolina
Matrix Project Number 151114

Room 3320
Middle Creek High School

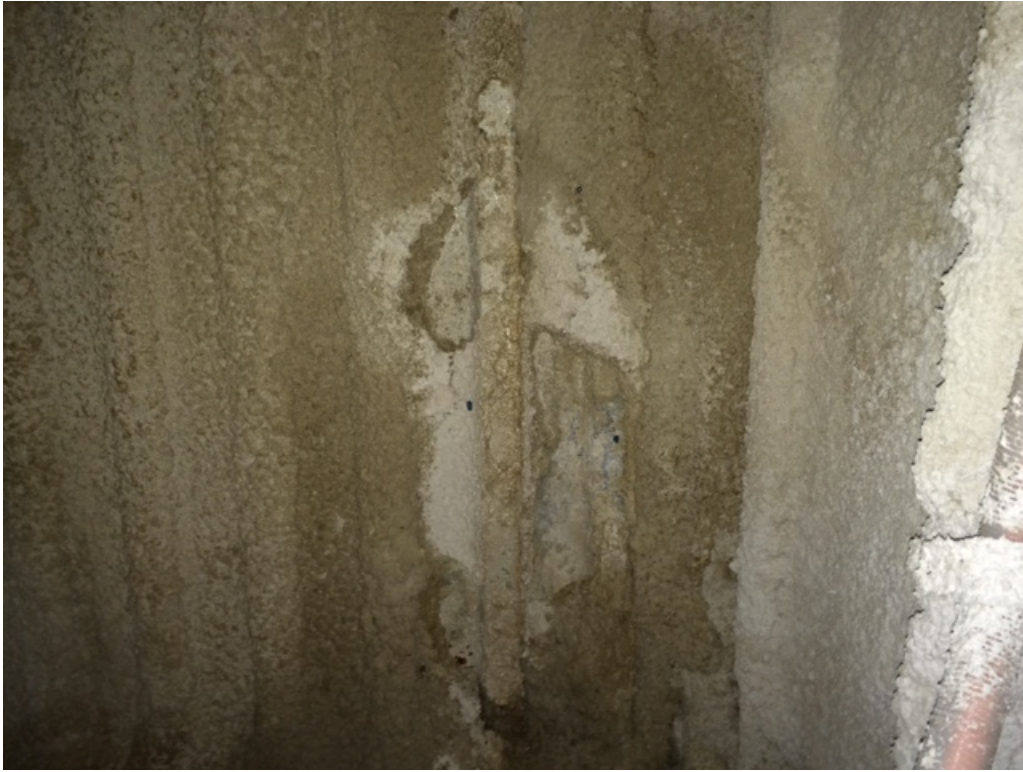
At the time of the survey, water stained fireproofing was observed above the suspended ceiling in the corner of the classroom. The supply and return registers for the HVAC were noted to be clean. The supply register over the teacher's desk had been blocked with cardboard to reduce direct airflow to that area. The HVAC fan and coil units in the mechanical room were also inspected for obvious issues. None were noted during our inspection.

Water damaged fireproofing above suspended ceiling in 3320.

Based on visual observations and testing data, it is our opinion that a potential exposure risk to mold is not currently present in the areas tested. It is recommended that the apparent roof leak be corrected to prevent potential issues in the future. Continued routine cleaning and maintenance of the HVAC system is recommended to ensure continued air quality.

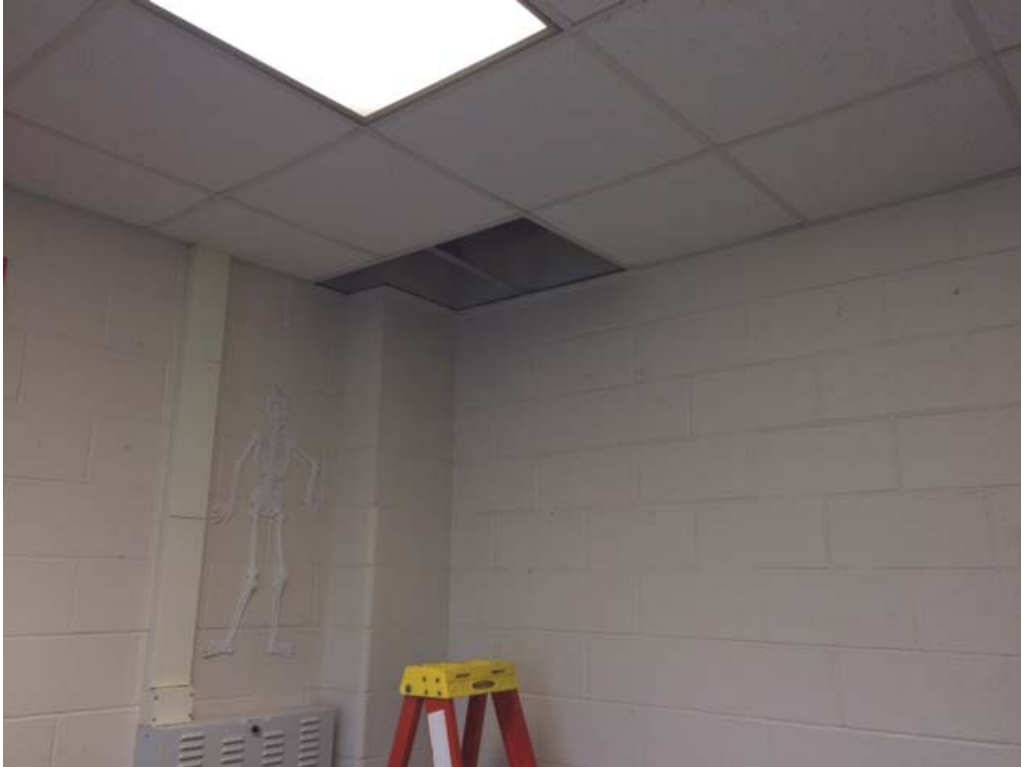
Target area of investigation in classroom 3320.

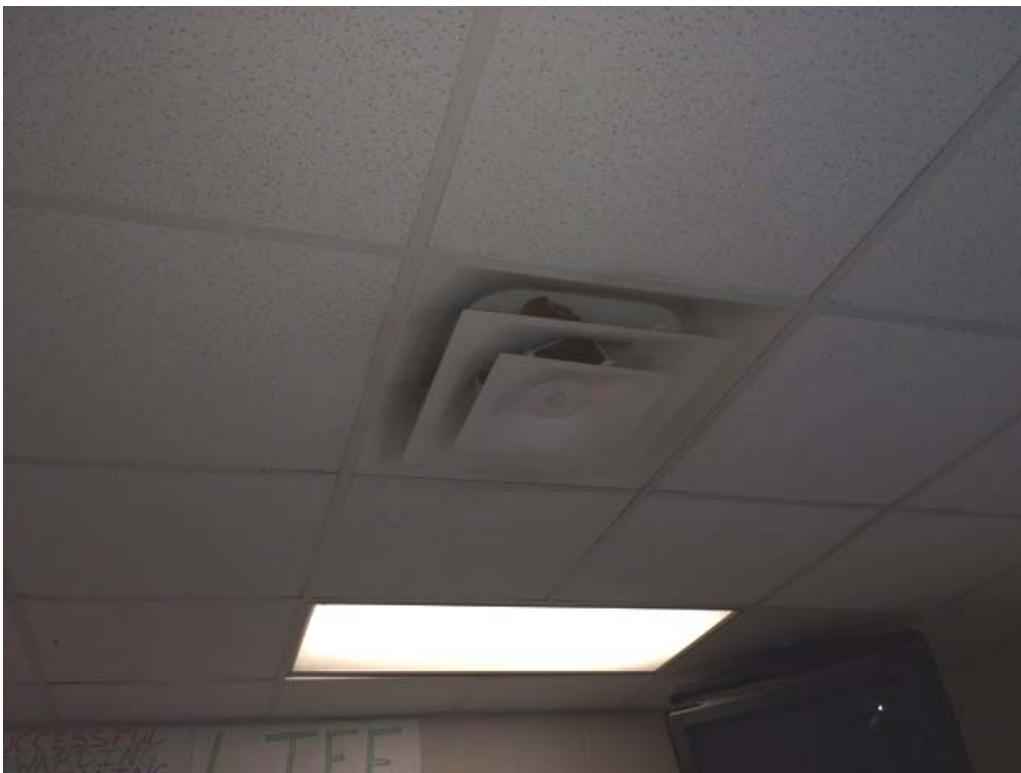
HVAC supply registers appeared to be clean. Register over teacher's desk was blocked with cardboard.
