NORTH CAROLINA STATE HIGHWAY PATROL

COLLISION RECONSTRUCTION UNIT

Traffic Collision Reconstruction Report:

**Location: I-85 Business (U.S. 29/70)
@ RP-1144 (River Road)**

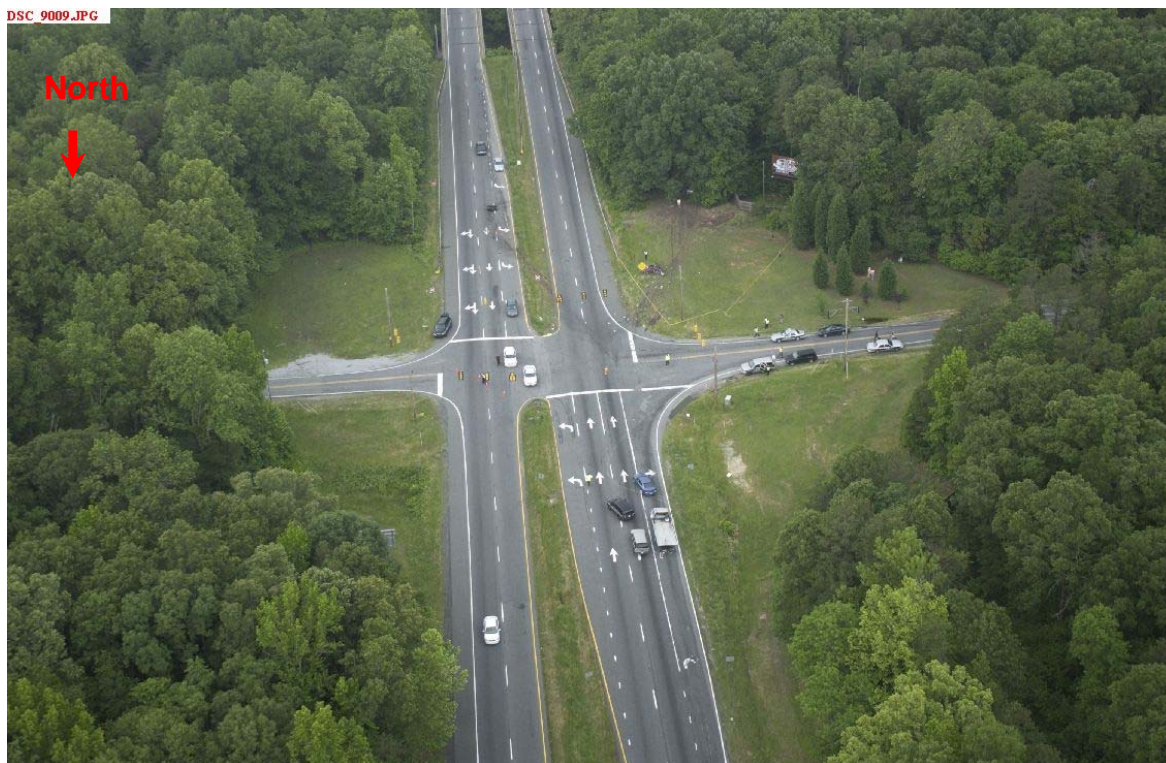
Photograph S-1

This collision occurred in Guilford County at the intersection of I-85 Business and RP-1144 commonly referred to as River Road. The collision scene is located approximately five tenths (.50) miles south of Jamestown, North Carolina. In the area of the collision, I-85 Business is six (6) lanes wide on the north side of the intersection, with four (4) southbound lanes consisting of a right and left designated turn lane, two (2) through lanes and two (2) northbound lanes separated by a grass median. The south side of the intersection is five lanes wide consisting of a designated left turn lane, a through lane, and a combination through and right turn lane on the northbound side, with two (2) southbound lanes separated by a grass median. The east and west sides of the intersection consist of two lane roadways each divided by double yellow lines. The intersection is governed by traffic signal lights for each lane. **Photograph S-1** below depicts the intersection of I-85 Business and RP-1144.

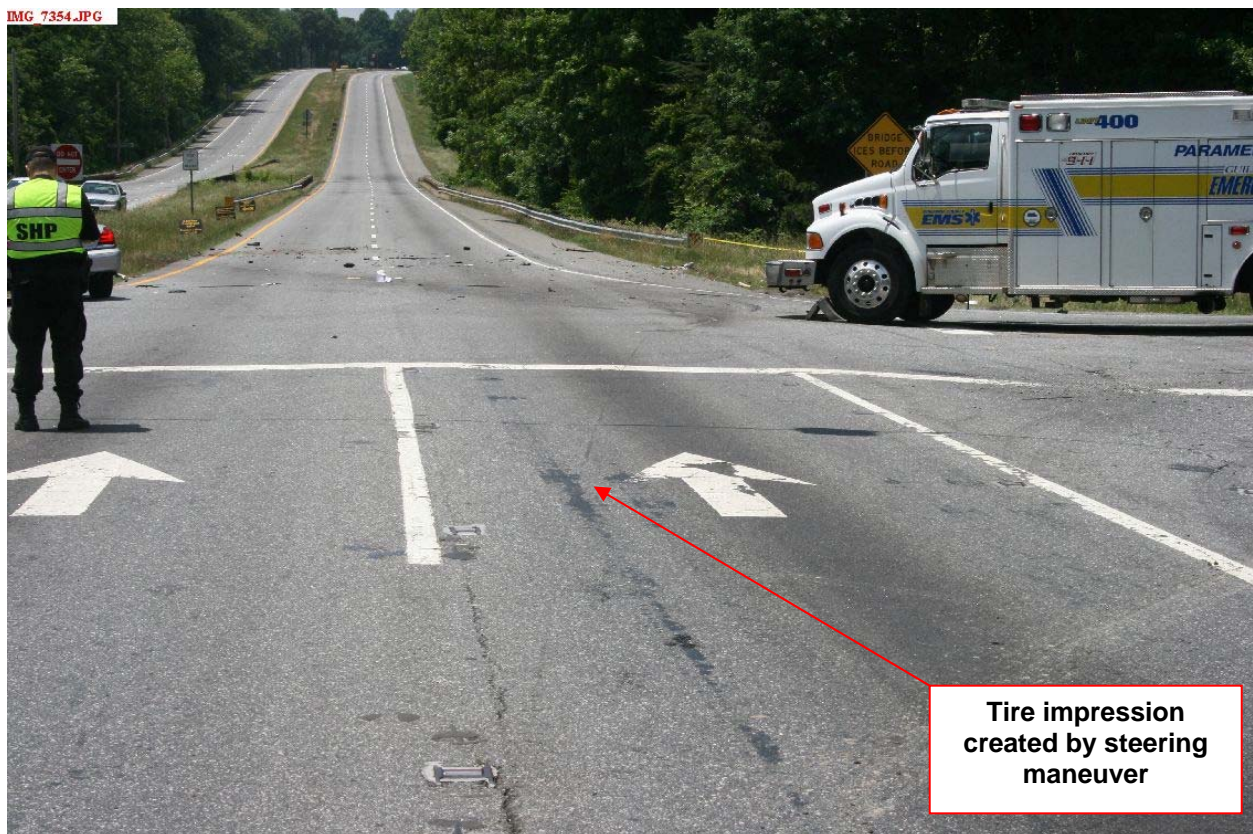
Photograph S-2

The first item of roadway evidence located was a tire impression that originated in the left southbound through lane and traversed into the right through lane and into the intersection to the area of impact. This mark measured seventy-six feet and was created by the loading of the front left tire of Vehicle 1 during an evasive steering maneuver. A like tire impression measuring sixty-four (64) feet in length was also located in the right through lane positioned parallel to the impression created by the left front tire. **Photographs S-2 and S-3** depict these tire impressions.

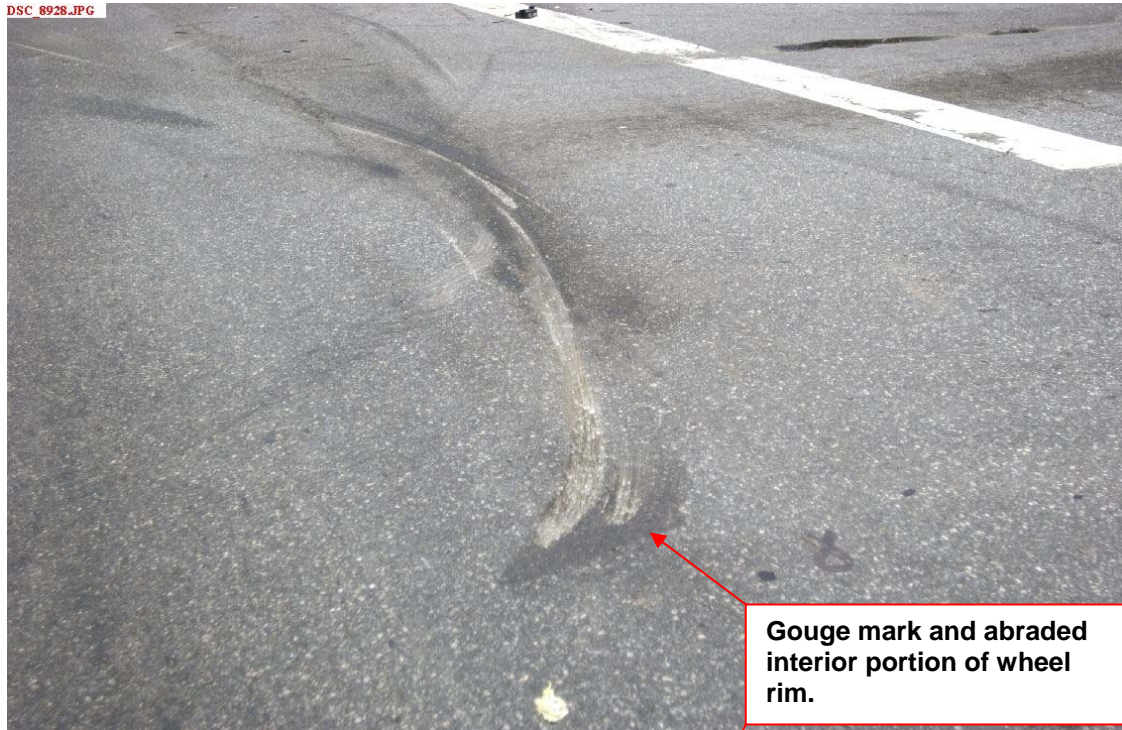
Photograph S-4

The next item of roadway evidence observed was a pavement gouge created by the interior portion of the right front wheel rim of Vehicle 2. This evidence was created upon impact. As Vehicles 1 and 2 reached the point of maximum engagement the right front rim of vehicle 2 began to gouge the pavement. The beginning of the gouge exhibited two (2) sections and the overall width of this area measured approximately eight (8) inches. The gouge arched in a southerly direction as it traveled from the initial impact area, and rubber from tire scuffing could be seen surrounding the gouge.

Photographs S-4 and S-5 on the following page depict this evidence.

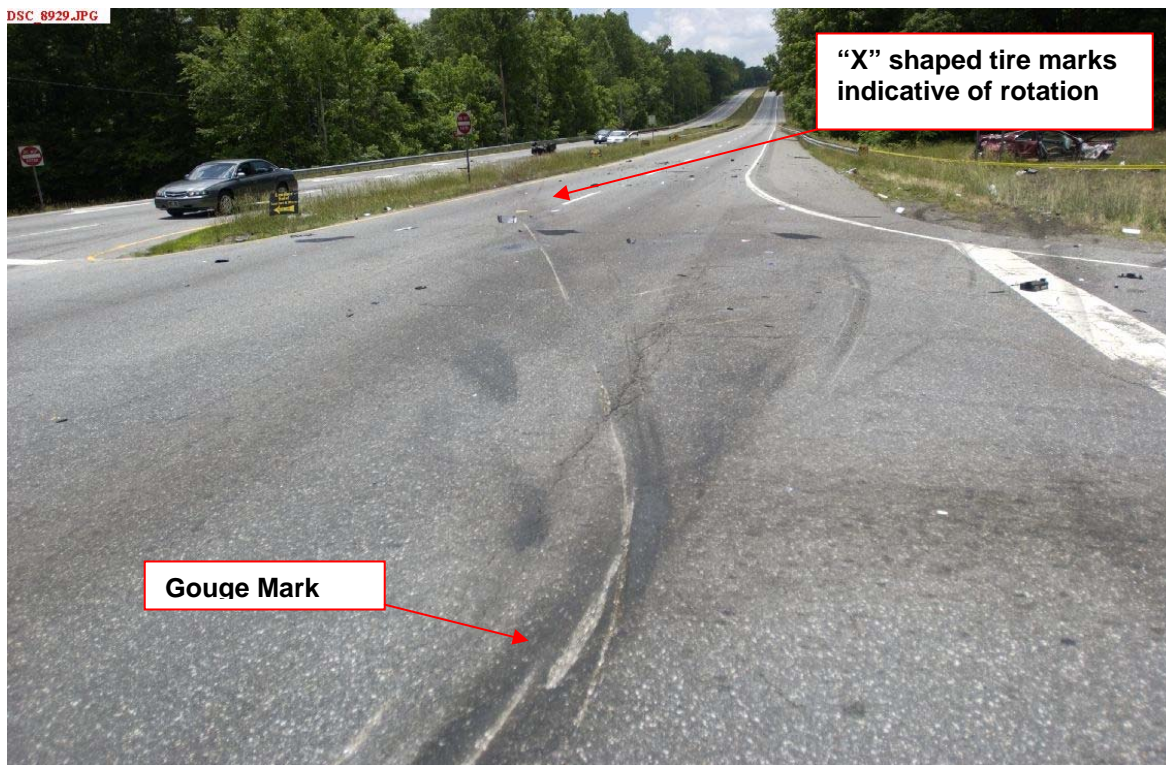
Photograph S-6

Vehicle 2 separated into two sections upon impact and the front and rear portions of the vehicle followed separate travel paths to final rest. The front section consisting of all vehicular components forward of the front doors, traveled in a southeasterly direction crossing from the southbound lanes across the grass median and into the northbound travel lanes. The front portion of Vehicle 2 came to rest in the center through lane on the northbound side of I-85 Business. The travel path of this portion of the vehicle was marked by pavement gouging and two tire marks in the shape of an “X” on the southbound side of the highway. The “X” shaped tire marks were indicative of rotation. **Photograph S-6** depicts the post impact departure path of the front portion of Vehicle 2 in the southbound lanes.

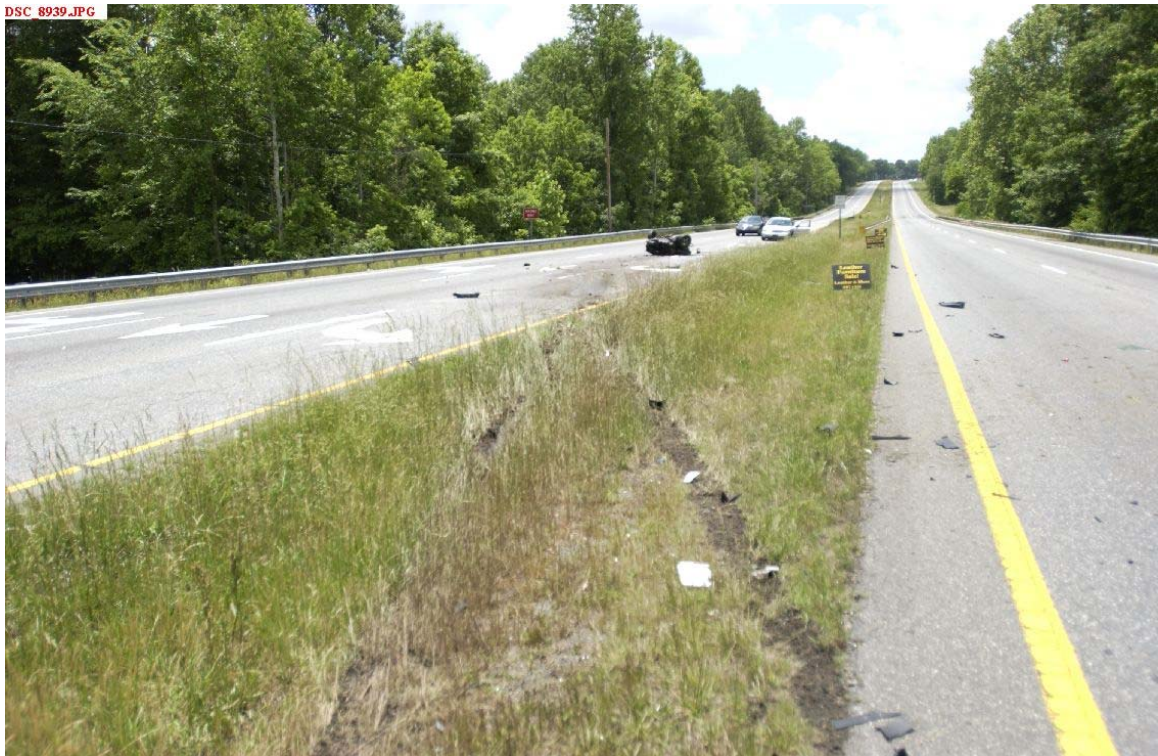
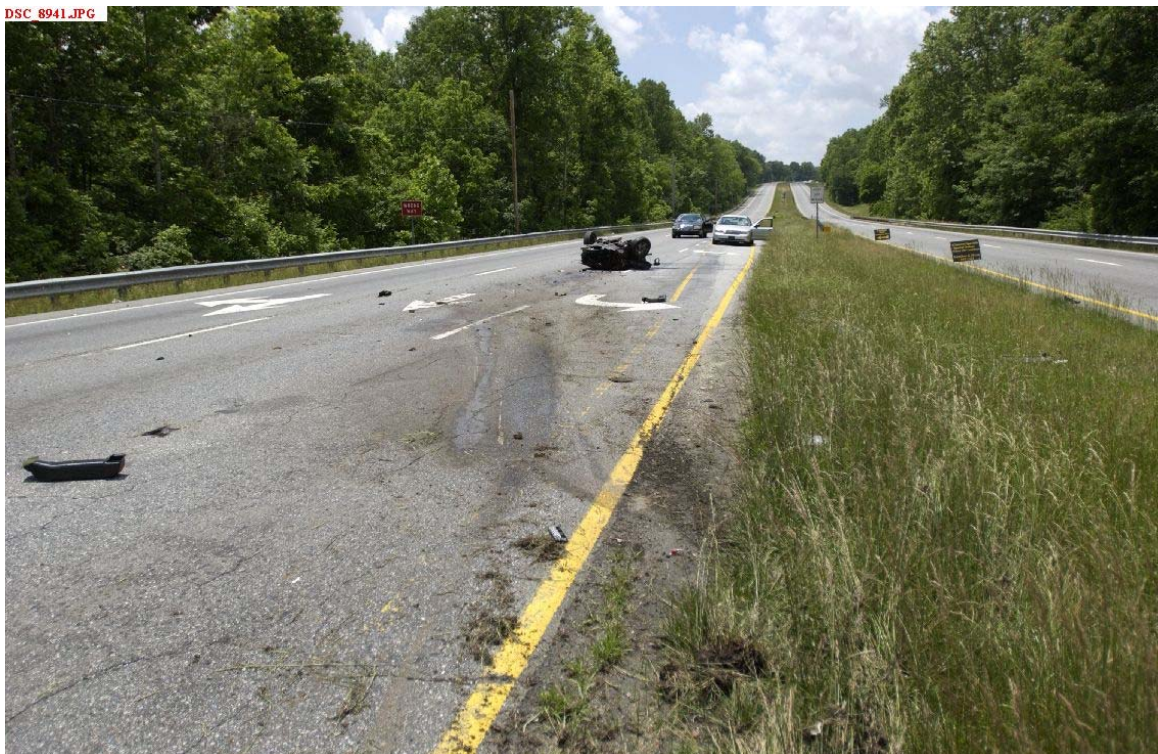
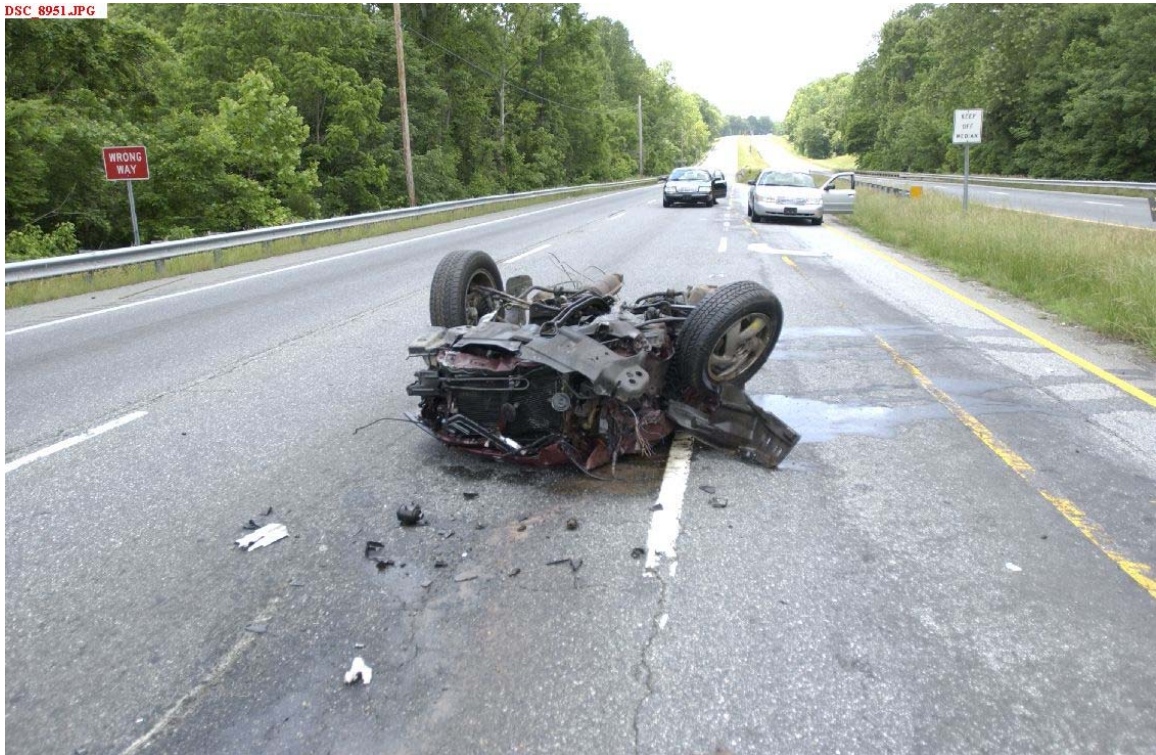
Two (2) distinct tire furrows could be seen where the front portion of Vehicle 2 traveled out of the southbound travel lanes and across the median. Upon crossing the median more gouging was observed as well as a fluid trail leading to the final resting position of the front portion of Vehicle 2. The total post impact travel distance for this section of Vehicle 2 was two hundred twenty-one (221) feet. The front portion of Vehicle 2 was found at rest upside down in the northbound through lane. **Photographs S-7, 8, and 9** depict the post impact path of Vehicle 2 as it crossed the median, traveled south in the

northbound lanes, and came to rest.

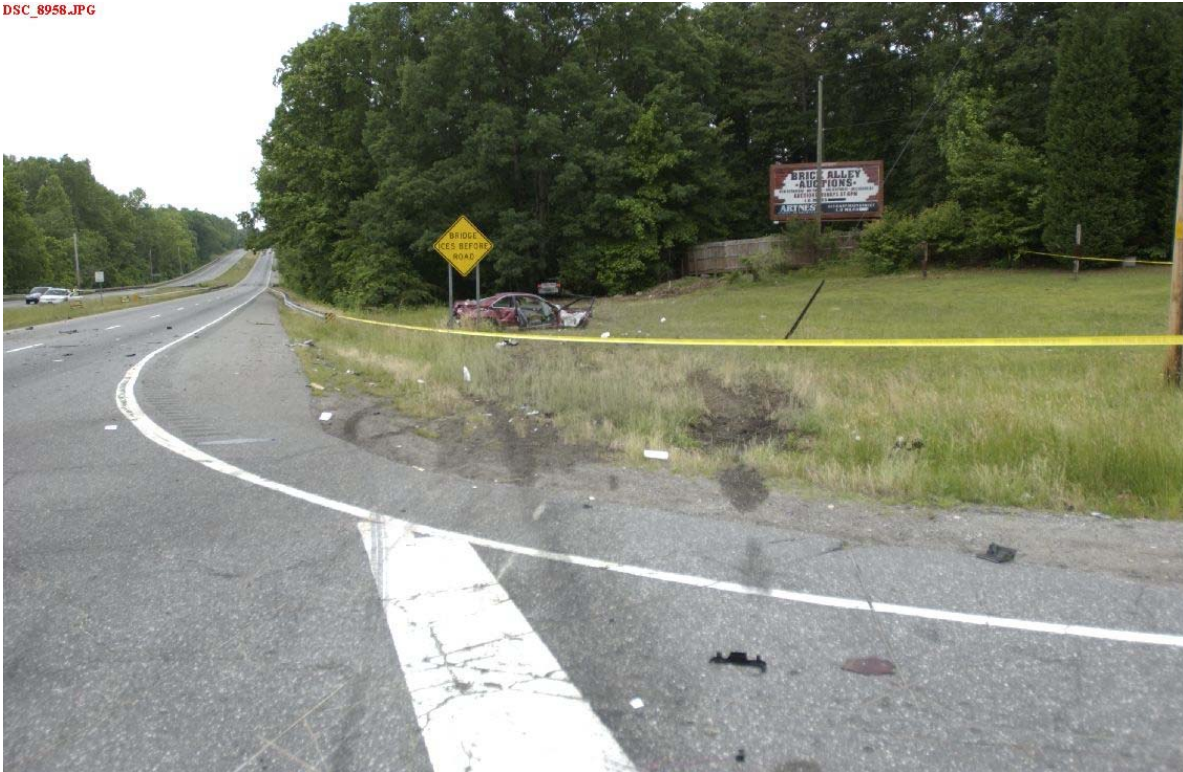
Photograph S-10

Vehicle 1 and the rear portion of Vehicle 2 departed the impact area in a southwesterly direction and traveled off of the pavement onto the shoulder of the roadway. Several tire marks created by rotational lateral skidding were observed at the southwest corner of the intersection. Just off of the roadway tire furrows were located that began on the grass shoulder, traveled across a drainage ditch and into a vacant grassy plot of land. The rear portion of Vehicle 2 came to rest one hundred fifteen (115) feet southwest of the area of impact on the west side of the roadway.

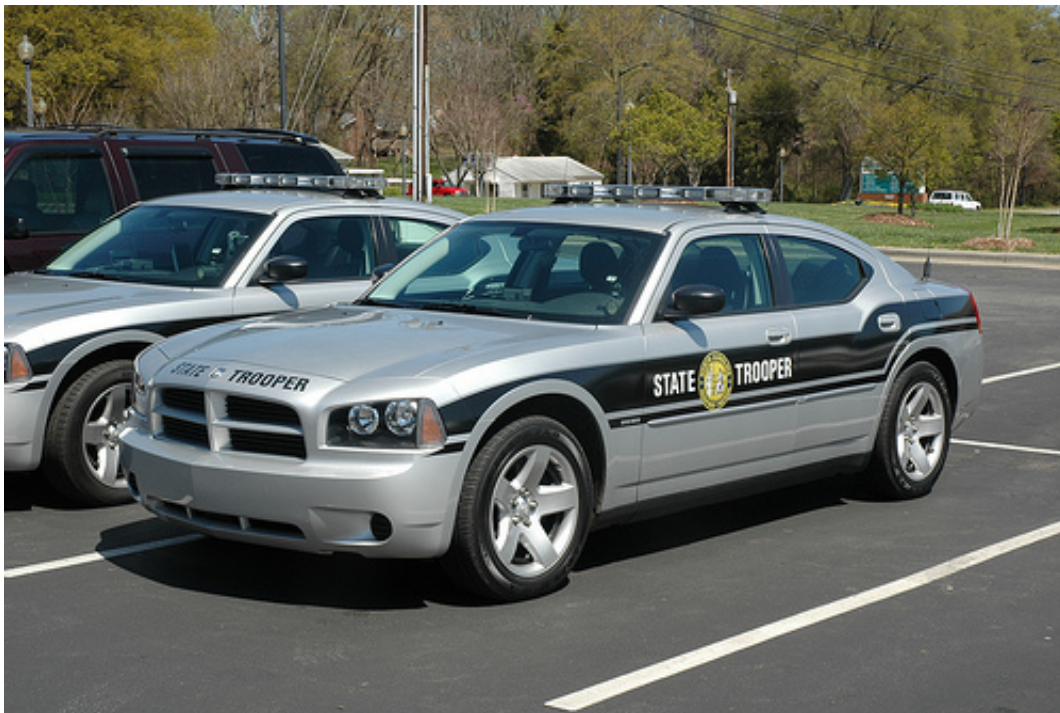
Photograph V1-1

Troopers B. K. Martin and B. K. Palmiter conducted a post-crash vehicle inspection at Troop D Garage, 2527 East Market Street, Greensboro, North Carolina on Tuesday, 25 May 2010. **Photograph V1-1** depicts an exemplar vehicle.

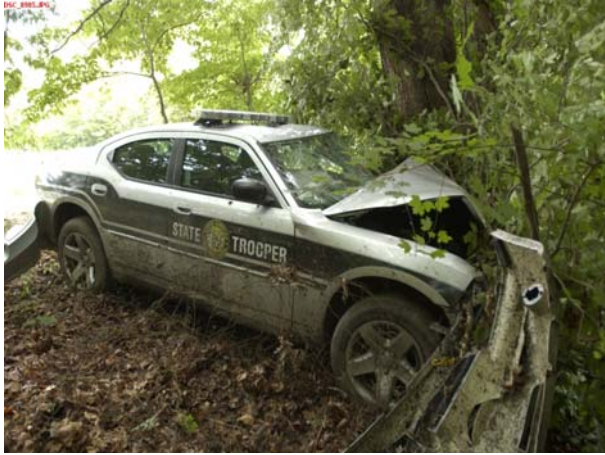
Photograph V1-2, Vehicle 1 at Crash Site

Photographs V1-2 and V1-3 depict the vehicle at the collision site and at the post-crash inspection.

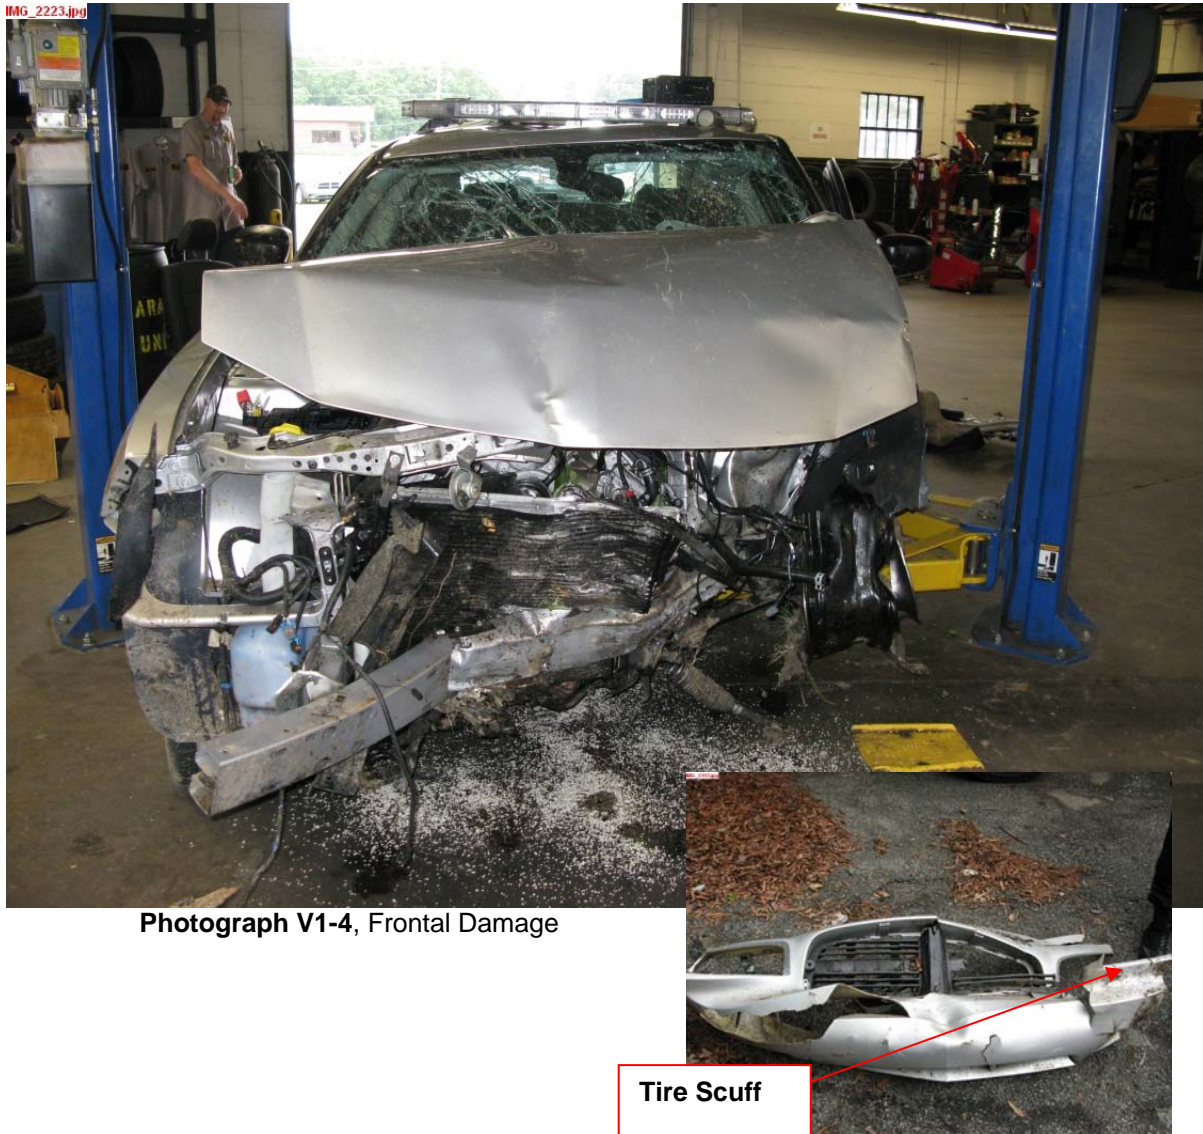
Photograph V1-4, Frontal Damage

Exterior Damage - Vehicle 1 sustained a substantial amount of frontal contact damage as a result of this collision. The damage extended from the right front headlamp assembly to the left front quarter panel. Both headlamp assemblies were torn away from their original mounted positions. Vehicle 1's hood was ajar from its original locked position and displaced upward towards the rear of the vehicle. Induced collision forces during the crash shattered the front windshield. The plastic bumper cover had been

torn away exposing a more rigid metal structure. The bumper cover displayed tire smears that were consistent with Vehicle 2's right front tire. The front of the vehicle was twisted towards the driver's side as a result of collision forces indicating the principle direction of force during the crash. **Photograph V1-4** depicts the above described evidence.

Tire Scuff

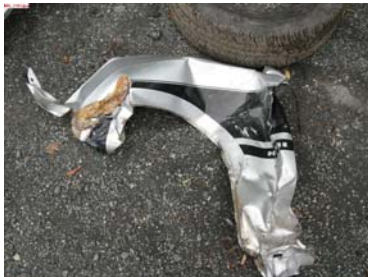
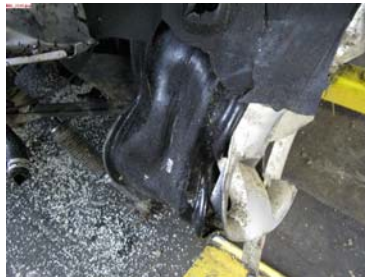
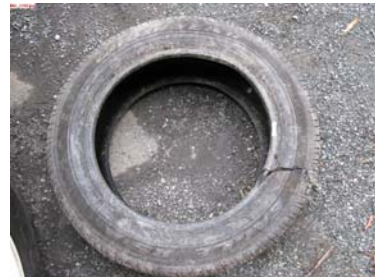
Photograph V1-5, Damage to the left front of Vehicle 1

Continuing to the left side of the vehicle, the left front quarter panel displayed contact damage extending from the front leading edge to the “A”-pillar and had been torn away. The “A”-pillar was displaced upward and to the rear towards the passenger compartment. The left front wheel was subjected to extreme collision force during maximum engagement and was severely deformed. The left front tire displayed a large laceration in the sidewall and was torn away from the vehicle. The tire was located near

the adjacent tree line to the right of the collision scene. After maximum engagement, Vehicle 1 and Vehicle 2 rotated in opposing directions causing a secondary collision or “slap”. As a result, contact damage in the form of concave depressions and creases in the sheet metal were present along the entire left side of the vehicle. Vehicle 1’s left front door had been pried open and was ajar at the time of the inspection.

Photographs V1-5 and V1-6 depict the aforementioned evidence.

Left Front Fender

Left Front Wheel

Laceration to the Left
Front Tire

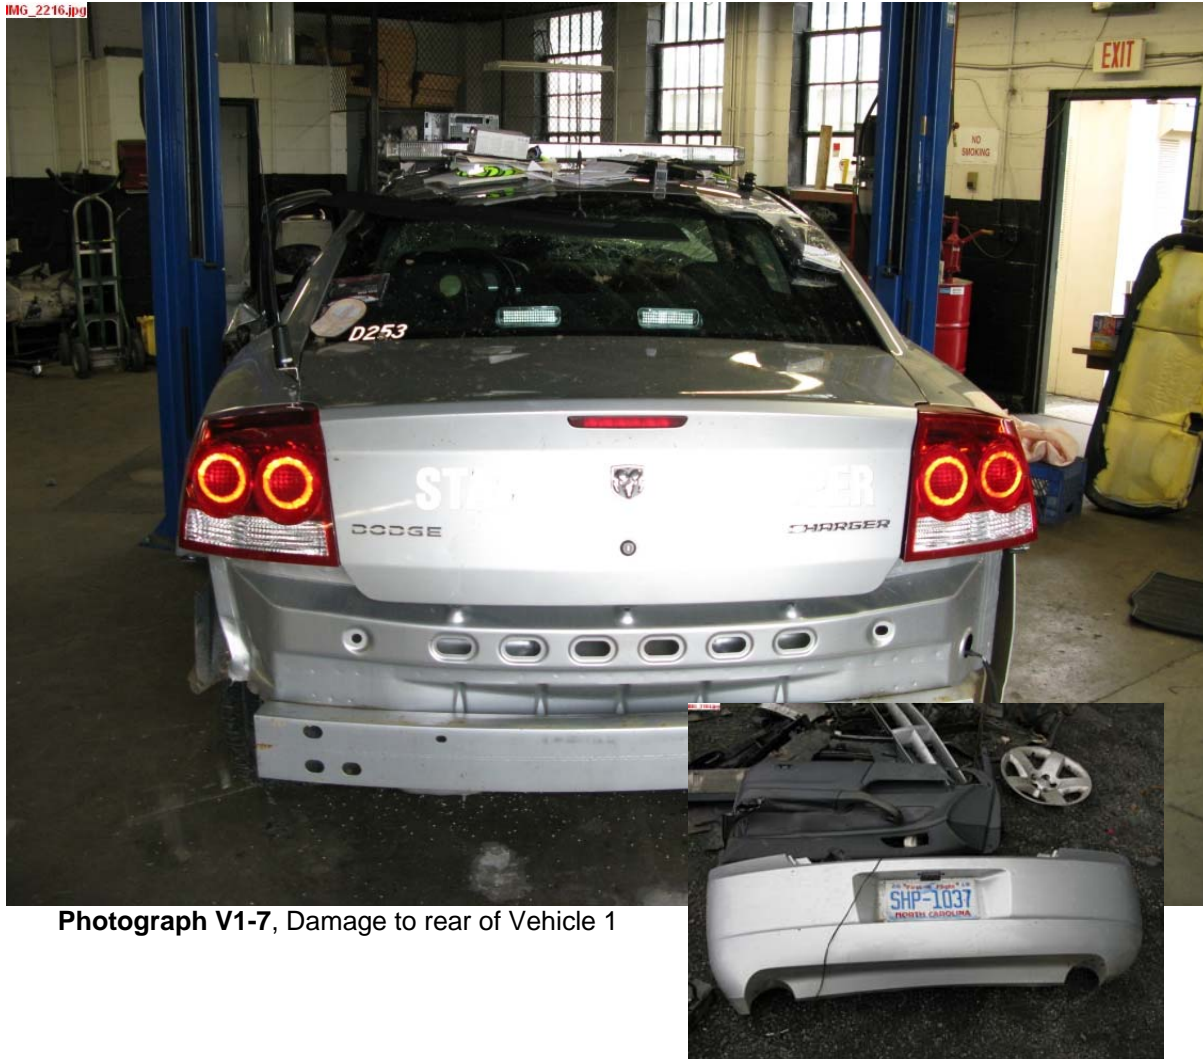
Photograph V1-7, Damage to rear of Vehicle 1

The rear of Vehicle 1 sustained minimal contact damage. The plastic rear bumper cover had been torn away during the crash. **Photograph V1-7** below depicts this evidence.

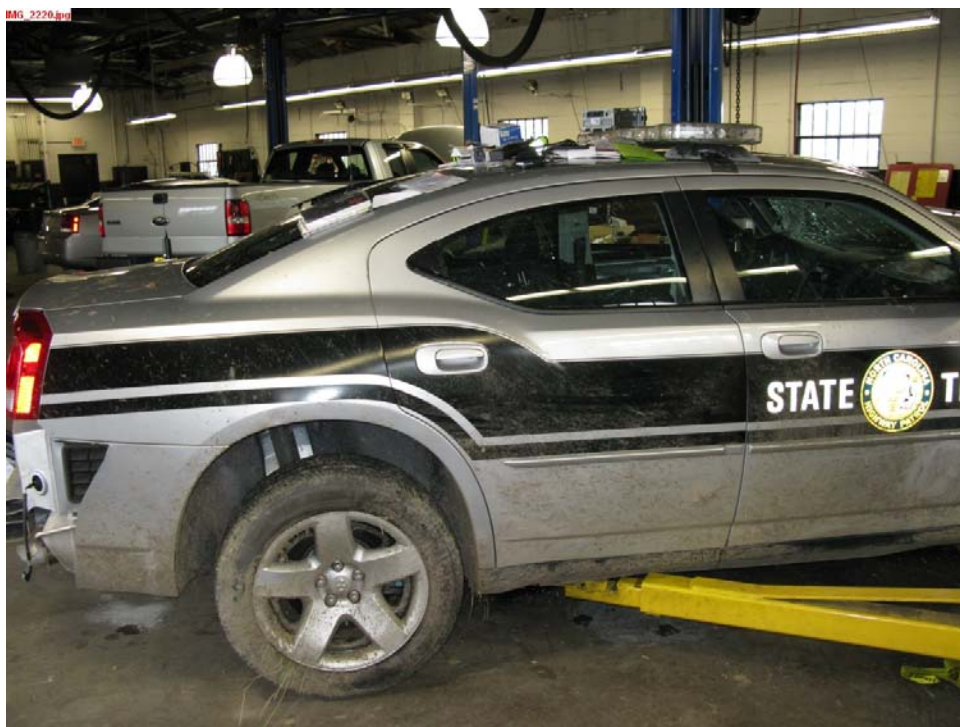
Photograph V1-8, Minimal to no Damage to the right Side of Vehicle 1

Continuing to the right side of the vehicle, it also sustained minimal to no contact damage. Superficial scratches were noted on the right front quarter panel that originated from the brush at the edge of the tree line where Vehicle 1 came to rest. This evidence is depicted on the following page in **Photograph's V1-8 and V1-9.**

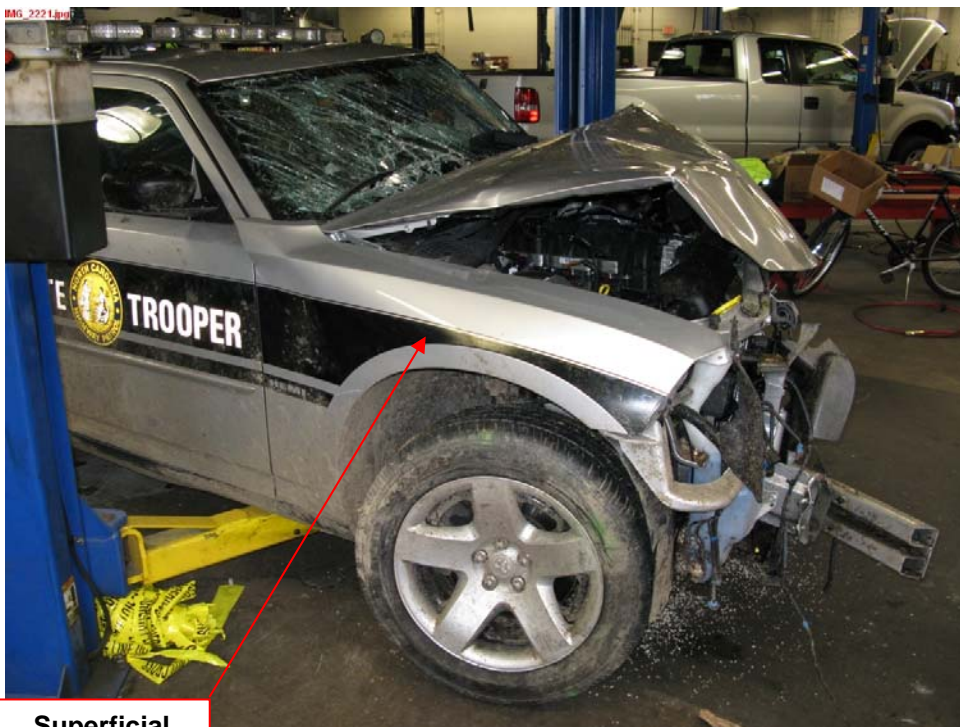
Photograph V1-9

**Superficial
Scratches**

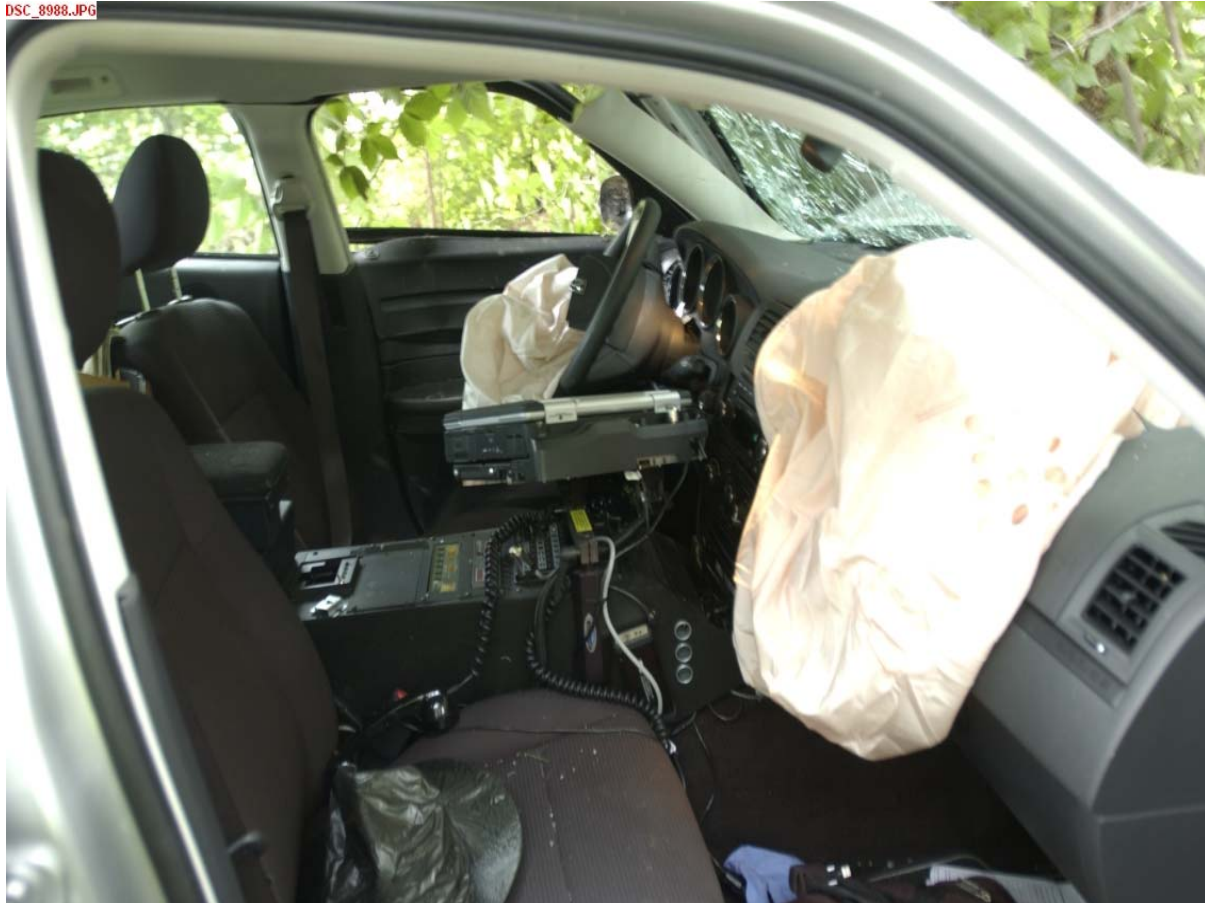
Photograph V1-10, - Interior of Vehicle 1

Interior Damage - Vehicle 1 was equipped with electric seats on the driver's side and manual sliding seats on the passenger side, both of which were unbroken and in their normal positions. The driver side headrest was located in the up position and the passenger side headrest was located in the down position. The driver's side passenger compartment was slightly encroached by the front dash. The operational status of all electrical system components inside Vehicle 1 were found to be in working order. Witnesses stated that the vehicle's emergency equipment (i.e. - blue lights, and four (4) way flashers) were operative at the time of the crash. Vehicle 1 was littered with various personal items but all standard equipment (i.e. - mobile data computers, radar units, etc.) were found to have been in their original mounted positions. In addition, Vehicle 1 was equipped with an automatic transmission and at the time of examination the gear shifter was located in the "P" - park position. **Photograph V1-10** depicts the interior of Vehicle 1.

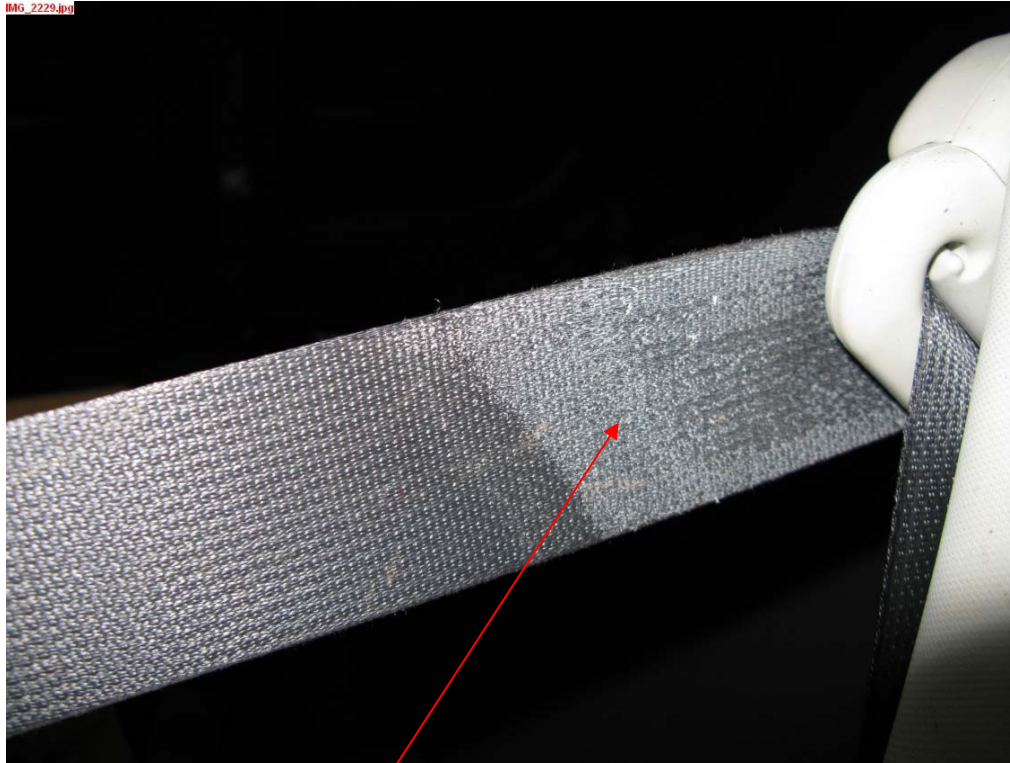
Photograph V1-11

Passenger Safety System - Vehicle 1 was equipped with driver and passenger side front airbags that were found to be deployed as a result of the crash. Transfers in the form of bodily fluids were noted on the surfaces of the air bags. However, it is to be noted that the transfer on the passenger side airbag is from the driver climbing out of the vehicle. The drivers' side seatbelt displayed areas of rubbing and slight burning of the belt edges, indicative of use during the collision and can be seen on the following page in **Photograph's V1-11 and V1-12.**

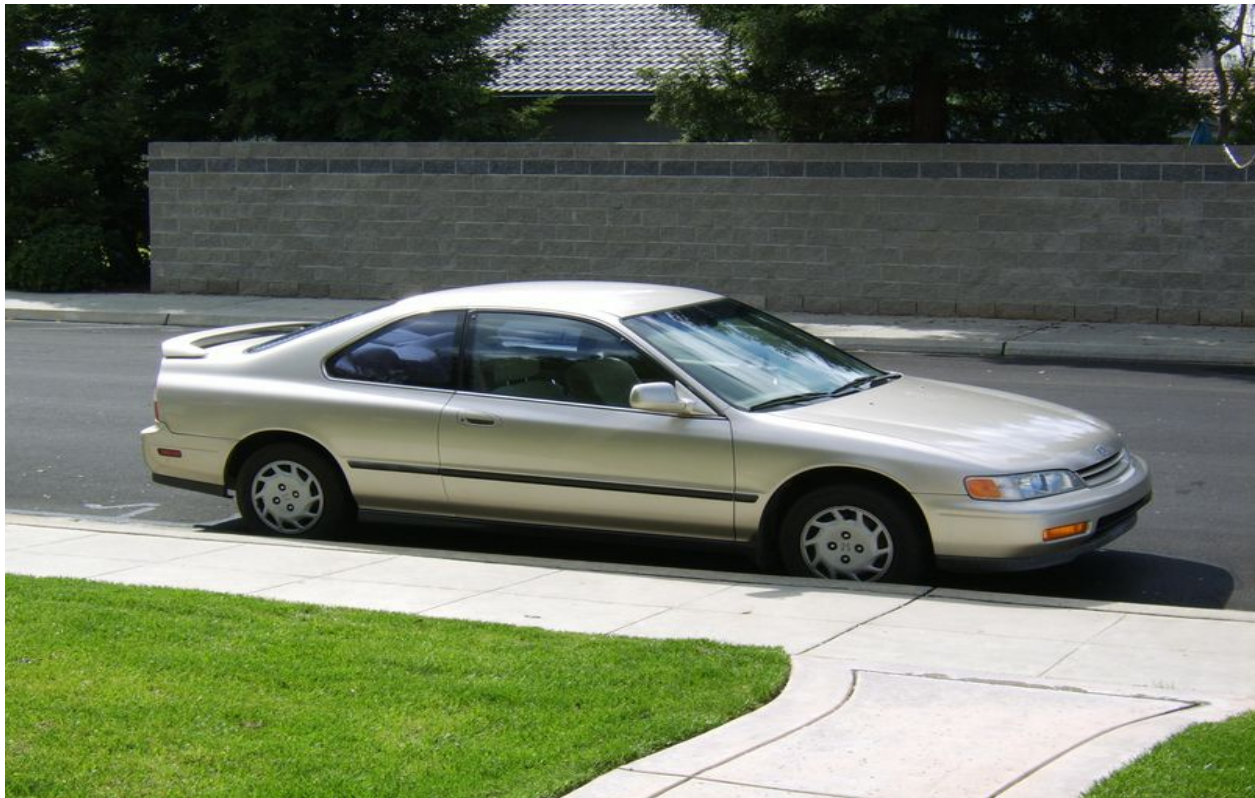
Photograph V2-1 is an exemplar Honda Accord

Vehicle 2 was identified as a 1995 Honda Accord LX two (2) -door. The vehicle was registered to Gerald Paul Allmond, 3311 Dillon Road, Jamestown, NC 27360. The Vehicle identification number (VIN) was 1HGCD7130SA041732. The Vehicle was displaying North Carolina registration plate ZNV-4415. The driver was Sandra Gail Allmond, 2514 Johnsonton Road Thomasville, NC 27360. On Tuesday, 25 May 2010, Trooper's B. K. Palmiter and B. K. Martin conducted a vehicle inspection of the 1995 Honda Accord at the North Carolina Highway Patrol's Troop "D" Garage located at 2527 East Market Street Greensboro, NC 27401 **Photograph V2-1** depicts an exemplar 1995 Honda Accord.

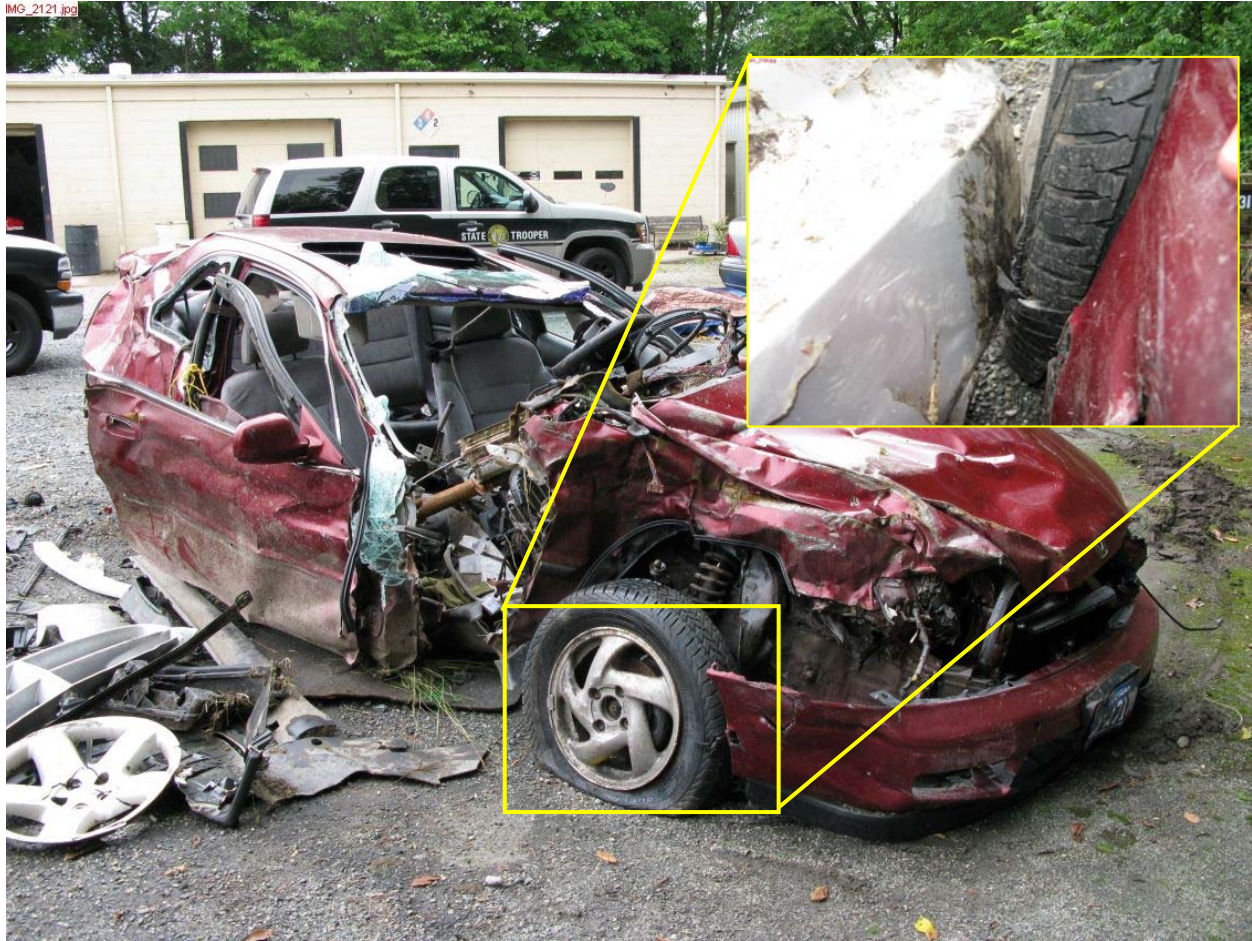
Photograph V2-2 on the following page depicts the post crash condition of Vehicle 2.

The yellow box highlights the point of initial contact with Vehicle 1. Illustrated in the inset photograph, the right front tire has been matched with the left front corner of the bumper cover of Vehicle 1. The hood sustained an extensive amount of crush as Vehicle 1 continued to penetrate the front end of the Honda.

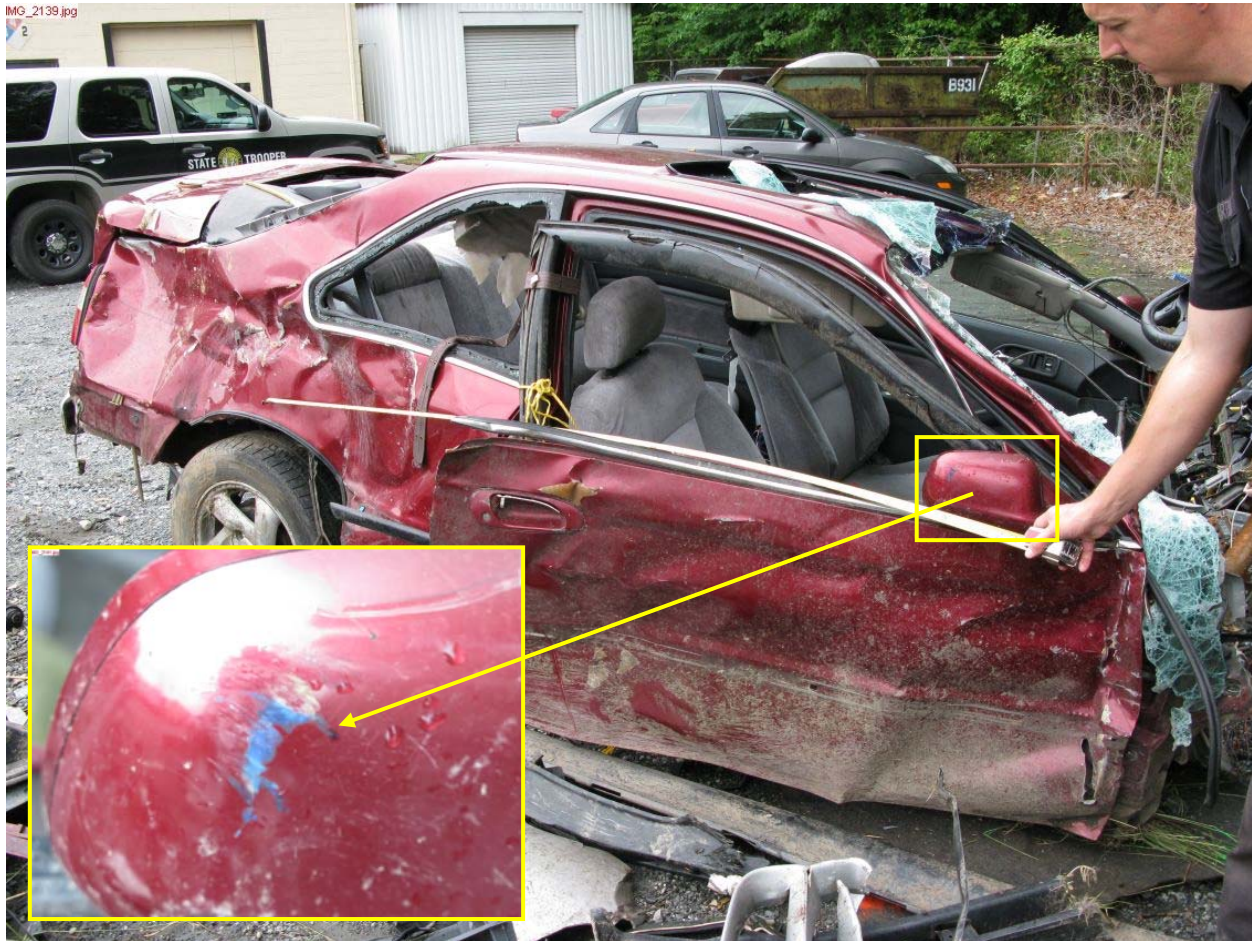
Photograph V2-5 illustrates the damage made from contact with the driver's side of Vehicle 1. Once the initial contact was made as described in **Photograph V2-2**, both Vehicles began to rotate; Vehicle 1 rotating clockwise and Vehicle 2 rotating counterclockwise respectively. The yellow square in **Photograph V2-5**, enlarged and inset, illustrates a scuff mark with a grey paint transfer made from contact with the driver's door of Vehicle 1. The two vehicles then rotated toward each other causing significant body damage to the sheet metal "skin". The severity of the crash shattered the windows and left small portions of the tempered windshield glass draped near the front of the passenger door.

Photograph V2-5, The passenger side of Vehicle 2

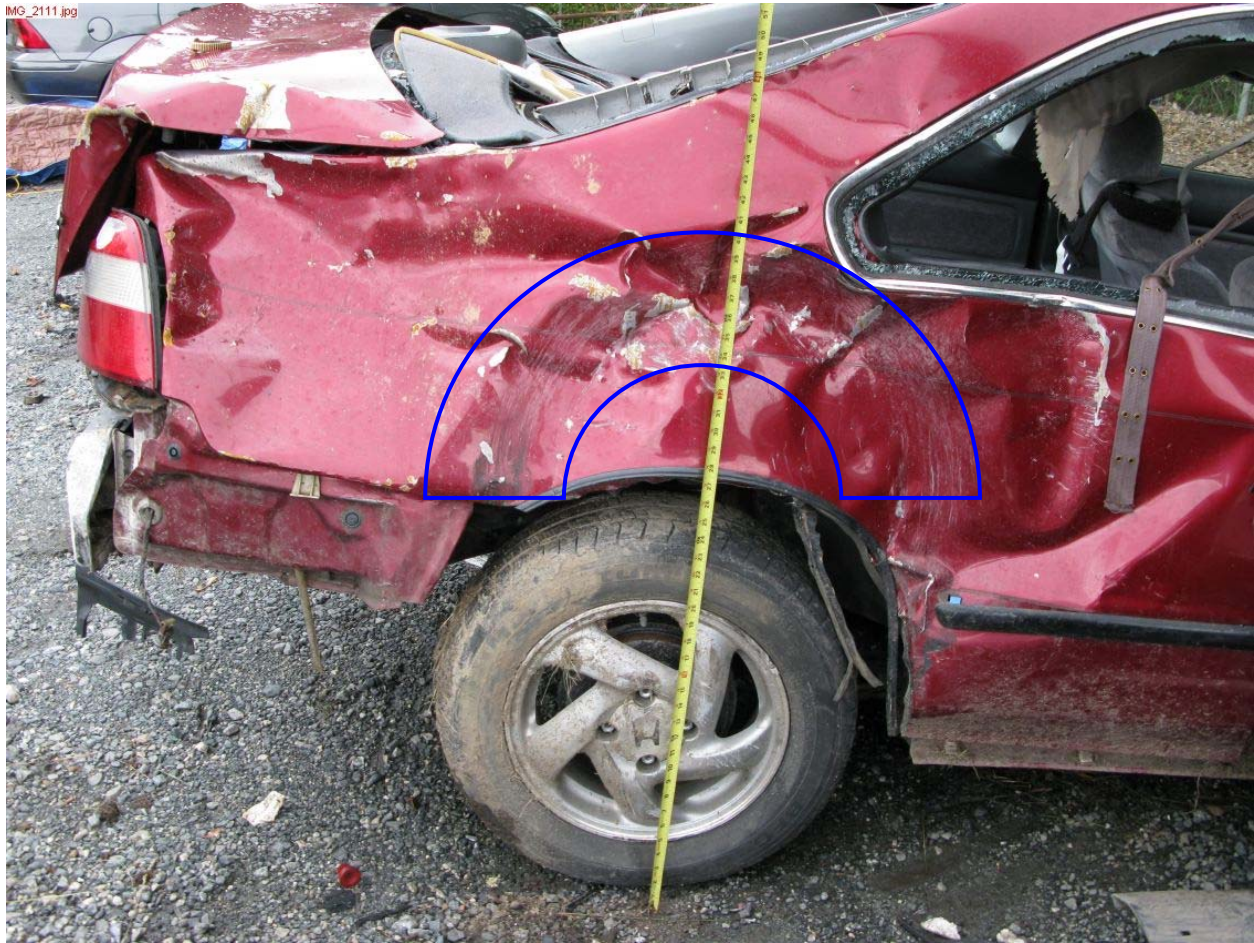
After the vehicles rotated into each other, the left rear tire of Vehicle 1 lifted off of the roadway and made contact with the right rear quarter panel of Vehicle 2. The rotation of the tire and wheel against the Honda, highlighted with a blue arc, made a scratched semicircular dented impression against the sheet metal. The severity of this impact rippled the sheet metal on the passenger side of the Honda. **Photograph V2-6**

Photograph V2-6, Right rear quarter of Vehicle 2
