NORTH CAROLINA STATE HIGHWAY PATROL

COLLISION RECONSTRUCTION UNIT

Traffic Collision Reconstruction Report:

**Location: I-85 Business (U.S. 29/70)
@ RP-1144 (River Road)**

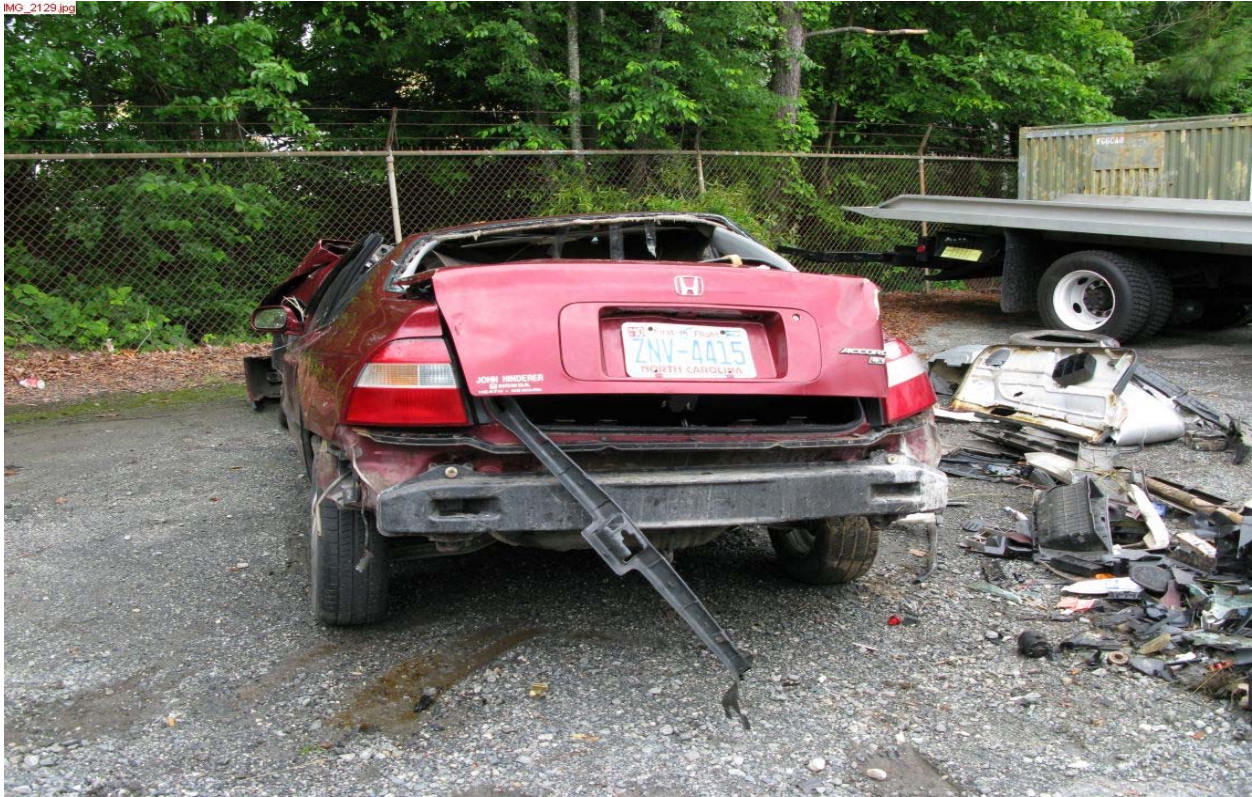
Photograph V2-7 depicts induced damage to the rear of Vehicle 2. The impact broke the trunk lid from its closed position and tore the rear bumper cover off of the rear bumper where it was mounted. **Photograph V2-8** indicates very little damage to the rear portion of the driver's side of Vehicle 2. The area circled in yellow illustrates induced damage to the vehicle sheet metal on the rear passenger side as a result of the twisting and rotating of the vehicle during the crash.

Photograph V2-7, Illustrates the rear of Vehicle 2

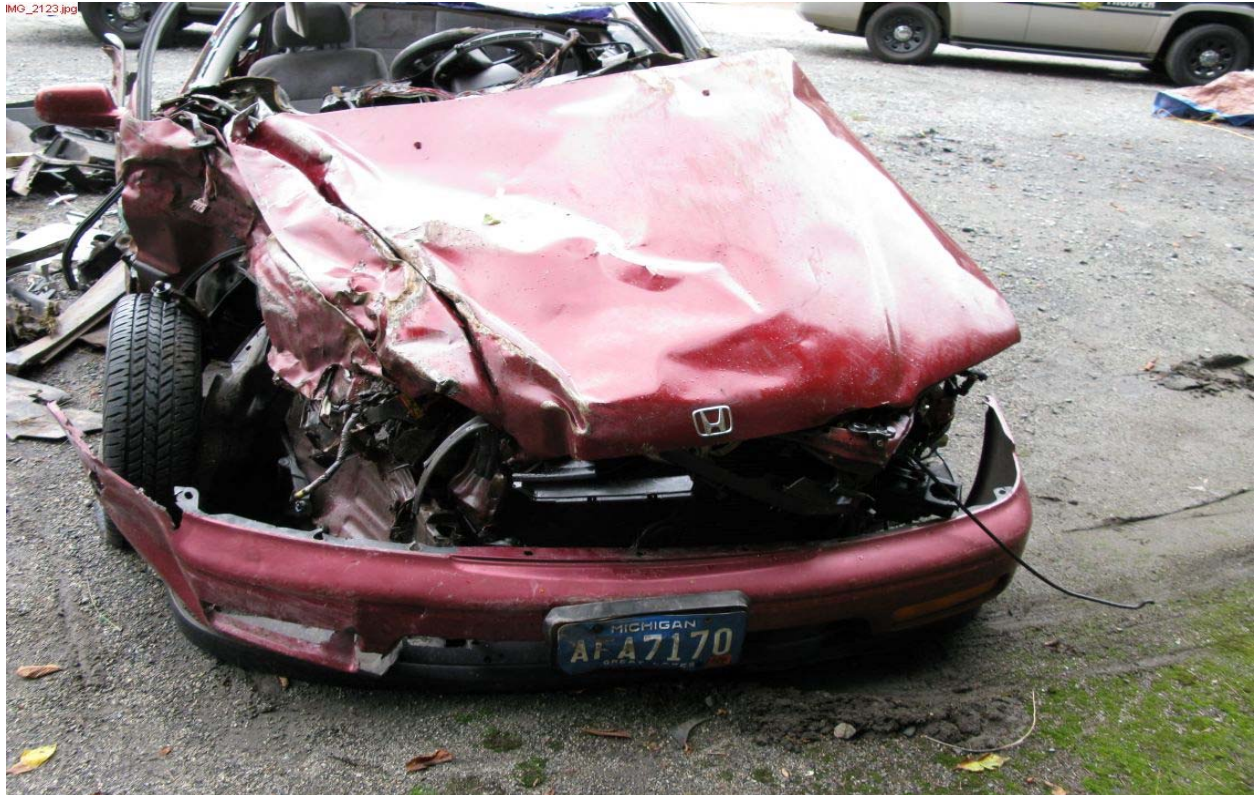
Photograph V2-9 depicts the front of Vehicle 2. The right front wheel sustained the most direct impact during the crash. As a result of the severity of the force of this impact the front end, from the dashboard forward, was sheered from the vehicle.

Photograph V2-9, Frontal view of Vehicle 2

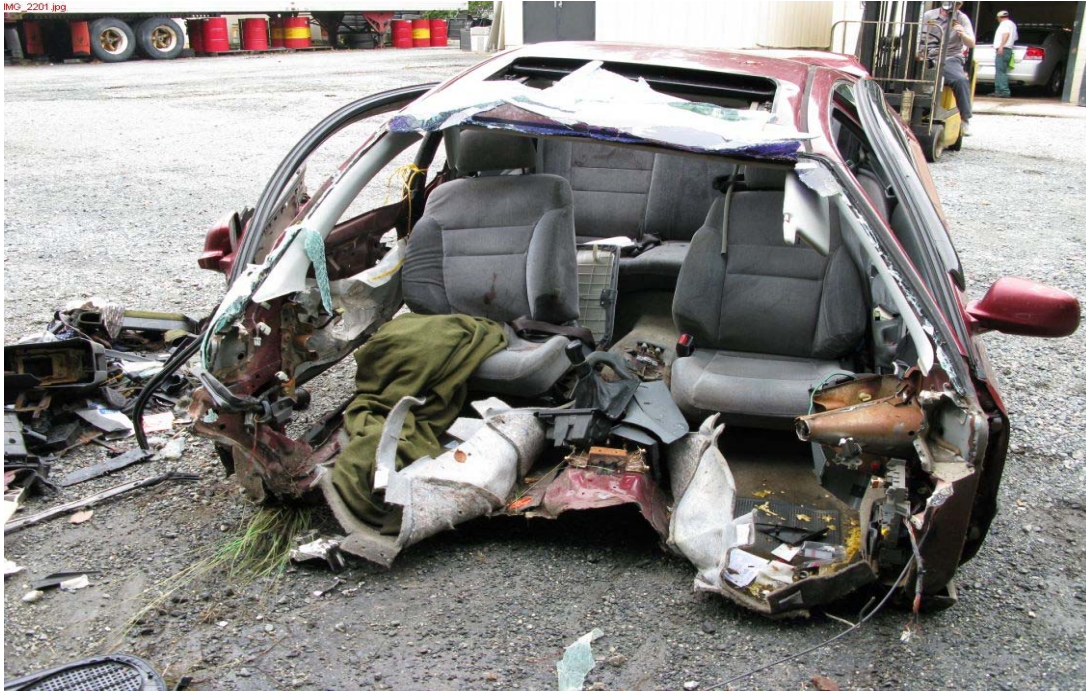
Photograph's V2-10 and V2-11 illustrate these two portions of Vehicle 2. The dashboard and steering wheel remained connected to the front wheel and engine compartment after it was sheered away.

Photograph V2-10, Illustrates the rear portion of Vehicle 2

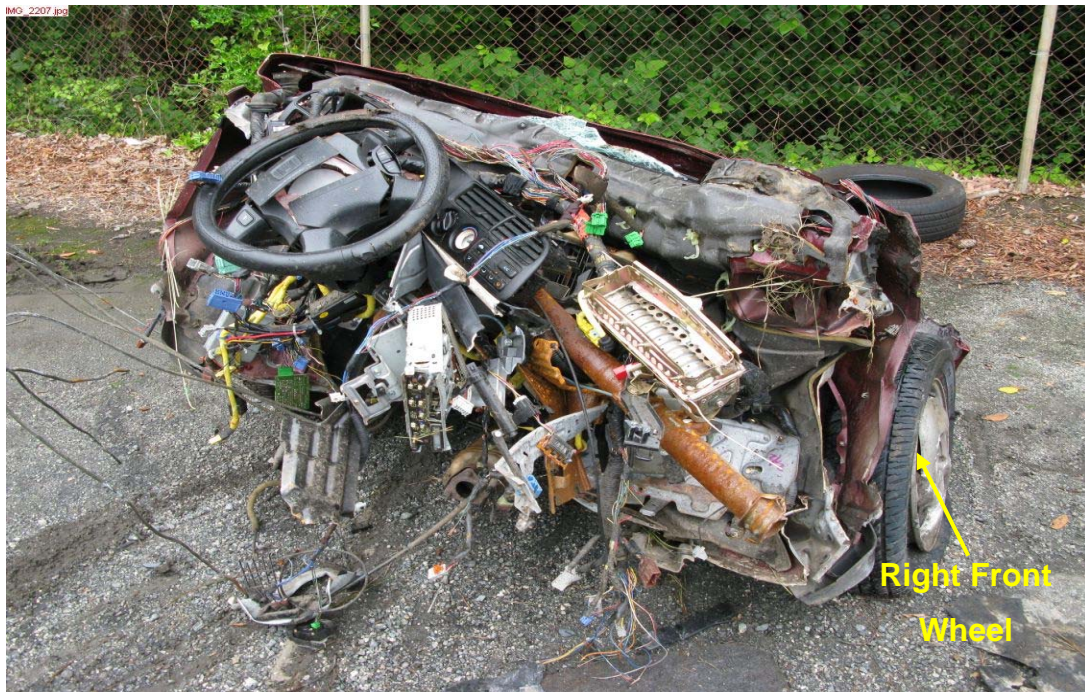
Photograph V2-11, Dashboard and front axle of Vehicle 2.

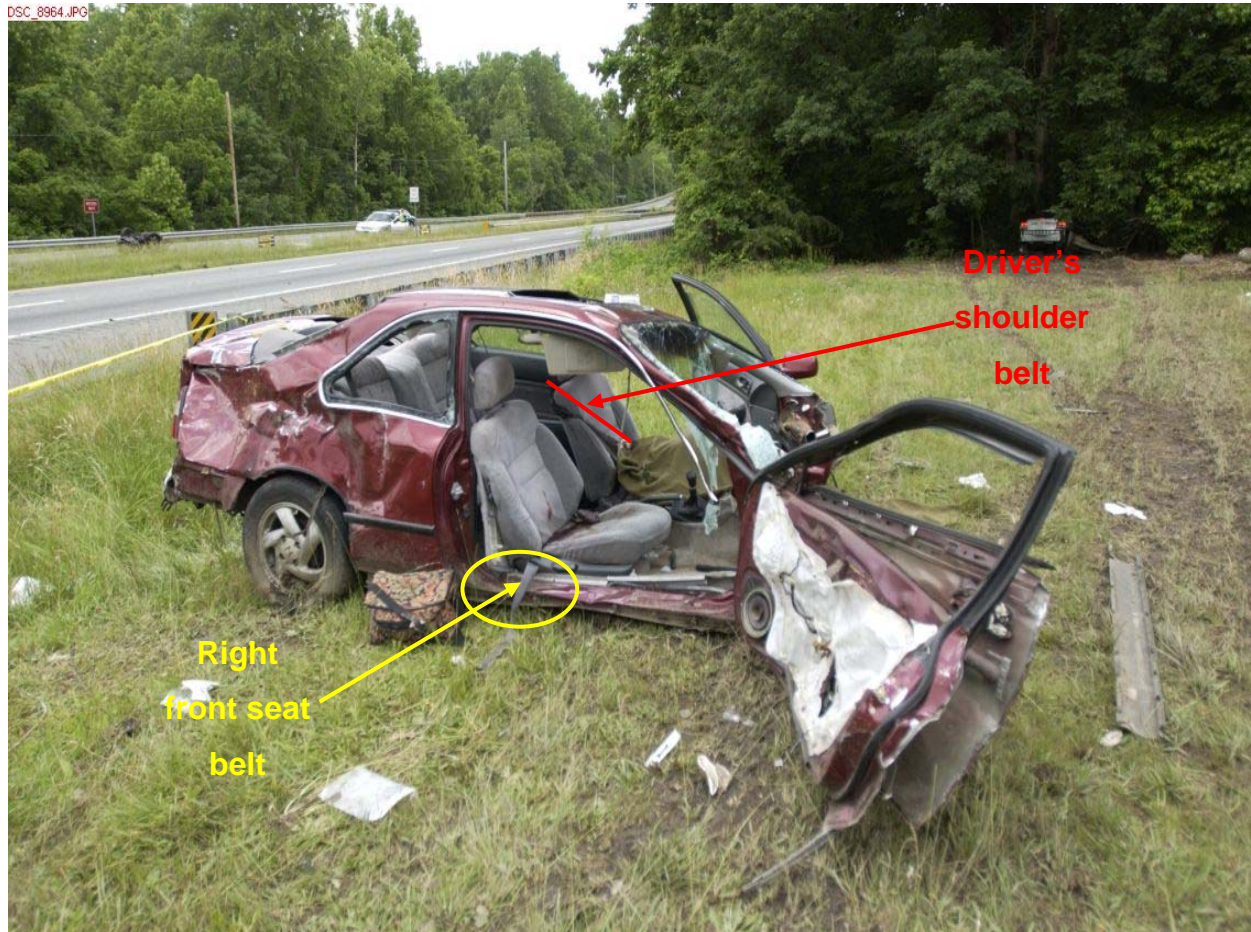
Photograph V2-12, Final resting position of Vehicle 2

Photograph V2-12 above depicts the final resting position of Vehicle 2 on the morning of the crash. Illustrated in this photograph is the interior damage to the cabin compartment. Circled in yellow is the right front passenger seat belt which, according to witness statements, was cut and removed from the passenger by the first arriving witnesses. Identified in red is the driver's shoulder belt in its post crash position. The driver's seat and the driver had slid forward toward the floor board causing the shoulder portion of the seat belt restraint to be wedged under the headrest. An abrasion to the neck of the driver indicated that the belt was being worn properly prior to the crash. Both rear seat passengers, according to witnesses, were wearing their shoulder and lap belt restraints.

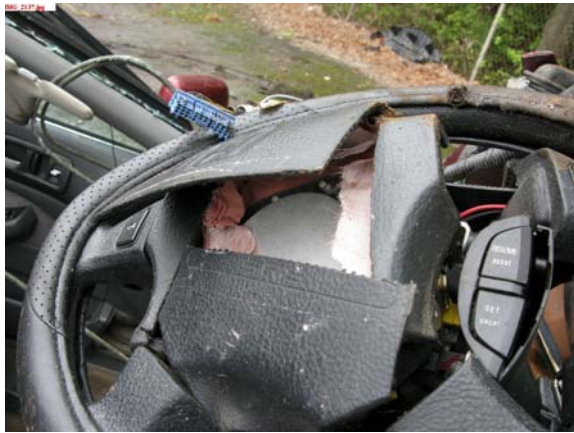
Photograph V2-13
Driver side air bag removed from vehicle 2

Continuing with the post crash inspection, it was discovered that there were no air bags inside Vehicle 2. According to a crash report filed by the High Point Police Department on 15 September 2008, both front air bags were deployed during this crash. Consequently, there were no air bags contained inside the steering wheel or passenger side dash location of the Honda at the time of the collision on 23 May 2010.

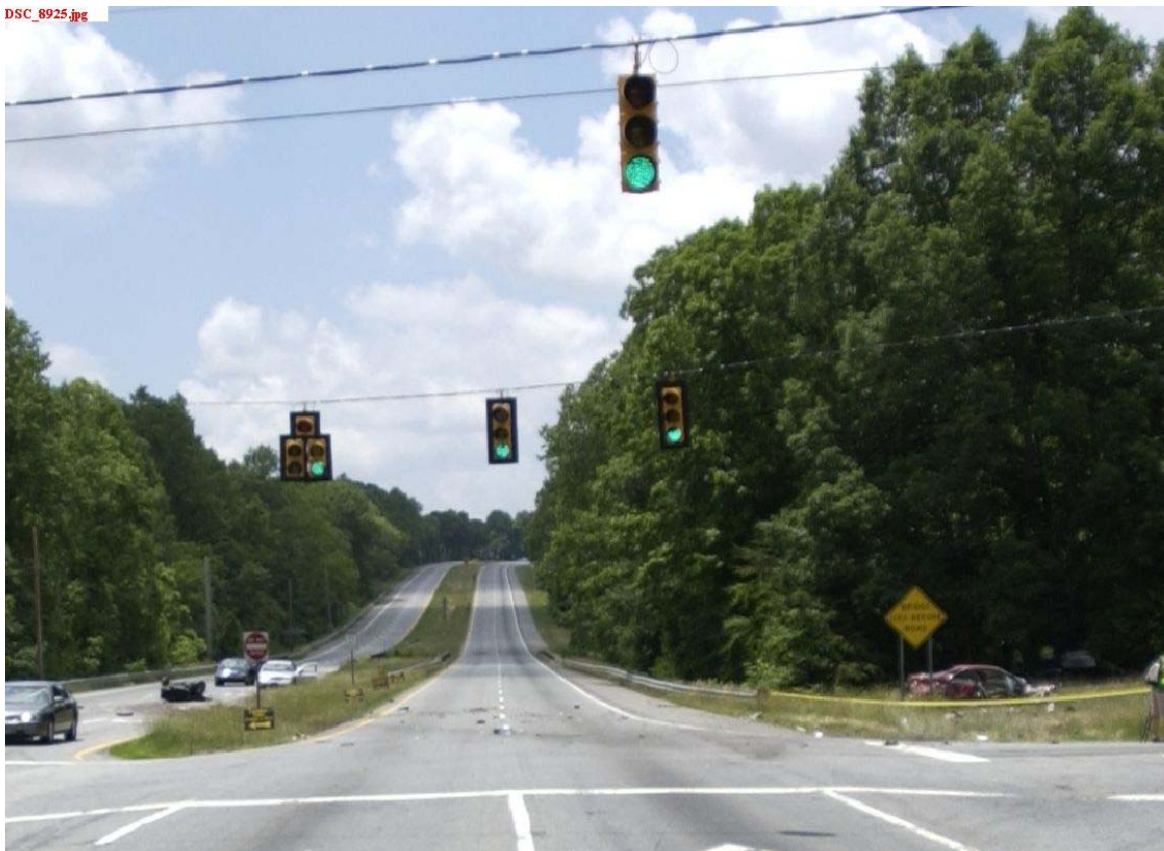
Photograph ST2-1

The intersection of I-85 Business and RP-1144 (River Road) is governed by traffic signal lights. The purpose of these lights is to facilitate the safe and efficient movement of traffic through the intersection. The southbound through lanes of I-85 Business are governed by three, three head signal lights, one signal head each for red, yellow and green. The left turn lane is governed by a five head signal light, one signal head each for red, yellow and green and one signal head each for a yellow arrow and a green arrow. Signal lights governing the northbound lanes are configured in the same manner. **Photograph ST2-1** depicts the signal lights at the intersection.

Signal light design for the intersection includes measures to safe guard against collisions being caused by a signal light malfunction. If traffic intending to make a left turn is receiving a green protected left turn arrow and the system calls for green lights for opposing through traffic, this will cause all lights at the intersection to begin to flash either yellow or red depending on the design specifications for the intersection. There is no evidence that the traffic signal lights on the morning of the collision ever went into a flash sequence.

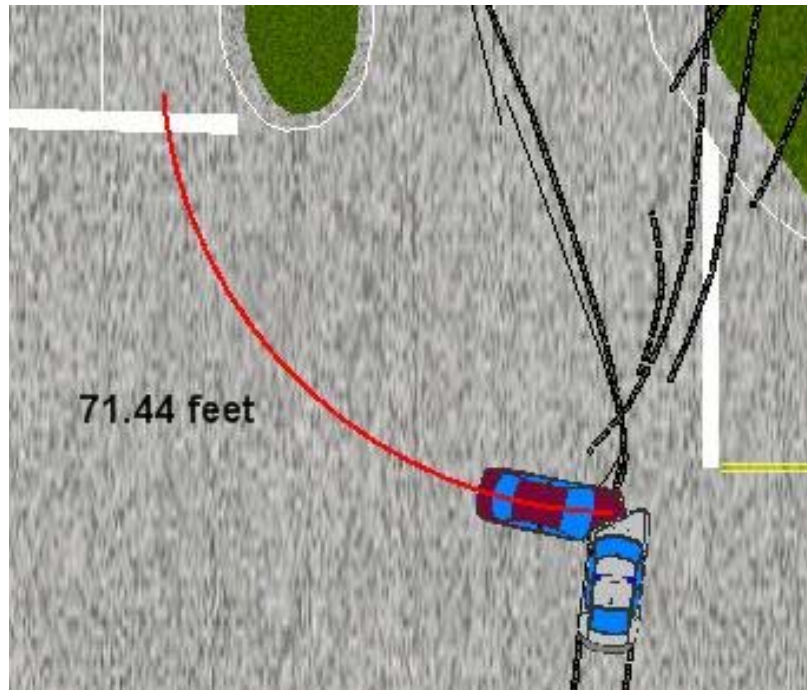
of $4.8 \text{ (ft/sec}^2\text{)}^1$, the estimated speed at impact for Vehicle 2 would be seventeen (17) miles per hour. **Illustration ST3-1** depicts the approximate turning path and distance for Vehicle 2.

Illustration ST3-1, Turning path and distance for Vehicle 2
