MULTIDISCIPLINARY ACCIDENT INVESTIGATION TEAM NARRATIVE/DIAGRAM

GS-067-24

Oakland Area

MAIT SUPPLEMENTAL

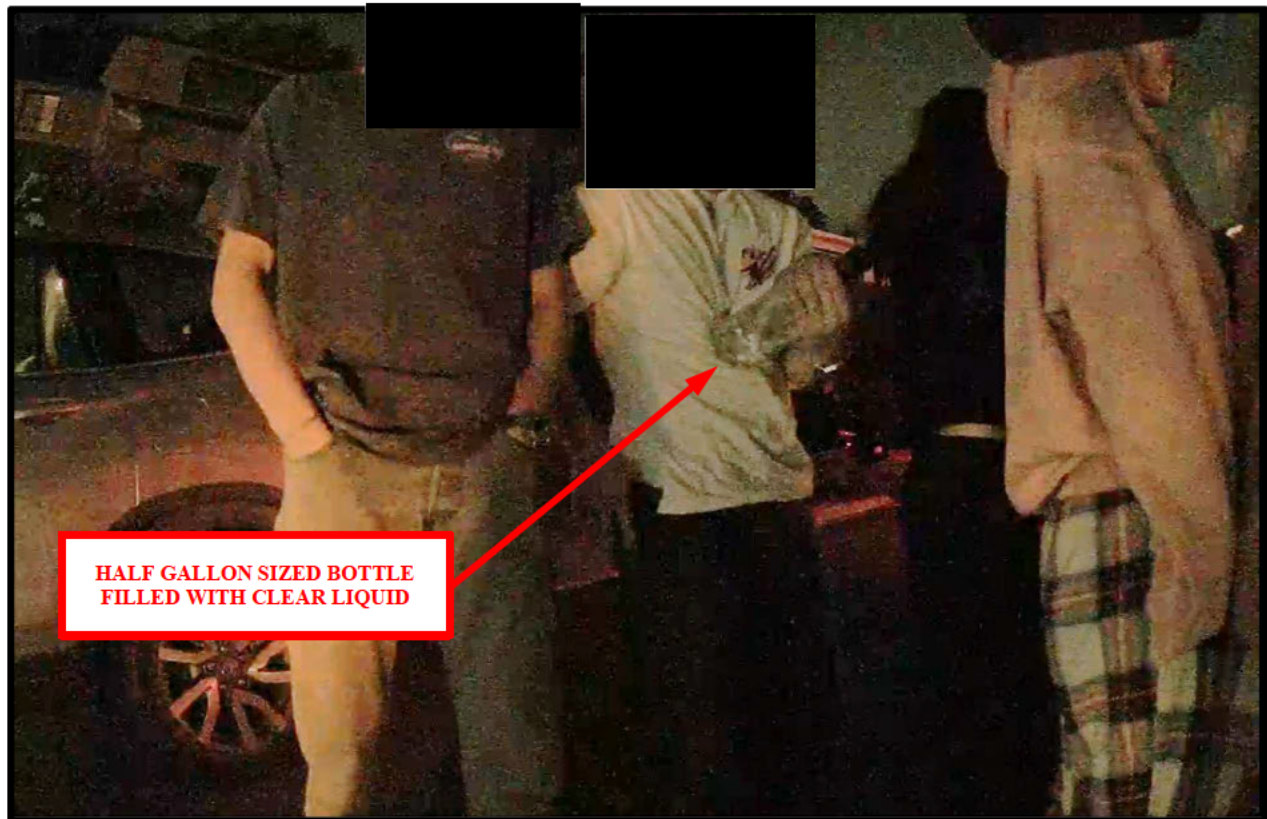
The Tesla Cybertruck backed to the east onto Somerset Road and pulled forward to the west next to a gray sport utility vehicle that was parked at the north curb. A young male wearing a dark short sleeved shirt walked toward the right side of the Tesla Cybertruck as a young female wearing a black sweatshirt and a young male wearing a white short sleeved shirt exited from the left rear door of the gray sport utility vehicle. A young female wearing a pink sweatshirt walked from the vicinity of the gray sport utility vehicle as all four pedestrians approached the right side of the Tesla Cybertruck. An arm extended out of the open right front passenger's window of the Tesla Cybertruck and shook the hand of the young female wearing the pink sweatshirt. The young male wearing the white short sleeved shirt was carrying a large half gallon sized bottle filled with a clear liquid.

Lightened image clipped from the Right Repeater camera at 03:03:40 hours

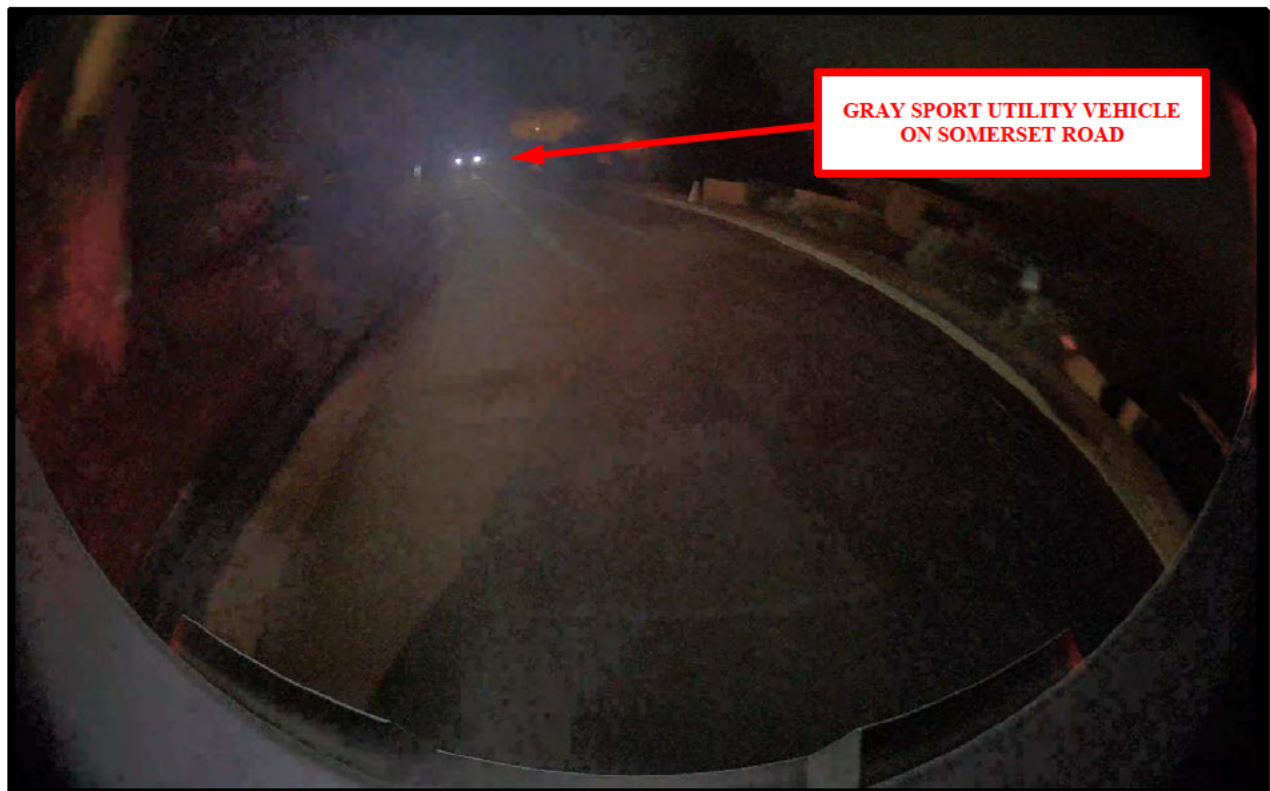
At approximately 03:04:26 hours, the right rear door of the Tesla Cybertruck was opened and the young male wearing the white short sleeved shirt entered the right rear seat while carrying the half gallon sized bottle filled with a clear liquid, followed by the young female wearing the black sweatshirt. The young male wearing the gray short sleeved shirt walked toward the driver's door of the gray sport utility vehicle as the young female wearing the pink sweatshirt walked toward the passenger side of the gray sport utility vehicle. The right rear passenger's door of the Tesla Cybertruck shut and moments later the Tesla Cybertruck drove west on Somerset Road followed by the gray sport utility vehicle.

Image clipped from the Rear camera at 03:05:24 hours

The Tesla Cybertruck rapidly pulled away from the gray sport utility vehicle as it traveled west on Somerset Road and turned left onto Crest Road. The video ended as the Tesla Cybertruck approached Hampton Road at approximately 03:06:02 hours.
