## **End of Line Observations**

### **Introduction**

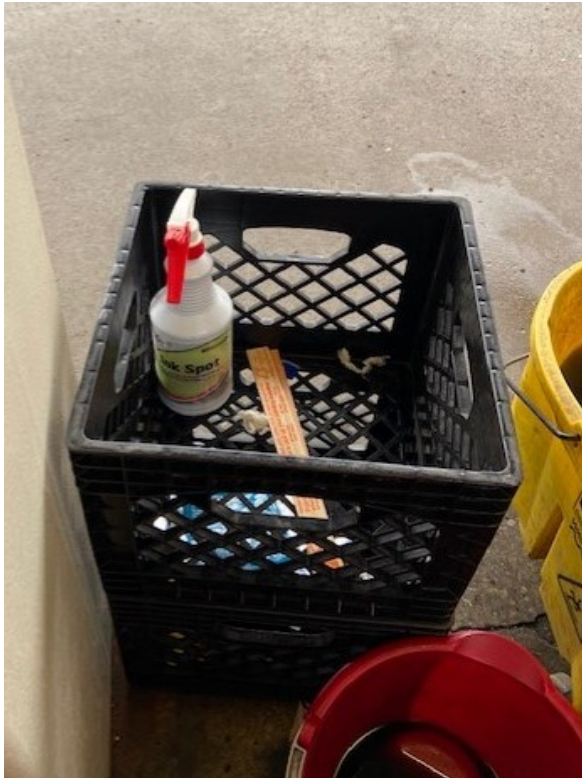
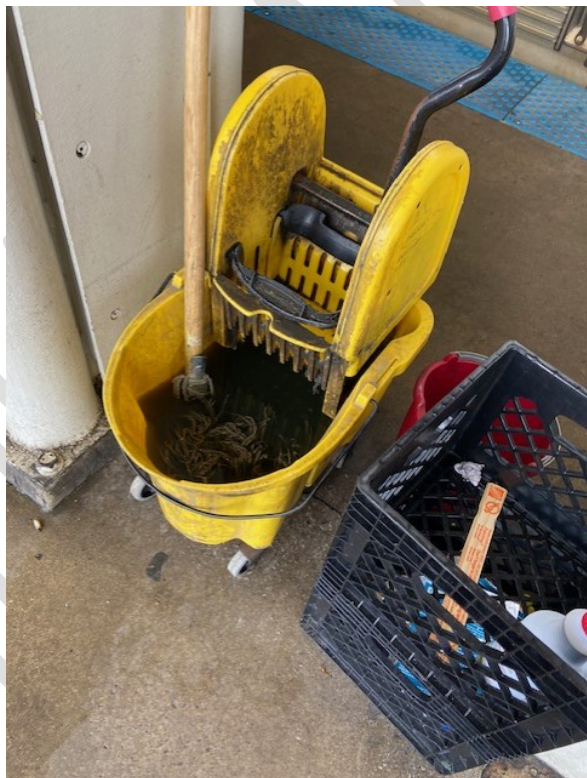
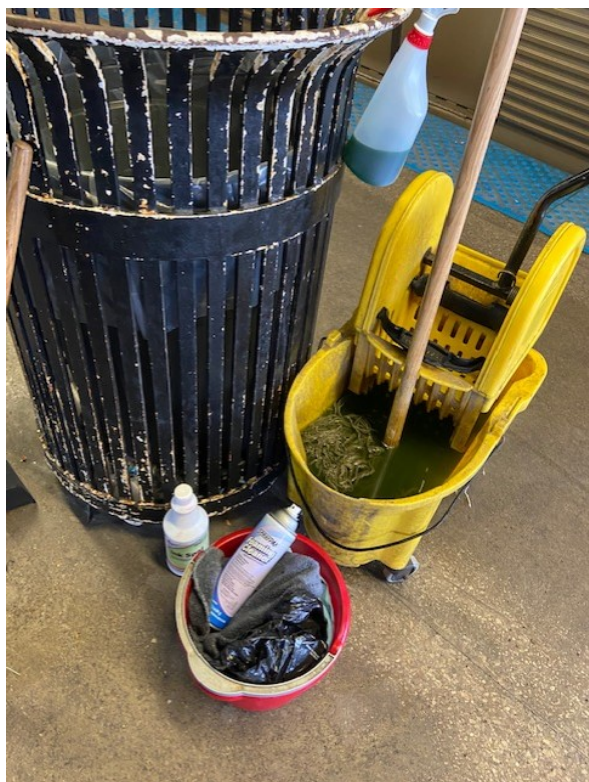
**Howard platform cleaning products photos:**

While observing the materials to be used for the cleaning of rail cars, there was notably no disinfectants present, only a bottle of graffiti remover, a can of foam cleaner, and an unlabeled bottle of green liquid. Also present was dirty mop water and used towels.
