MULTIDISCIPLINARY ACCIDENT INVESTIGATION TEAM NARRATIVE/DIAGRAM

DATE OF COLLISION (MONTH-DAY-YEAR)	TIME (2400)	NCIC	OFFICER I.D.	NUMBER	MAIT CASE NUMBER	PAGE
07-22-2010	0214	9435	15751	2010-07-0219	CF-023-10	i

Central Division

CF-023-10

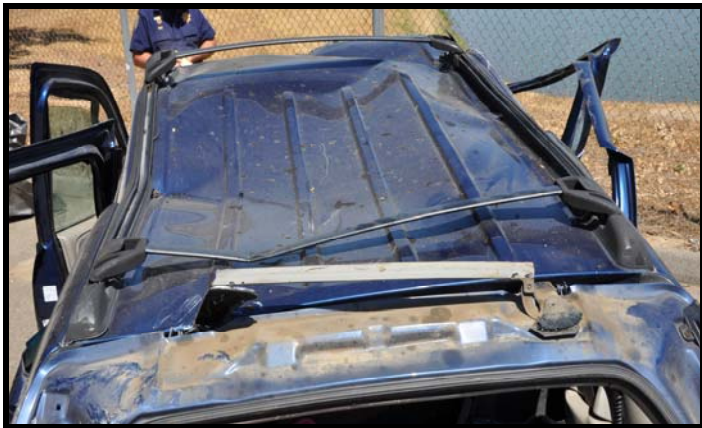
The roof was separated from the top of both A-pillars. In the area of the B-pillars, the roof was bowed upward. There was a fold from the leading edge of the roof, near the midline, to above the right B-pillar. The hinge, originally attached to the lift gate glass, was twisted and bent upward. The roof rack's rear lateral support was bent downward. The majority of the roof was displaced downward.

Roof of Vehicle 1 (Chevrolet), rear looking forward.
CF-023-10 07-29-10 DH-B (39) cropped

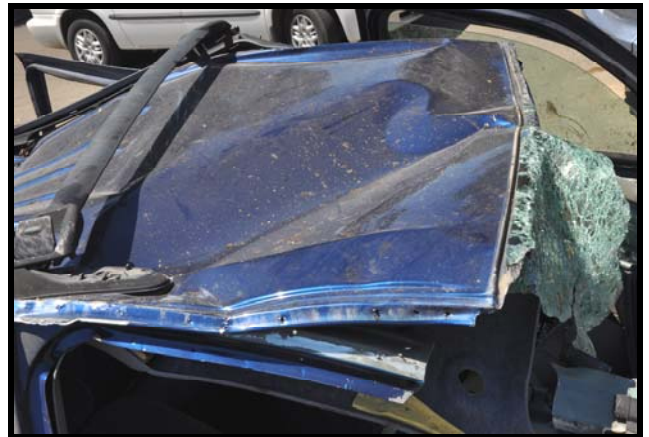
Right side of roof, Vehicle 1 (Chevrolet).
CF-023-10 07-29-10 DH-B (41) cropped

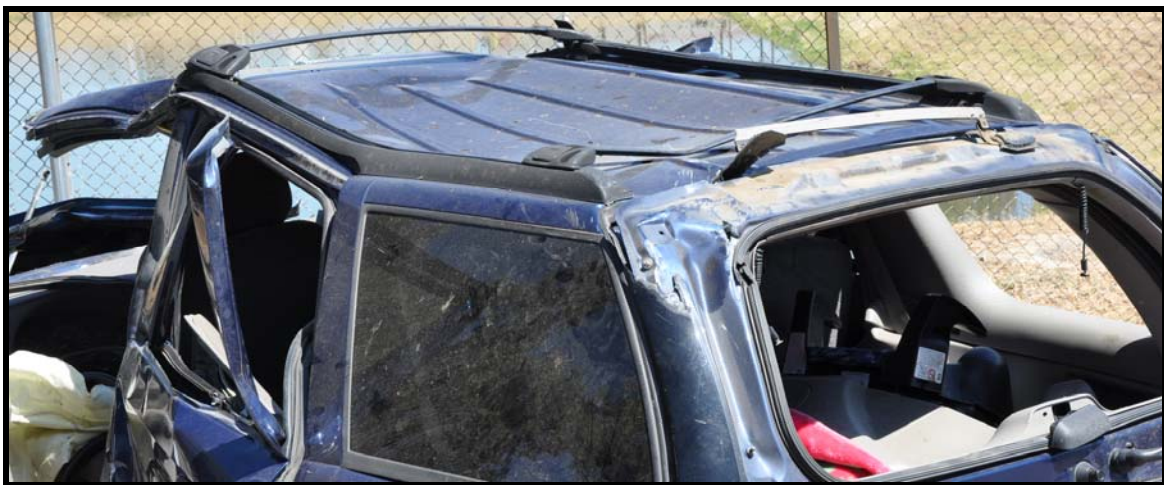
Left side of roof, Vehicle 1 (Chevrolet).
CF-023-10 07-29-10 DH-B (18) cropped

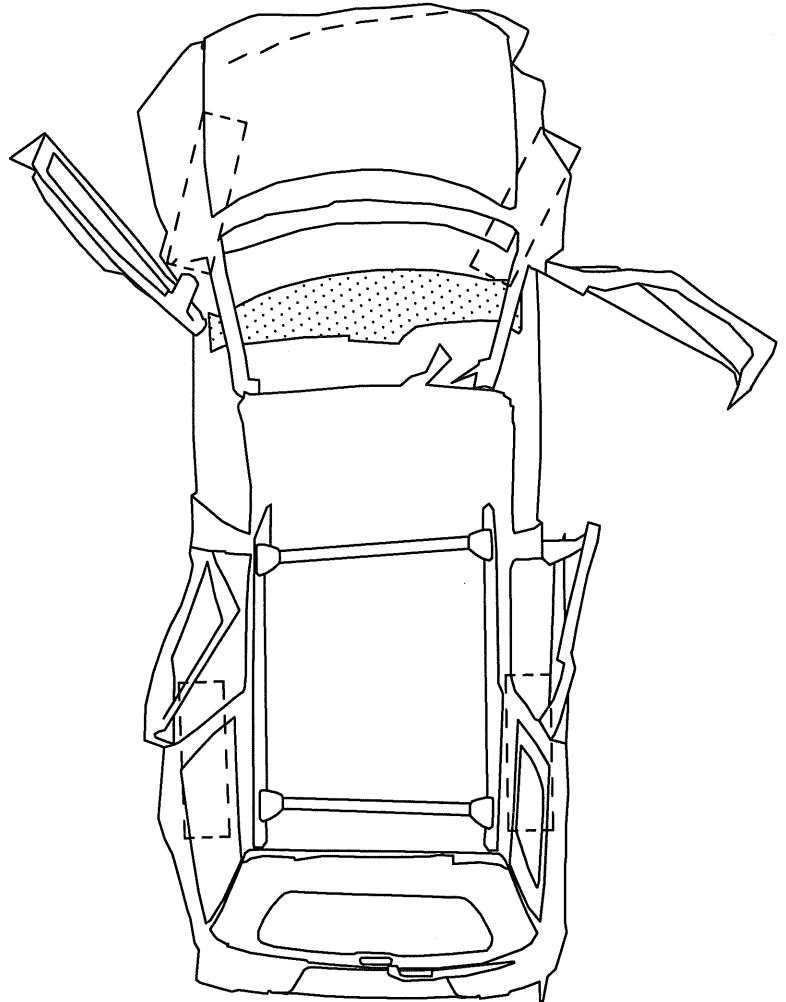
Vehicle 1 (Chevrolet)

Vehicle damage profile drawn
by Investigator Nees

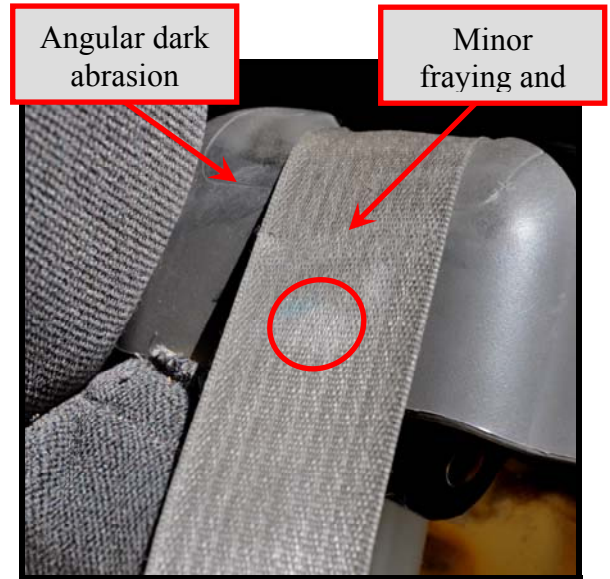
Restraint webbing and loop guide cover.
CF-023-10 08-02-10 DH (53) cropped

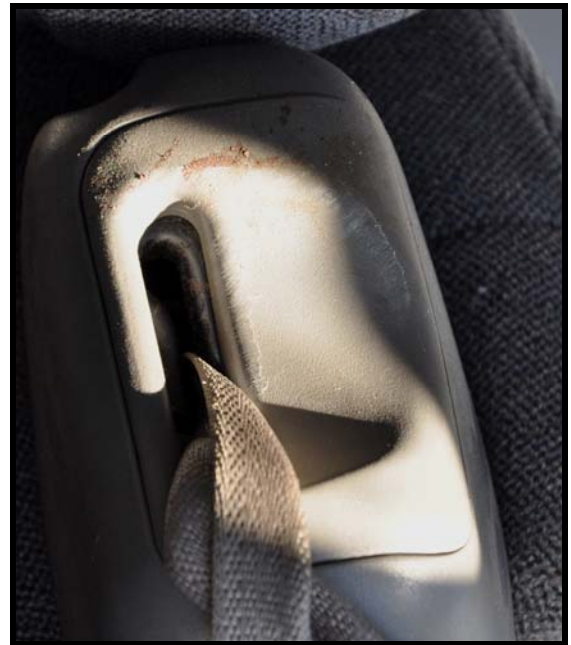
Material transfer and imprinting on loop guide
cover.
CF-023-10 08-02-10 DH (57) cropped

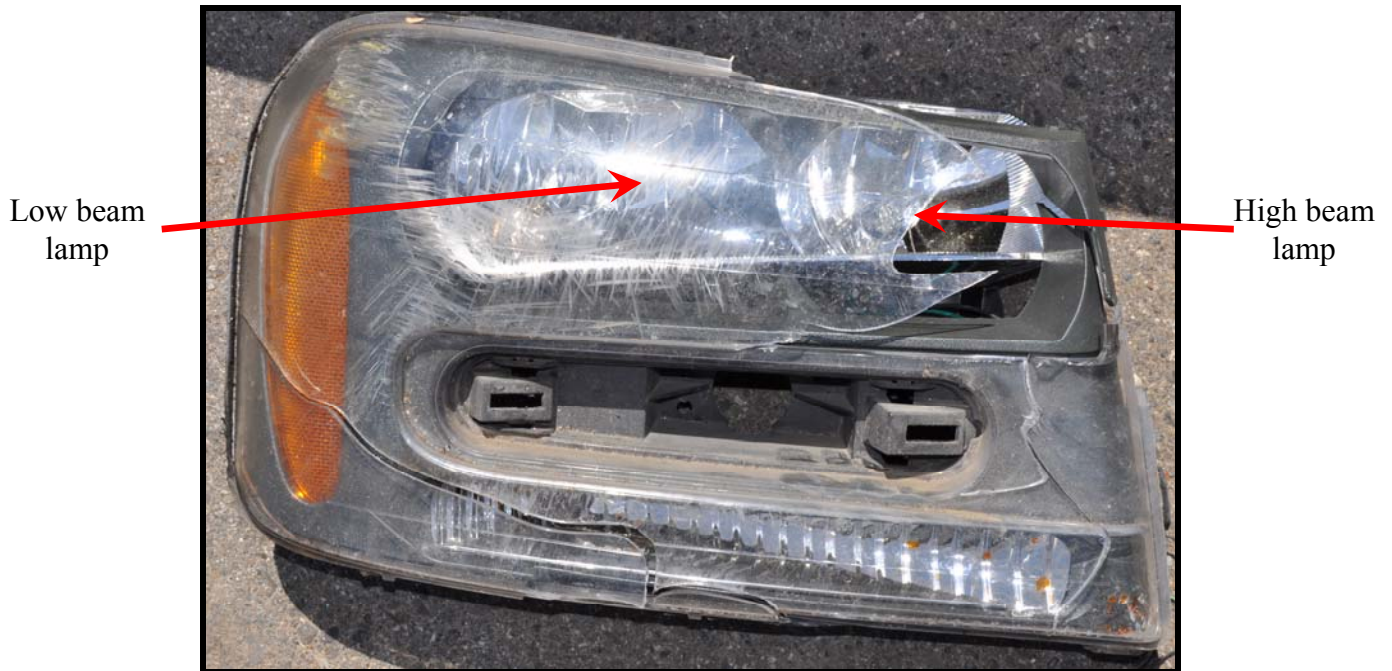
The right headlamp assembly was detached from the vehicle and located at the scene (evidence item 38). During the lamp inspection the assembly was located by investigators in the rear cargo area of Vehicle 1 (Chevrolet). The headlamp assembly contained two separate lamps. The outboard bulb was the low beam lamp and the inboard lamp was the high beam lamp.

Detached right headlamp assembly of Vehicle 1 (Chevrolet).
CF-023-10 07-29-10 DH-B (86) cropped

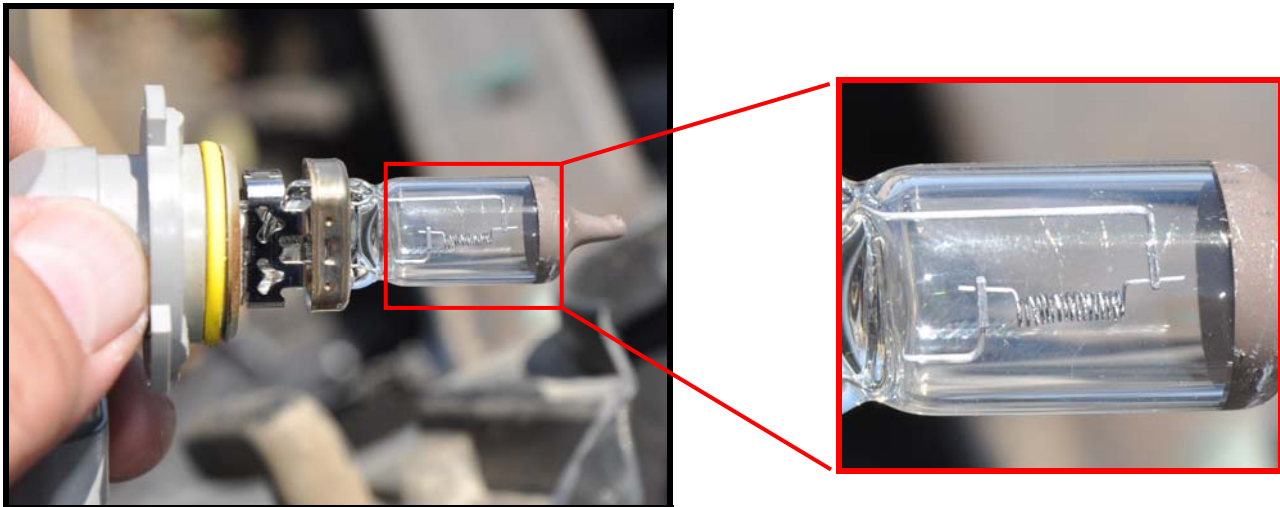
The glass envelope was intact. There was continuity through the filament. The filament was bright, shiny and silver in luster. The filament's coils were even in spacing and pitch.

Right low beam headlamp of Vehicle 1 (Chevrolet).
CF-023-10 07-29-10 DH-C (58) cropped

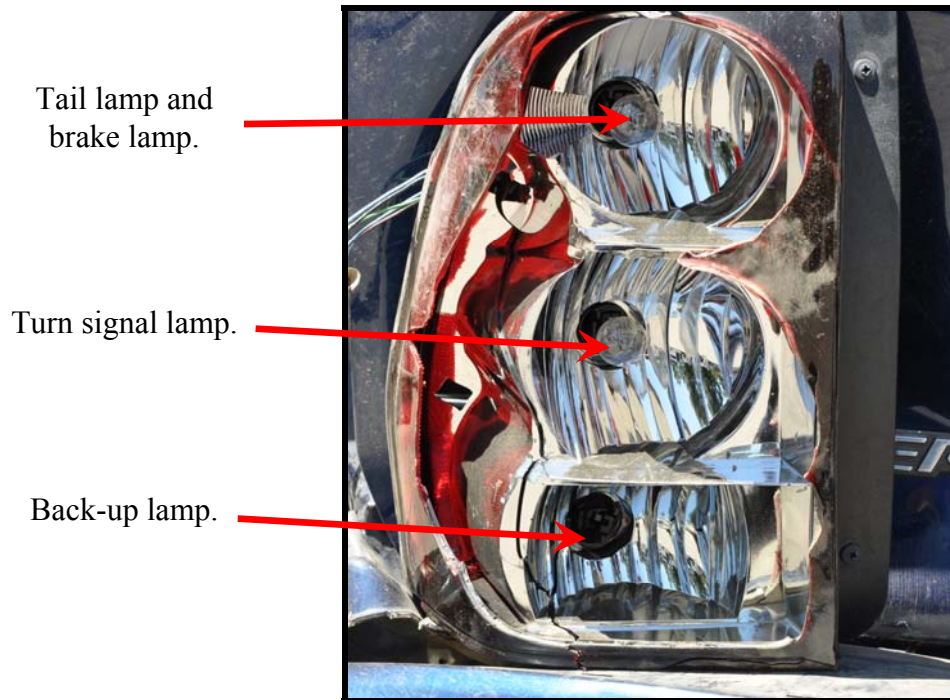
The left tail lamp assembly from Vehicle 1 (Chevrolet) was located attached to the left rear of the vehicle by the wiring harness. The tail lamp assembly contained three lamps. The uppermost lamp was for the tail lamp and brake lamp, the middle lamp was for the turn signal, and the lower lamp was for the back-up lamp. The lower lamp was detached from the vehicle and therefore was not examined.

Left tail lamp of Vehicle 1 (Chevrolet).
CF-023-10 08-02-10 DH (2) cropped

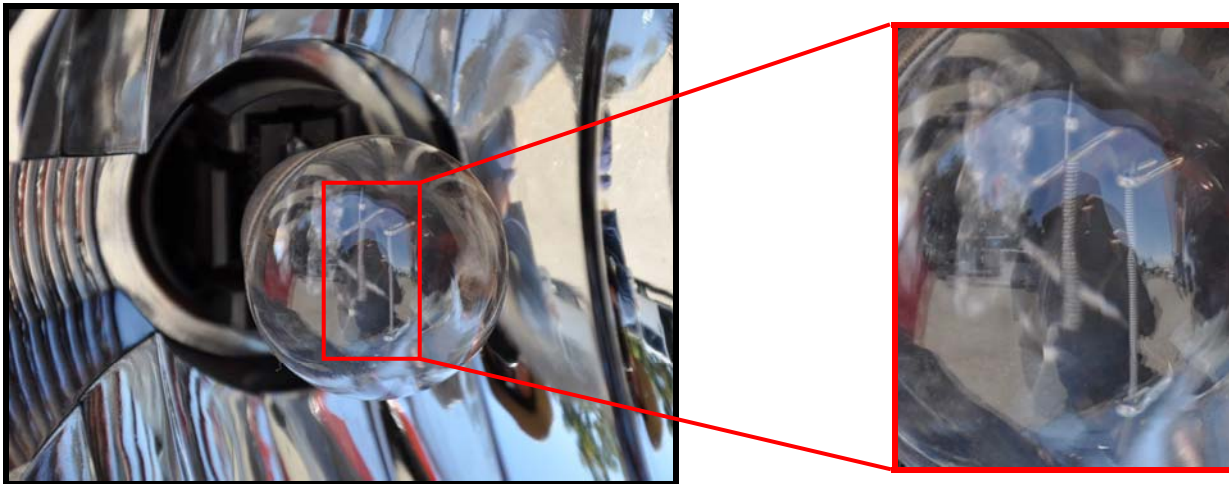
The glass envelope was intact. There was continuity in both filaments. Both filaments were bright, shiny and silver in luster, and the coils were even in spacing and pitch.

Left tail lamp and brake lamp from
Vehicle 1 (Chevrolet).
CF-023-10 08-02-10 DH (4) cropped

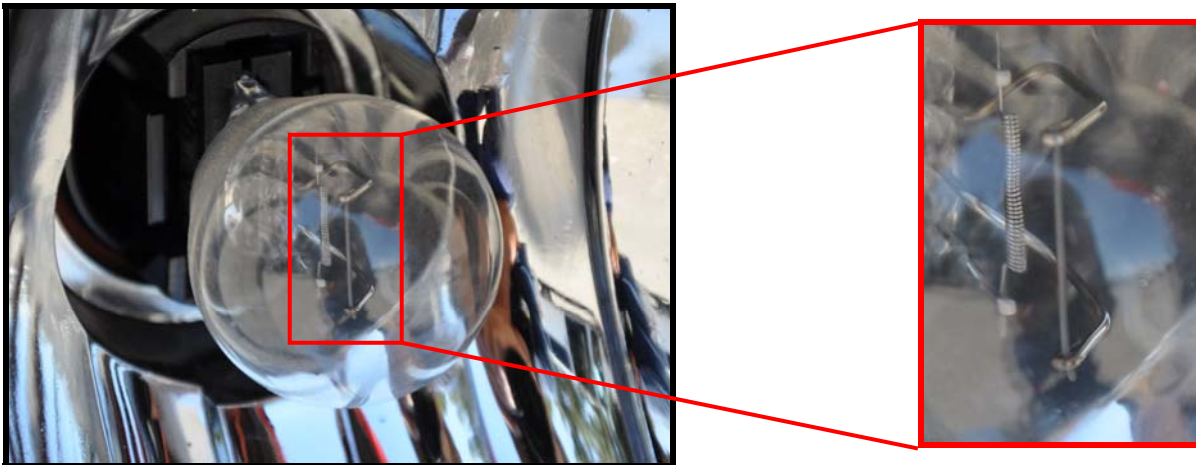
The glass envelope was intact. There was continuity in both filaments. Both filaments were bright, shiny and silver in luster, and the coils were even in spacing and pitch.

Left turn signal lamp from Vehicle 1 (Chevrolet).
CF-023-10 08-02-10 DH (6) cropped

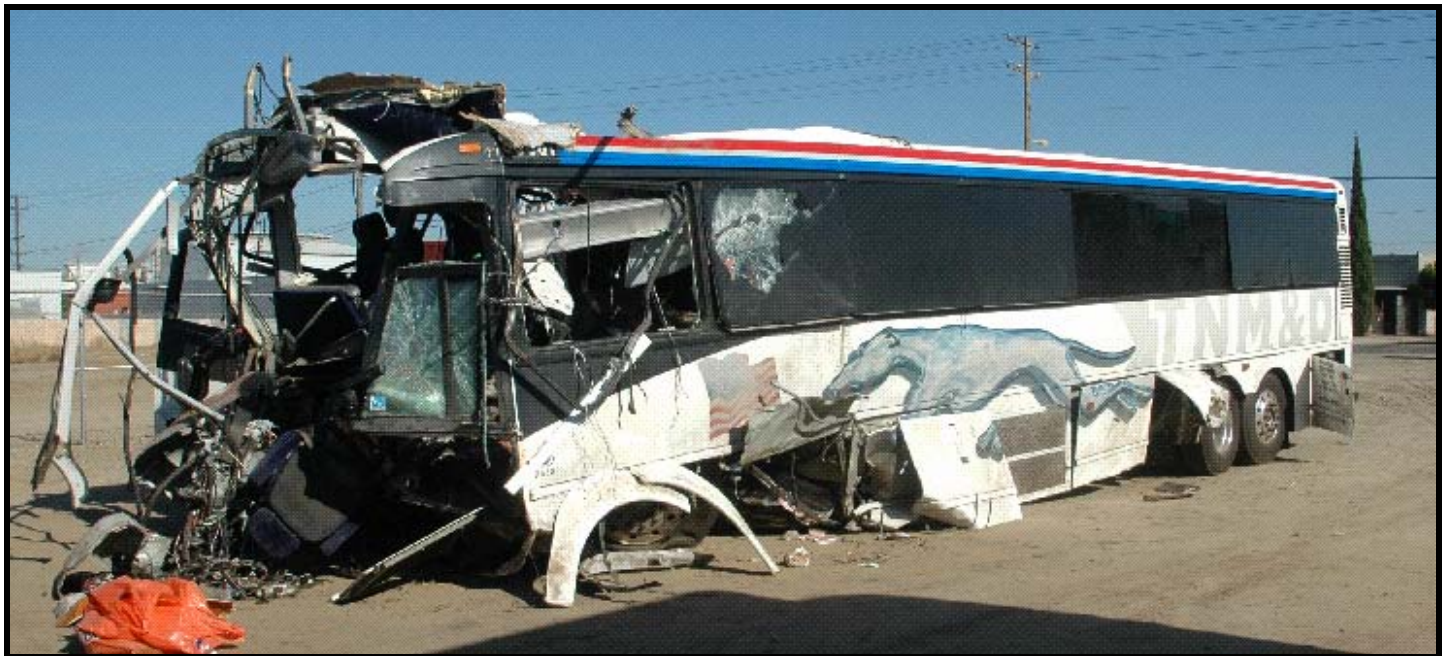
This vehicle sustained major front end damage. The principle direction of force was from front to rear and from right to left.

Vehicle 2 (MCI) at Action Towing and Dive Team, Incorporated's impound facility.
CF-023-10 07-27-10 SP (3) cropped

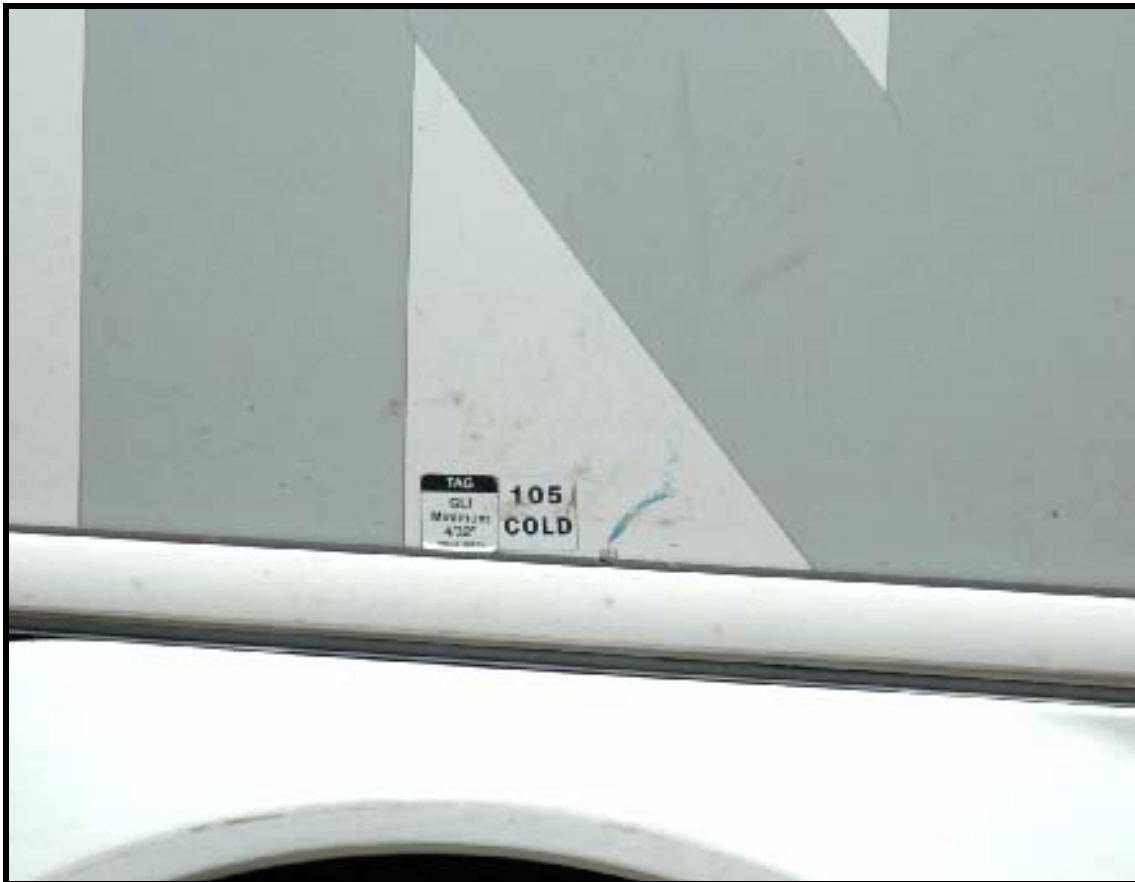
There was a blue paint transfer that was located on the vehicle side panel above axle 3. The remainder of the right side of Vehicle 2 (MCI) appeared unremarkable.

Blue transfer above axle 3.
CF-023-10 07-26-10 DN-B (14) cropped

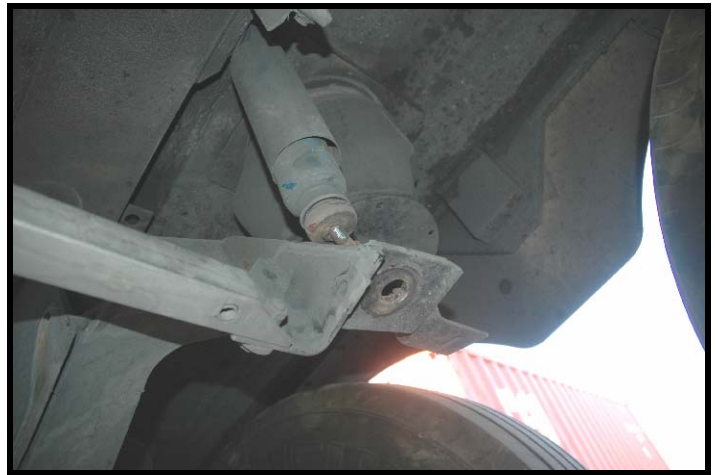
The frame to which the upper diagonally positioned radius rods were attached was displaced. As a result, axle 2 was displaced in a counterclockwise direction within the chassis. The drag link of axle 3 was bent rearward and upward near the tie rod end. There were several gouges perpendicular to the axis of the tie rod. The marks appeared to be fresh tool marks from J-hooks utilized by recovery crews moving Vehicle 2 (MCI) from the scene of the collision. This caused the alignment of axle 3 to be different than axle 2. This change in alignment appeared to have been caused by recovery efforts. The left rear shock absorber lower mount was pulled from its suspension mount. The shock absorber lower mount stud was bent.

Left rear shock absorber of Vehicle 2 (MCI).
CF-023-10 08-06-10 (MS) 40

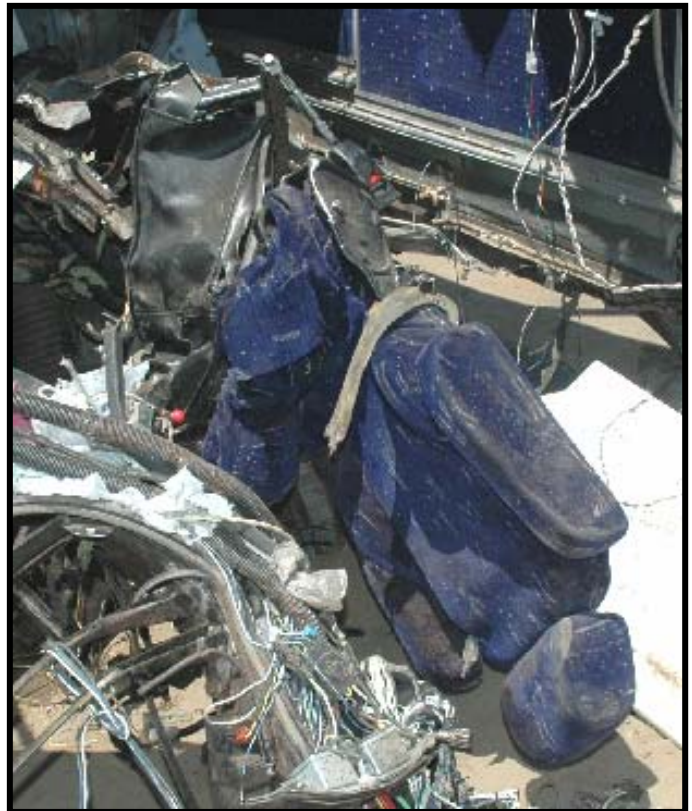
The driver's seat was located twisted to the right and was inverted, with the majority of the seat located outside of the vehicle. The seat base and the seat back remained attached; however the seat base was disfigured and was compressed rearward and upward. The armrests were in the upright position. The floor beneath the seat was shattered, and the seat was unsupported.

Driver's seat of Vehicle 2 (MCI).
CF-023-10 07-26-10 DN-A (2) cropped

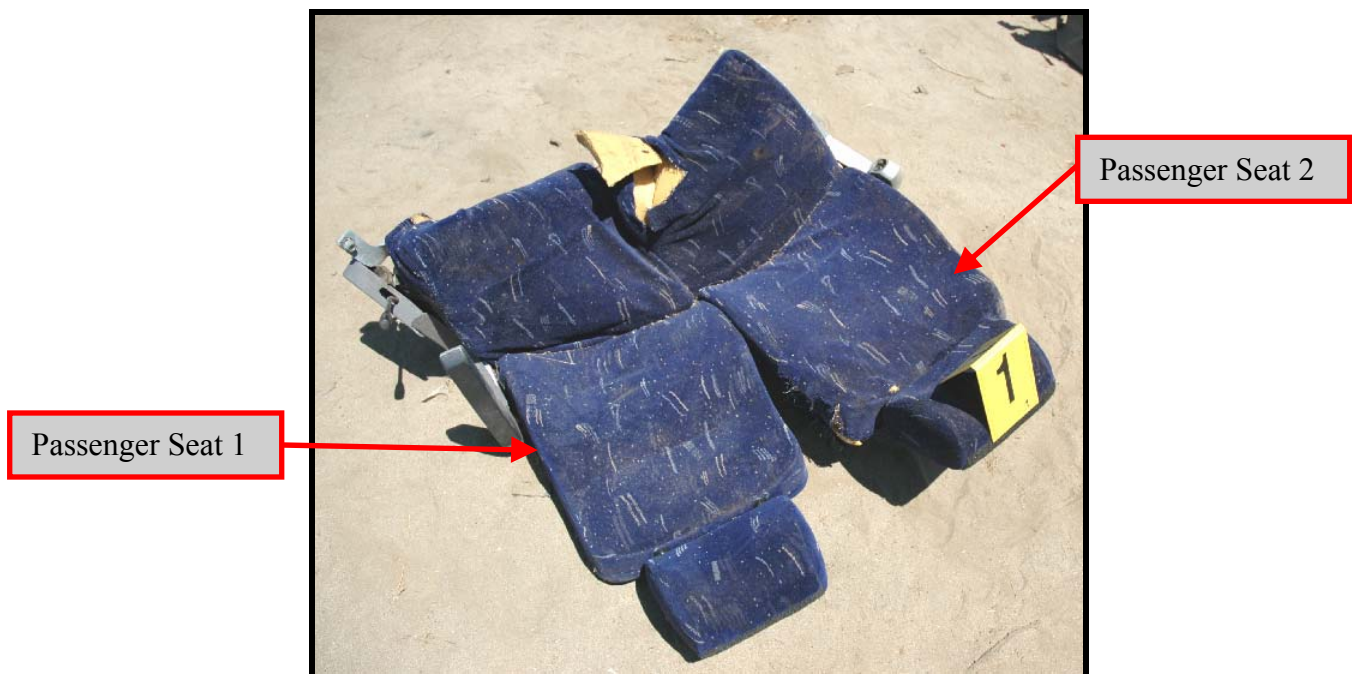
Passenger seats 1 and 2 were located at the scene of the collision (physical evidence item 78) outside of Vehicle 2 (MCI) upon the arrival of MAIT investigators. The entire seat base and the mounting frames were disfigured. The T-bolt mounting holes in the frames exhibited evidence of partial ejection from the vehicle during the collision. The bolt holes in the bottom of the pedestal were disfigured from being pulled from the bolts in the floor track. There was twisting of the seat base framework which resulted in associated disfigurement of the seat bases. There was a clean cut to the pedestal which was consistent with extrication tools used by rescue personnel. These seats remained attached to their pedestal. The outboard brackets to these seats were disfigured. The T-bolts and their associated flange nuts were attached to the seat brackets, except for the bolt to the rear bracket of the seat pair, which was missing. The leading lateral frame rail was pushed downward and rearward at its midpoint. The seat base cover for passenger seat 2 was torn and the underlying foam was partially pulled out. The leading sections of both seat bases were compressed rearward, with the seat base for passenger seat 1 pushed downward. The cover of the upper left side of the seat back of passenger seat 2 was torn. The adjustable arm rest adjacent to passenger seat 2 was missing. The headrests for both seats were positioned downward and appeared relatively undamaged.

Passenger seats 1 and 2.
CF-023-10 07-26-10 DN-A (98) cropped

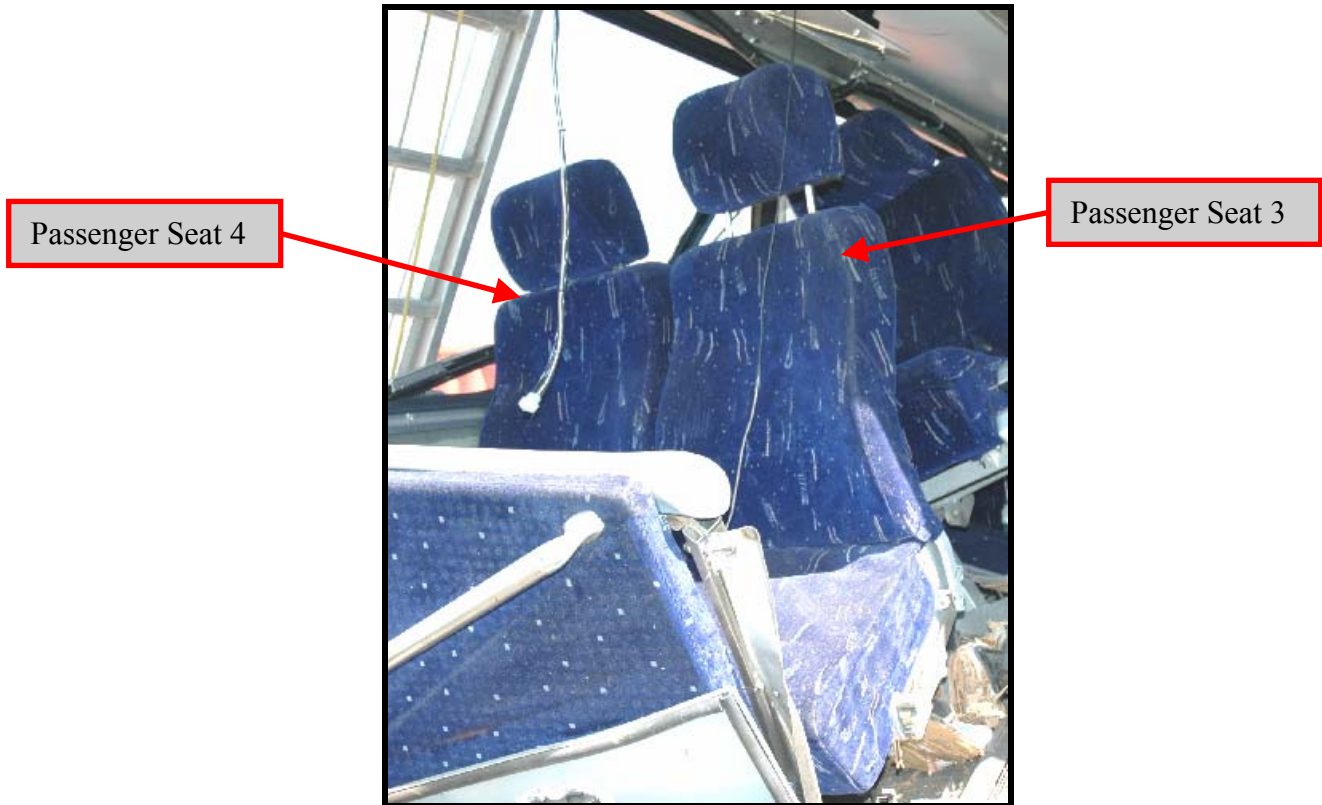
Passenger seats 3 and 4 were securely mounted to the floor of Vehicle 2 (MCI), however as a result of upward floor displacement the seats were tilted forward, with the seat bases tilted downward. The adjustable armrest for passenger seat 3 was missing. The seat floor attachment frame displayed moderate disfigurement, with associated deformation of the seat bases noted. The rear pedestal T-bolt was missing due to floor displacement. The front pedestal T-bolt remained in place and was securely mounted to the floor of the vehicle. Both seat backs were in the upright position. There was a dent in the rear of the seat back of seat 3. The headrest for passenger seat 3 was in the up position, while the headrest for passenger seat 4 was in the down position. The overhead structures were displaced downward toward the seats. The passenger service module was suspended by its electrical wiring and was lying in seat 3.

Passenger seats 3 and 4.
CF-023-10 07-26-10 DN-A (3) cropped

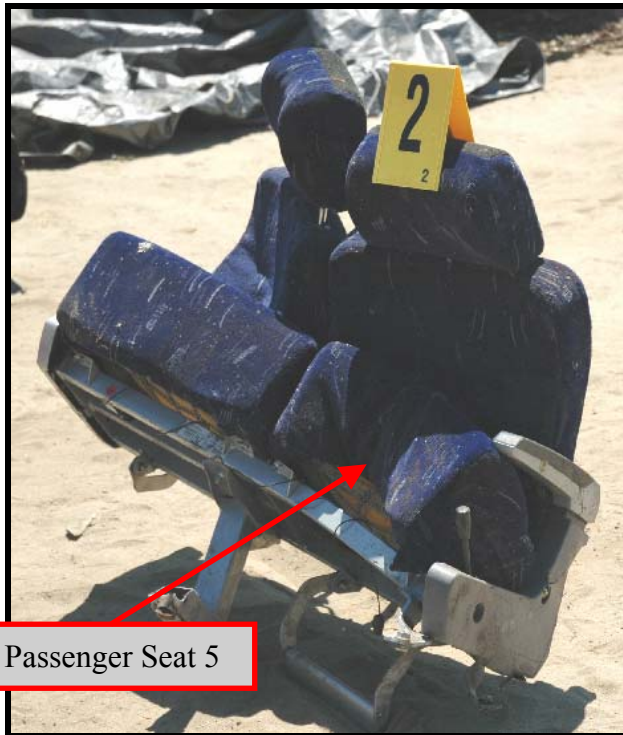
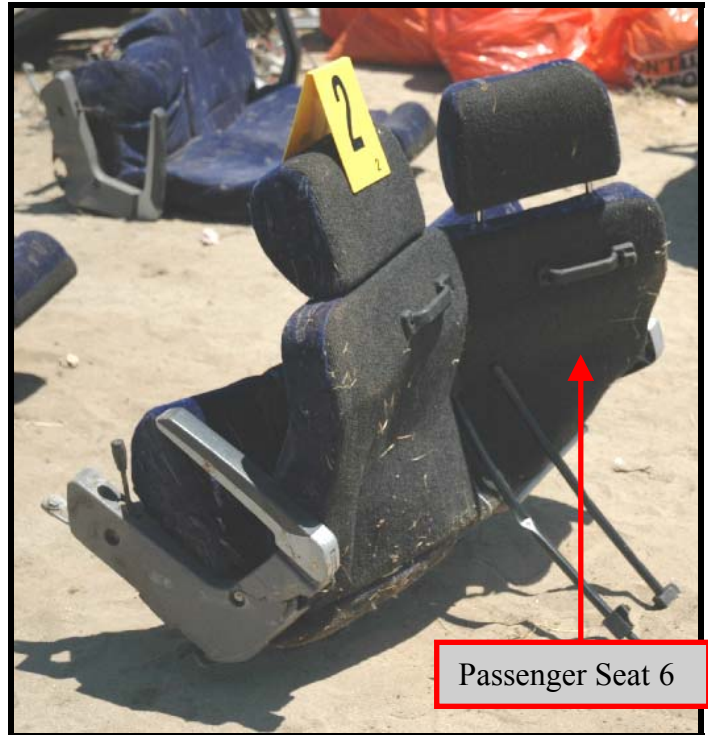
Passenger seats 5 and 6 were located at the scene (physical evidence item 77) outside of Vehicle 2 (MCI) upon the arrival of MAIT investigators. The pedestal was attached to the seat frame but was bent toward the left. The T-bolt mounting holes in the frame exhibited evidence of being ejected from the vehicle at the time of the collision. The framework for the seats was displaced to the left. The leading edge of the seats were displaced rearward, with more significant displacement noted on passenger seat 5. Both seat backs were pushed forward, and were contacting the seat bases. Passenger seat 6 exhibited clockwise twisting of the seat back. The seat back for passenger seat 5 exhibited counterclockwise twisting. Both of the seat backs displayed indentations, or bending, at the rear facing midpoint of the seat backs. The headrest for passenger seat 5 was in the down position, while the headrest for passenger seat 6 was in the up position.

Passenger seats 5 and 6 (front view).
CF-023-10 07-26-10 DN-A (111) cropped

Passenger seats 5 and 6 (rear view).
CF-023-10 07-26-10 DN-A (115) cropped

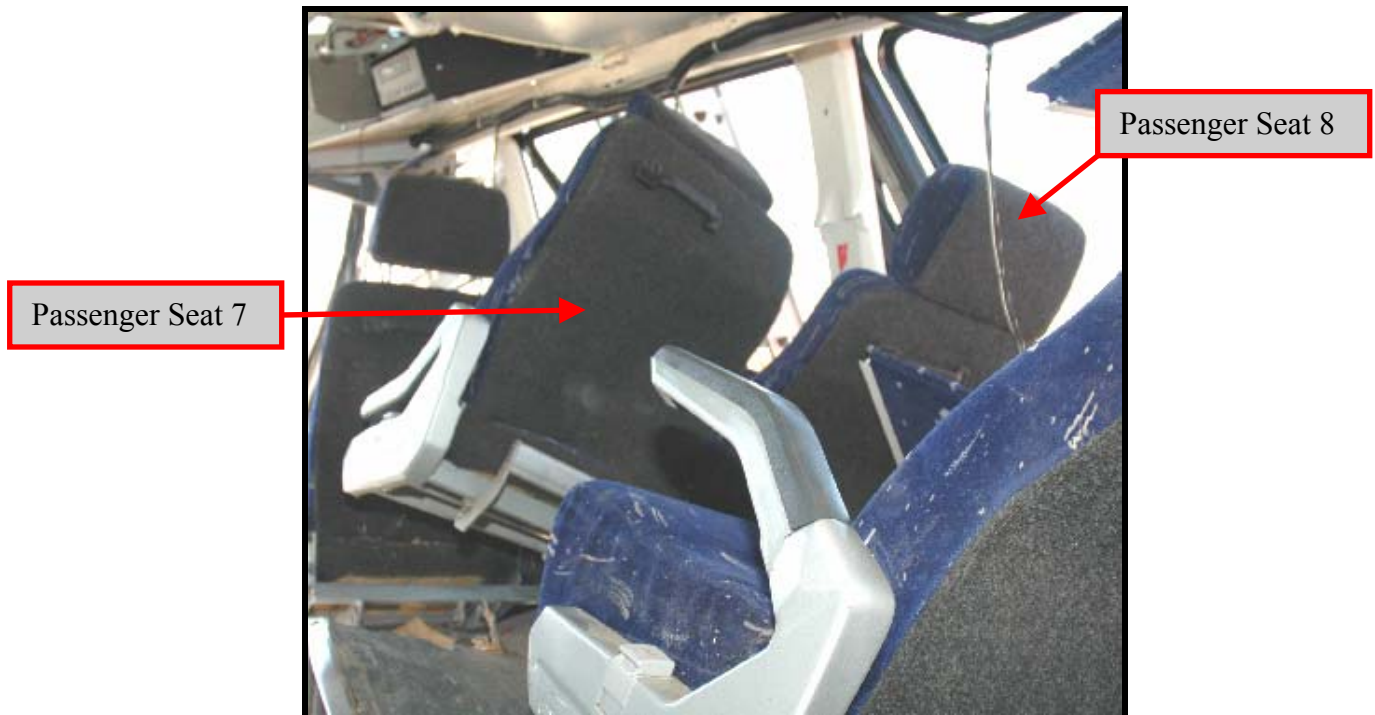
Passenger seats 7 and 8 were tilted upward and toward the right as a result of the upward displacement of the floor. The footrests in front of both seats were in the down position. The rear pedestal T-bolt was torn through the pedestal but remained in the track. The front T-bolt was pulled from the floor track and was pulled partially through the pedestal. The seat backs for both seats were buckled. The seat back for passenger seat 7 was displaced forward and the headrest was rotated downward. The headrests for both seats were in the down position. The armrest adjacent to seat 7 was in the down position. The overhead parcel racks were displaced downward. The passenger service module was suspended by its electrical wiring and was lying in seat 8.

Passenger seats 7 and 8.
CF-023-10 07-26-10 DN-A (6) cropped

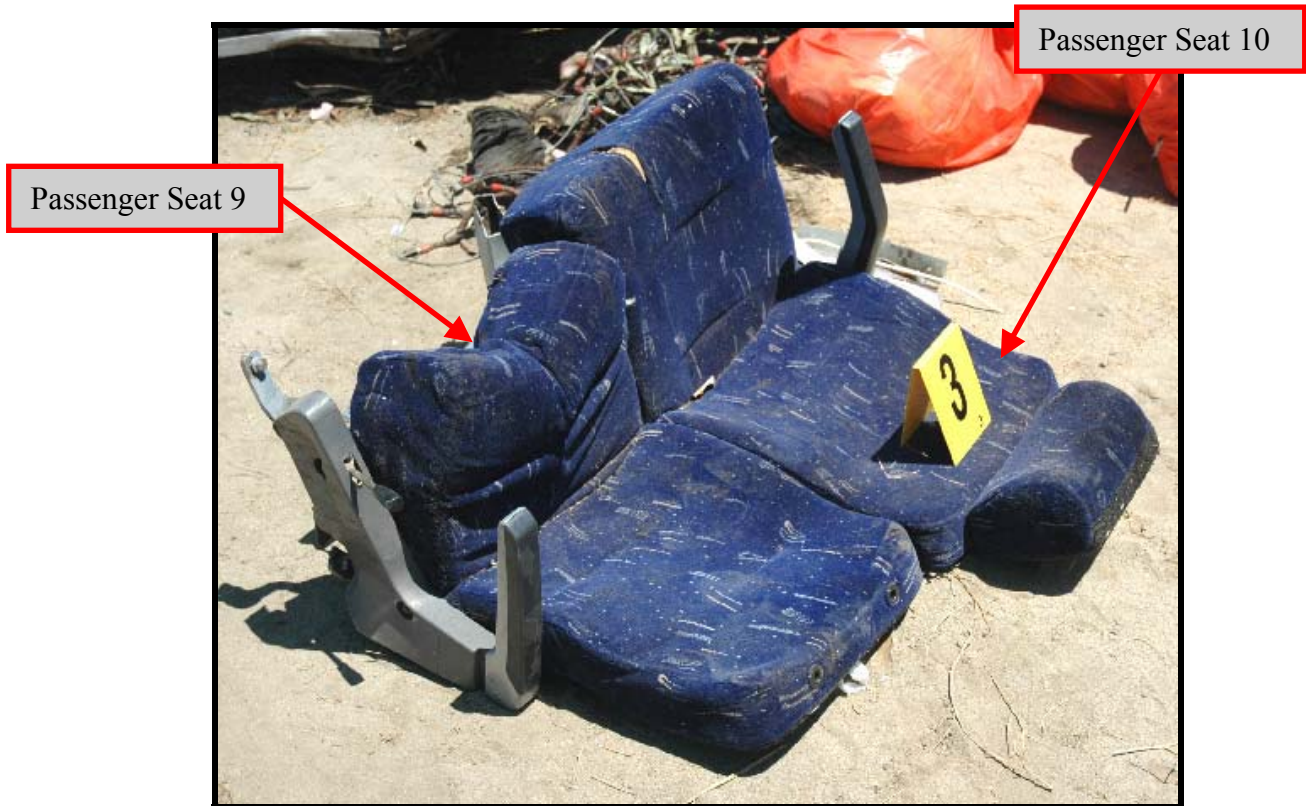
Passenger seats 9 and 10 were located at the scene of the collision (physical evidence 76) outside of Vehicle 2 (MCI) upon the arrival of MAIT investigators. The pedestal frame was attached to the seat frame but was bent toward the right. The T-bolt mounting holes in the frame exhibited evidence of being ejected from the vehicle at the time of the collision. The footrest located on the rear of seat 9 was pushed forward. The leading edge of the seat base of seat 9 was displaced rearward, with folding and creasing of the seat cushion. The seat base cover for seat 10 was torn vertically and the underlying foam padding was exposed. Both seat backs were in the rearward position. Both of the seat backs displayed indentations, or bending, at the rear facing midpoint of the seat backs. The headrest for passenger seat 9 was missing, while the headrest for passenger seat 10 was in the down position. Both armrests were intact.

Passenger seats 9 and 10.
CF-023-10 07-26-10 DN-A (122) cropped

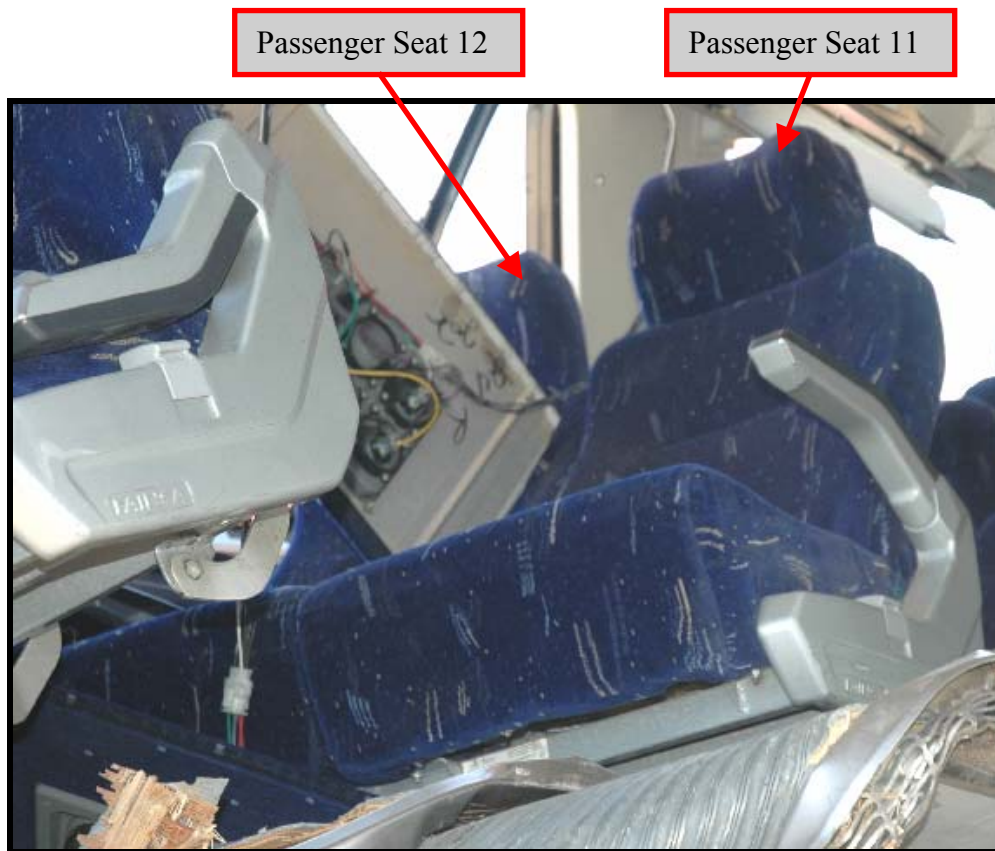
Passenger seats 11 and 12 were securely mounted to the floor of Vehicle 2 (MCI), however as a result of upward floor displacement, the seats were tilted upward and toward the right. The footrest in front of seat 11 was in the up position, while the footrest in front of seat 12 was in the down position. The seat back of seat 12 was buckled and was rotated counterclockwise. The armrests for both seats were intact and appeared undamaged. The overhead structures were displaced downward and the passenger service module was suspended by its electrical wiring and was lying in seat 11.

Passenger seats 11 and 12.
CF-023-10 07-26-10 DN-A (5) cropped

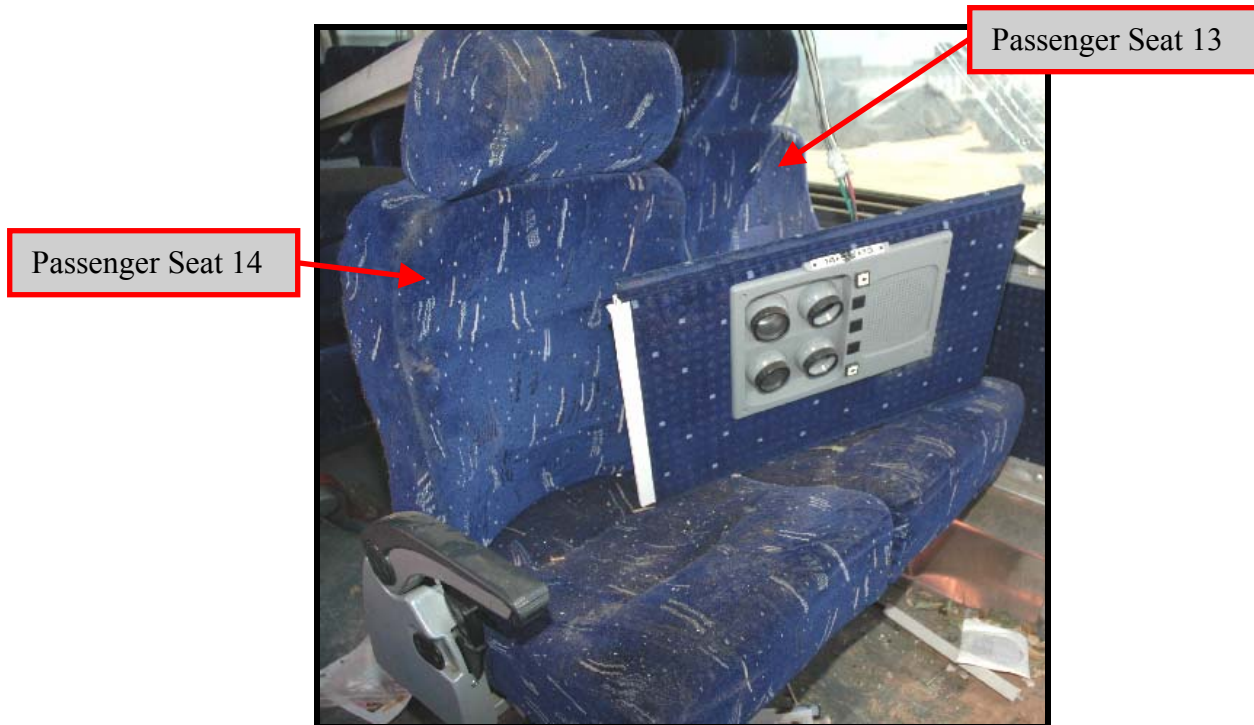
The floor in front of seats 13 and 14 was pushed upward. The seat bases appeared undamaged, and the seats were securely fastened to the floor of the vehicle with two floor mounted pedestals. The pedestals were equipped with quick release latches to the floor tracks that were utilized for wheelchair accessibility. The rear of each seat pedestal frame was outfitted with a red colored release lever. Lifting of the release levers released tension between the seat pedestals and the floor rails allowing the seats to be moved forward and rearward along the rails.

The seat back for seat 14 was twisted in a clockwise direction. At the rear pedestal attachment, there was a washer between the seat frame and the pedestal. The bolt was installed with the bolt head below the top of the pedestal with the washer against the bolt head. The headrests for both seats were in the lowered position and the armrests appeared undamaged. The passenger service module was suspended by its electrical wiring and was lying across both seats.

Passenger seats 13 and 14.
CF-023-10 07-26-10 DN-A (9) cropped

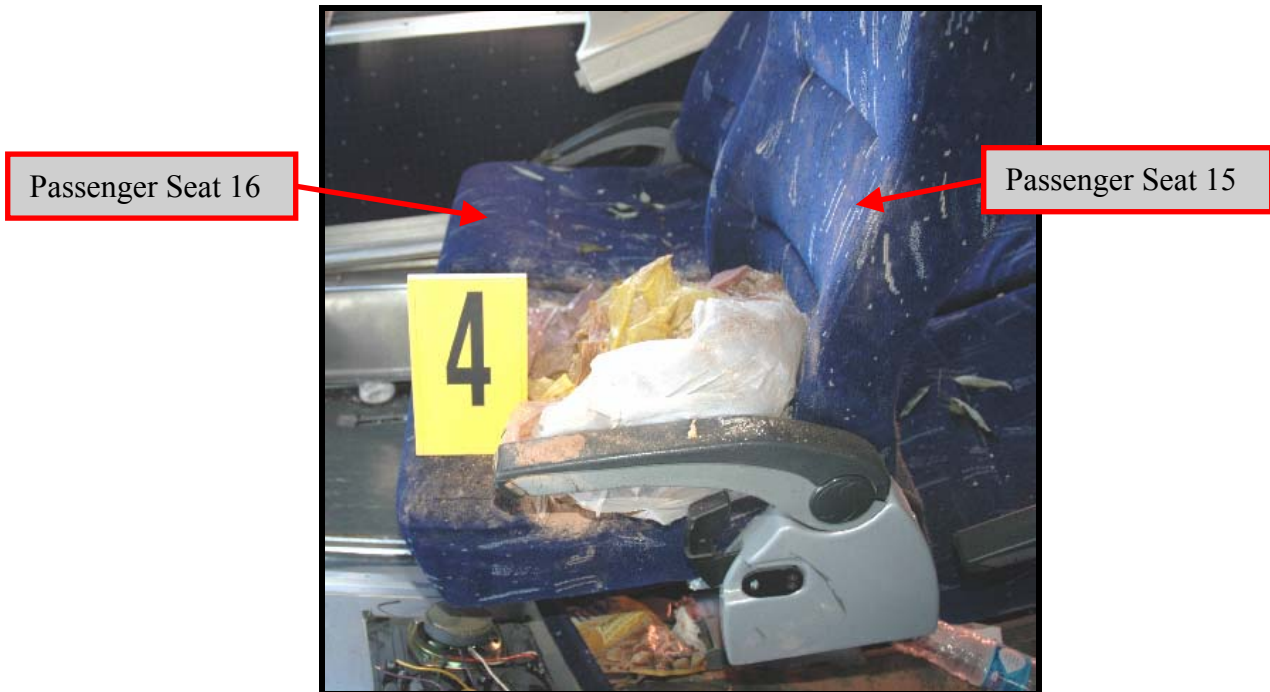
The floor in front of seats 15 and 16 was displaced upward. Seat 15 was displaced forward and was rotated counterclockwise slightly. Seats 15 and 16 were attached to Vehicle 2 (MCI) with two floor mounted pedestals. All of the pedestal bolts were pulled through their associated frames. The pedestals were equipped with quick release latches to the floor tracks that were utilized for wheelchair accessibility. The rear of each seat pedestal frame was outfitted with a red colored release lever. Lifting of the release levers released tension between the seat pedestals and the floor rails, allowing the seats to be moved forward and rearward along the rails.

The seat back for seat 15 was twisted in a counterclockwise direction. The headrests for both seats were in the lowered positions and the left armrest was undamaged. The armrest for seat 16 was in the down position. Both footrests in front of the seats were in the down position. The passenger service module was separated from the underside of the overhead parcel rack and was lying on the floor in front of seat 15.

Passenger seats 15 and 16.
CF-023-10 07-26-10 DN-A (33) cropped

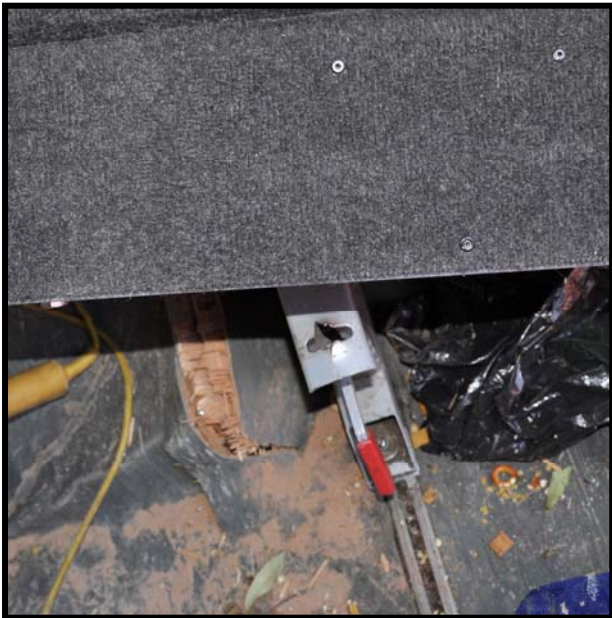
The rear bolt on the inboard pedestal was not installed according to plans specified by the manufacturer. The bolt was installed from the bottom without a washer. The bolt head was pulled through the pedestal. There was a washer on the nut end of the fastener, which was located above the seat frame. The front bolt was installed properly, but it was also pulled through the pedestal.

The inboard pedestal of seat 15 and 16.
CF-023-10 07-30-10 DH-A (43) cropped

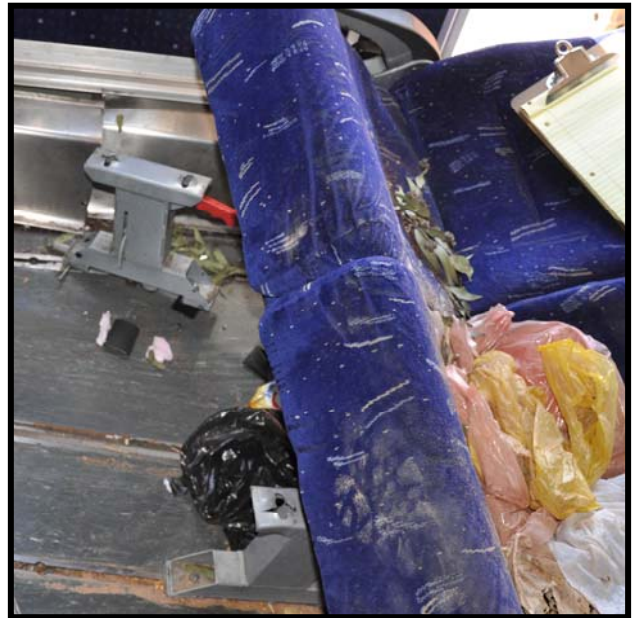
The rear bolt on the outboard pedestal was not installed according to plans specified by the manufacturer. The rear bolt head on the outboard pedestal was installed from the bottom without a washer. This bolt head was pulled through the pedestal. There was a washer on the nut end of the fastener, which was located above the seat frame. The front bolt was installed in the proper direction, although the nut had two washers. The top washer was thinner than the standard washer and was not deformed. The bottom standard washer was deformed around the nut, which had pulled through the slot in the pedestal. The rear T-bolt was broken.

The outboard pedestal of seat 15 and 16.
CF-023-10 07-30-10 DH-A (34) cropped

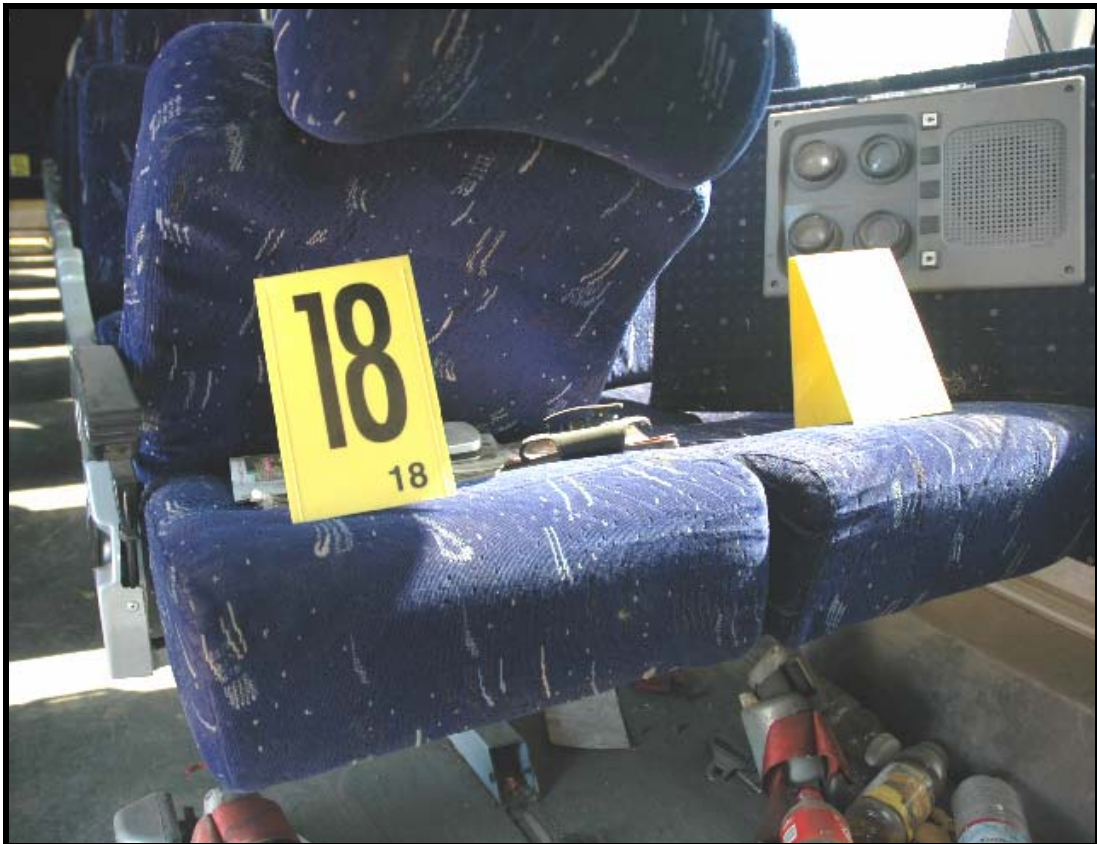
The seat pedestal was securely fastened to the floor rail. The seat back of seat 18 was pushed forward and exhibited minor clockwise rotation. The seat back of seat 17 was in the upright position. The seat bases appeared undamaged. The seat headrests were in place and in the lowered position. There were no footrests in front of seats 17 or 18. The armrests were in place and appeared undamaged. The passenger service module was separated from the overhead parcel rack and was found in seat 17. The wheelchair restraint was located on the floor. There was a shoulder restraint mounted to the E-pillar adjacent to seat 17. The restraint was intact and undamaged.

Passenger seats 17 and 18.
CF-023-10 08-06-10 JK-A (59) cropped
