MULTIDISCIPLINARY ACCIDENT INVESTIGATION TEAM NARRATIVE/DIAGRAM

DATE OF COLLISION (MONTH-DAY-YEAR)	TIME (2400)	NCIC	OFFICER I.D.	NUMBER	MAIT CASE NUMBER	PAGE
07-22-2010	0214	9435	15751	2010-07-0219	CF-023-10	i

Central Division

CF-023-10

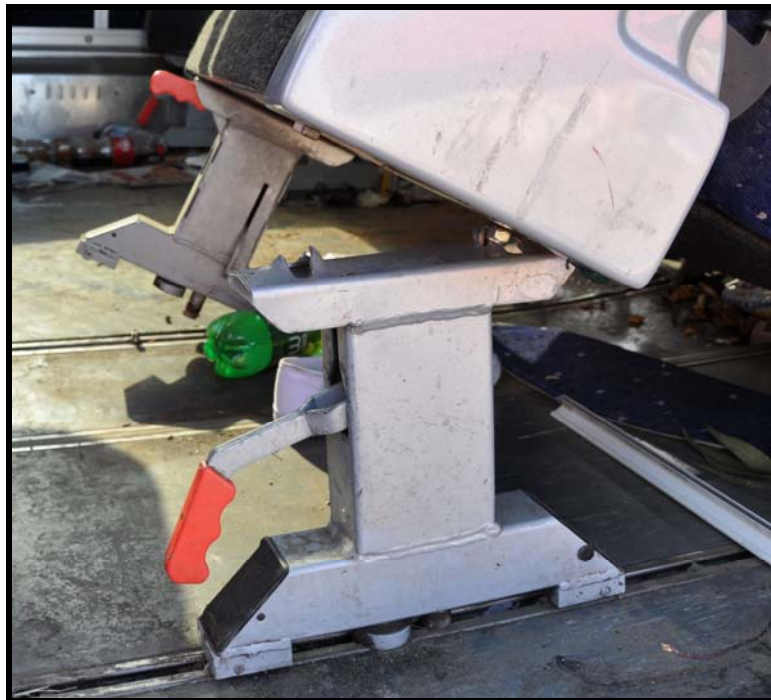
The seat headrests were in place and in the lowered position. There were no footrests in front of seats 19 and 20. The armrests were in place and appeared undamaged. The outboard pedestal was securely mounted to the floor of the vehicle. The top of the outboard pedestal was separated from the underside of seat 20, allowing seats 19 and 20 to be rotated upward and forward. Seat 20 was in the reclined position, while seat 19 was in the upright position.

Seat separation from the pedestal.
CF-023-10 07-29-10 DH-A (14)

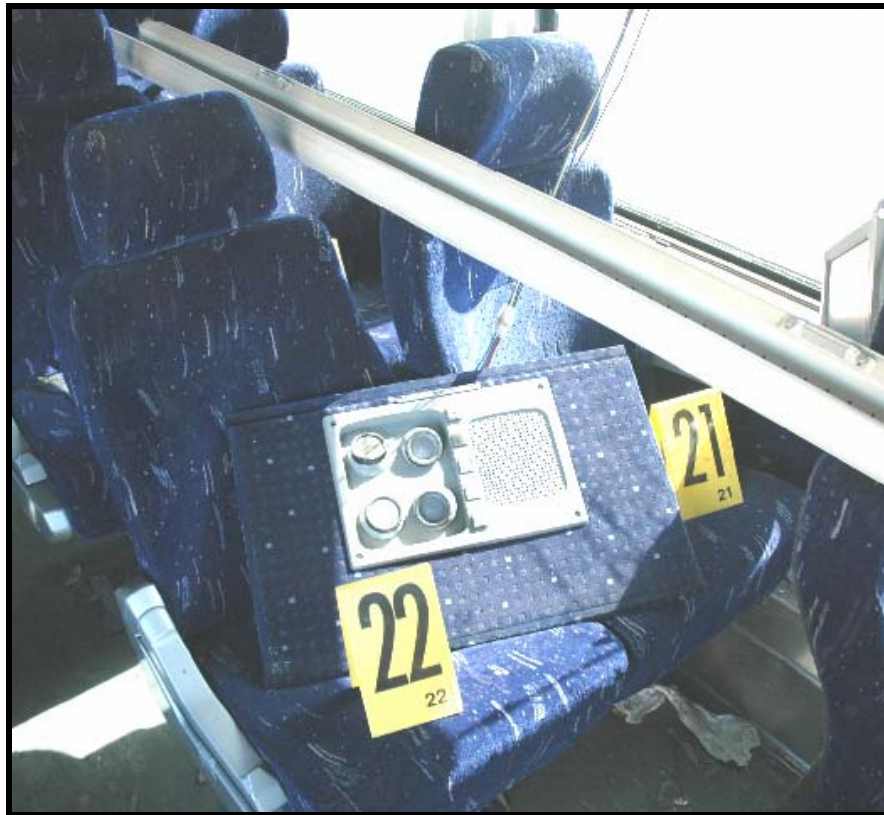
Passenger seats 21 and 22 were securely fastened to the floor rail of Vehicle 2 (MCI). The seat back for seat 21 was undamaged and was displaced slightly forward with a minor counterclockwise rotation. The seat back for seat 22 was undamaged and was reclined. The armrest for seat 22 was in the down position and was undamaged. The armrest for seat 21 was undamaged. The footrest for each seat was in the down position. The headrests were undamaged and in the down position. A portion of the overhead console was resting between seats 21 and 22. The passenger service module was separated from the overhead parcel rack but was suspended by its electrical wiring. The module was lying across both seats.

Passenger seats 21 and 22.
CF-023-10 08-06-10 JK-A (61) cropped

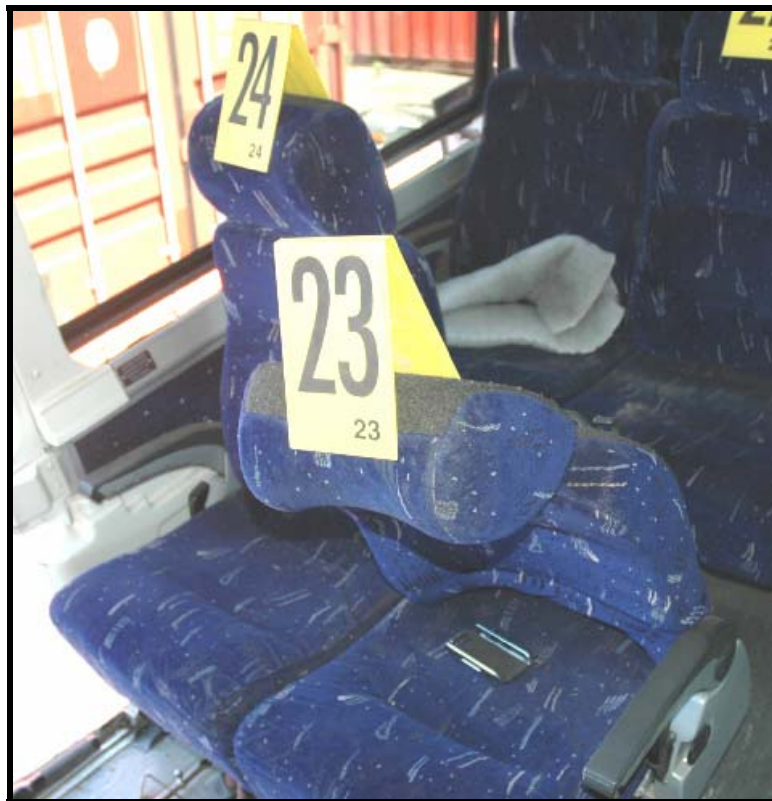
Passenger seats 23 and 24 were part of the wheelchair access seats. Both seats were securely fastened to Vehicle 2 (MCI). The seat back for seat 23 was displaced forward and was twisted in a counterclockwise direction. The seat back for Seat 24 was rotated in a clockwise direction and was located in an upright position. The armrests were undamaged. There were no footrests for these seating positions. The seats in these positions could be folded up for wheelchair access; however both seats were in the down position. There was a shoulder restraint retractor mounted to the E-pillar adjacent to seat 24 for wheelchair bound occupants. The retractor was undamaged and the webbing was completely contained within the retractor. The headrest for seat 23 was displaced forward and was turned slightly in a counterclockwise direction. The headrest for seat 24 was undamaged and in the down position. The wheelchair restraint was lying on the floor below seat 23 and appeared undamaged.

Passenger seats 23 and 24.
CF-023-10 08-06-10 JK-A (95) cropped

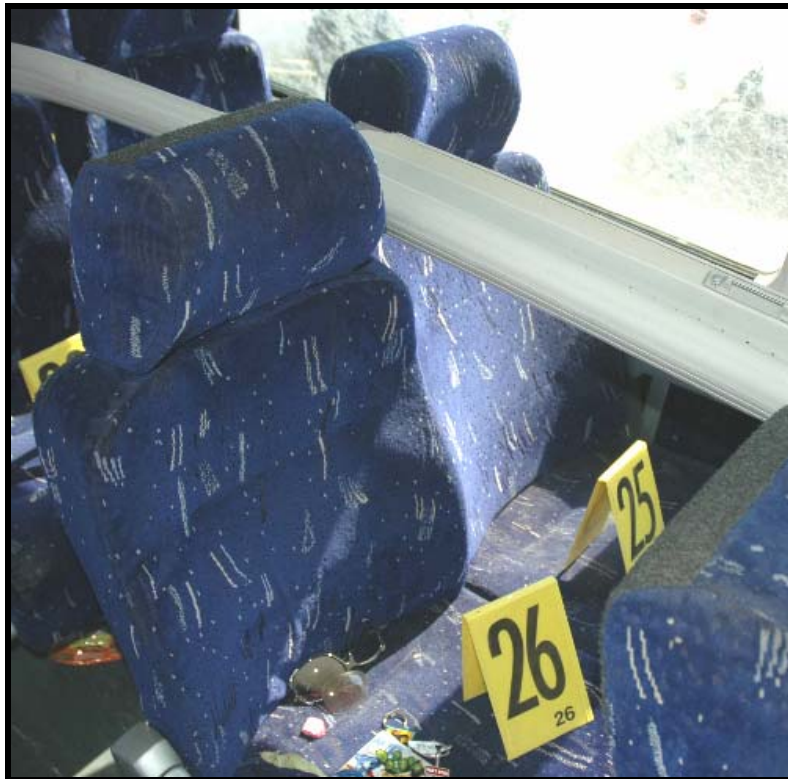
Passenger seats 25 and 26 were securely fastened to Vehicle 2 (MCI). The seat back for seat 26 was displaced forward and was twisted in a clockwise direction. Seat 25 was undamaged, but was slightly reclined. The armrests for the seats were undamaged, and the armrest for seat 26 was in the down position. The footrest for each seat was in the down position. The headrests were undamaged and in the down position. A portion of the overhead console was resting between the seats.

Passenger seats 25 and 26.
CF-023-10 08-06-10 JK-A (63) cropped

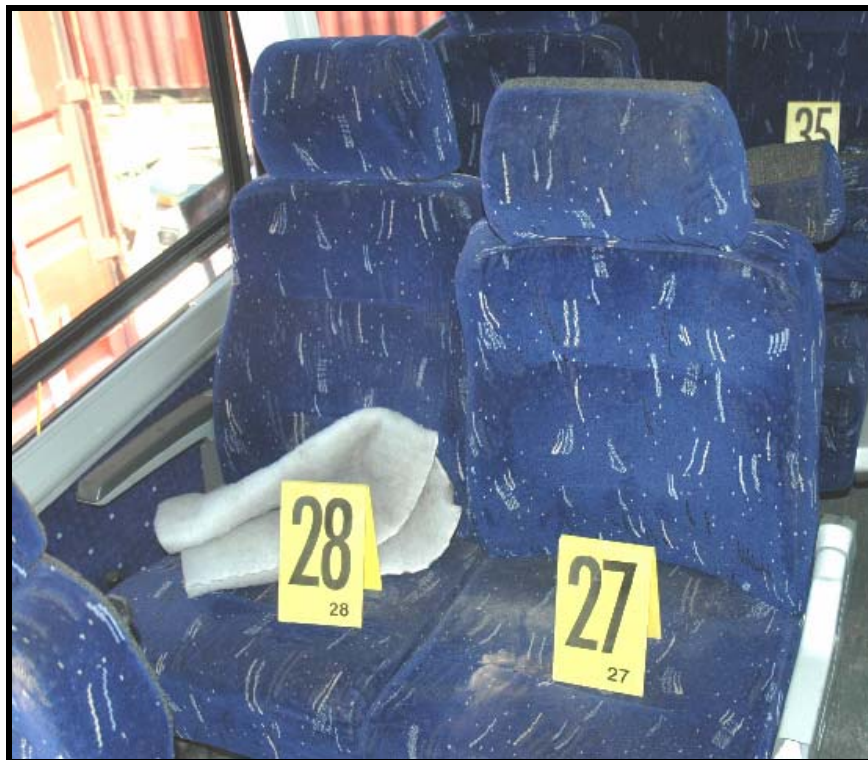
Passenger seats 27 and 28 were securely fastened to Vehicle 2 (MCI). The seat back for seat 27 was displaced forward. Seat 28 was undamaged. The armrests for the seats were undamaged and the armrest for seat 27 was in the down position. The footrest for each seat was in the down position. The headrests were undamaged and in the down position.

Passenger seats 27 and 28.
CF-023-10 08-06-10 JK-A (27) cropped

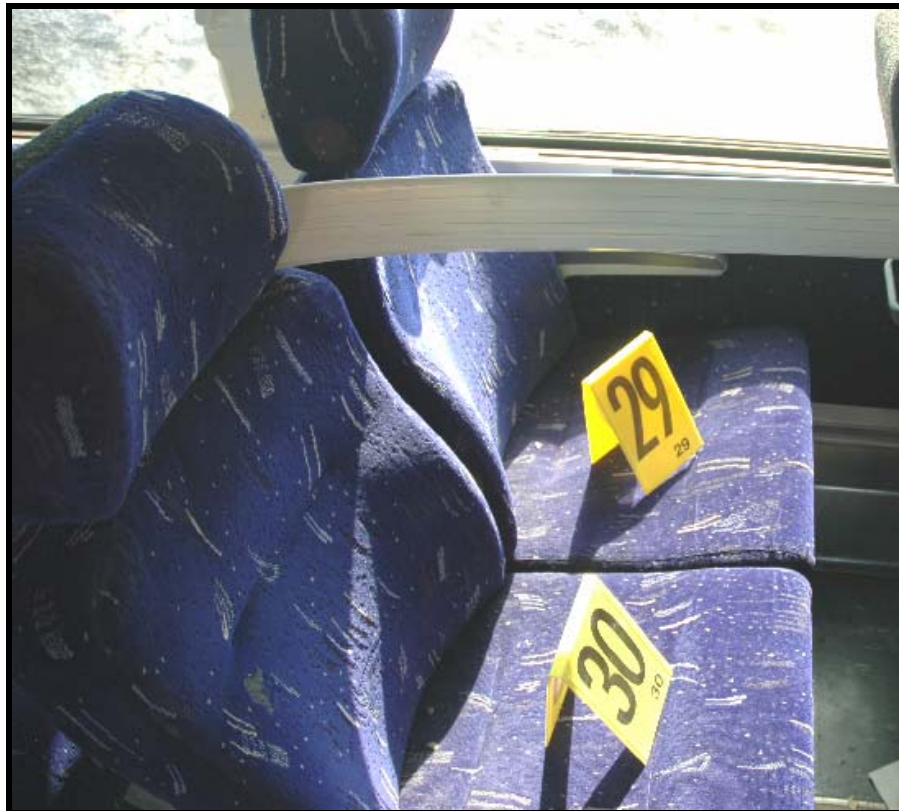
Passenger seats 29 and 30 were securely fastened to Vehicle 2 (MCI). Both seats were undamaged. The seat back for seat 29 was in the upright position, while the seat back for seat 30 was slightly reclined. The armrests for both seats were intact and undamaged. The footrest for each seat was in the down position. The headrests were undamaged and in the down position. A portion of the overhead console was resting between the seats.

Passenger seats 29 and 30.
CF-023-10 08-06-10 JK-A (31) cropped

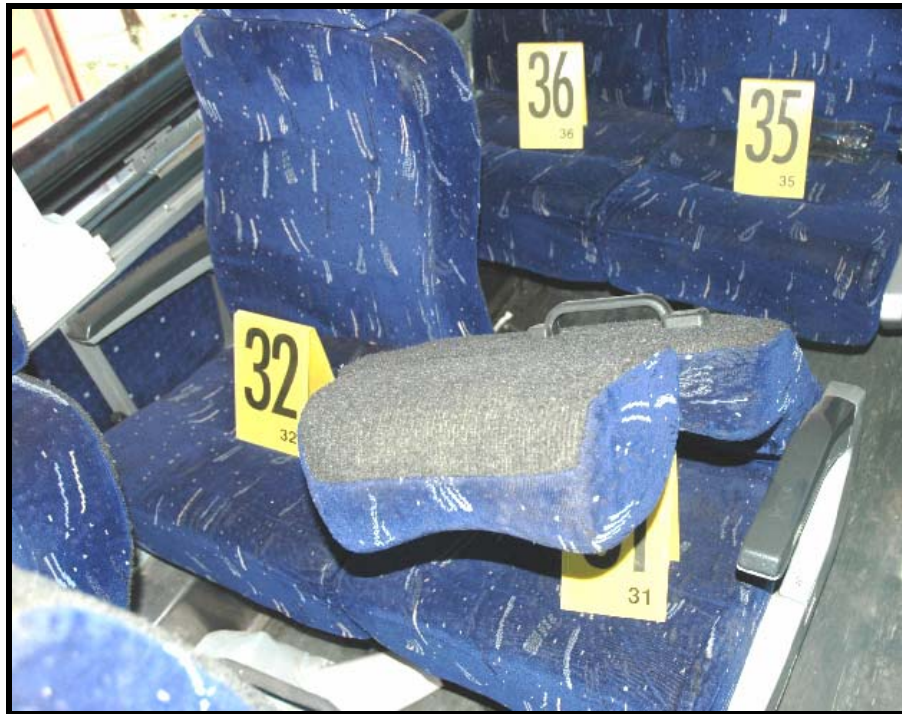
Passenger seats 31 and 32 were securely fastened to Vehicle 2 (MCI). The seat back for seat 31 was displaced forward and was rotated in a counterclockwise direction. The seat back for seat 32 exhibited minor forward displacement and was slightly rotated in a clockwise direction. The armrests for both seats were intact and undamaged. The footrest for each seat was in the down position. The headrests were undamaged and in the down position.

Passenger seats 31 and 32.
CF-023-10 08-06-10 JK-A (30) cropped

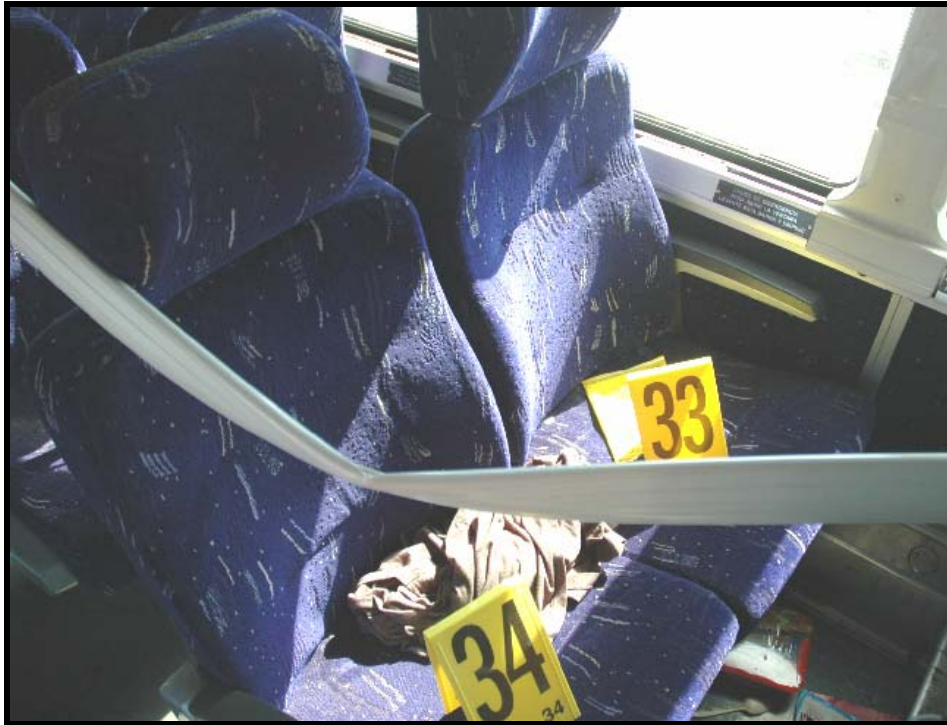
Passenger seats 33 and 34 were securely fastened to Vehicle 2 (MCI). The seat backs were in the upright position and were undamaged. The armrest for seat 34 was displaced to the left. The armrest for seat 33 was intact and undamaged. The footrest for seat 33 was halfway down, while the footrest for seat 34 was in the down position. The headrests were undamaged and in the down position. A section of the overhead parcel rack was detached and was hanging down over seat 34.

Passenger seats 33 and 34.
CF-023-10 08-06-10 JK-A (35) cropped

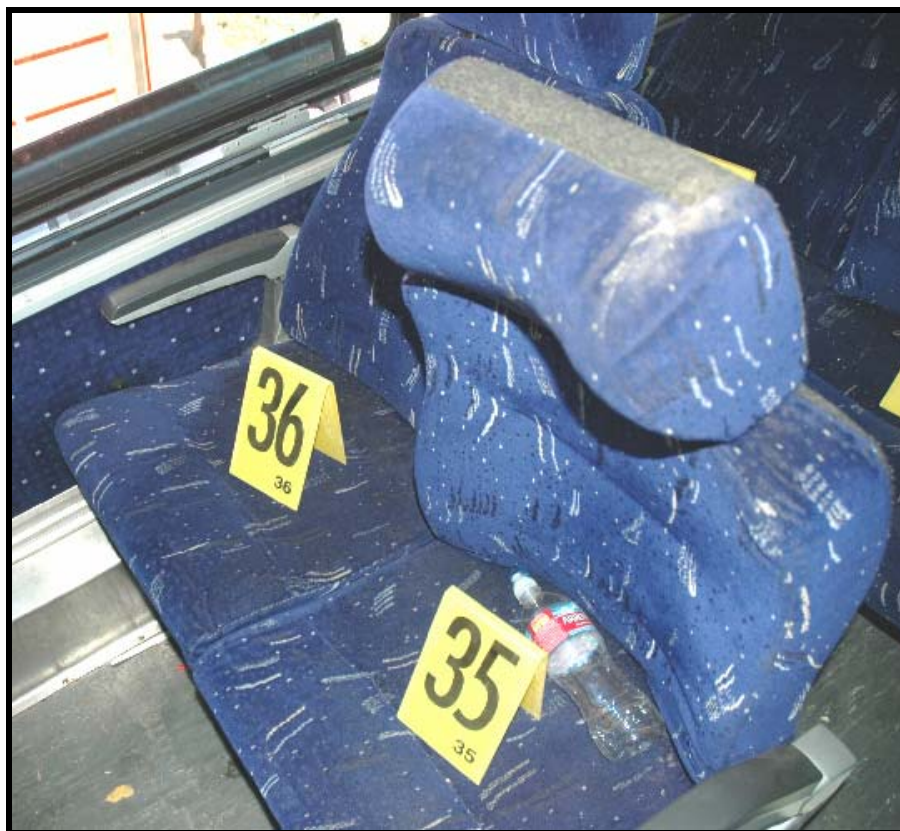
Passenger seats 35 and 36 were securely fastened to Vehicle 2 (MCI). The seat back for seat 35 was displaced forward and was rotated counterclockwise. The seat back for seat 36 was in the upright position. The armrests for seats 35 and 36 were undamaged. The footrest for each seat was in the down position. The headrests were undamaged and in the down position.

Passenger seats 35 and 36.
CF-023-10 08-06-10 JK-A (33) cropped

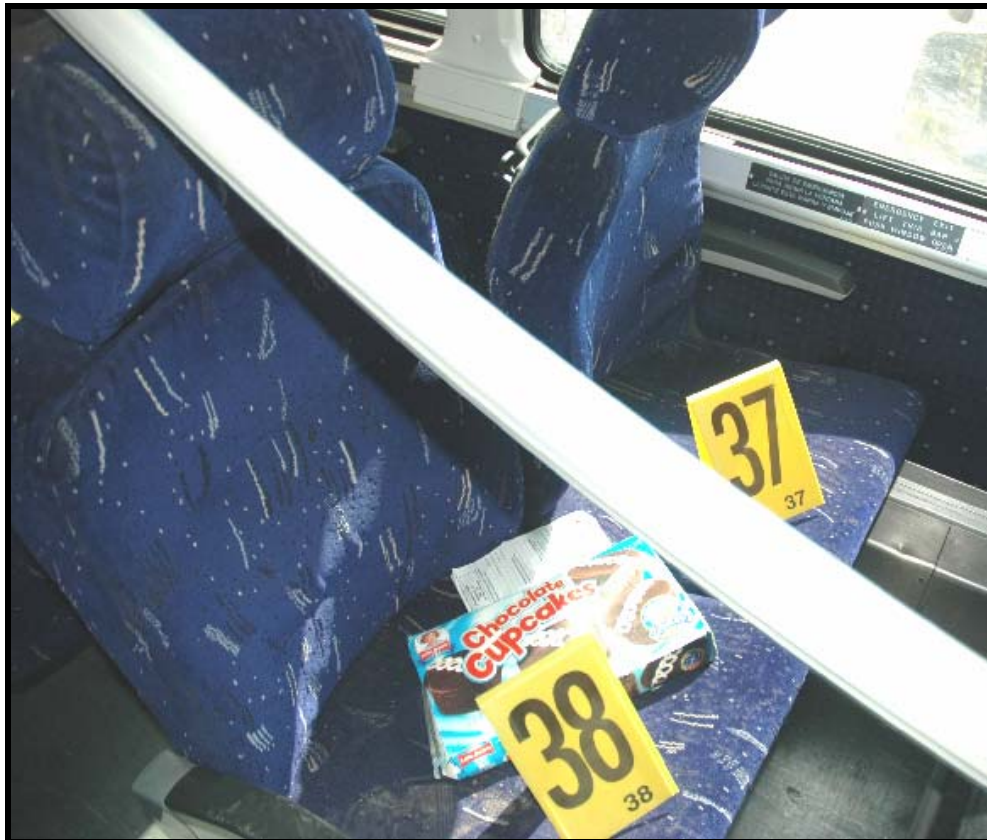
Passenger seats 37 and 38 were securely fastened to Vehicle 2 (MCI). The seat back for seat 37 was displaced forward and was rotated slightly counterclockwise. The seat back for seat 38 was in the upright position. The armrests for both seats were intact and undamaged. The footrest for each seat was in the down position. The headrests were undamaged and in the down position. A section of the overhead parcel rack was detached and hanging down over seat 38.

Passenger seats 37 and 38.
CF-023-10 08-06-10 JK-A (38) cropped

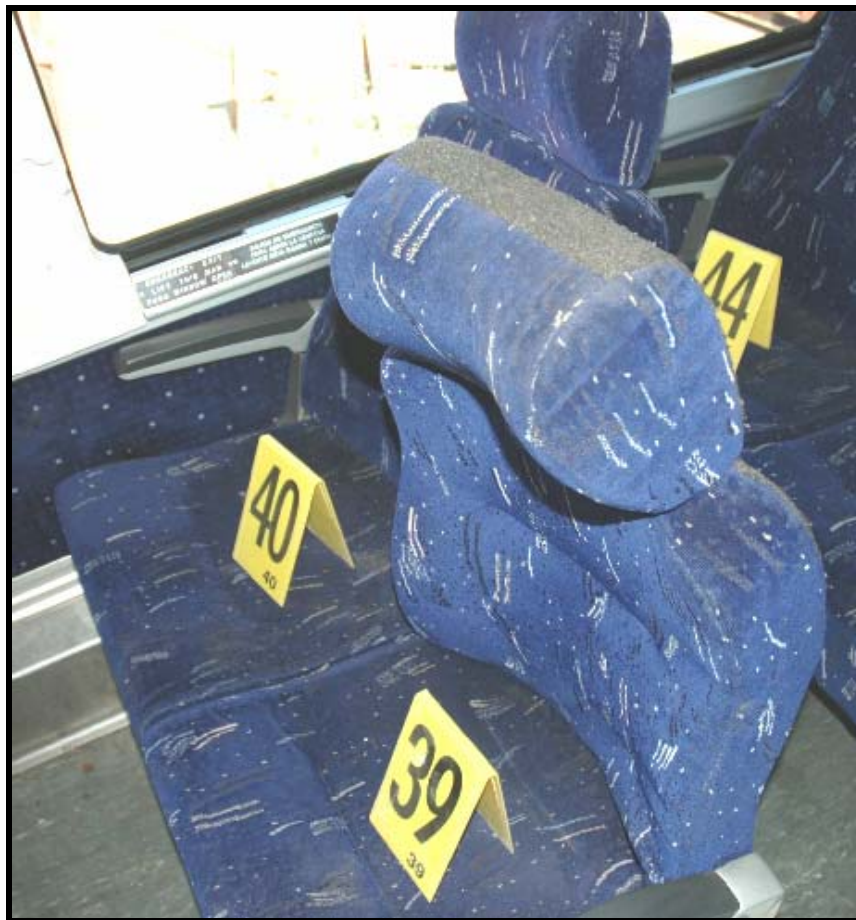
Passenger seats 39 and 40 were securely fastened to Vehicle 2 (MCI). The seat back for seat 39 was displaced forward and was rotated counterclockwise. The seat back for seat 40 was reclined and was undamaged. The armrests for both seats were intact and undamaged. The footrest for each seat was in the down position. The headrests were undamaged and in the down position.

Passenger seats 39 and 40.
CF-023-10 08-06-10 JK-A (37) cropped

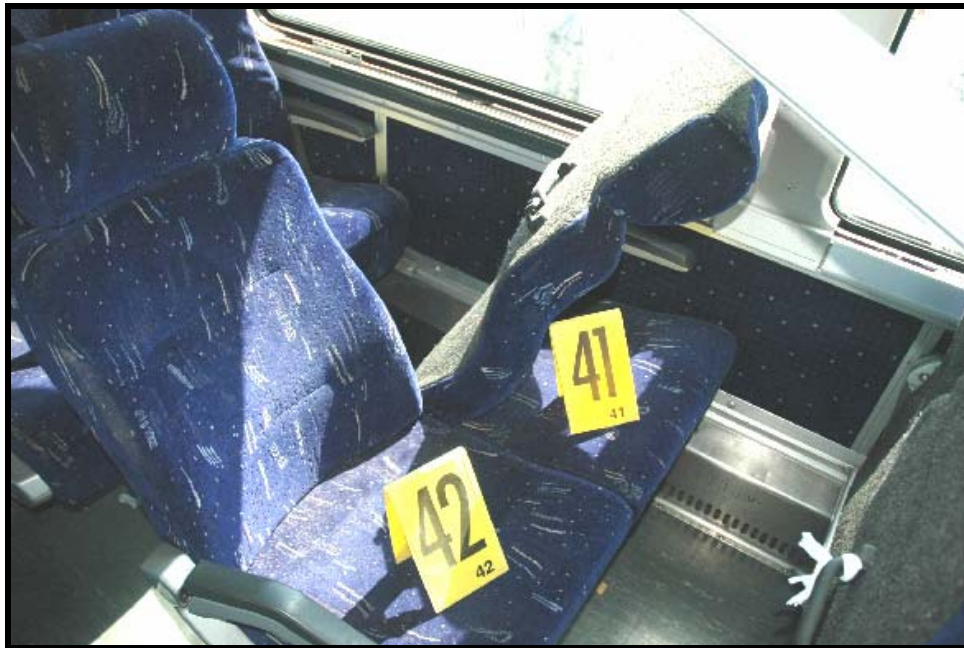
Passenger seats 41 and 42 were securely fastened to Vehicle 2 (MCI). The seat back for seat 41 was pushed forward and was rotated counterclockwise. The seat back for seat 42 displayed minor clockwise rotation and the armrest was pushed down and to the left. The armrest for seat 41 was intact and undamaged. The footrest for seat 41 was in the up position and the footrest for seat 42 was in the down position. The headrests were undamaged and in the down position.

Passenger seats 41 and 42.
CF-023-10 08-06-10 JK-A (42)

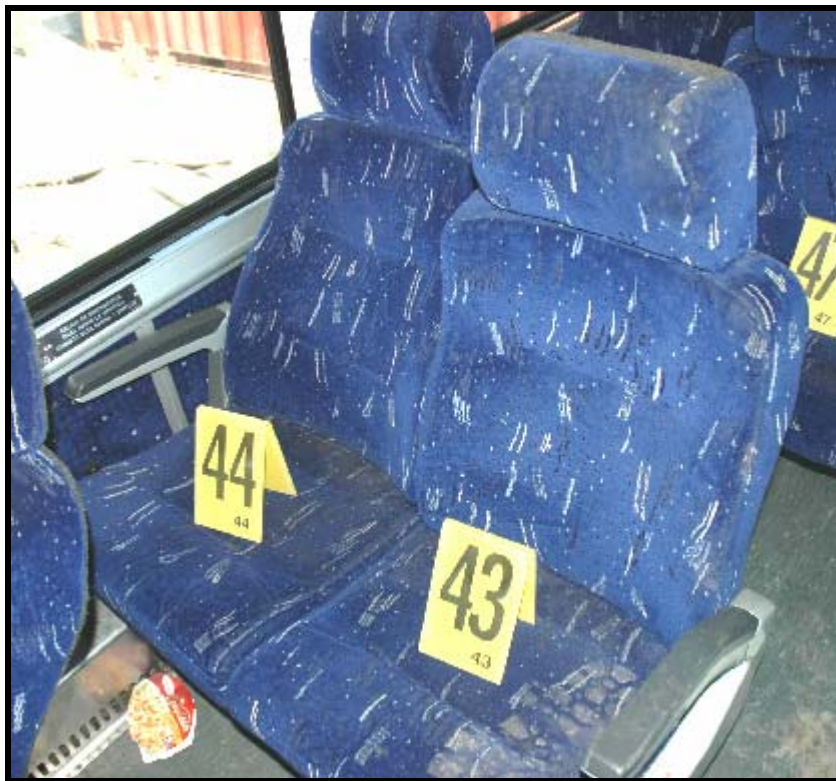
Passenger seats 43 and 44 were securely fastened to Vehicle 2 (MCI). The seat back for seat 44 was in the reclined position. The seat back for seat 43 was rotated in a counterclockwise direction. The armrests were intact and undamaged. The footrest for each seat was in the down position. The headrests were undamaged and in the down position.

Passenger seats 43 and 44.
CF-023-10 08-06-10 JK-A (72) cropped

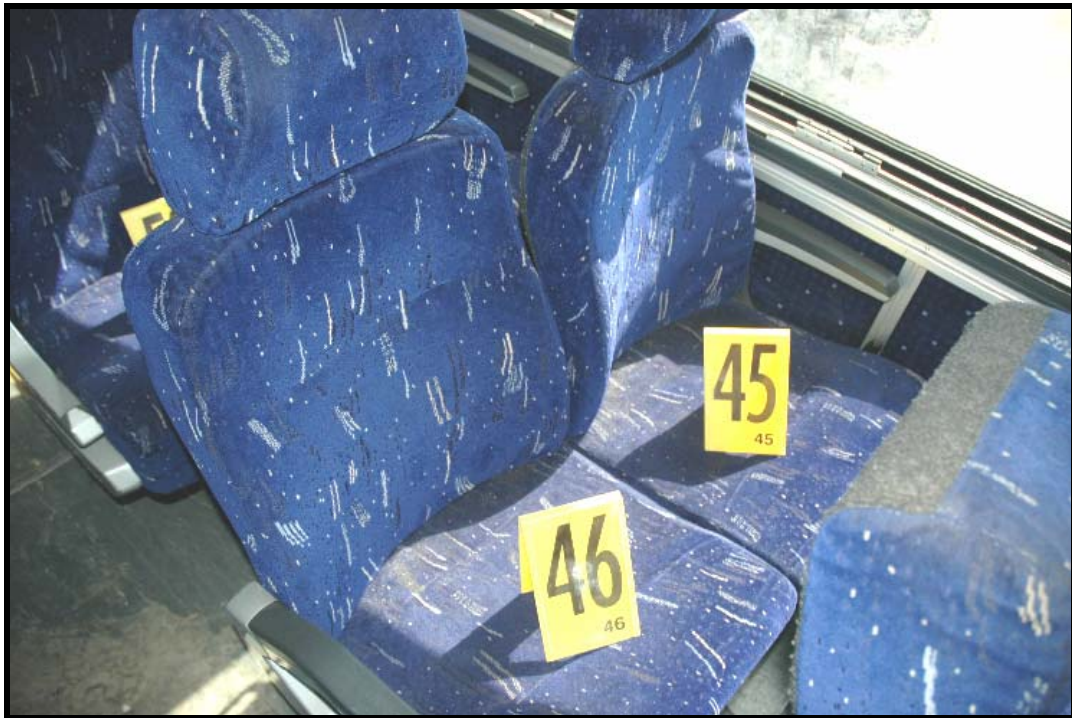
Passenger seats 45 and 46 were securely fastened to Vehicle 2 (MCI). The seat back for seat 45 was displaced forward and the headrest was turned slightly in a counterclockwise direction. The seat back for seat 46 was undamaged. The footrest for each seat was in the down position. The headrest for seat 46 was undamaged and both headrests were in the down position.

Passenger seats 45 and 46.
CF-023-10 08-06-10 JK-A (78)

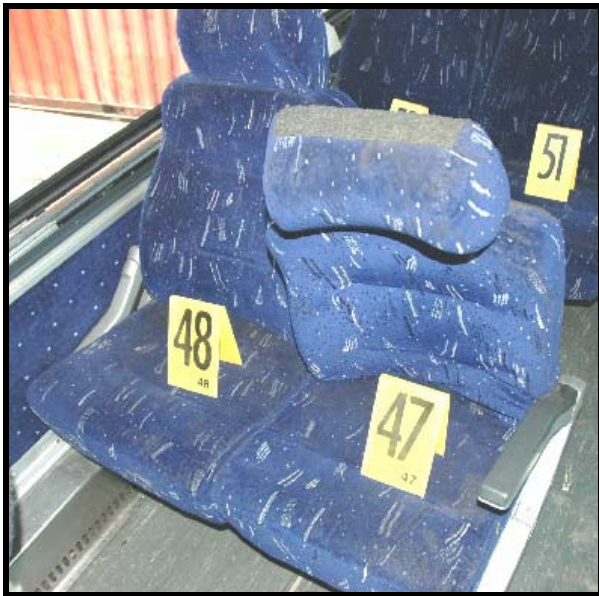
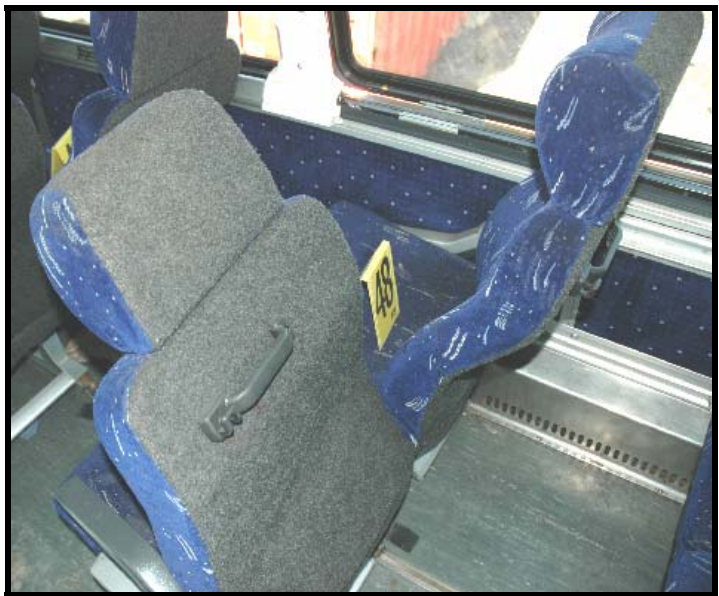
Passenger seats 47 and 48 were securely fastened to Vehicle 2 (MCI). The seat back for seat 47 was pushed forward and was rotated in a counterclockwise direction. The armrest for seat 47 was loose and displaced to the right. The armrest for seat 48 was in the down position. The seat back for seat 48 was in the upright position and undamaged. The footrest for each seat was in the down position. The headrests were undamaged and in the down position.

Passenger seats 47 and 48.
CF-023-10 08-06-10 JK-A (74) cropped

Passenger seats 47 and 48.
CF-023-10 08-06-10 JK-A (77) cropped

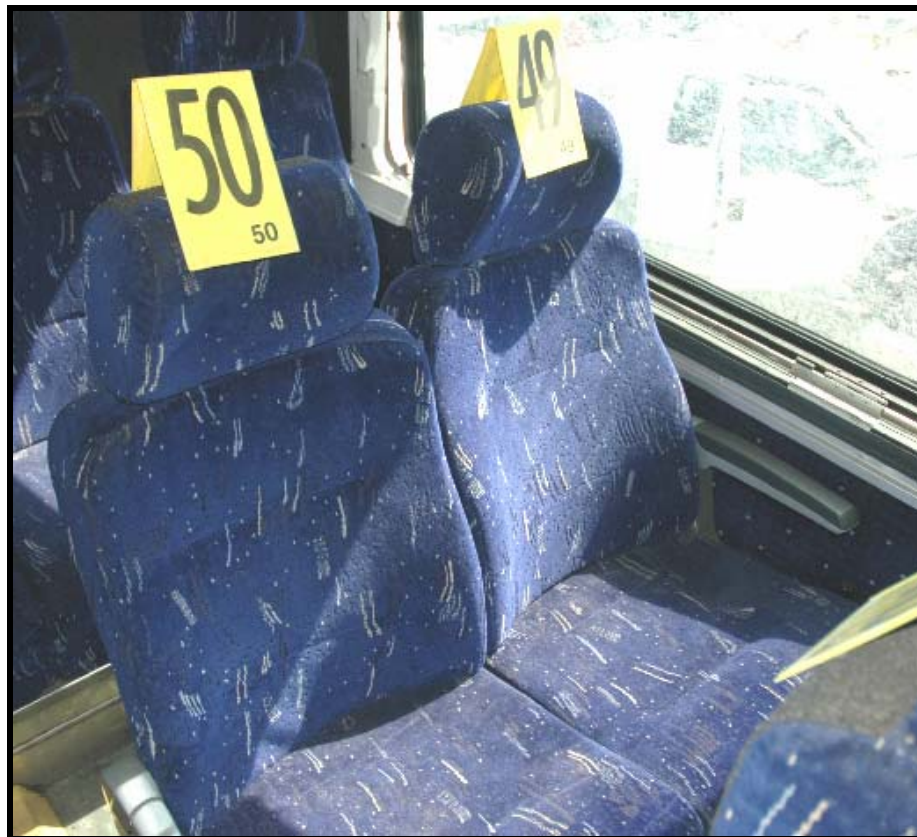
Passenger seats 49 and 50 were securely fastened to Vehicle 2 (MCI). The seat back for seat 50 was slightly displaced in a clockwise direction. The seat back for seat 49 was slightly reclined and undamaged. The armrests were intact and undamaged. The footrest for each seat was in the down position. The headrests were undamaged and in the down position.

Passenger seats 49 and 50.
CF-023-10 08-06-10 JK-A (114) cropped

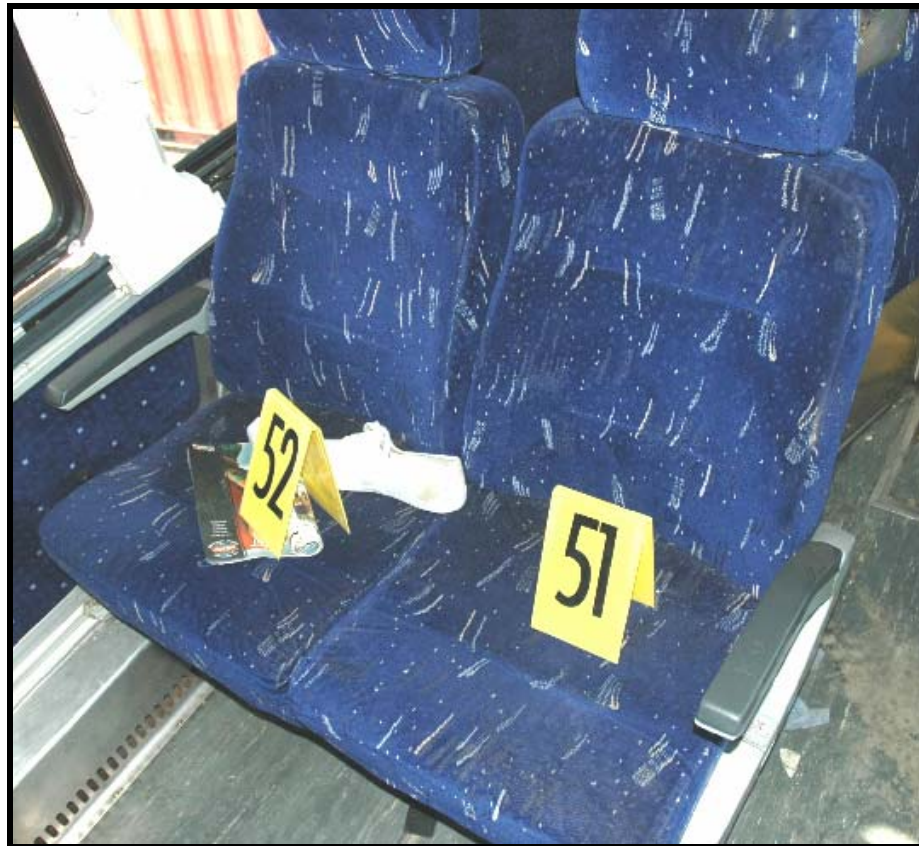
Passenger seats 51 and 52 were securely fastened to Vehicle 2 (MCI) and appeared undamaged. The armrests were intact and undamaged. The footrest for each seat was in the down position. The headrests were undamaged and in the down position.

Passenger seats 51 and 52.
CF-023-10 08-06-10 JK-A (79) cropped

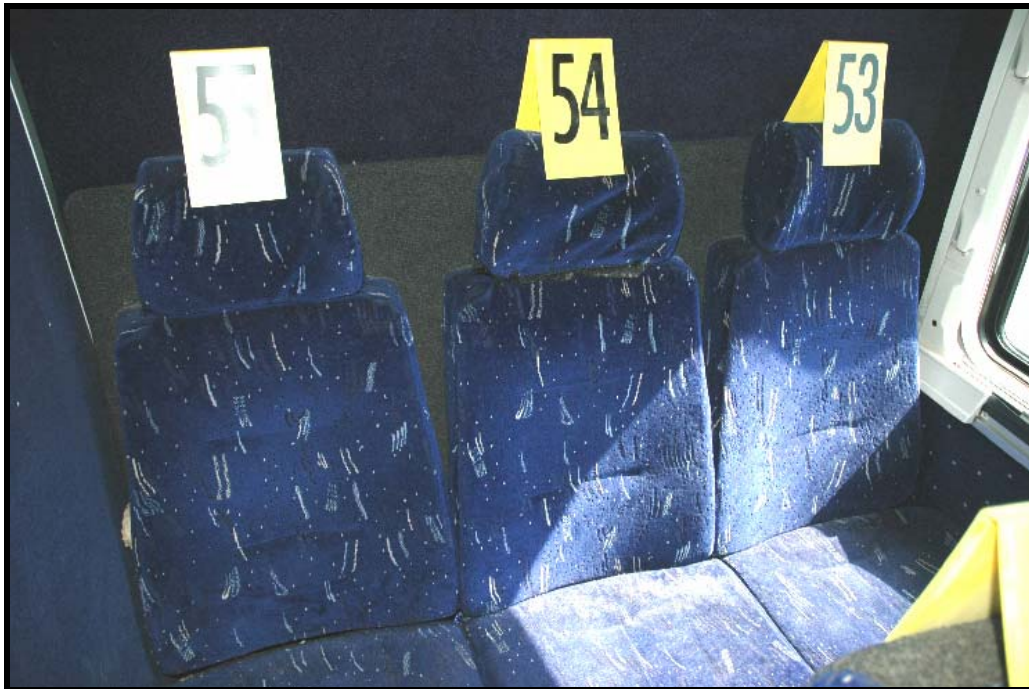
Passenger seats 53, 54 and 55, located in the last row of Vehicle 2 (MCI), were undamaged and securely fastened. These seats were not equipped with armrests and would not recline. The footrest for seat 53 the footrest for seat 54 were both in the down position. There was no footrest for seat 55. The headrests were undamaged and in the down position.

Passenger seats 53, 54 and 55.
CF-023-10 08-06-10 JK-A (115)

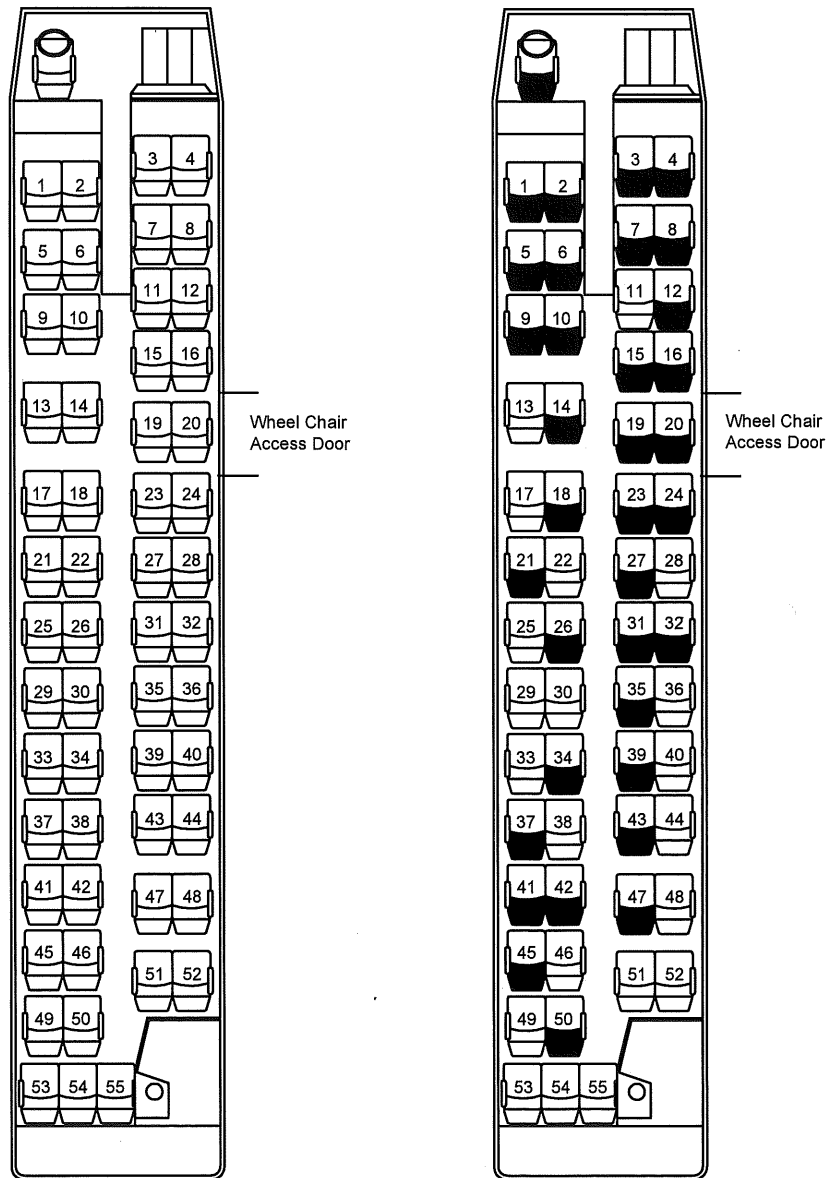
The shaded seats in the diagram below illustrate the damaged seats of Vehicle 2 (MCI).

Vehicle 2 (MCI) Seat Diagram
(damaged)

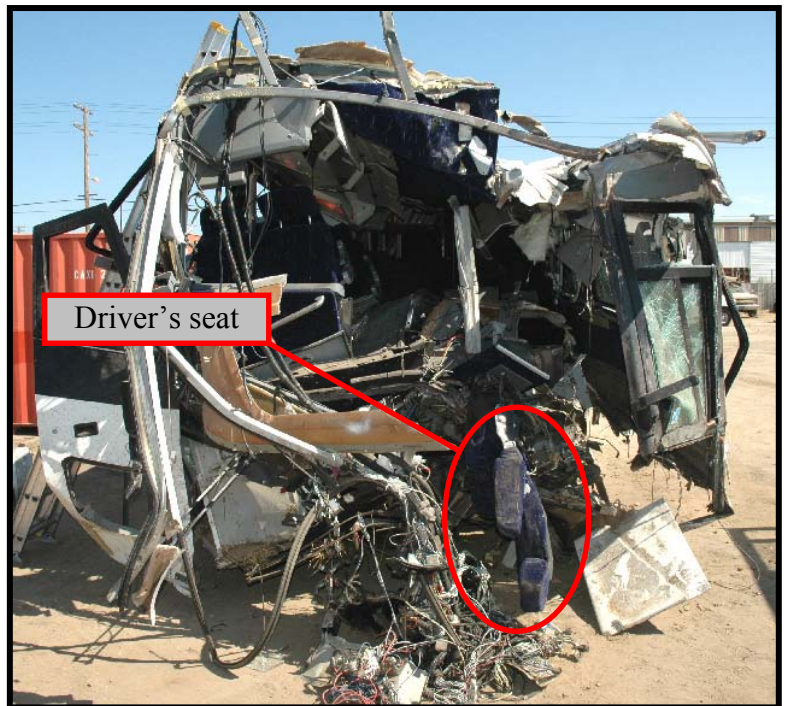
As a result of the collision, the forward section of the vehicle frame and the attached flooring were disfigured and shattered. Consequently, the driver's seat of Vehicle 2 (MCI) was displaced downward and to the right. Inspection of the driver's restraint revealed the restraint webbing was separated into two pieces. The webbing appeared to be torn. The torn ends of the webbing revealed uneven separation as well as balling and blackening of the individual fibers of the webbing in the torn area.

Front of Vehicle 2 (MCI).
CF-023-10 07-26-10 DN-A (1) (cropped)

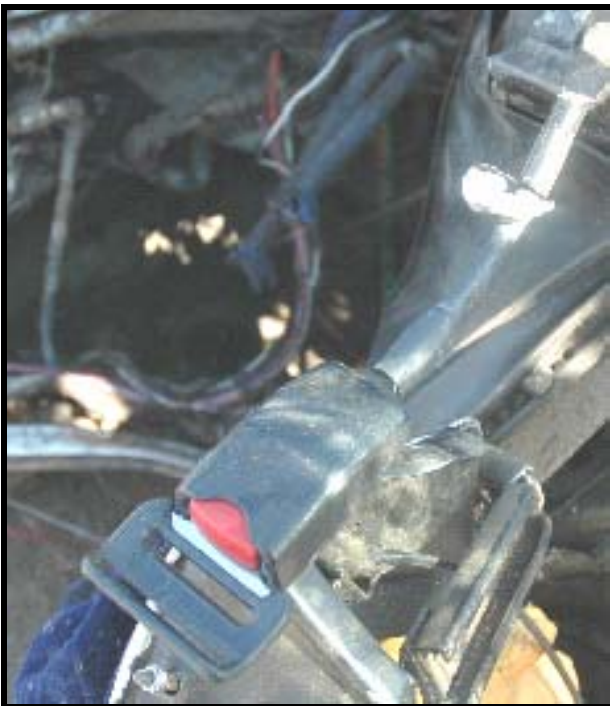
The buckle assembly remained securely attached to the right side of the driver's seat. The buckle assembly was in good condition, with minor soiling and grime buildup on its external surfaces. The sliding latch plate was located securely fastened in the buckle assembly and the restraint webbing was missing from the latch plate. The red release button, mounted to the top of the buckle assembly, was intact and exhibited sufficient spring tension. Depressing the red release button adequately ejected the latch plate from the buckle assembly. The latch plate was reinserted into the buckle assembly. The locking mechanism within the buckle assembly securely locked the latch plate in place. Movement of the latch plate within the buckle assembly did not result in a release of the latch plate from the buckle.

Buckle and latch plate assemblies.
CF-023-10 07-27-10 DN (2) (cropped)

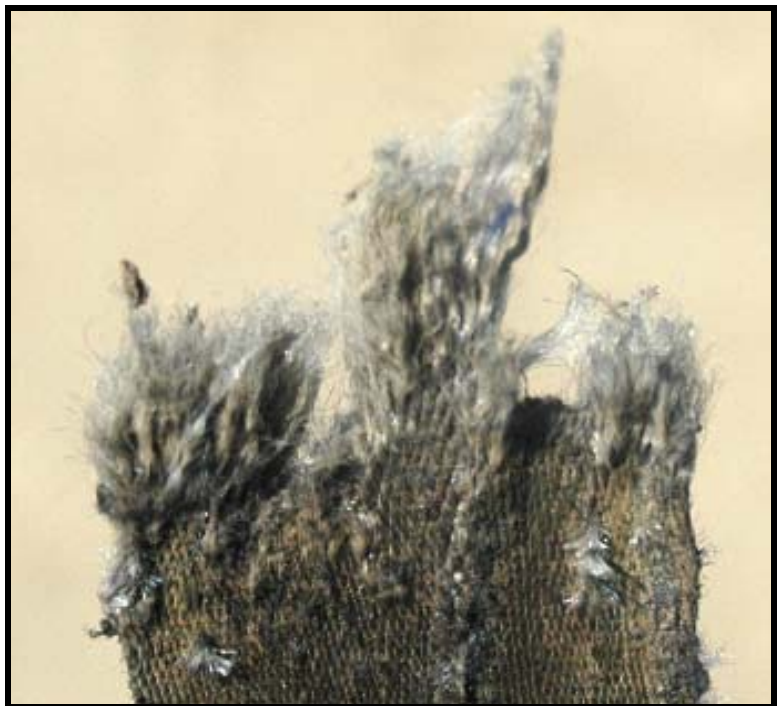
Torn restraint webbing.
CF-023-10 07-27-10 DN (39) (cropped)

It was determined the belt webbing separated as a result of the collision.

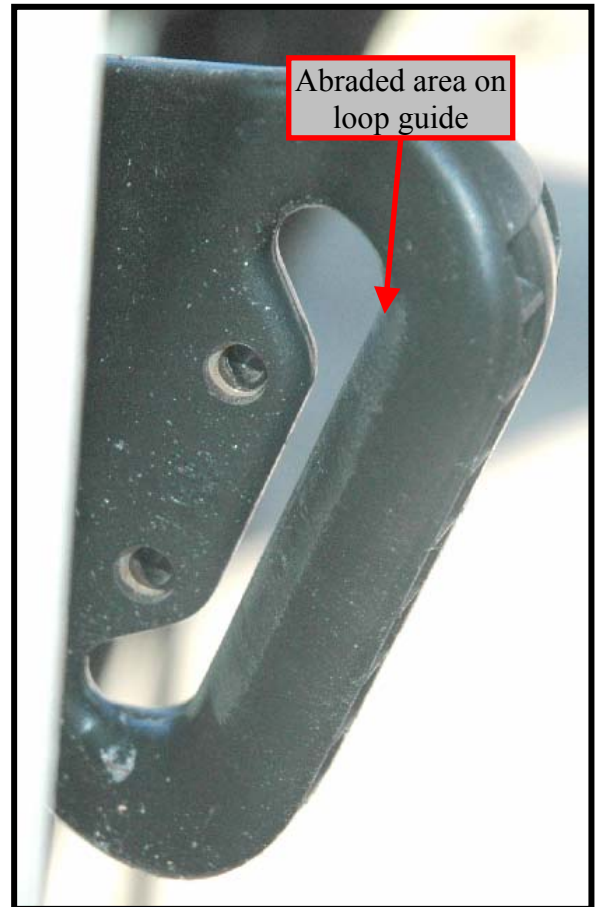
An inspection of the plastic coverings of the latch plate and the loop guide revealed there were material transfers and imprinting consistent with restraint webbing loading. Waviness and abrasions of the restraint webbing were observed along its length. The restraint webbing also exhibited evidence of regular usage, such as minor scratches and abrasions on the sliding latch plate, wear on the webbing selvage, and a buildup of grime and soiling of the restraint webbing and buckle assembly.

Based on the material transfers and imprinting observed on the plastic components of the restraint hardware, the abrasions and waviness observed on the restraint webbing, and the location of the latch plate securely fastened within the buckle assembly at the time of the inspection, it was determined that Party 2 (Jewett) was utilizing the occupant restraint for the driver's seat position at time of the collision.

B-pillar mounted loop guide.
CF-023-10 07-26-10 DN (24) (cropped)

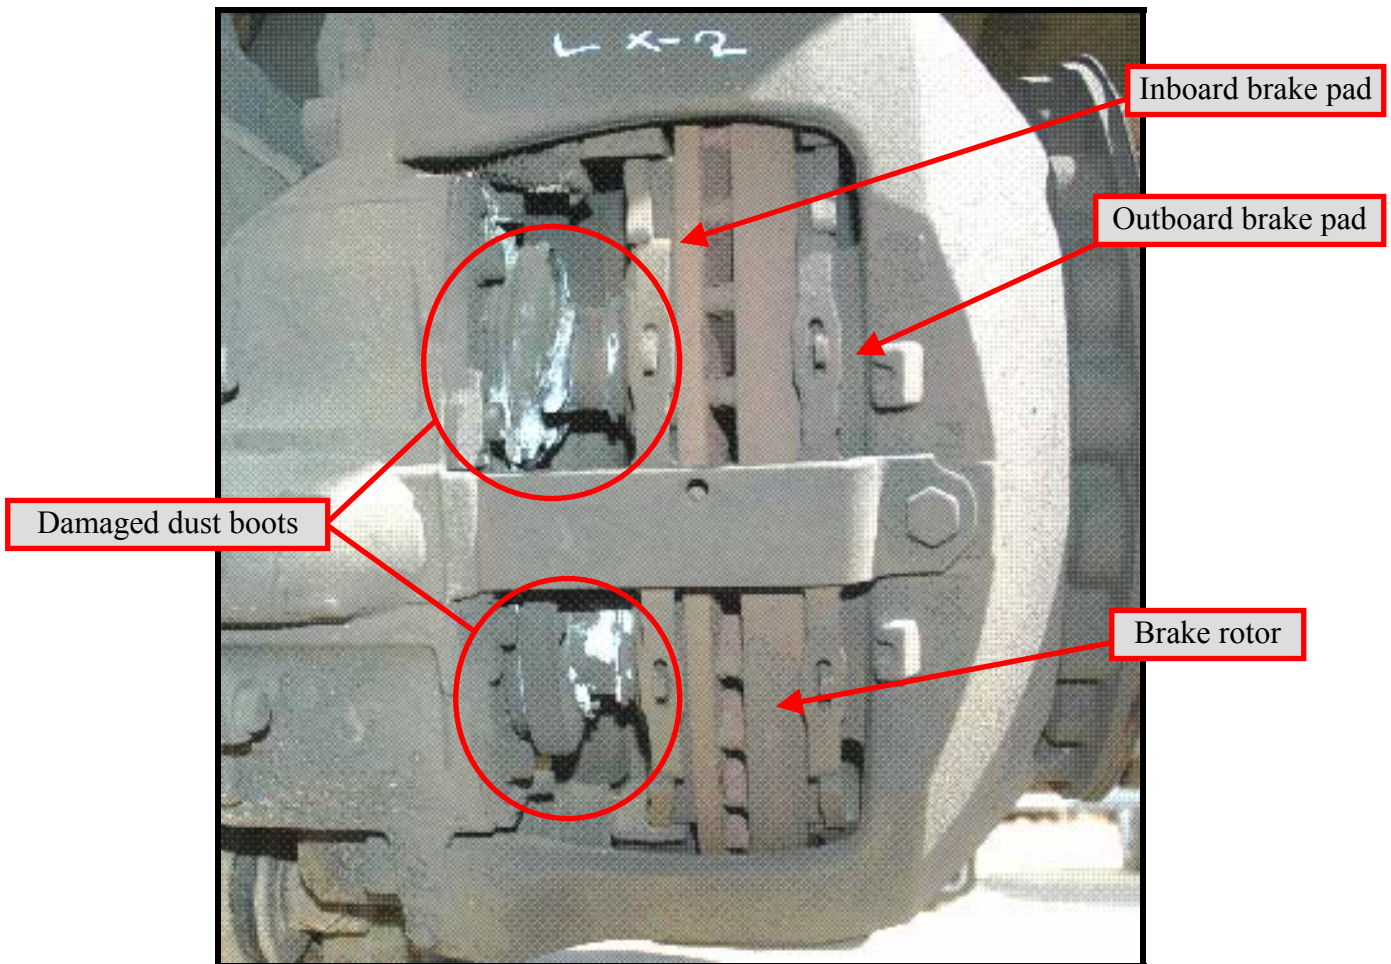
- The piston dust boots on the left caliper of axle 2 were damaged by excessive brake heat. The damage consisted of discoloration and breeches, or openings, in the dust boots. The functional testing of the left caliper of axle 2 revealed that the brake unit operated correctly, with no binding, restrictions, or air leakage noted.

Left brake assembly of axle 2 of Vehicle 2 (MCI).
CF-023-10 07-27-10 SP (8) cropped

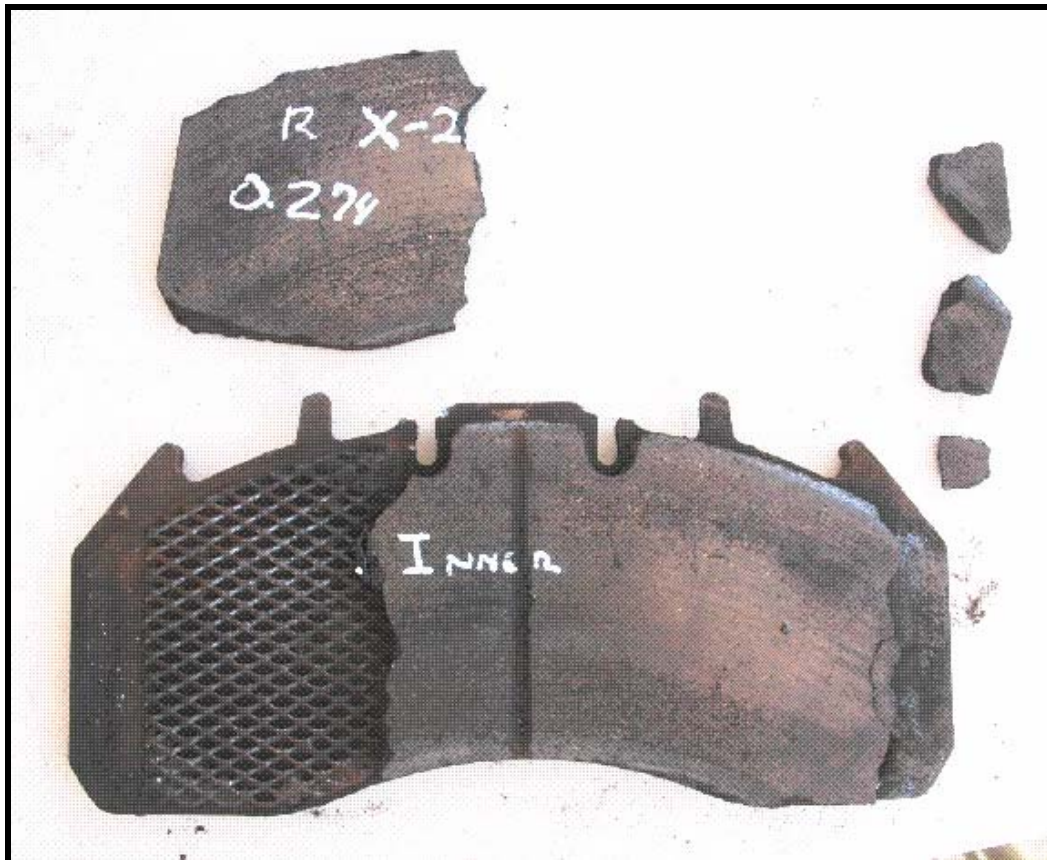
- The right inboard brake pad of axle 2 displayed friction material that was fractured into several pieces. The fractured pieces of friction material were separated from the metal backing plate. The thickness of the friction material of this brake pad was 0.274 inches, which was above the recommended minimum specification set forth by the manufacturer which was 0.120 inches. The cracked/fractured friction material from the right inboard brake pad of axle 2 was determined to be a preexisting condition and not a result of collision damage. This was determined by the amount of brake dust residue located on the backing plate behind the large portion of the separated friction material. Additionally, the edges near the fracture of the friction material were dulled due to vibration over time.

Right inboard brake pad of axle 2 of Vehicle 2 (MCI).
CF-023-10 07-27-10 SP (54) cropped

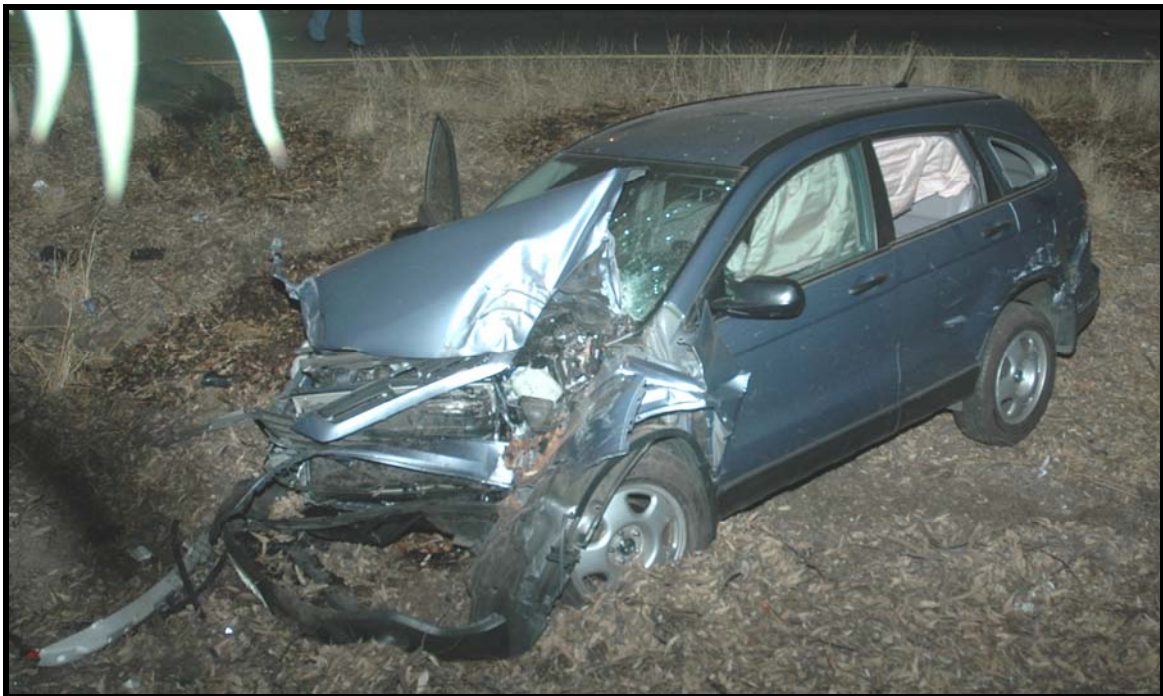
All references to direction are oriented from the driver's seat of the vehicle looking forward through the windshield. This vehicle sustained major front end damage. The principle direction of force was from front to rear and from left to right. The following damage description is not inclusive of all the damage sustained by Vehicle 3 (Honda).

Vehicle 3 (Honda) at point of rest.
CF-023-10 07-22-10 MS-A (10) cropped
