MULTIDISCIPLINARY ACCIDENT INVESTIGATION TEAM NARRATIVE/DIAGRAM

DATE OF COLLISION (MONTH-DAY-YEAR)	TIME (2400)	NCIC	OFFICER I.D.	NUMBER	MAIT CASE NUMBER	PAGE
07-22-2010	0214	9435	15751	2010-07-0219	CF-023-10	i

Central Division

CF-023-10

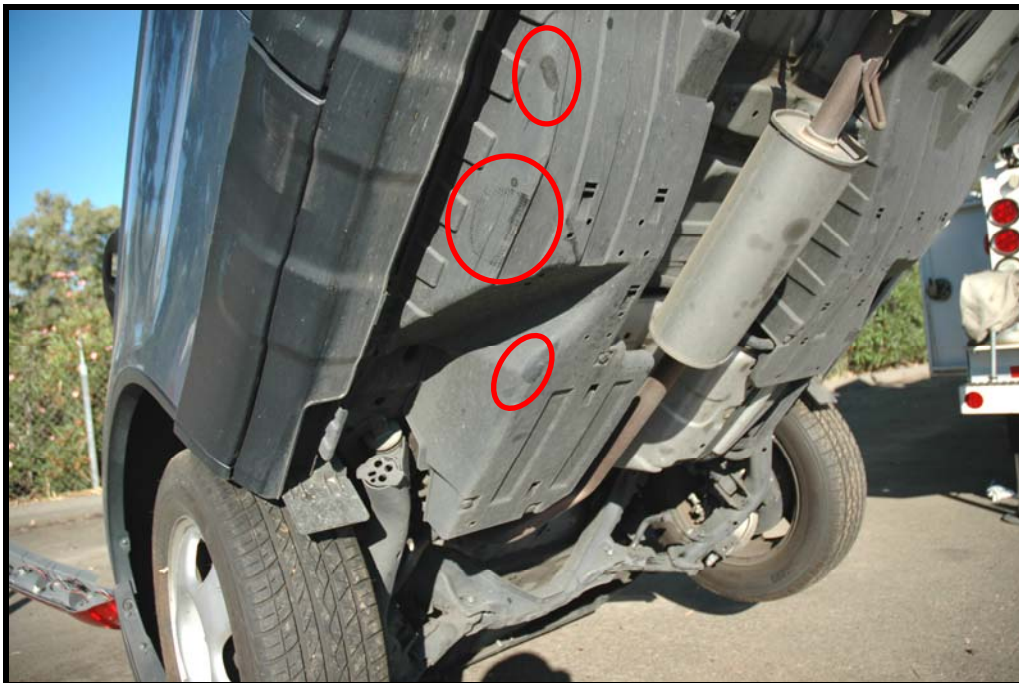
The undercarriage damage consisted of areas of where the dirt and road grime were cleaned from various components (noted by red ovals in photograph). One of the areas appeared to contain a biological substance. Another area contained what appears to be fabric imprinting. There were scrapes on the lower portion of the right rear lower control arm.

Undercarriage of Vehicle 3 (Honda).
CF-023-10 08-04-10 DN-A (14)

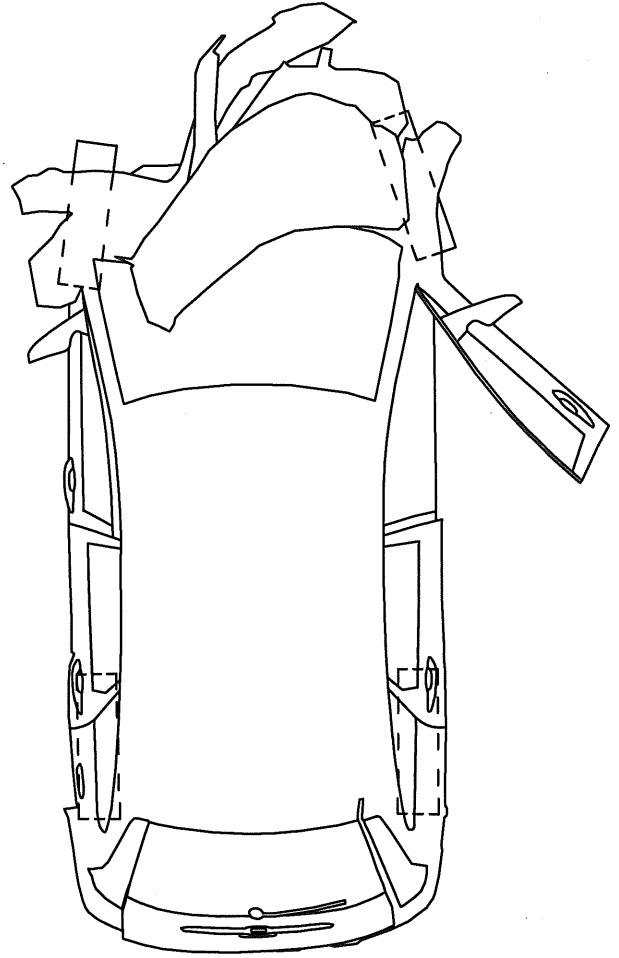
Vehicle 3 (Honda)
Vehicle damage profile drawn
by Investigator Nees

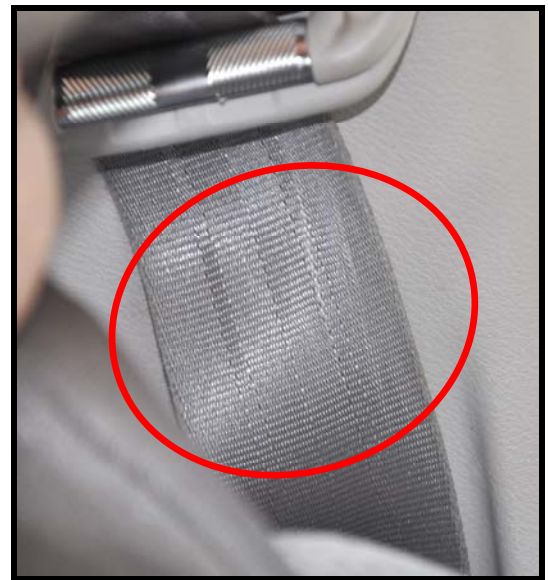
An inspection of the plastic coverings of the latch plate loop guide revealed there were material transfers and imprinting consistent with restraint webbing loading (red oval below). Minor waviness of the restraint webbing was observed on the webbing below the left B-pillar mounted adjustable height loop guide (red circle below).

Waviness to restraint webbing.
CF-023-10 07-27-10 DH-A (100) (cropped)

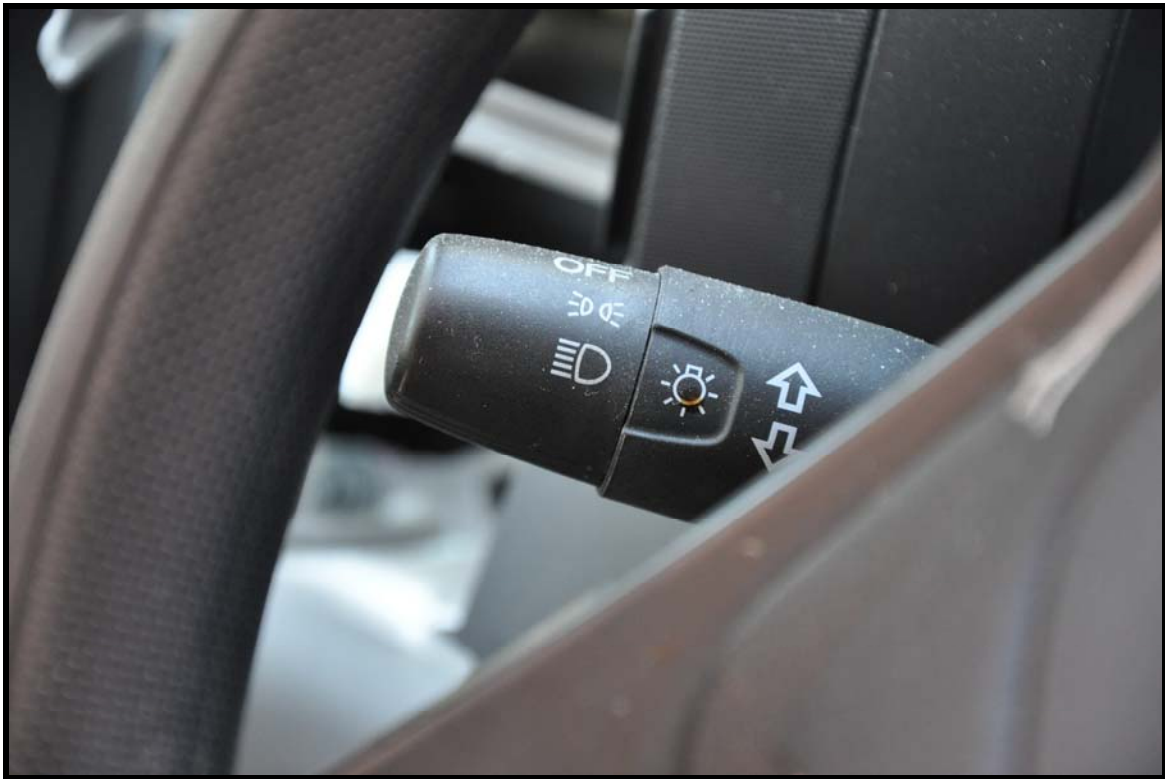
The lighting controls were mounted on the turn signal lever which was attached to the left side of the steering column. The rotary lighting control switch was in the "On" position. This position would have energized the circuits of the headlamps, tail lamps, and side marker lamps.

Lighting control switch of Vehicle 3 (Honda).
CF-023-10 07-27-10 DH-A (92)

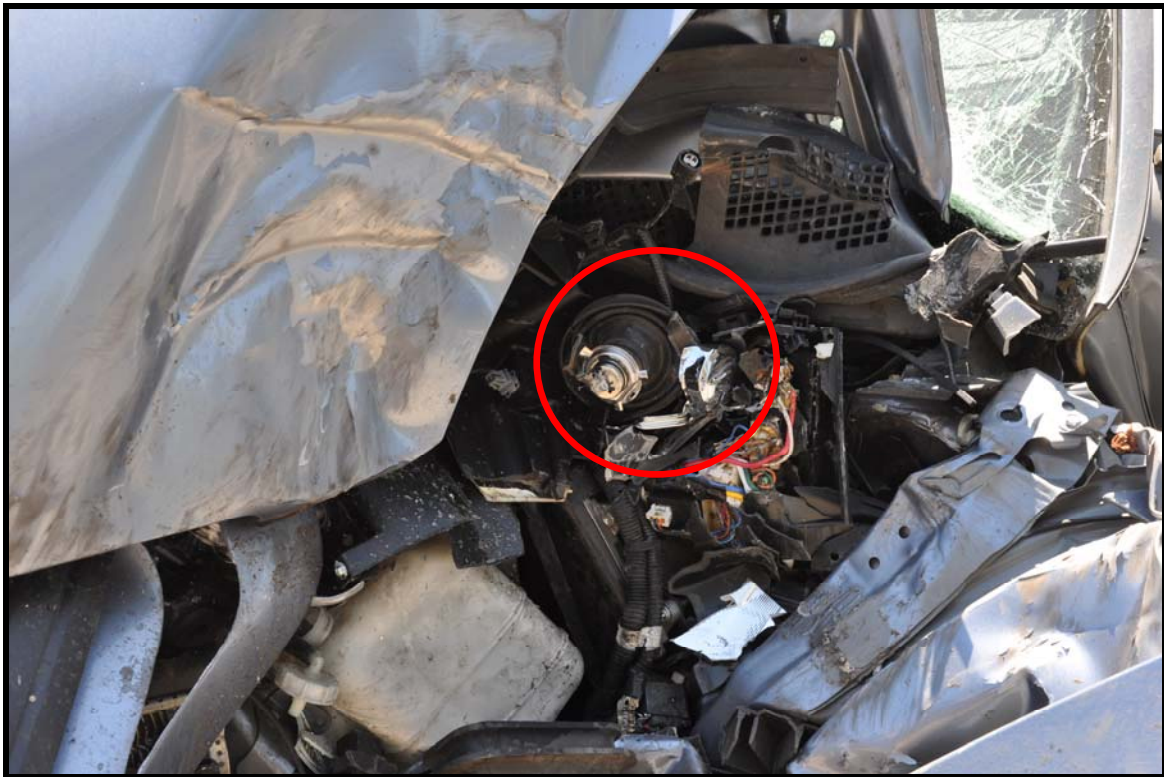
The left headlamp assembly was displaced rearward into the engine compartment bulkhead. The headlamp assembly was shattered. The glass envelope was shattered which exposed the internal components of the lamp (red circle). The lamp was kept in place for examination.

Left headlamp of Vehicle 3 (Honda).
CF-023-10 07-27-10 DH-A (84)

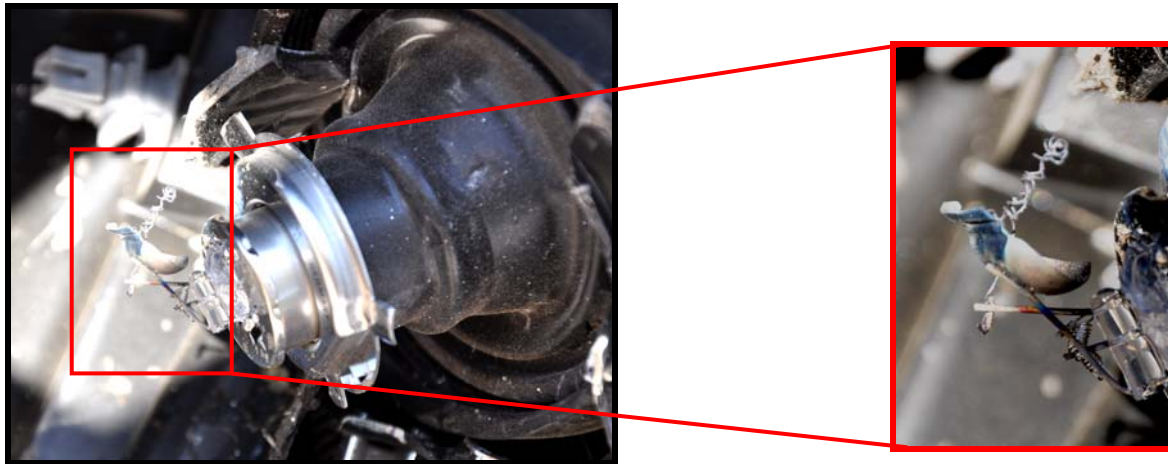
The glass envelope was broken. The upper filament (low beam filament) was stretched with uneven spacing and pitch of its coils. This filament was oxidized and its supports were oxidized near the filament's tails. The supports were tinted from green to violet below the oxidation and above the lower (high beam) filament. The lower filament (high beam filament) was bright, shiny and silver luster. The filament's coils were bent around the positive filament support which produced an uneven spacing and pitch of the coils.

Left headlamp of Vehicle 3 (Honda).
CF-023-10 07-27-10 DH-A (87) cropped

The upper filament's distortion and discoloration, coupled with the discoloration of its supports, are evidence of hot shock. Hot shock is evidence that this filament was incandescent when the lamp's glass envelope was broken and the filament was exposed to the atmosphere.

The lower filament's distortion around the positive support post, and its lack of discoloration is evidence that the heat produced by the upper filament's incandescence heated the lower filament to the point of being ductile enough to bend without fracture but not enough to be considered incandescent.

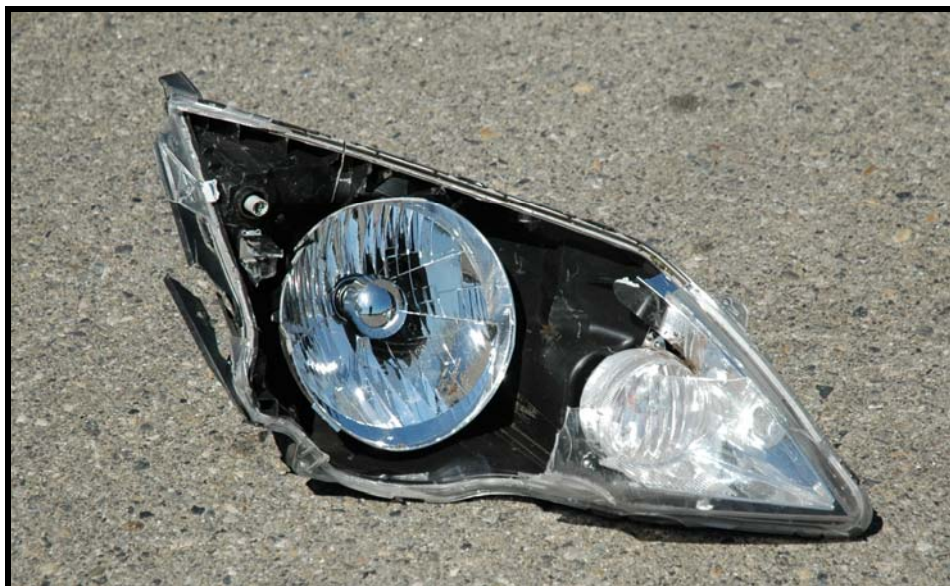
The right headlamp assembly was detached from Vehicle 3 (Honda) and was located by MAIT investigators in the rear cargo area of the vehicle. The headlamp was located mounted in the headlamp assembly. The headlamp was removed from the assembly for inspection.

Right headlamp assembly of Vehicle 3 (Honda).
CF-023-10 07-29-10 DN (38) cropped

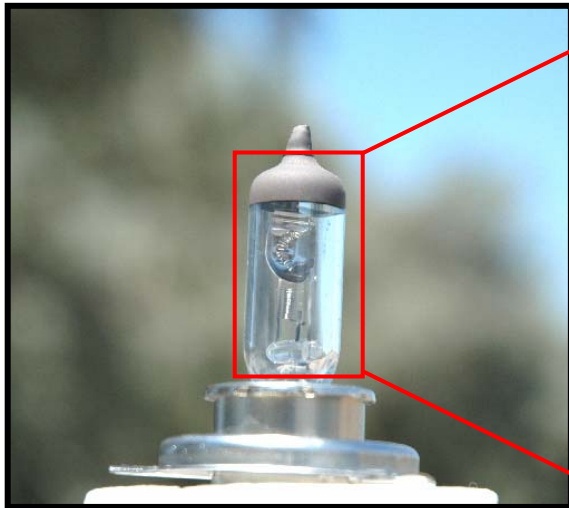
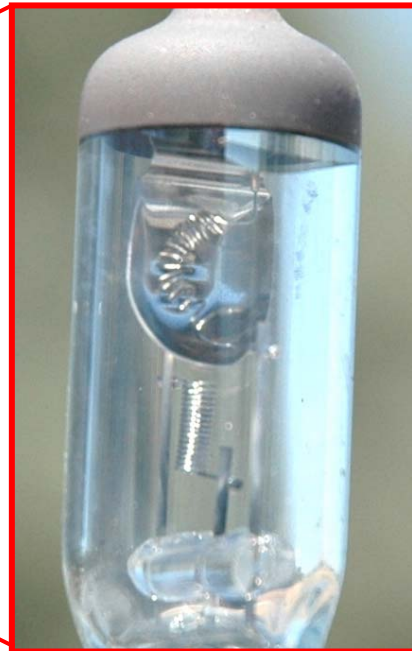
The glass envelope was intact. The upper filament's coils were stretched with uneven spacing and pitch. The lower filament was bright, shiny and silver luster with evenly spaced and pitched coils

Right headlamp of Vehicle 3 (Honda).
CF-023-10 07-29-10 DN (52) cropped

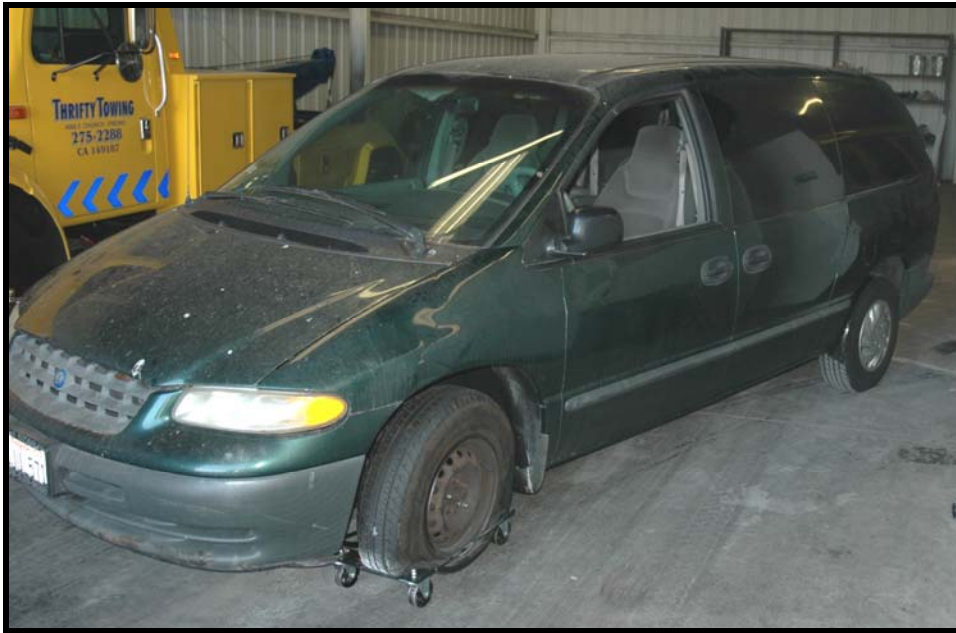
All references to direction are oriented from the driver's seat of the vehicle looking forward through the windshield. This vehicle sustained damage primarily to the front bumper and undercarriage. The principle direction of force was from front to rear. The following damage description is not inclusive of all the damage sustained by Vehicle 4 (Plymouth).

Vehicle 4 (Plymouth) damaged.
CF-023-10 07-28-10 DN (3) cropped and lightened

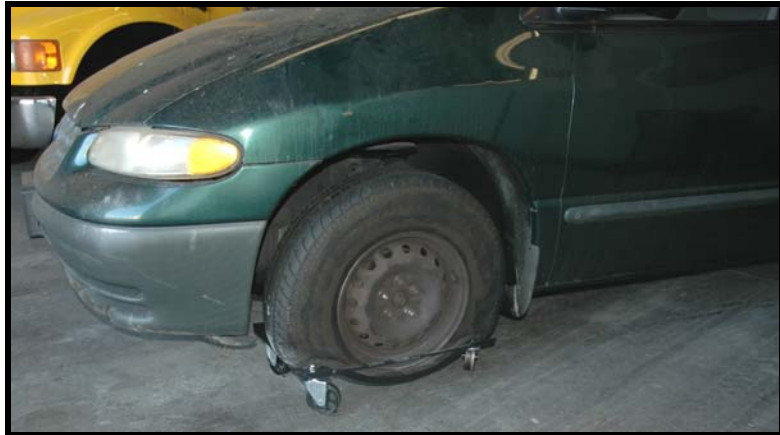
The front tire was flat. Inspection of the front tire revealed an oblique tear on the inboard sidewall of the tire (red circle). The wheel sustained a minor radial collapse (red oval) on the inboard side above the oblique tear in the tire. There were miscellaneous dents and scratches along the side of the vehicle, all of which appeared to be previous damage.

Left front tire of Vehicle 4 (Plymouth).
CF-023-10 07-28-10 DN (20) cropped

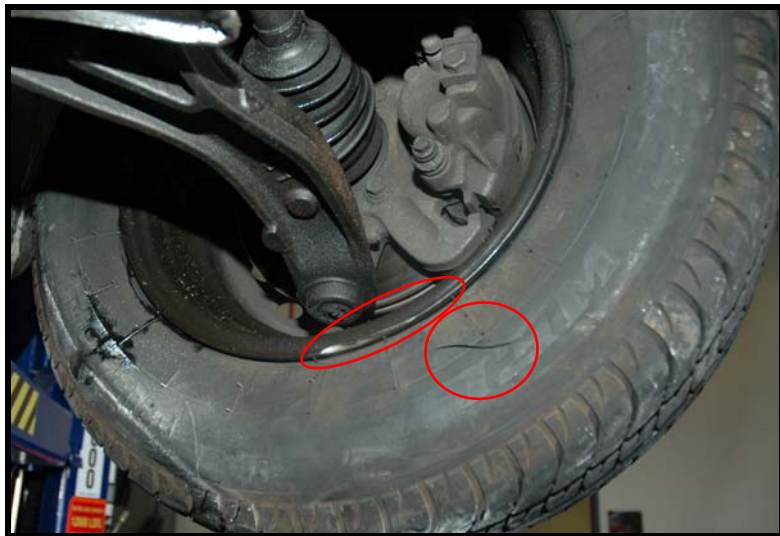
Inboard side of the left front tire of Vehicle 4 (Plymouth).
CF-023-10 07-28-10 DN (53) cropped

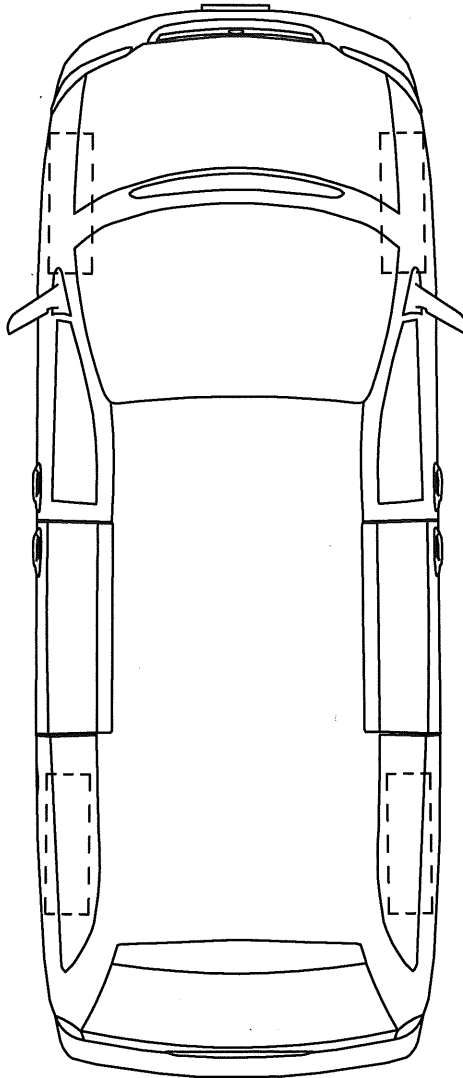
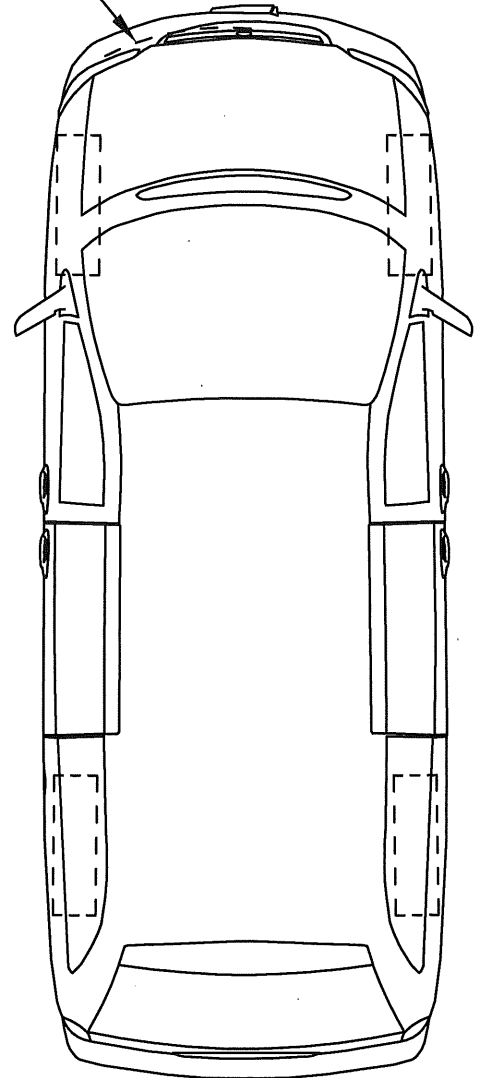
Vehicle Damage Profile

Damaged area under bumper
