# ***Columbia* Crew Survival Investigation Report**

NASA/SP-2008-565

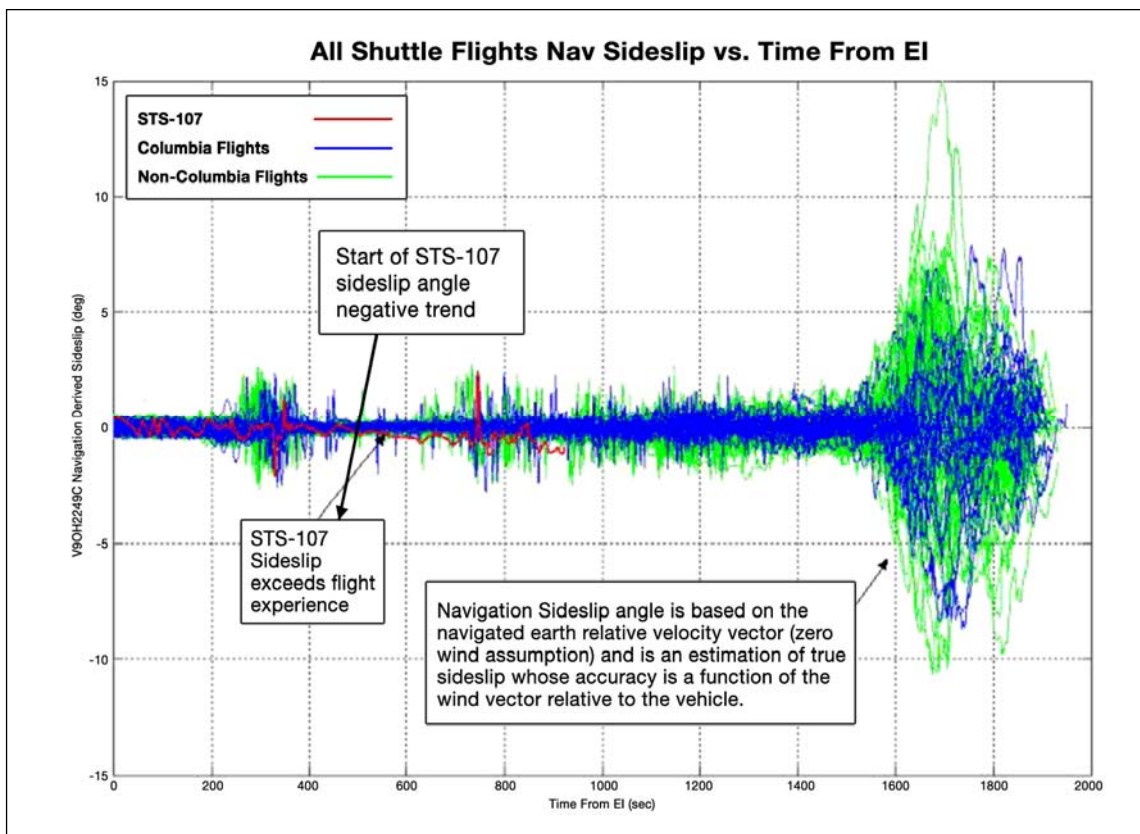
Figure 1.1-10. Negative trend starts at GMT 13:51:46 (EI+457) and exceeds flight experience at GMT 13:53:38 (EI+569).<sup>11</sup>

At GMT 13:53:38 (EI+569), the sideslip angle (left yaw) exceeded all previous flight experience (figure 1.1-10).

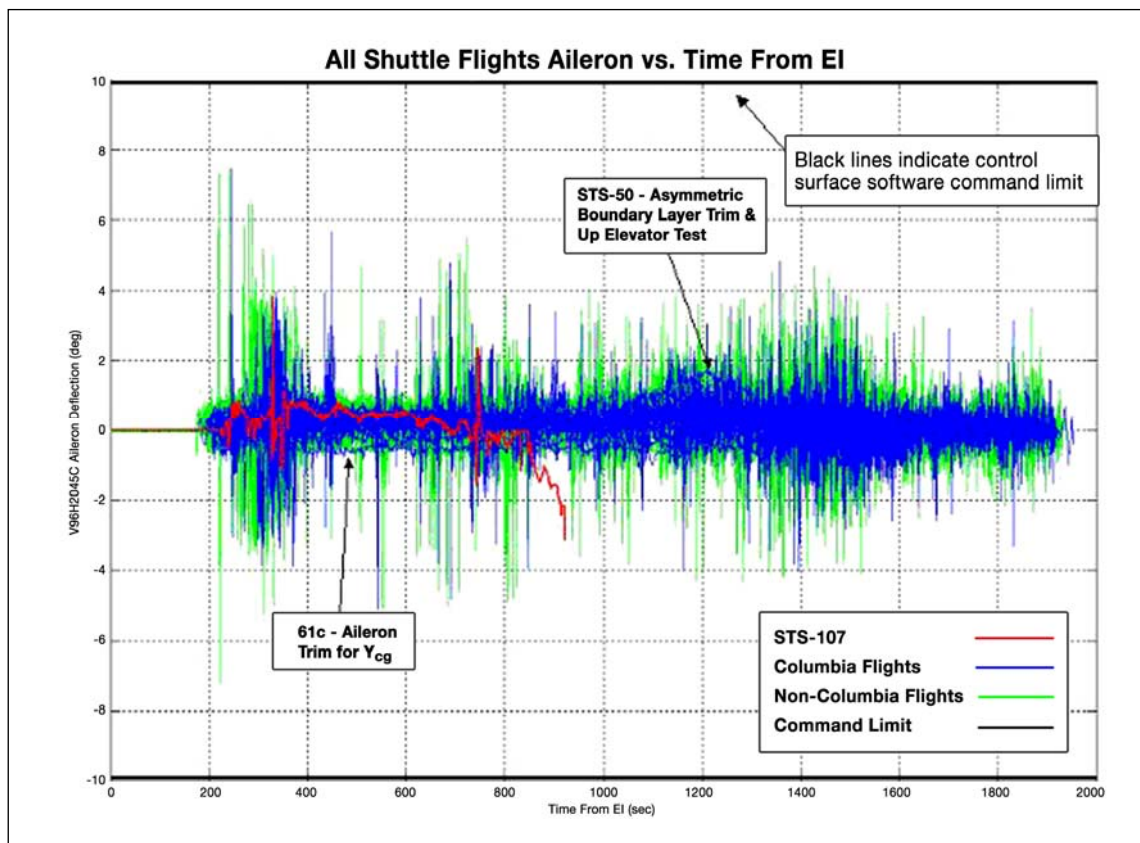
Figure 1.1-11. The sharp divergence from previous flight experience starts at approximately GMT 13:58:19 (EI+850).<sup>12</sup>

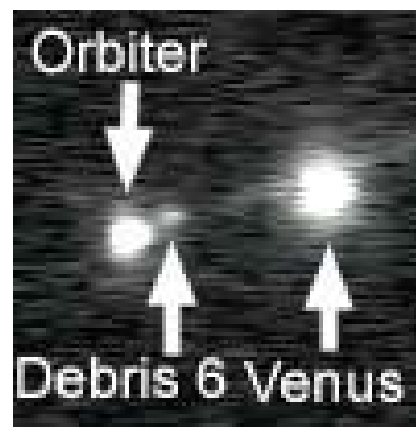
The brightest debris shedding event that occurred in this phase, Debris 6, is first visible on video at GMT 13:54:36 (EI+627) (figure 1.1-14). Ballistic estimates determined that the actual release time was 4 seconds earlier. Luminosity measurements and calculated rates of deceleration were used to determine that the mass was probably a few hundred pounds.<sup>17</sup> There were no data from sensors, instrumental indications, or apparent crew recognition of this debris loss.

Figure 1.1-14. The brightest debris event known to have occurred prior to loss of signal. The orbiter is traveling from right to left.

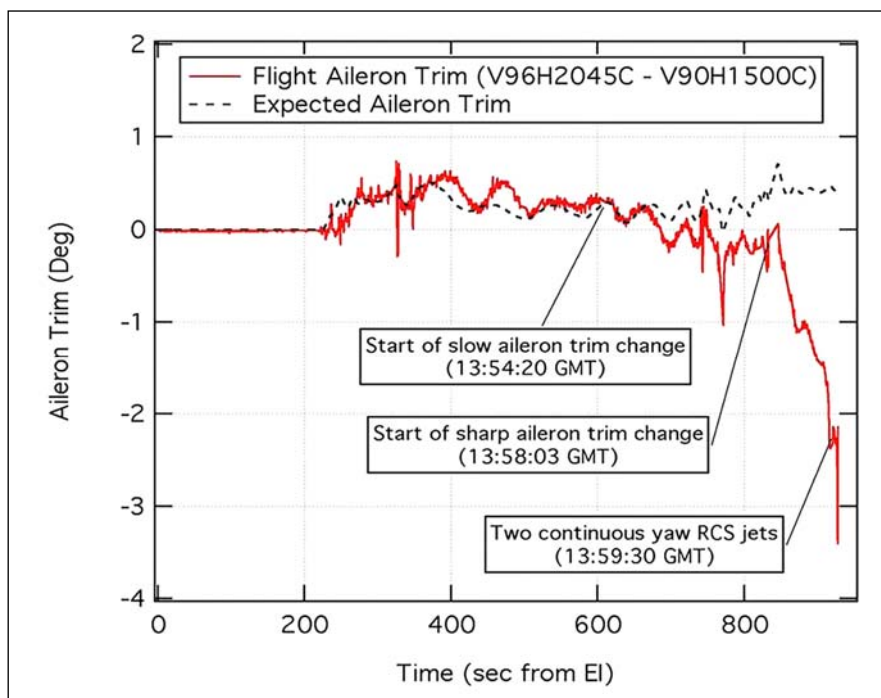
At approximately GMT 13:58:03 (EI+834), the aileron trim begins to diverge sharply from the expected values to counteract the increasing adverse moments due to the left wing damage (figure 1.1-15).

Figure 1.1-15. *Aileron trim discrepancy.*<sup>18</sup>

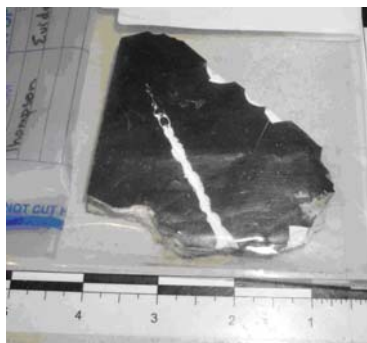
Ballistic analysis indicates that the westernmost piece of recovered *Columbia* debris was released at GMT 13:58:21 (EI+852). This debris, a tile from the left wing upper surface located just inboard of RCC panels 8 and 9, was found in Littlefield, Texas<sup>19</sup> (figure 1.1-16).

Figure 1.1-16. *The Littlefield tile.* [Picture from the *Columbia* Reconstruction Database, debris item no. 14768]

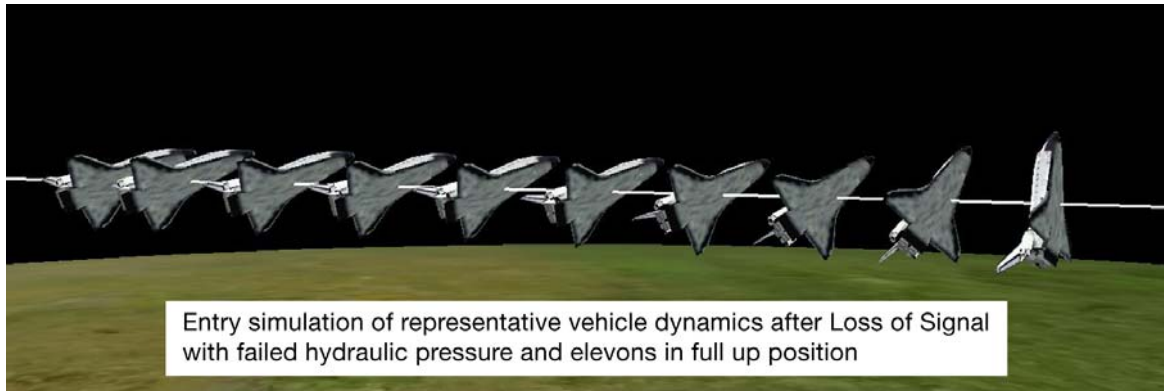
**Figure 1.1-20. Sequence (1-second intervals) showing a simulation of orbiter loss of control pitch-up from GMT 13:59:37 (EI+928) to GMT 13:59:46 (EI+937). White line indicates vehicle trajectory relative to the ground.**

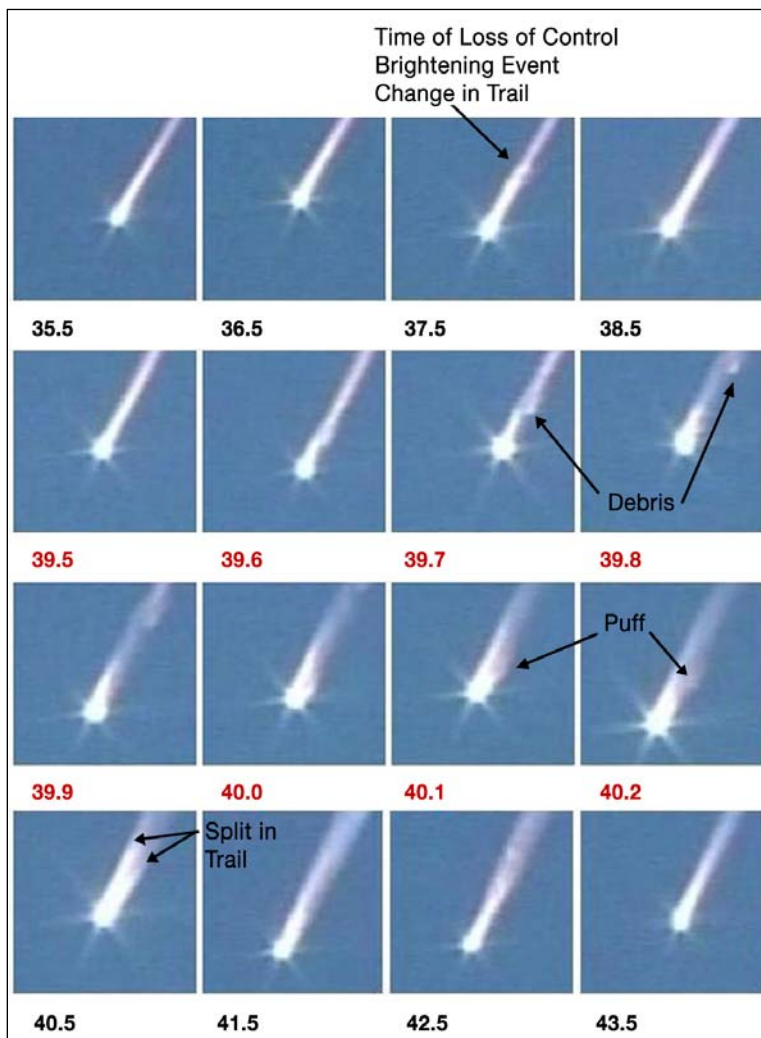
**Figure 1.1-21. Video frame captures from ground-based video, beginning at GMT 13:59:35.5 (EI+926) and ending at GMT 13:59:43.5 (EI+937). The numbers below each frame indicate the seconds after GMT 13:59:00. The frames in the first and last rows are 1 second apart. The frames in the second and third rows are 0.1 second apart.**

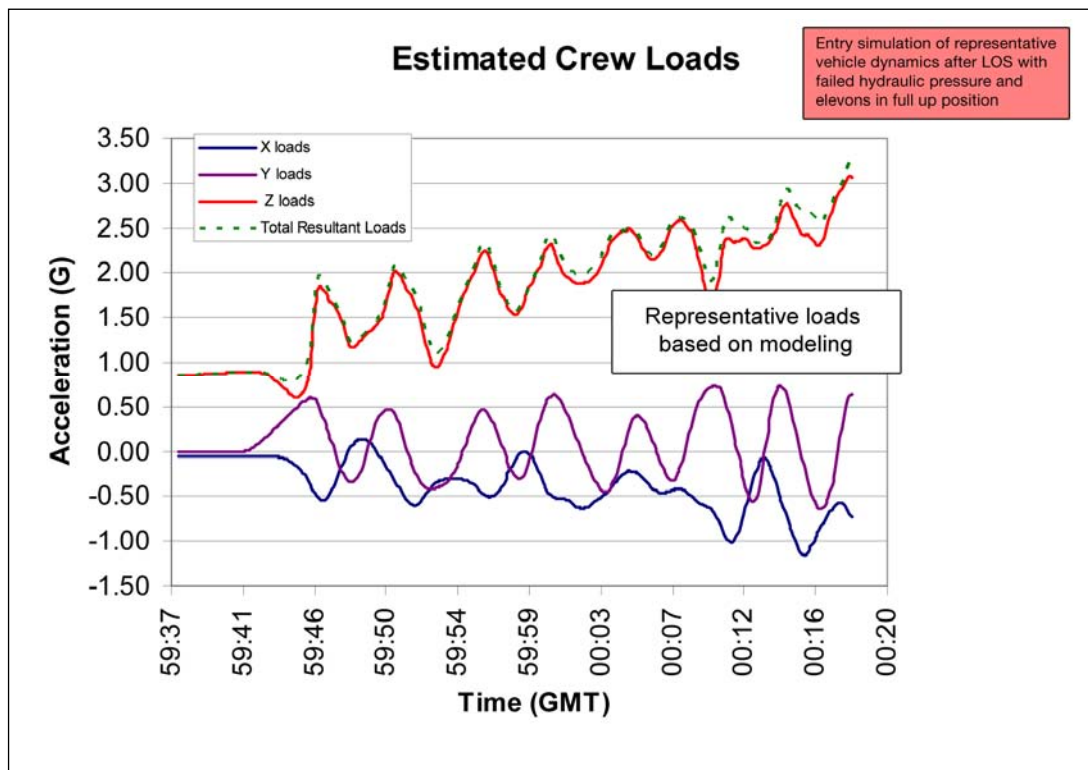
Figure 1.1-22. Resultant acceleration (G) vs. time prior to Catastrophic Event in the crew coordinate frame from the aerodynamic simulation model.

Results of a shuttle LOC simulation show that the motion of the orbiter in this timeframe is best described as a highly oscillatory slow (30 to 40 degrees per second) flat spin, with the orbiter's belly generally facing into the velocity vector. It is important to note that the velocity vector was still nearly parallel to the ground as the vehicle was moving along its trajectory in excess of Mach 15. The crew experienced a swaying motion to the left and right (Y-axis) combined with a pull forward (X-axis) away from the seatback. The Z-axis accelerations pushed the crew members down into their seats. These motions might induce nausea, dizziness, and disorientation in crew members, but they were not incapacitating. The total acceleration experienced by the crew increased from approximately 0.8 G at LOC to slightly more than 3 G by the CE (figure 1.1-22).

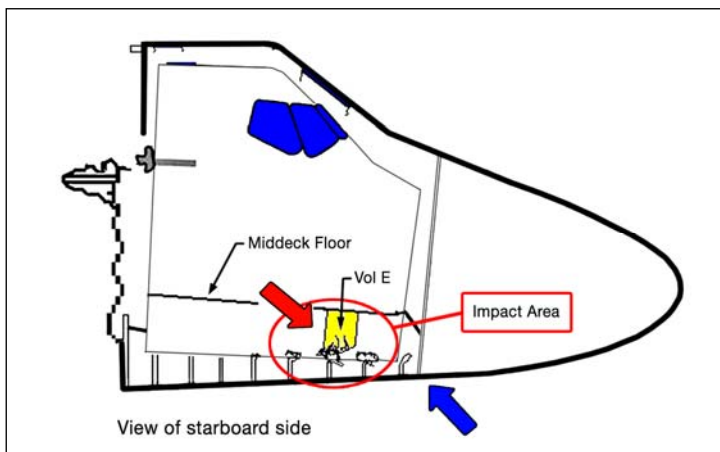
Figure 1.1-26. Scenario showing how the crew module pressure vessel could impact the forward fuselage, and the middeck Volume E could impact the crew module pressure vessel, with resultant damage.

The resulting jerk acting on the crew module attach fittings as the forebody separated from midbody structure caused motion of the crew module within the forward fuselage shell. The crew module pressure vessel impacted the forward fuselage, which apparently resulted in damage to the crew module pressure vessel, internal crew module structure, and forward fuselage structure. Debris evidence shows that internal damage occurred to some volumes and lockers on the middeck in close proximity to the pressure vessel shell. At least one crew module pressure vessel breach occurred in the lower equipment bay or middeck area (figure 1.1-26), probably at or near the time of the CE, but definitely not later than GMT 14:00:35 (EI+986) ±5 sec. This time is based on the ballistic analysis of a recovered mission patch confirmed to have come from inside the crew module from one of the volumes (Volume E) that suffered damage.

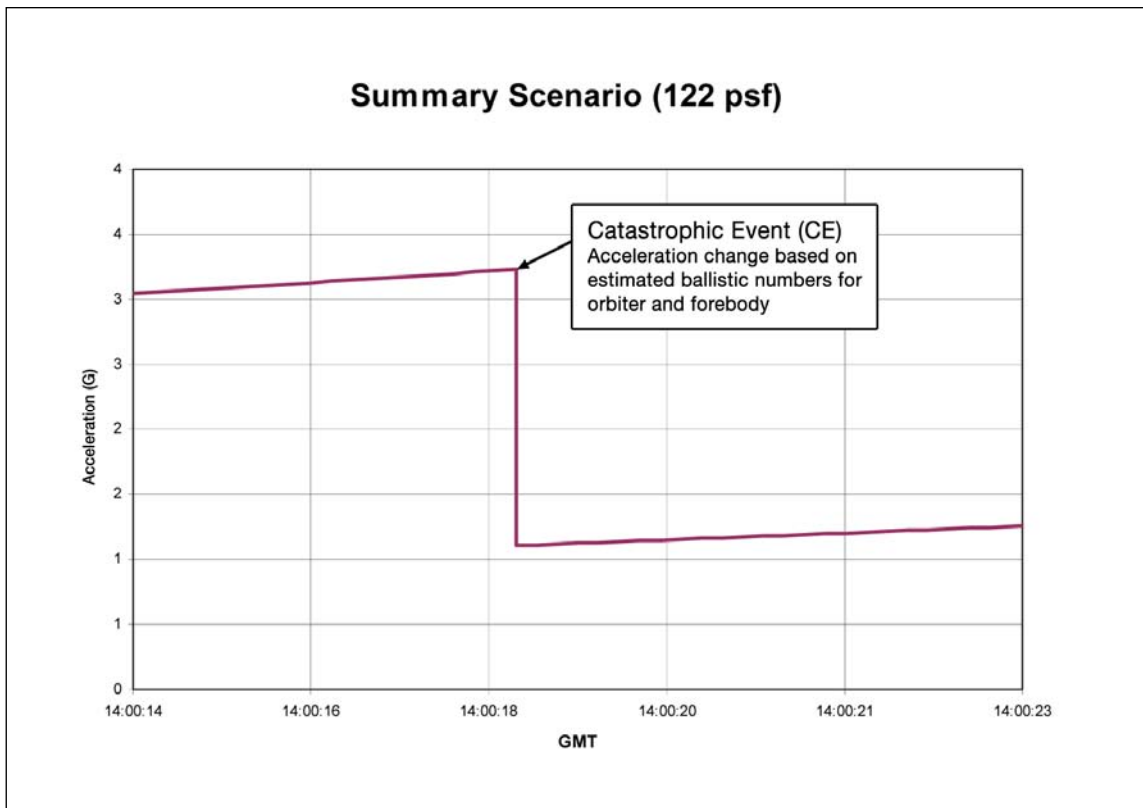
Figure 1.1-27. Estimated change in total G experienced by the forebody due to a change in ballistic number from the orbiter breakup.

As the forebody broke free from the rest of the orbiter, its ballistic number underwent a sharp change from an average ballistic number of 41.7 pounds per square foot (psf) (out of control intact orbiter) to 122 psf (free-flying forebody). The aerodynamic drag of the forebody instantaneously decreased, resulting in a reduction in the translational deceleration from approximately 3.5 G to about 1 G (figure 1.1-27).

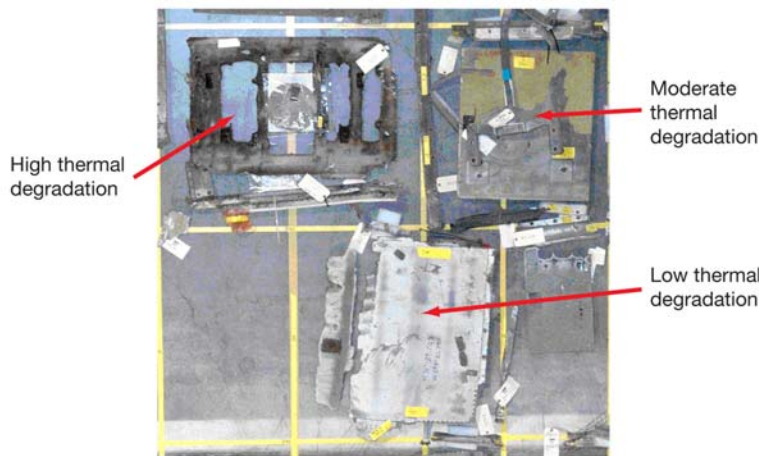
**Figure 1.1-31. Middeck floor debris in original relative orientation showing varying thermal exposure.**

There is no evidence of an explosion or a fire. Analysis of thermal vectors on numerous debris items showed multiple independent heat vectors across the structure. For example, many recovered middeck floor panels were nearly pristine with paint still visible, while floor panels from immediately adjacent locations had melted materials deposited on them and other signs of high thermal exposure (figure 1.1-31). After breakup, individual items experienced their own trajectories and heat exposure. This heat exposure can vary enormously with ballistic number and other effects such as shadowing from other debris items and orientation of the item into the heat vector. The lack of consistent directional heating vectors on crew module debris suggests heating was due to individual item trajectories and random exposure during breakup rather than a major breach resulting in directional heating.

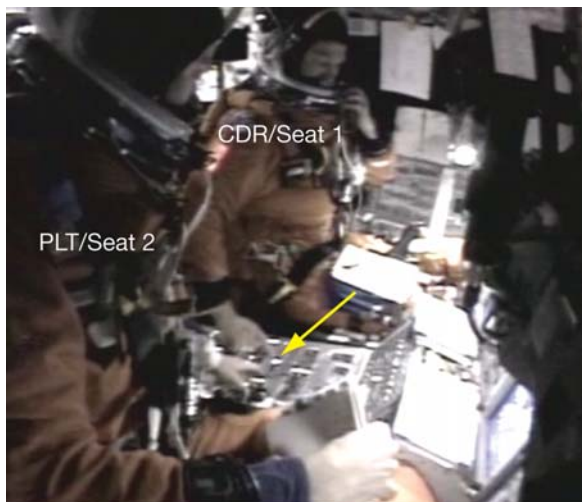
Figure 1.2-7. Digital autopilot button on the C3 panel is illuminated.

**DAP DNMODE RHC.** Primary Avionics Software System (PASS) DAP DOWNMODE RHC (time from telemetry analysis). The message indicates that the RHC movement in the previous event was sufficient to mode the DAP out of AUTO into Inertial mode. When this occurs, a “DAP DOWNMODE RHC” caution and warning message is displayed, the INRTL button on the C3 panel is illuminated (see arrow in figure 1.2-7), and a tone, which can be heard in the recovered video tape, is annunciated (figure 1.2-7).

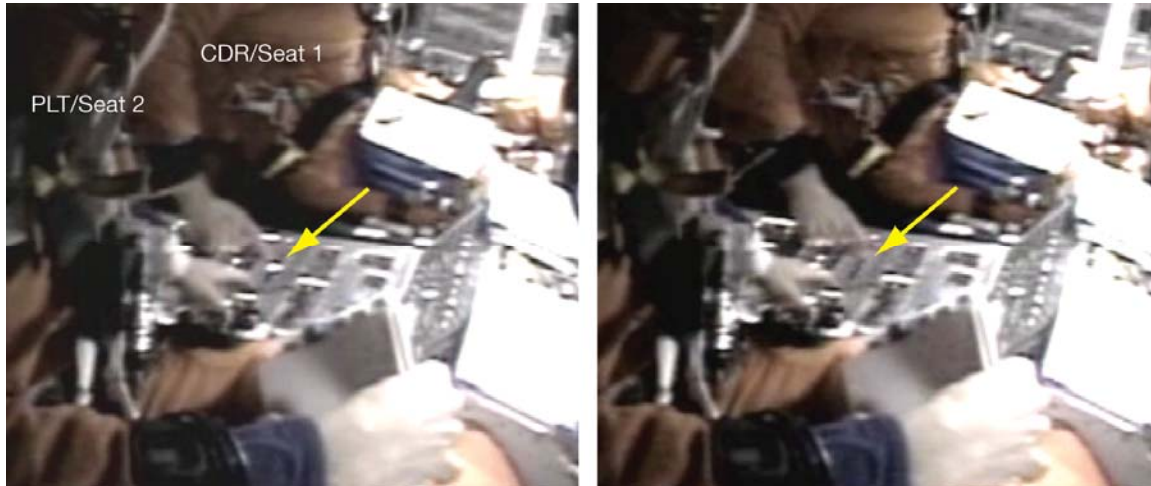
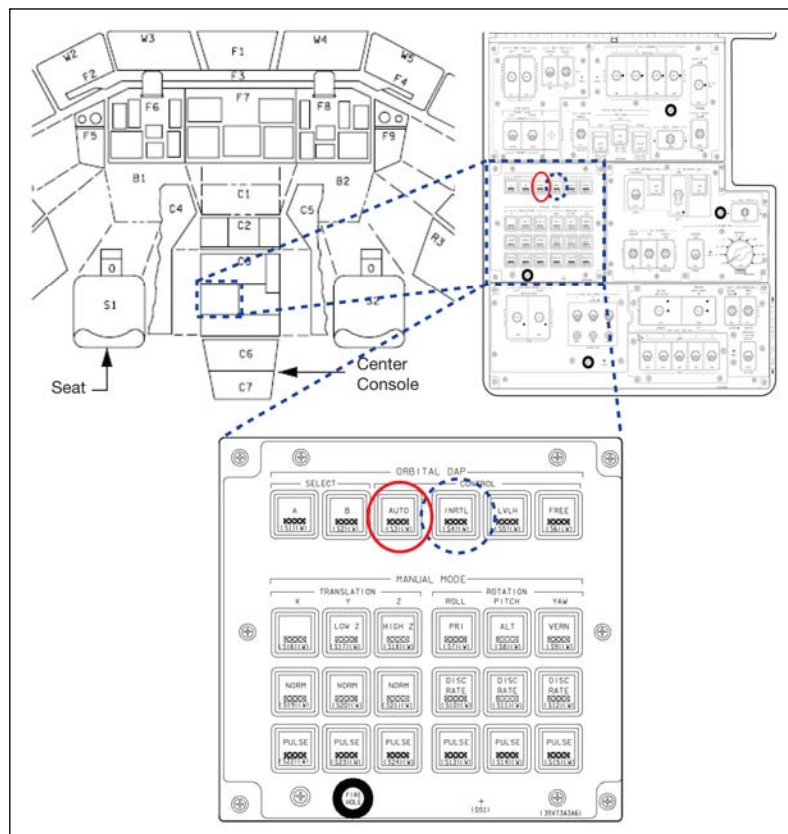
CDR/Seat 1 responds to the DAP DOWNMODE RHC message by pressing the illuminated AUTO button on the C3 panel to restore the DAP to AUTO (figures 1.2-8 and 1.2-9).

Figure 1.2-8. Digital autopilot is no longer in AUTO, INRTL light is ON (left figure); Commander/Seat 1 restores digital autopilot to AUTO, INRTL light is OFF (right figure).

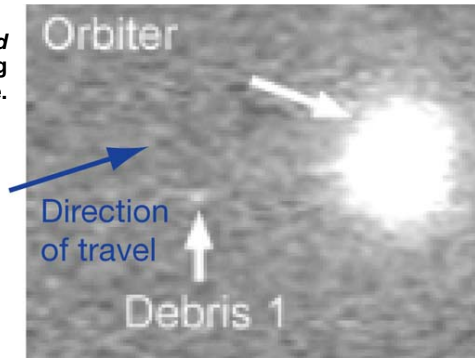
**First Observed Incident of Debris Being Shed.** This is most likely a piece of the left wing. Debris 1 is seen just aft of the orbiter envelope 1 second after a trail anomaly that consisted of a noticeably luminescent section of the plasma trail. There were no reported entry observations while Columbia was over the Pacific Ocean prior to GMT 13:53:15 (EI+546), so it is

not possible to know whether debris was being shed before this time. Image of Debris 1 is 0.6 second after first visual detection of it. Analysis indicates that the mass of the debris was probably less than 8 lbs. Neither the crew nor MCC personnel were aware of the shedding events (blue arrow shows direction of flight) (figure 1.2-24).

Figure 1.2-24. Video capture of the first observed incident of debris being shed. The orbiter is traveling from left to right in this image.

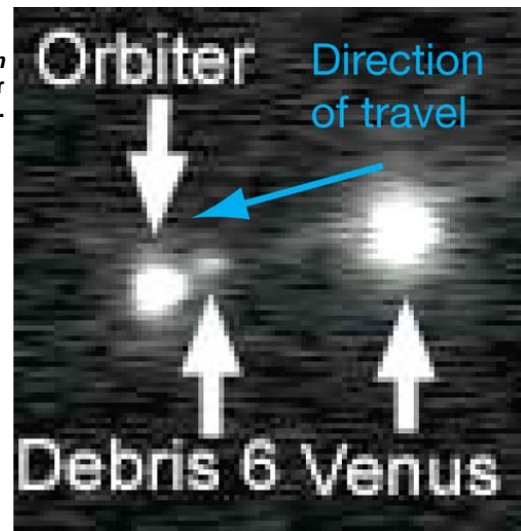
Debris 6 released. The brightest debris-shedding event occurring in this phase, Debris 6, is first visible on video at GMT 13:54:36 (EI+627) (figure 1.2-28). Ballistic estimates determined that the actual release time was 4 seconds earlier. Luminosity measurements and calculated rates of deceleration were used to determine that the mass was probably a few hundred pounds. <sup>7</sup> There were no data from sensors, instrumental indications, or apparent crew recognition of this debris loss.

Figure 1.2-28. The brightest debris event known to have occurred prior to loss of signal. The orbiter is traveling from right to left.

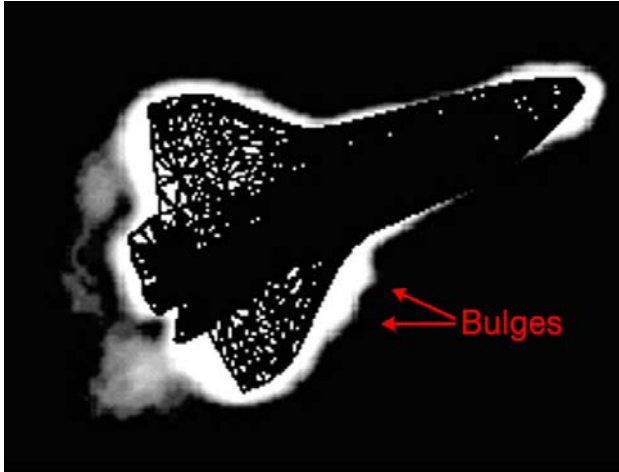
(as marked) at the left wing could not be explained by a nominal condition (figure 1.2-31).

Figure 1.2-31. *Infrared photograph of the shuttle during entry.*<sup>8</sup>

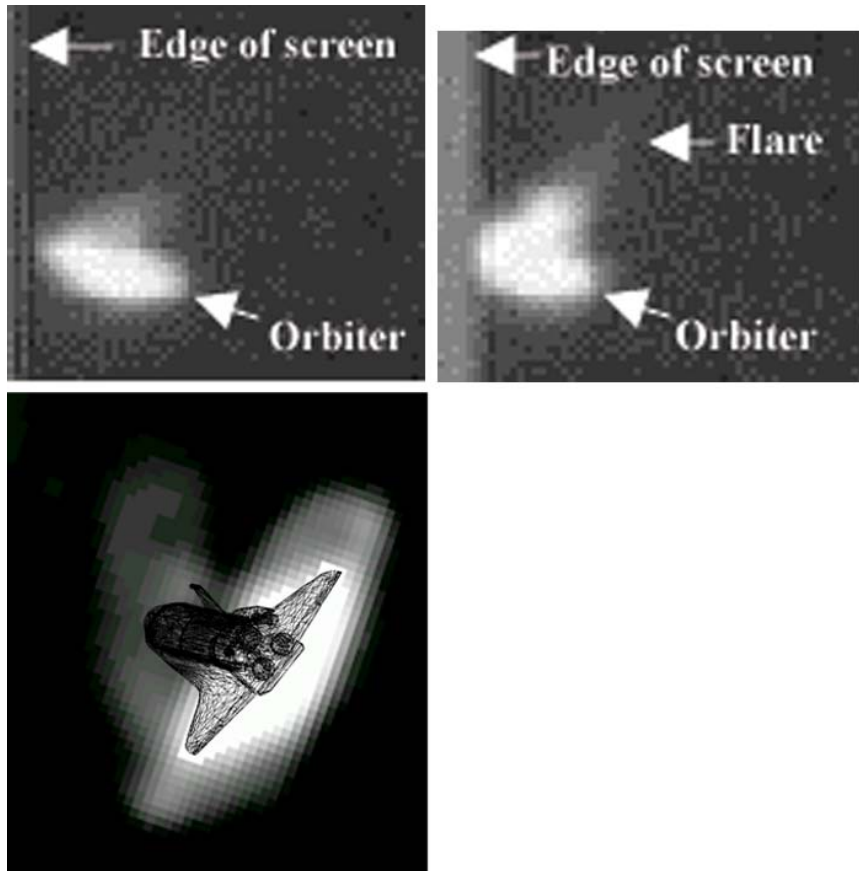
Flare 1 is an asymmetrical brightening of the orbiter shape at GMT 13:57:54.7 (EI+825) ±1 sec. This brightening was detected in images taken by a charge coupled device camera on a telescope, so its image is well magnified. Another brightening event was detected 6 seconds later (see GMT 13:58:00 (EI+831)). The two small images are the raw images from the data. The left image is interpreted to be the orbiter in a nominal condition. The image on the right is 0.4 second later. The larger image has been rotated to its correct viewing orientation and enhanced; a wireframe model of the orbiter at approximately the correct scale and orientation has been overlaid (figure 1.2-32).

Figure 1.2-32. Enhanced video captures showing the first observed flare in the trail.<sup>9</sup>

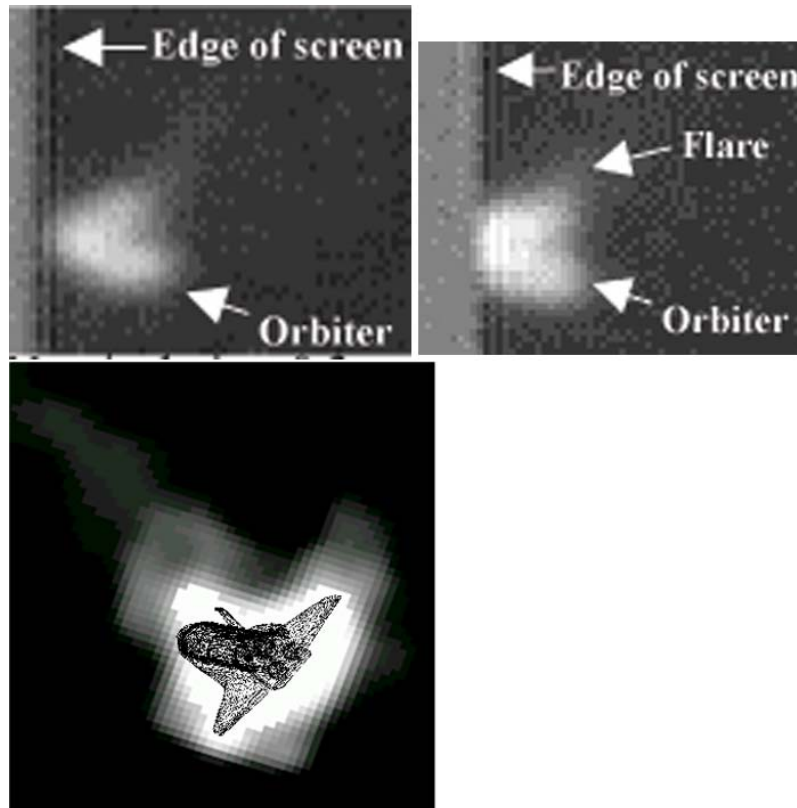
Figure 1.2-33. Enhanced video captures showing the second observed flare in the trail.

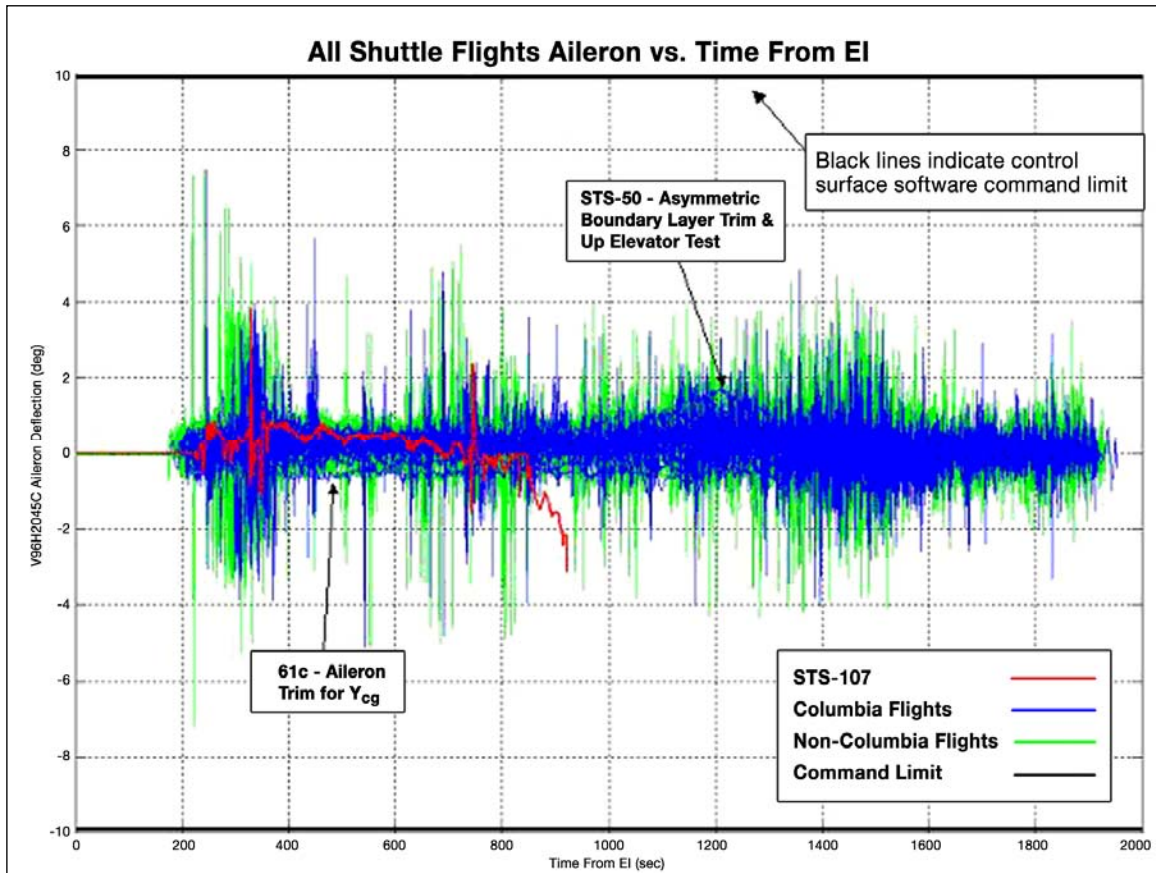
<b>Start of “Sharp” Elevon Trim Increase.</b> The FCS is now compensating for increasingly asymmetric aerodynamic loading and is commanding the elevon trim at a much higher than nominal rate. Time is uncertain (<math>\pm 10</math> sec) (figure 1.2-34). [Master Timeline Rev. 15] </p>

Figure 1.2-34. The sharp divergence from previous flight experience starts at approximately GMT 13:58:19 (EI+850).<sup>10</sup>

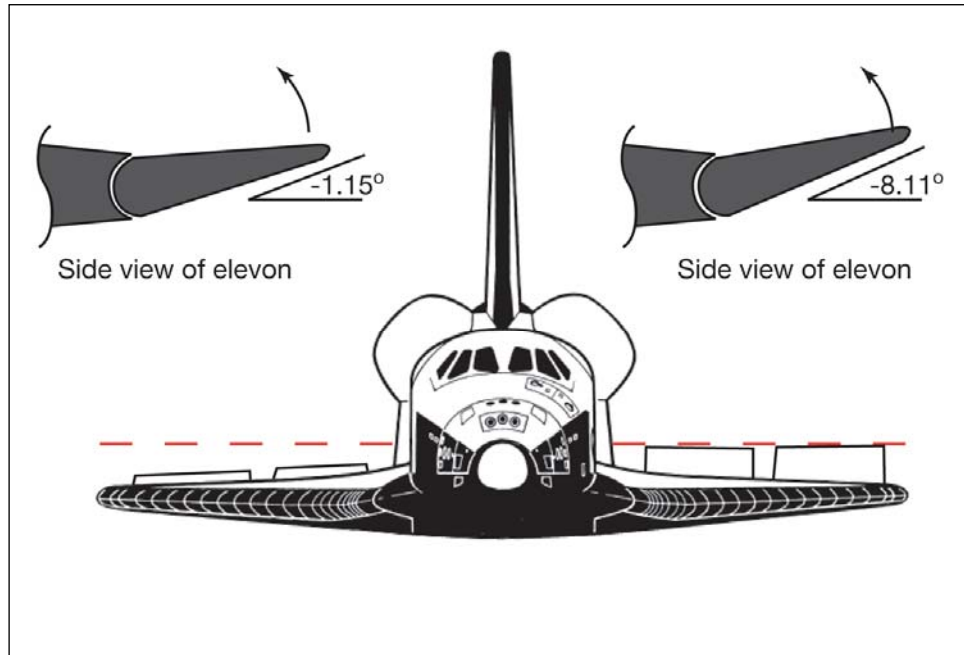
Last observed elevon deflections (figure 1.2-38):<sup>15</sup>

TIME	EVENT
	Left: -8.11 deg (deflected up) Right: -1.15 deg (deflected up)

Figure 1.2-38. Illustration of the last observed elevon deflections.

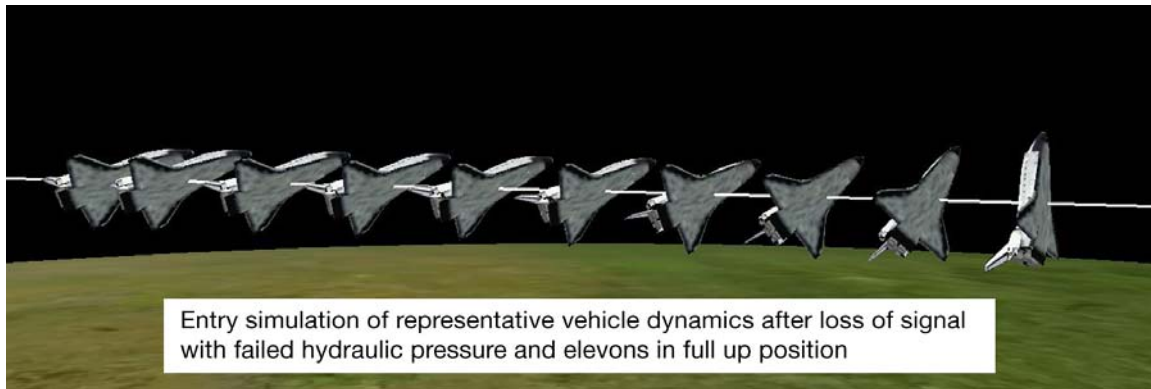
<b>Beginning of the Orbiter Pitch-up.</b> Based on the time of the ROLL REF message (GMT 13:59:46 (EI+937)) and the divergence from the drag profile required to generate the ROLL REF alarm, this is the probable time that control was lost due to the probable loss of hydraulic pressure to the control surfaces. The loss of hydraulic pressure would have resulted in a Master Alarm being annunciated and the orbiter pitching up. While the drag had yet to diverge out of bounds of the drag profile, the orbiter was no longer in controlled flight. This marks the beginning of the transition from a controlled glide to an uncontrolled ballistic entry. Orbiter heating, lift, and drag would no longer be controlled, the ballistic number would be constantly changing with the changing attitudes, and downrange control would be lost (figure 1.2-40).

Figure 1.2-40. Sequence (1-second intervals) showing a simulation of orbiter loss of control pitch-up from GMT 13:59:37 (EI+928) to GMT 13:59:46 (EI+937). White line indicates vehicle trajectory relative to the ground.

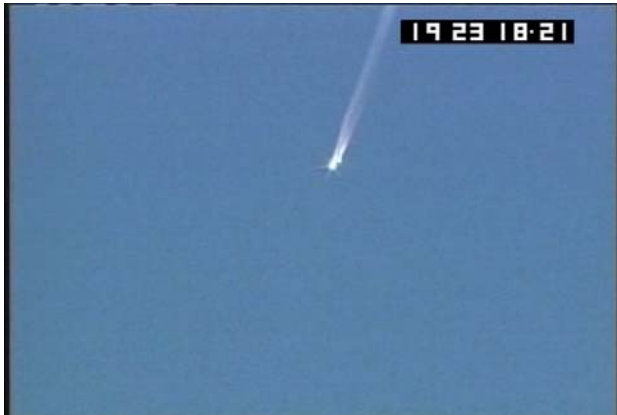
<b>Debris D (possible Left OMS Pod).</b> Video analysis identifies this as the earliest time at which Debris D is observed. Debris D was identified as possibly being the left OMS pod. (figure 1.2-42).</p>

Figure 1.2-42. Debris D is depicted in this frame.

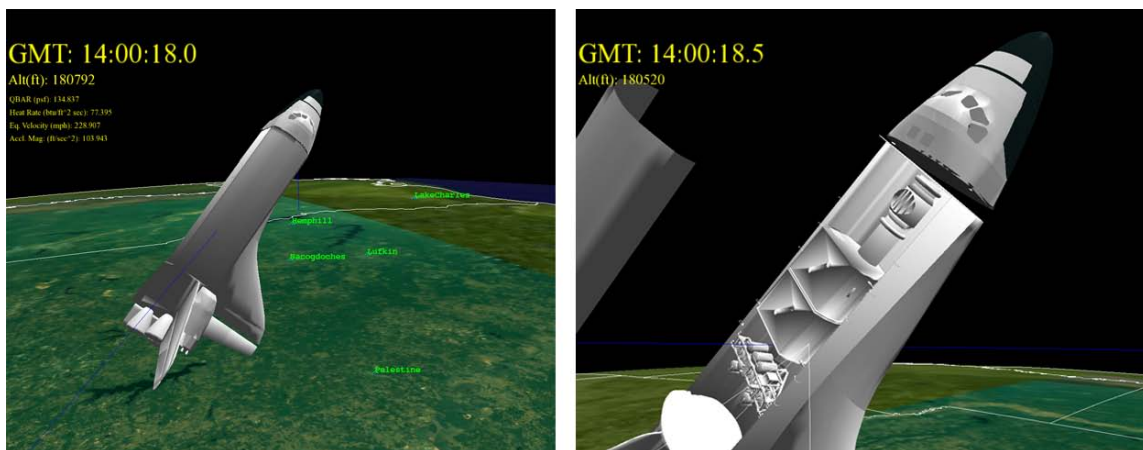
**CATASTROPHIC EVENT.** The CE is a period of time during which the orbiter vehicle is undergoing a major structural breakup. At this time, the accelerations on the forebody were estimated to be 3.5 Gs. The breakup sequence progressed over several seconds. Analysis of ground-based video of the event established the first detectable signs at GMT 14:00:18 (EI+969). Based on engineering analysis, the CE is thought to have started with the compromise of the PLBDs, exposing the payload bay longeron sill to entry heating. The skin splice between the midbody and the X<sub>0</sub> 582 ring frame bulkhead area, aft of the starboard x-link, failed due to a combination of mechanical and thermal loads. The forebody rotated away from starboard to port, causing the port x-link to fail due to bending loads. As the forebody separated from the midbody, various power, data, and ECLSS lines failed and the crew module was free to move forward and strike the inside of the forward fuselage. At GMT 14:00:25 (EI+976), the separated forebody is marginally visible. The CE is further supported by a collection of evidence that includes ground-based video of a large debris-generating event, the loss of the MADS/OEX recorder function, and the debris footprint (figures 1.2-43 and 1.2-44).

Figure 1.2-43. The Catastrophic Event is depicted in these three frames of video that cover 0.1 second. There is no change in the magnification/zoom factor. The third frame represents GMT 14:00:18.3 (EI+969.3).

Figure 1.2-44. Simulation of the Catastrophic Event.

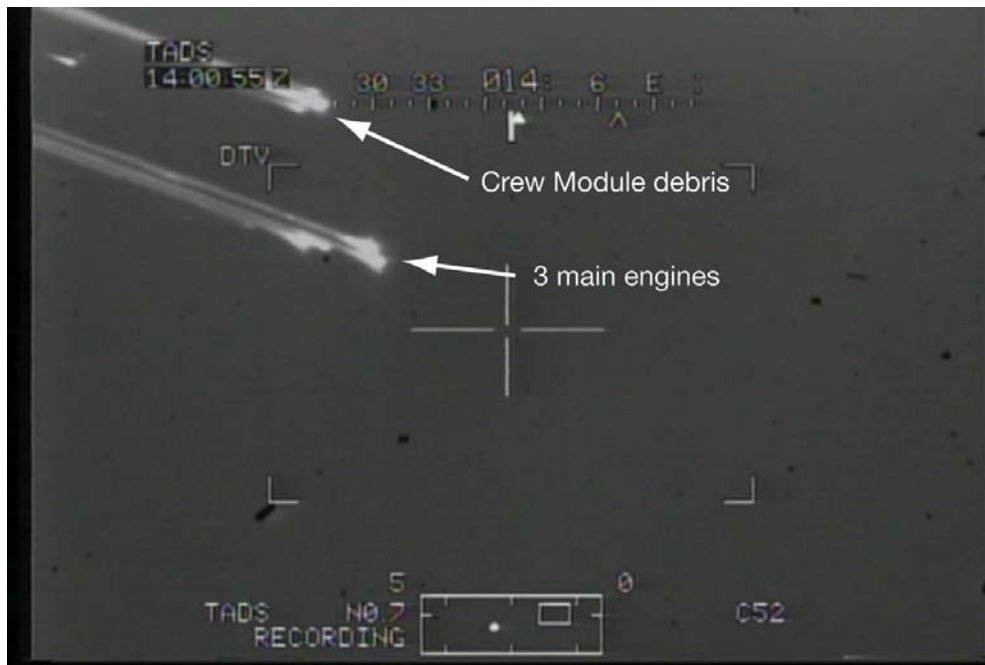
<b>CREW MODULE CATASTROPHIC EVENT Begins.</b> The CMCE is the initiation of a period of time during which the forebody was undergoing a major structural breakup. The breakup sequence progressed over several seconds and ends at approximately GMT 14:01:10 (EI+1021). Analysis of ground-based video of the event established the first detectable signs at GMT 14:00:53 (EI+1004). Based on engineering analysis, CMCE is thought to have started with the failure of the forward fuselage. Once the forward fuselage began to break away, the exposed crew module rapidly failed due to the combined effects of the high G-loads, aerodynamic forces, and thermal loads. The flight deck maintained structural integrity longer than the middeck (figure 1.2-47).
--------------------	--

Figure 1.2-47. Image from Apache<sup>35</sup> video showing crew module debris (top cluster) and the three main engines (cluster to left of cross hairs).

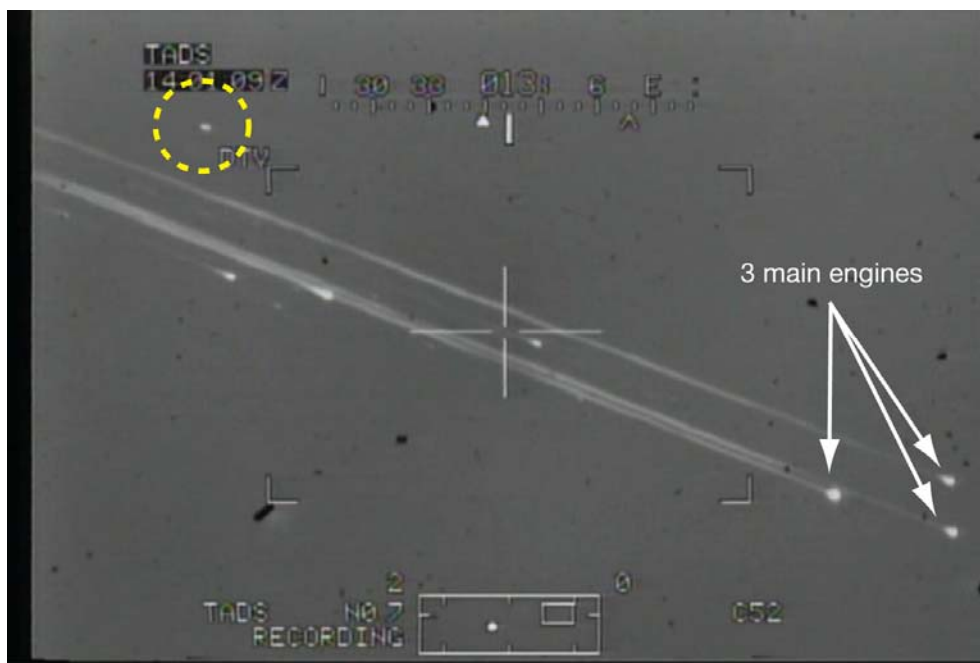
<b>TD –</b> Forward fuselage and crew module have fragmented into pieces too small to be detected on any of the ground-based videos (figure 1.2-48).
--------------------	--

Figure 1.2-48. Image is from the Apache video. Dotted circle indicates area where crew module debris is last visible. The three points in the lower right are the three main engines.

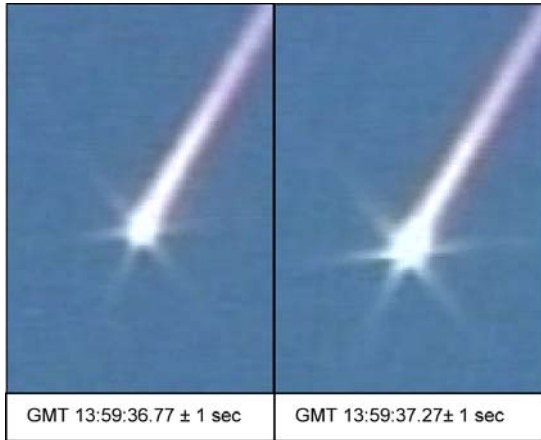
Significantly, ground-based video shows a marked change in the appearance of the orbiter’s trail at GMT 13:59:37 (immediately after the end of the first RGPC data set, RGPC-1) (figure 2.1-5). The width of the trail increases at this time, which likely indicates a change in the orbiter’s flight condition. In addition to the change in the width of the trail, the trail appears to pulse or “corkscrew” over a period of less than 1 second. It is possible that a large debris event (such as loss of a major portion of the wing) may have caused

**Figure 2.1-5. Noticeable change in brightness at GMT 13:59:37±1 second.**

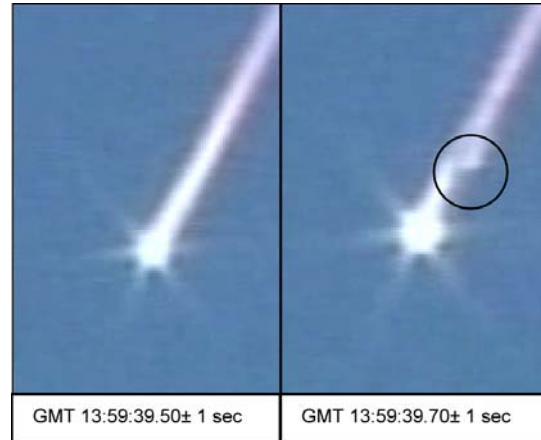
the LOC. However, the debris event closest to the LOS that was apparent in the video occurred 2 seconds, or more than 60 frames (figure 2.1-6), after the change in the trail's appearance. This suggests that it was subsequent to the LOC and was not the cause. Video time errors are up to 1 second, but the relative sequence of the events (brightening, followed by a debris event) is not changed.

**Figure 2.1-6. Noticeable debris shedding event (circled at right) at GMT 13:59:39±1 second.**

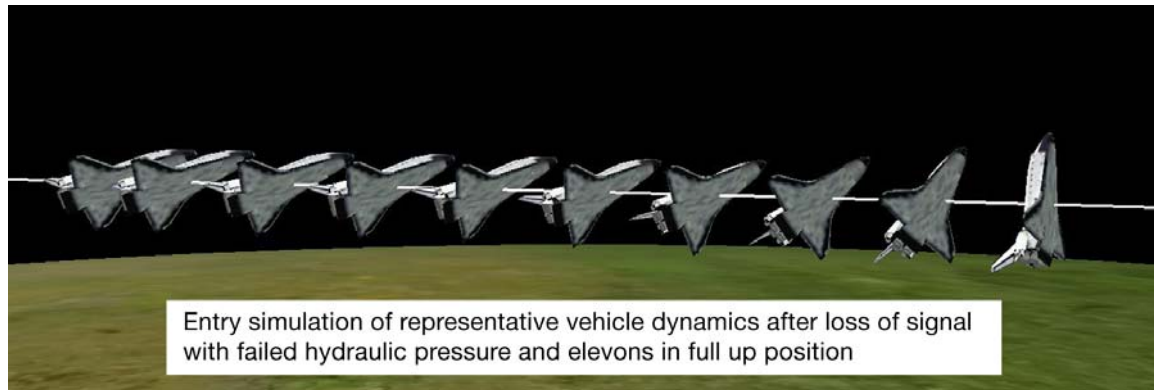
It was concluded that the most credible scenario for LOC was the loss of all hydraulic systems, causing the aerosurfaces to float and resulting in an uncontrolled pitch-up. Since the left wing contains locations where all three hydraulic systems have lines that are in close proximity (including the left gear well), it is probable that the loss of hydraulics was due to thermal damage as a result of the breach in the wing. Consequently, the SCSIT defined the vehicle LOC to begin at GMT 13:59:37, immediately after the LOS, when it was determined by inference that hydraulic power to the aerosurfaces was lost. Prior to this time, *Columbia's* DAP was still in control of the orbiter. The FCS was commanding the elevons and the RCS yaw jets to counteract the increasing drag on the damaged left wing. The LOC marks the time when the *ability* to control the vehicle was lost, not when *Columbia* departed known attitudes (which occurred shortly thereafter).

Figure 2.1-7 shows the increasing angle-of-attack simulation. The figure shows the orbiter attitude at 1-second intervals, beginning at GMT 13:59:37 and ending at GMT 13:59:46. The white line in the figure is the reference trajectory.

**Figure 2.1-7. Sequence (1-second intervals) showing a simulation of orbiter loss of control pitch-up from GMT 13:59:37 to GMT 13:59:46. White line indicates vehicle trajectory relative to the ground.**

**Recommendation L3-2.** Future vehicles should be designed with a separation of critical functions to the maximum extent possible and robust protection for individual functional components when separation is not practical.

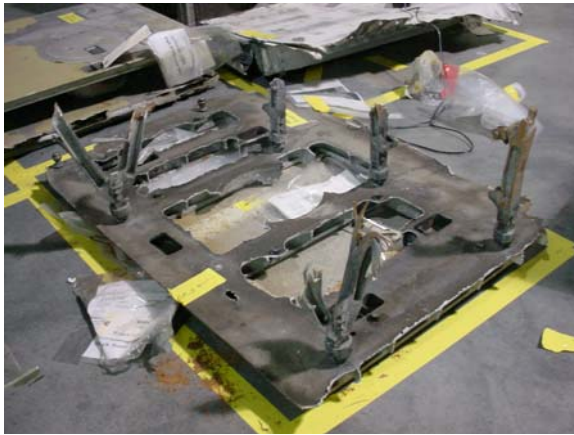
The lithium hydroxide (LiOH) stowage volume door was recovered with portions of the two seats still attached (figure 2.1-33). The LiOH door is located on the middeck floor with seats 6 and 7 attached to the door (figure 2.1-34). The condition of the door was markedly different from other segments of the middeck floor in that significant thermal erosion of the thinner areas had occurred (see Section 2.4). The hypothesis was formed that additional mass attached to this piece of debris resulted in higher heating. A thermal analysis was performed to determine whether the additional mass provided by the two seats and/or two crew members would result in the observed thermal damage.

Figure 2.1-33. Recovered lithium hydroxide door with some seat legs still attached.

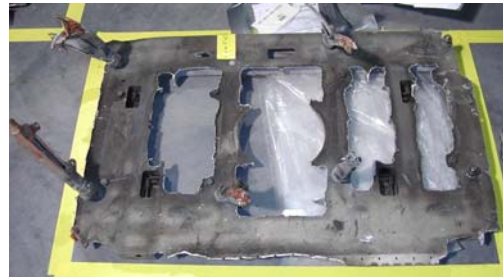
Photographs of the recovered LiOH door are shown in figures 2.1-36 and 2.1-38. The thermal failure corresponds to the thin sections of the door. Sections that are thicker show little or no thermal erosion. From observations of the material deposition patterns and the burn-throughs on the recovered door, the major thermal effects were directional, with flow impinging primarily on the bottom side (the side with the stiffeners). This is supported by the highly directional deposition on seats 6 and 7 (see Section 3.1).

Figure 2.1-36. Top surface of the recovered lithium hydroxide door, facing the middeck.

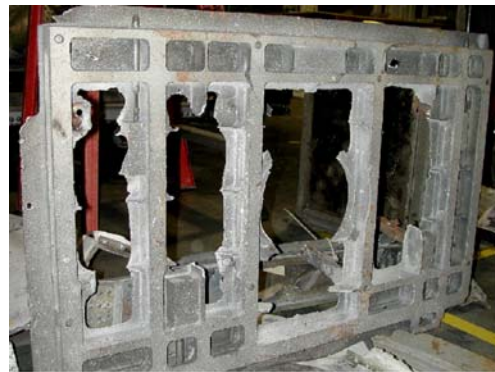
Figure 2.1-38. Lower surface of the recovered lithium hydroxide door, facing the lower equipment bay.

For the GMT 14:00:59 estimated release time, the analysis implies the third and fourth configurations (door with one and two crew members, respectively) can produce the thermal damage observed on the recovered LiOH door. Since visual inspection of the recovered door suggests that the object was not tumbling, the stable fourth configuration is the most thermally viable solution. However, both the third and the fourth configurations are improbable because the thermal effects would have melted the seat straps and released the crew members. The surrounding debris was evaluated to determine whether the LiOH inside the compartment caught on fire. Significant portions of LiOH canisters were recovered as well as other items stored in the compartment. Both the canisters and the structures of the compartment were not seriously thermally damaged, which strongly suggests that a fire did not occur.

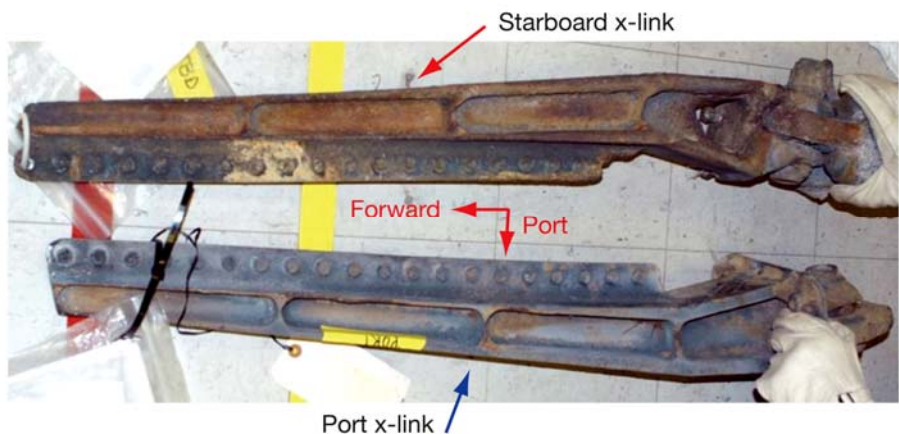
Figure 2.1-47. Comparison of port and starboard x-links recovered from Columbia. [Columbia Reconstruction Database, debris item no. 1678, and Columbia Reconstruction Database, debris item no. 1765]

Examination of the recovered CM attachment fittings, known as the x-links, identified intriguing thermal damage. The two x-links attach the CM to the FF and the midbody and carry load in the orbiter X body axis (see Section 2.4 for diagrams of structure). While both x-links showed melting in the same relative locations, the starboard x-link displayed more thermal damage than the port x-link. Because the x-links are composed of Titanium 6Al-4V, which has a melt temperature of approximately 3,000°F (1,649°C), very high heating is required to create the damage that was observed on the recovered x-links. Analyses were performed to determine the thermal mechanism that could have caused this damage. Figure 2.1-46 shows a model of a pristine port and starboard x-link, while figure 2.1-47 shows the two recovered *Columbia* x-links placed side by side.

**Finding.** Thermal analyses predicted that entry aeroheating alone was insufficient by an order of magnitude to produce the observed thermal damage on the x-links. Therefore, the x-links must have experienced other heating mechanism(s) in addition to normal entry heating.

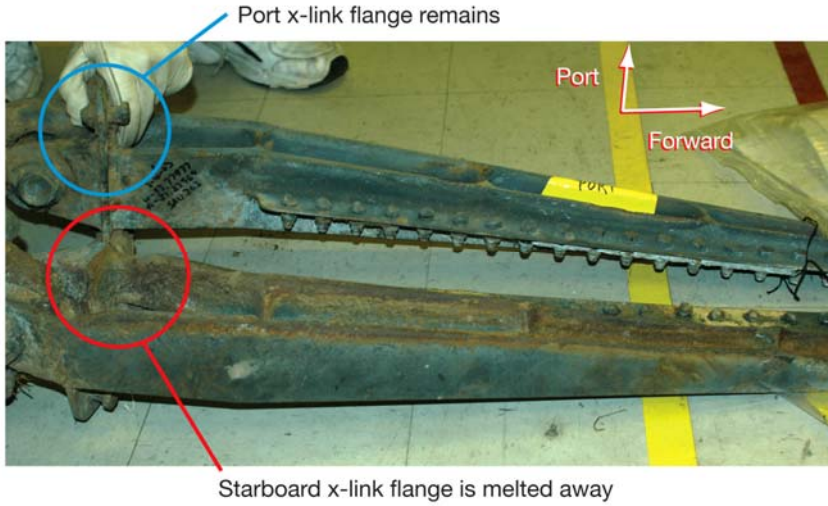
Figure 2.1-48. Comparison of port and starboard x-link flanges. [Columbia Reconstruction Database, debris item no. 1678 (top) and Columbia Reconstruction Database debris item no. 1765 (bottom)]

The heating experienced by the starboard x-link was severe enough to melt away the top flange and to burn a hole through the 0.25-in.-thick web. Figure 2.1-48 shows another comparison of the two x-links with a better viewing angle to see the flange damage. Figure 2.1-49 shows a close-up view of the starboard x-link where a hole has been melted through the web.

**Conclusion A13-2.** The heating from a Type IV shock-shock impingement and titanium combustion (in some combination) likely resulted in the damage seen by the forward payload bay door rollers and the x-links.
