# ***Columbia* Crew Survival Investigation Report**

NASA/SP-2008-565

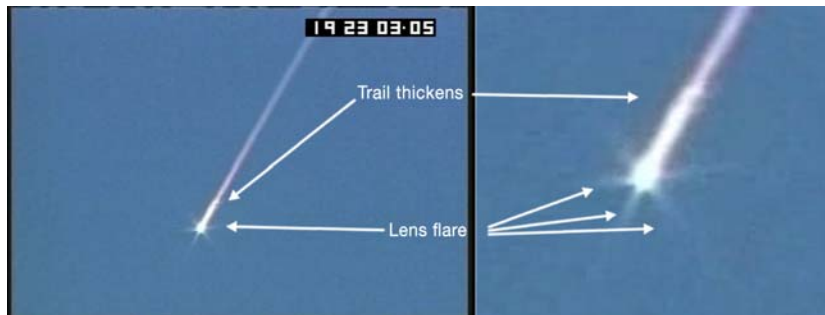
Figure 2.2-3. GMT 13:59:37.43, 13 frames after figure 2.2-2. Right image is a zoomed view of the left image.

Figure 2.2-1 is the first frame of video for the eastern timeline. Figure 2.2-2 shows GMT 13:59:37, 135 frames (4.5 seconds) after figure 2.2-1. Figure 2.2-3, which shows 13 frames (approximately 0.5 second) after figure 2.2-2, correlates to LOC at GMT 13:59:37. The width of the trail increases at this time, which likely indicates a change in the flight condition. In addition to the change in the width of the trail, the trail appears to pulse or “corkscrew” over a period of less than 1 second (figure 2.2-4). This is consistent with the motion analysis, which suggests that the orbiter went into a flat spin.

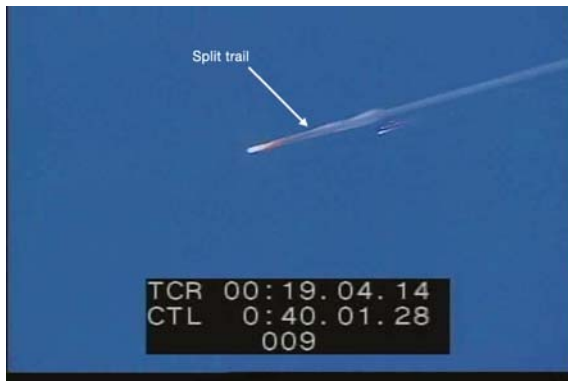
Figure 2.2-6. Split trail after the Catastrophic Event. [GMT 14:00:18.6]

Shortly after the brightening event and color change, a split trail is seen (figure 2.2-6). This strongly supports that the orbiter broke into multiple pieces at the time of the CE. The NBC video shows that the orbiter has an intermittent split trail prior to the CE. Prior to the CE, the split trails are tied to the separation of pieces of debris, and a singular main body trail continues after the separation of the debris. The split trail seen after the CE is constant; it does not dissipate and does not resolve back to a singular trail (figure 2.2-7).

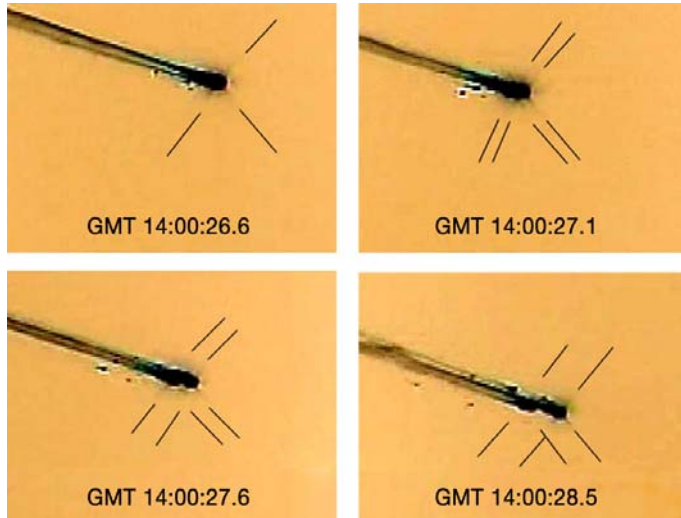
Figure 2.2-8. Color-inverted video images of the start of the double star event (GMT 14:00:26.6). Black lines have been added to more clearly identify the two separate objects.

Due to camera effects of saturation of pixels, magnification settings, distance to the orbiter, and angle of view of the orbiter, visual separation of the major pieces of the orbiter is not identifiable until 8 seconds after the CE. The visual separation of the orbiter into separate identifiable pieces is first made evident by the appearance of a second “star” beside the first “star.” Figure 2.2-8 uses reversed color (“inverted”) images of the orbiter to more readily show the “star” (lens flares). The dark lines on the images are shown in an effort to illustrate the lens flares.

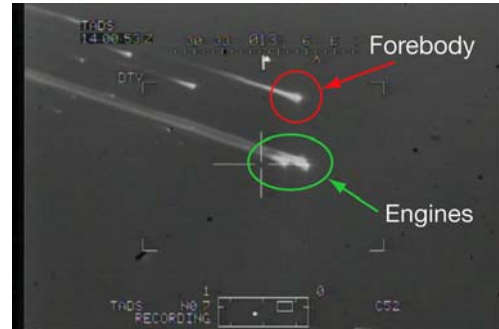
Figure 2.2-10. Clear visual separation of the three main engines.

The last time at which the main engines visually appeared to be a single unit is GMT 14:00:50.6; this is defined as the starting point for engine separation. Figure 2.2-10 shows the engines at GMT 14:00:53, the three pieces below the forebody which are circled in green. Their separation is already well under way. Considering that visual separation of the orbiter pieces after the CE took about 10 seconds, the actual time of separation of the engine components from one another may have been

much earlier than GMT 14:00:50.6. Available data do not allow for a more accurate time of separation.

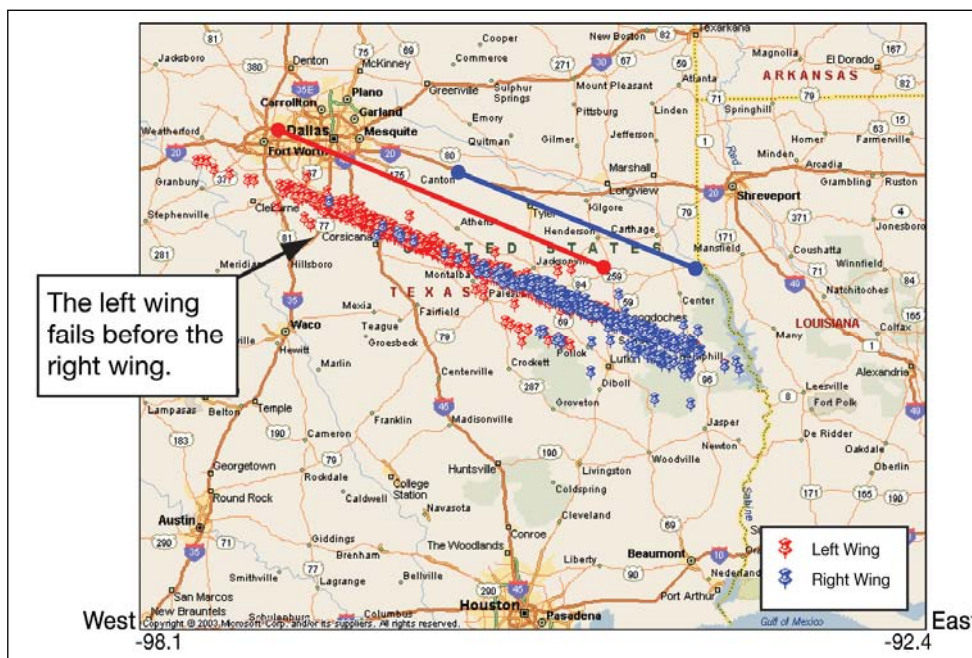
Figure 2.2-12 identifies where the wing structure is in relationship to the other orbiter structural components. TPS tile is included in these figures, as some tile adhered to structure and it was not easily possible to separate out individual tiles. Figure 2.2-13 shows a ground debris map that is similar to that produced in the CAIB Report, Volume I, p. 75; however, figure 2.2-13 shows all the debris for the wings whereas the CAIB map shows only the RCC panels. As the CAIB reported, the left wing failed before the right wing. This is implied in figure 2.2-14 as well. Overlay mapping of debris at their correct latitudes and longitudes prevents easy recognition of their actual ground footprints. The bars shown on the map and in later ground debris maps represent the main cluster of the debris. If coverage extends beyond the map shown, an arrow indicates that the footprint continues off the map. The bar shown above each histogram indicates the longitude range covered by the overlay mapping.

Figure 2.2-13. Debris field of the left and right wings.

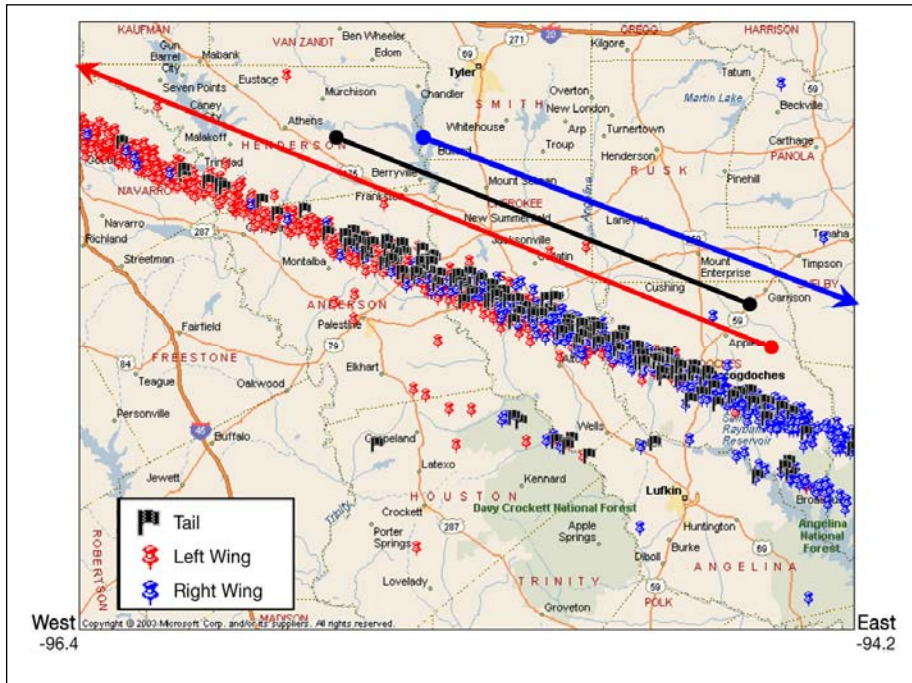
Figure 2.2-14 illustrates the debris of the tail section in relation to the wing debris. The bulk of the tail debris impacted west of the bulk of the right wing debris. Figure 2.2-15, which is a histogram of longitude vs. the number of debris items, shows this as well. The lines above the histogram indicate the approximate area of the histogram that the debris map covers. Figure 2.2-15 suggests that the tail possibly began to depart between the left wing and the right wing.

Figure 2.2-14. Partial debris field of the left wing, right wing, and tail.

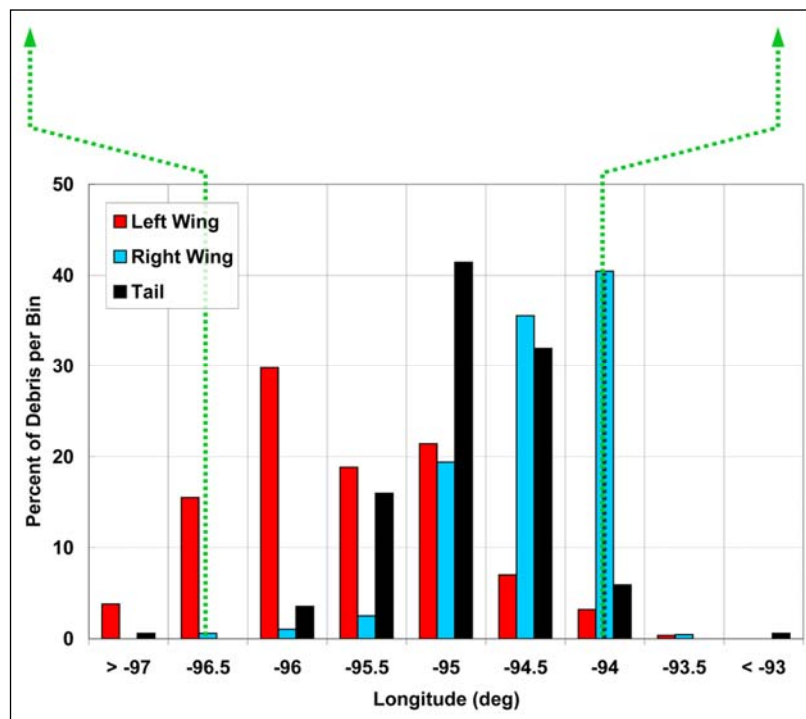
Figure 2.2-15. Histogram of the left wing, right wing, and tail debris. The green dotted lines are the projection onto the histogram of the longitude range shown in the map.

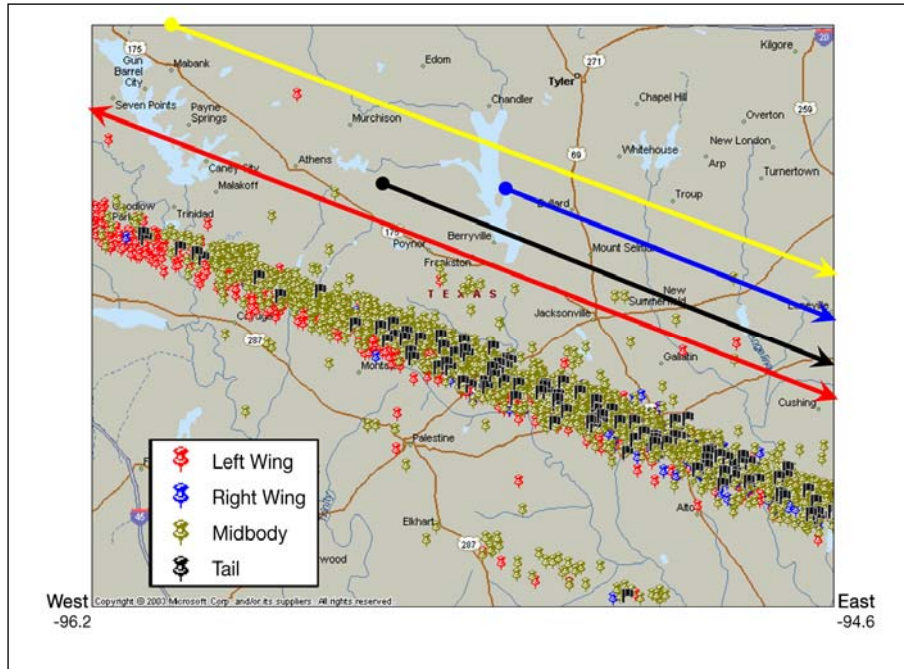
Figure 2.2-12 identifies where the midbody is related to the other orbiter structural components. The midbody consisted of the mid fuselage, payload bay, and PLBDs (SPACEHAB is not included in this chart). The midbody began losing structure and shedding objects after the left wing but prior to the tail (figures 2.2-16 and 2.2-17). The midbody debris shown is comprised predominantly of PLBD structure, although pieces of the midbody are scattered throughout the entire debris field.

Figure 2.2-16. Partial debris field of the left wing, right wing, midbody, and tail.

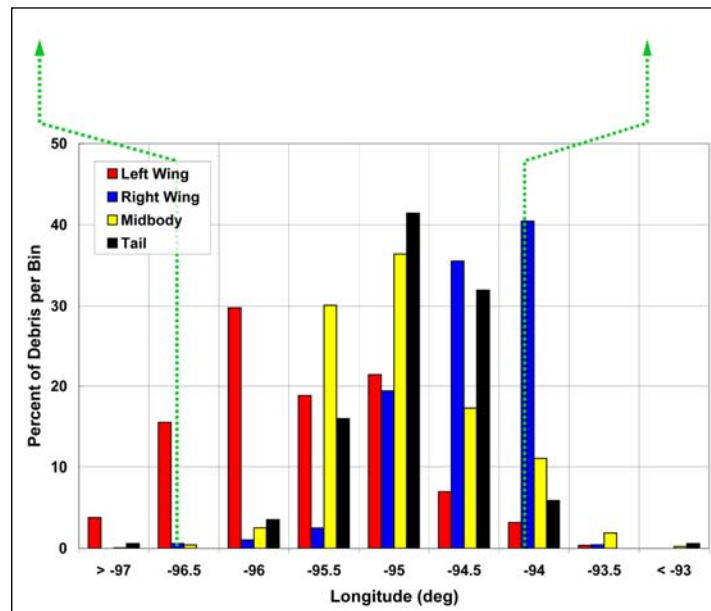
Figure 2.2-17. Histogram of the percentage of debris found vs. longitude for the left wing, right wing, midbody, and tail. The green dotted lines are the projection onto the histogram of the longitude range shown in the map.

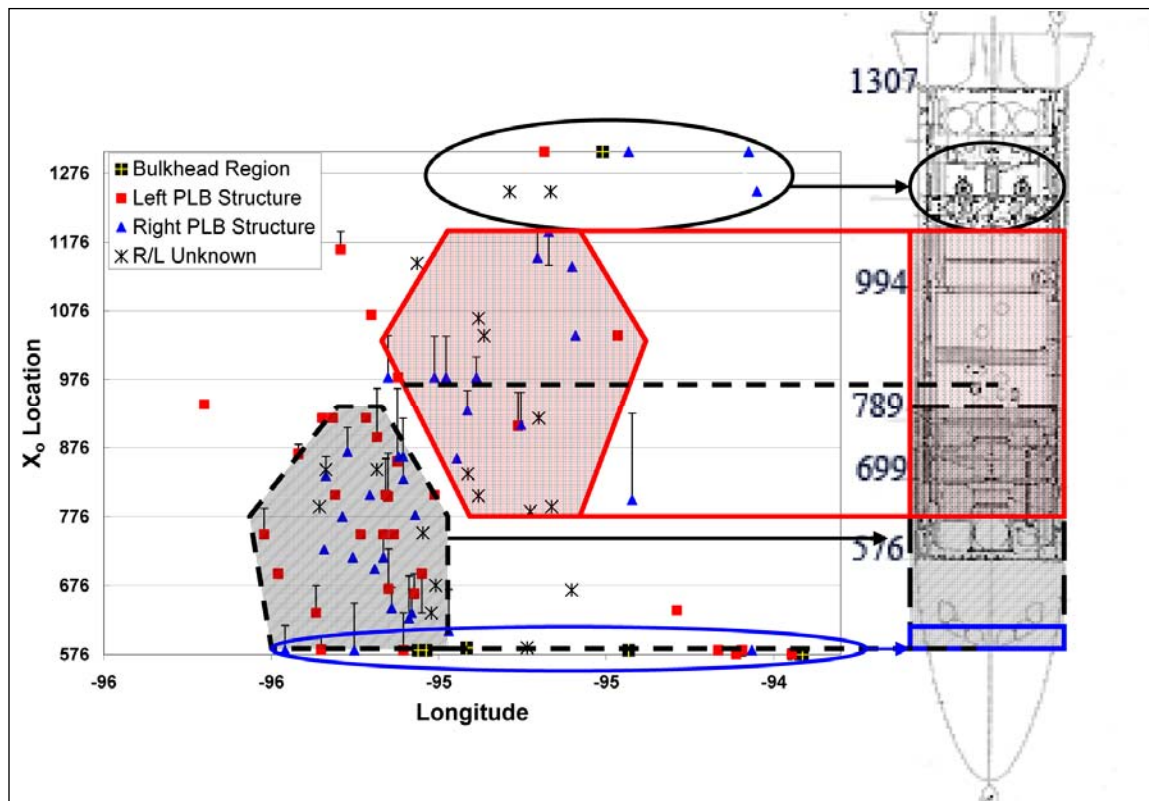
The westernmost piece of ground debris from the midbody structure with a known  $X_o$  location was a port location just aft of SPACEHAB. However, this appears to be an outlier data point. Figure 2.2-18 indicates that based upon recovered midbody structure, the midbody first suffered a major failure ranging from about  $X_o$  582" to  $X_o$  919".

The next grouping of debris predominantly originates from  $X_o$  776" (towards the aft of SPACEHAB) to aft of the Fast Reaction Experiments Enabling Science, Technology, Applications, and Research (FREESTAR) payload near  $X_o$  1124", although there are a few pieces near the forebody bulkhead ( $X_o$  582").

The final cluster is from the aft region of the midbody. As debris originating from near the midbody aft bulkhead ( $X_o$  1307") appears farthest east in the debris field, this suggests that some midbody payload bay structure remained attached to the aftbody.

Figure 2.2-18. Longitude vs. the  $X_o$  origin of the structural debris of the mid fuselage. To the right is a drawing of the mid fuselage with key  $X_o$  positions marked.

The data in figure 2.2-18 cannot be used to determine a port or starboard initiation of breakup of the midbody. Size of individual items was also examined with the assumption that ballistic numbers of objects of roughly the same size and shape will land in the order in which they separate from the orbiter. The number

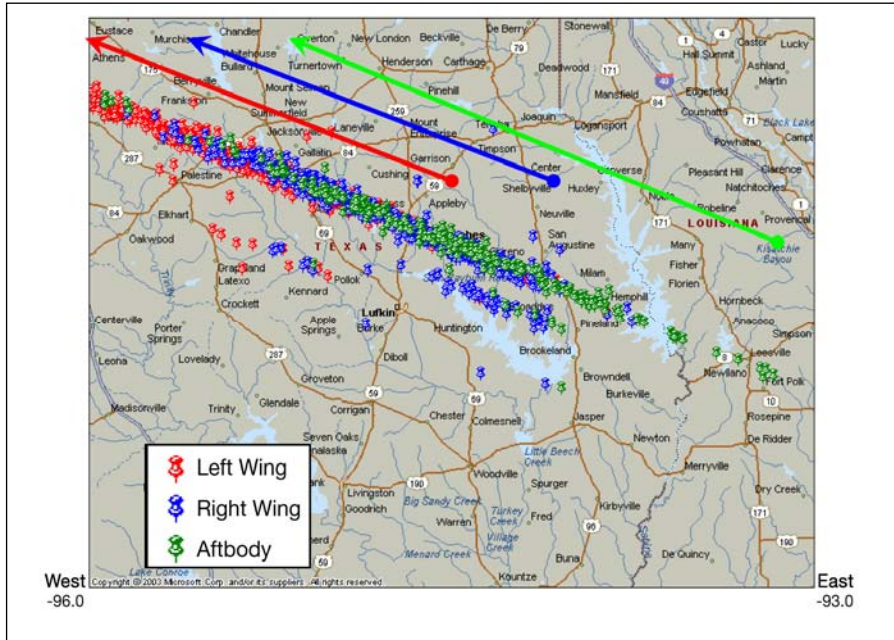
Figure 2.2-19. Partial debris field of the left wing, right wing, and aftbody.

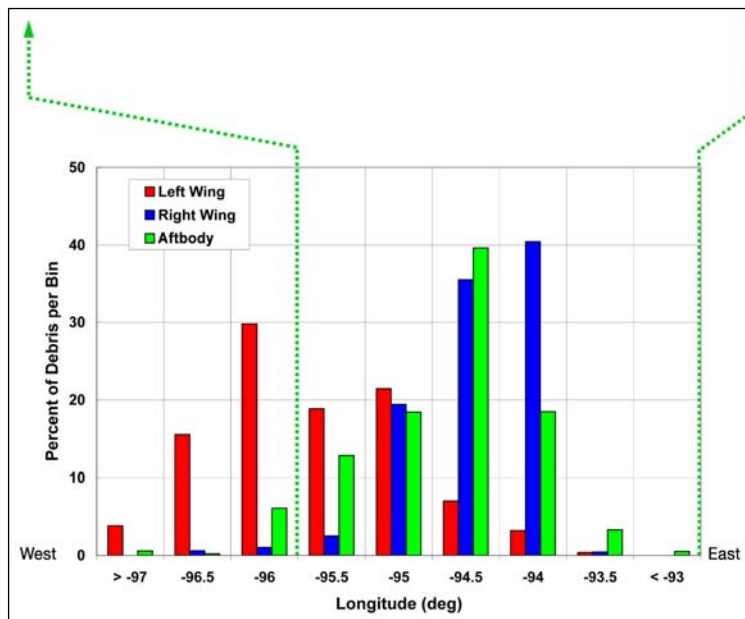
Figure 2.2-20. Histogram of debris of the wings and aftbody (including orbiter main engines). The green dotted lines are the projection onto the histogram of the longitude range shown in the map.

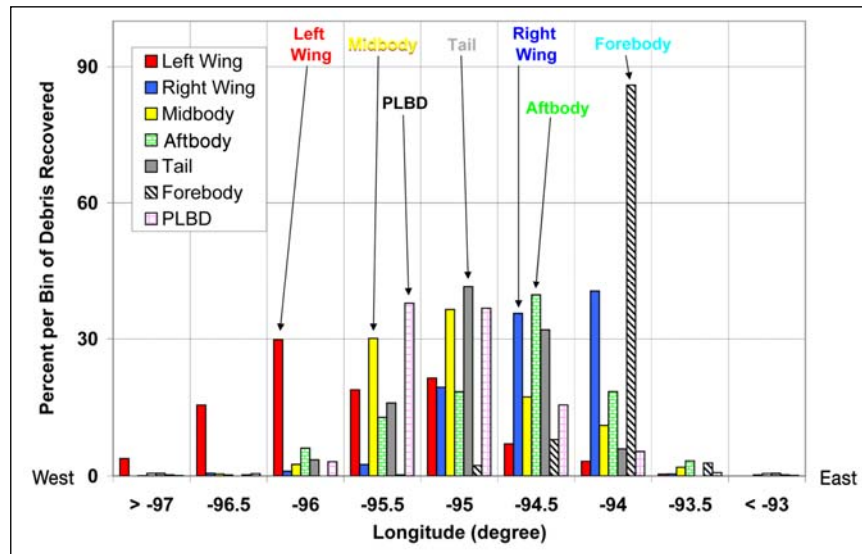
In summary, figure 2.2-21 shows an overall assessment of debris clusters. The westernmost longitude bin of each group that exceeded 30% of the recovered debris group is referenced with an arrow; the label above the bin identifies the debris group. It was observed that when the number of recovered debris items from one orbiter structural zone reached approximately 30%, the next group began to appear in rapidly increasing numbers. The significance of this observation is not known. It may be an artifact of data processing, or it may be characteristic of a cascade effect of structural breakup. This is a topic that may warrant further research and investigation.

Figure 2.2-21. Histogram of the relative order of the major debris groups recovered.

There was no evidence from the ballistic or debris cluster analysis that the forebody suffered any major breach before it separated from the midbody. Figure 2.2-21 (in the debris cluster assessment section) shows that forebody debris does not begin to appear in the debris field until other midbody debris is present in large quantities.

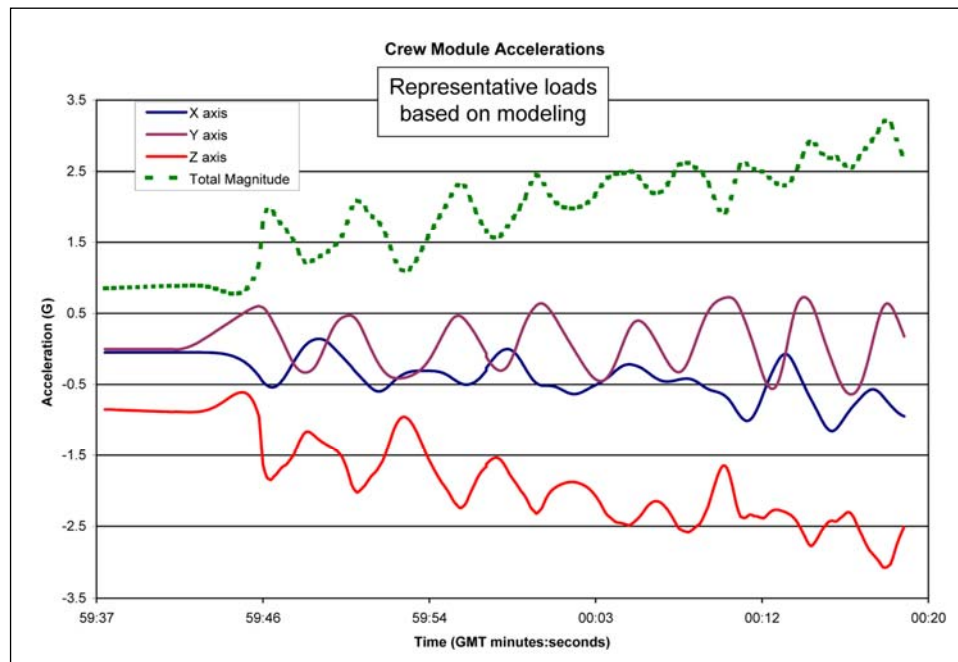
It is unlikely that any part of the FF experienced major structural failures under the estimated loading before the CE. A motion analysis was performed to compute loads at key locations after the LOC of the orbiter (see Section 2.1). Figure 2.2-26 shows that the estimated G loading at the CM increased to slightly more than 3 G just prior to the CE. Acceleration along the vehicle's Z axis (G<sub>z</sub>) is the major component. This analysis assumed intact PLBDs. Loss of the doors may have increased loads in unknown ways such that the motion may have been affected. Assuming that the PLBDs were still intact, the results indicated that inertial loads were within the orbiter vehicle design limits.

Figure 2.2-26. Resultant acceleration (G) vs. time prior to the Catastrophic Event in the orbiter coordinate frame.

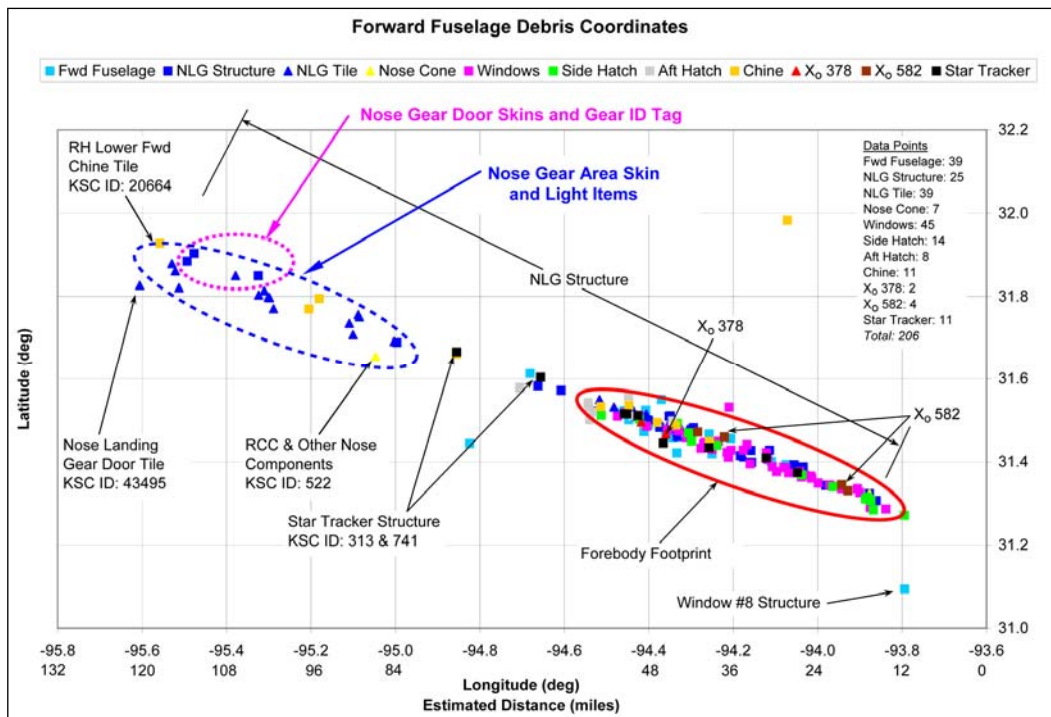
Most of the FF debris components that were recovered west of the main forebody debris field were TPS fragments and external items such as star tracker doors that came from the forward section of the FF, probably due to warping of the skin and aerodynamic loads as the forebody rotated (figure 2.2-27). Approximately 87% of the remaining FF structural debris has the same footprint as the CM debris footprint. This implies that the significant FF structural breakup occurred nearly coincidental with the CM shell breakup.

Figure 2.2-27. Forward fuselage debris field.

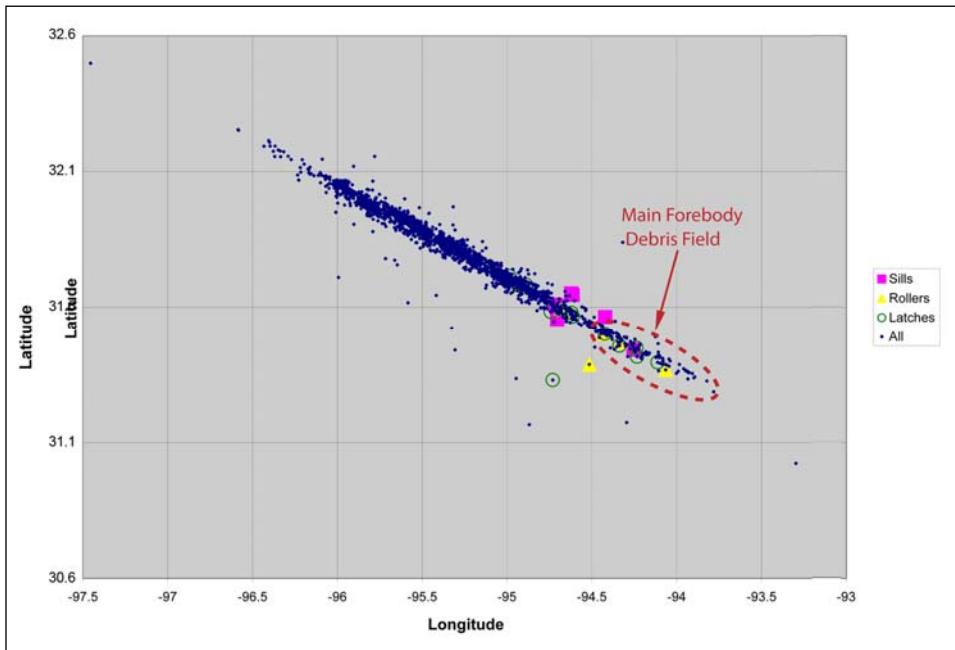
Figures 2.2-28 and 2.2-29 show the debris field coordinates for the recovered PLBD debris and a comparison of the PLBD vs. payload bay structures. Ballistics analysis showed very late release times (well past the CMCE)

that were considered suspect and assumed to contain errors due to lift generation and/or cascading events. Evaluation of the PLBD debris vs. payload bay structures shows that the debris field was extremely long, suggesting a very complex breakup and cascading event.

Figure 2.2-28. Payload bay door debris footprint relative to the main crew module debris field.

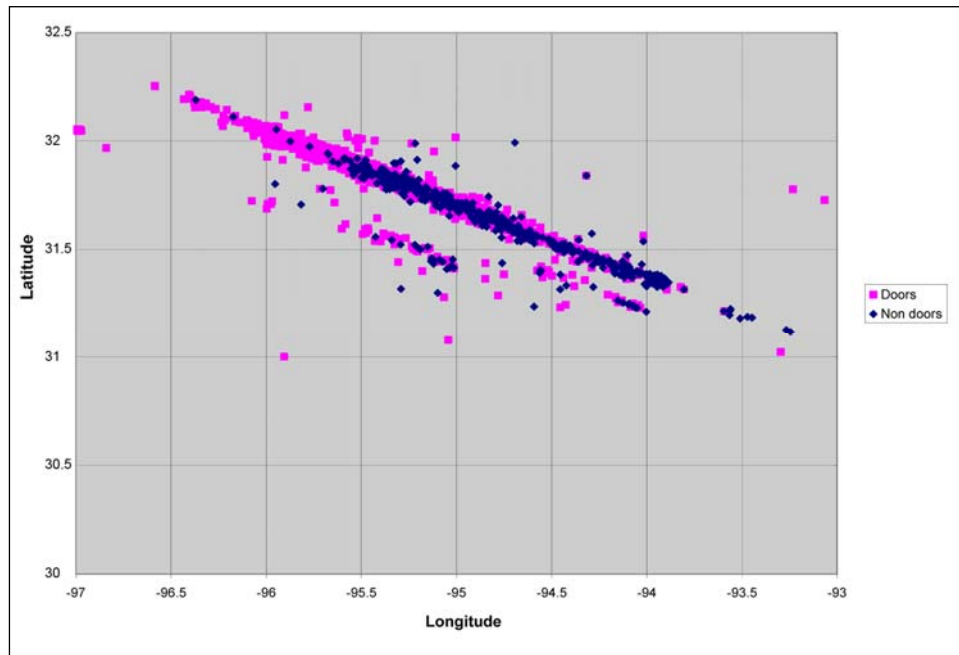
Figure 2.2-29. Payload bay door debris footprint relative to the payload bay structure.

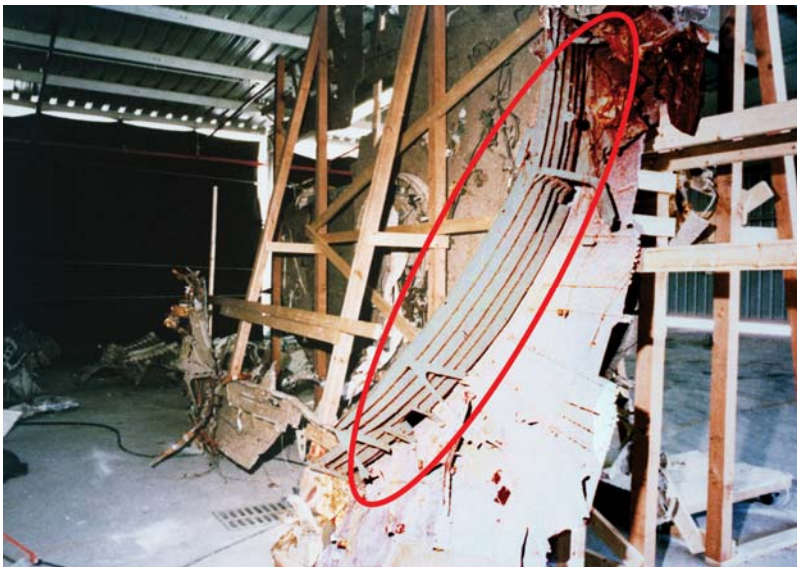
However, the SCSIT review of *Challenger* debris photographs clearly showed that part of the X<sub>o</sub> 582 ring frame bulkhead was recovered with the *Challenger* X<sub>o</sub> 576 bulkhead debris (figure 2.2-30).

Figure 2.2-30. Recovered X<sub>o</sub> 576 bulkhead of the *Challenger* crew module showing a portion of the X<sub>o</sub> 582 ring frame bulkhead (circled in red).

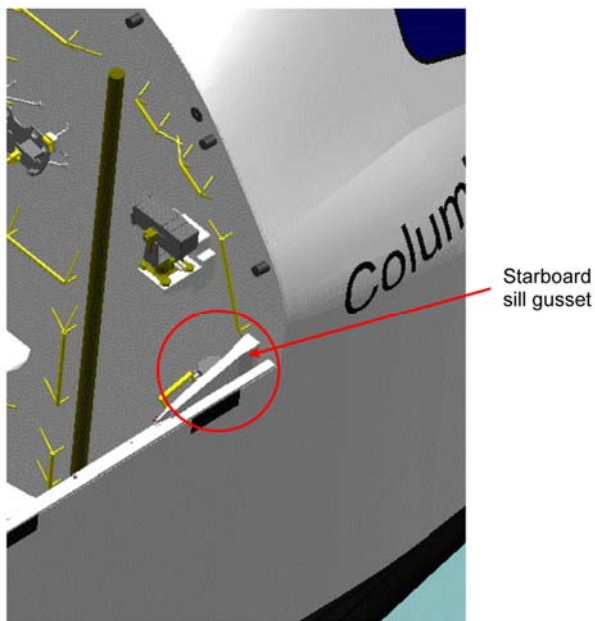
Without the PLBDs, the weak zone between the forebody and the midbody is the sill joint gusset on the aft side of the X<sub>o</sub> 582 ring frame bulkhead (figure 2.2-31). This gusset is an offset structural connection that transfers the major X-axis loads from the CM to the midbody sill longeron via the x-links.

Figure 2.2-31. Close-up of the starboard sill gusset area.

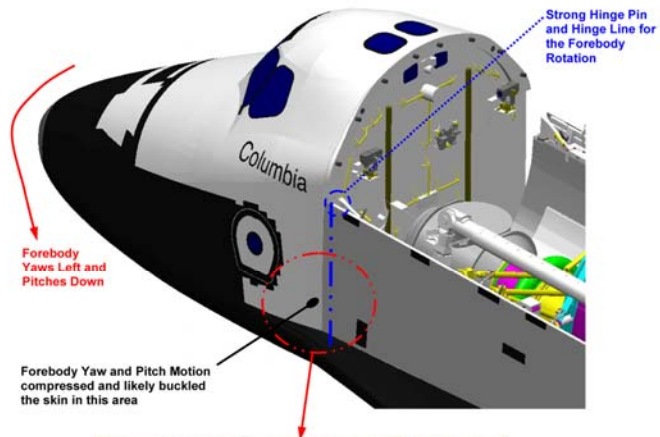
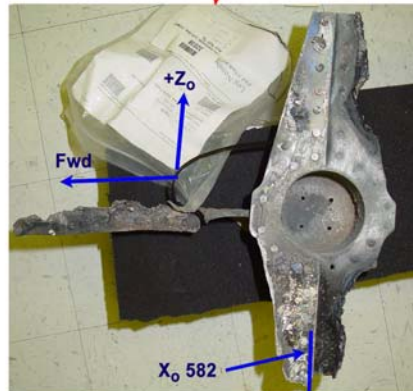
The condition of the recovered forward portside hoist fitting (figure 2.2-34) indicates that the Xo 582 ring frame bulkhead likely broke away from the midbody skin via mechanical failure, prior to any thermal effects. The Bay 1 side skin pulled away because of mechanical failure. The midbody skin splice severed the fasteners from the titanium hoist fitting by mechanical force, some Hilok bolts were cut off, and some flush bolt heads pulled through the skin splice. This damage, which may have occurred at the CE, suggests that the forebody yawed left and pitched down relative to the midbody. This motion may also have broken the port x-link lug (discussed in the next section). This kind of mechanical failure could only happen when the hoist fitting was still attached to the FF, when sufficient mass existed to exert this level of force.

Figure 2.2-34. Forward port hoist fitting, Columbia Reconstruction Database debris item no. 32038.

Unlike the starboard hoist fitting, the skin panel forward of the port hoist fitting was not recovered. One possible explanation is that the FF skin on the forward side of this item was deformed or wrinkled by compression loading at the CE when the forebody yawed left and pitched down. This may be supported by the fact that the port forward hoist fitting was recovered in the middle of the forebody debris field while the starboard hoist fitting was found in the western end of the debris field. Wrinkled skin most likely debonded TPS tiles, so this area would be subjected to thermal flow damage on at least the skin-side surface starting at the CE, then on both sides after it departed from the forebody after the CMCE. Alternatively, the port area may have simply stayed intact longer and received more entry heating following the CMCE.

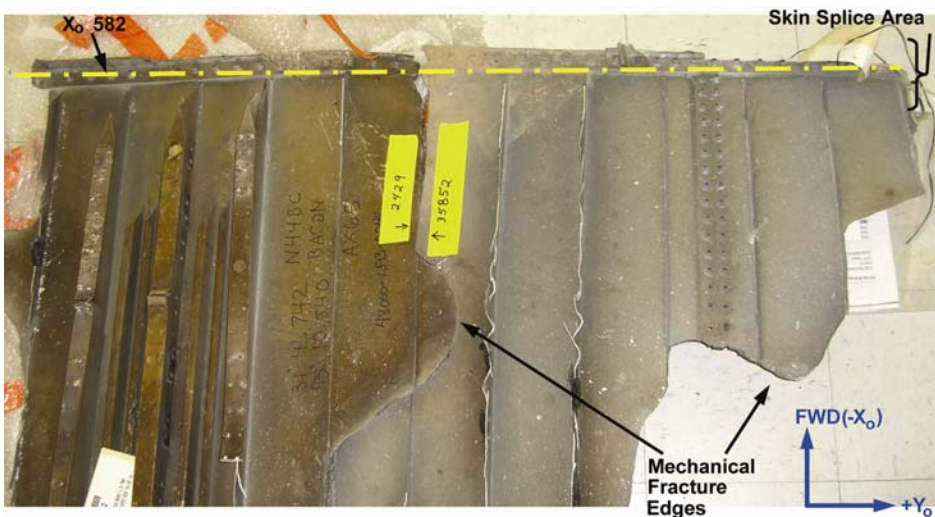
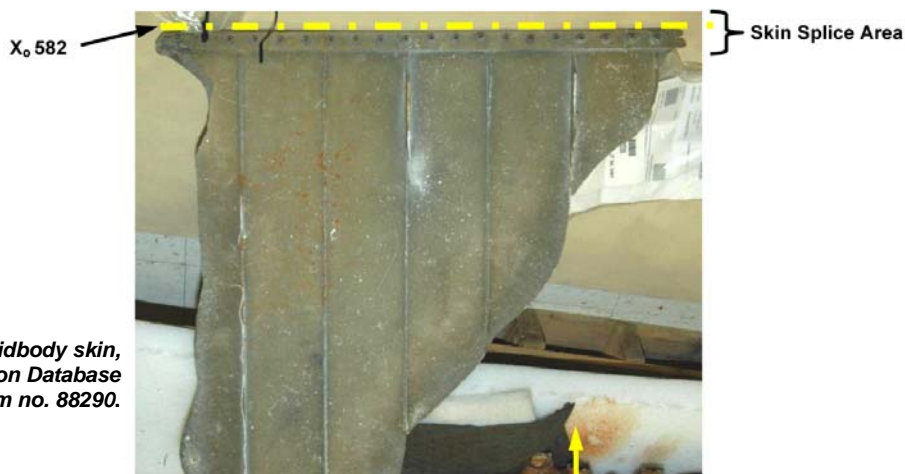
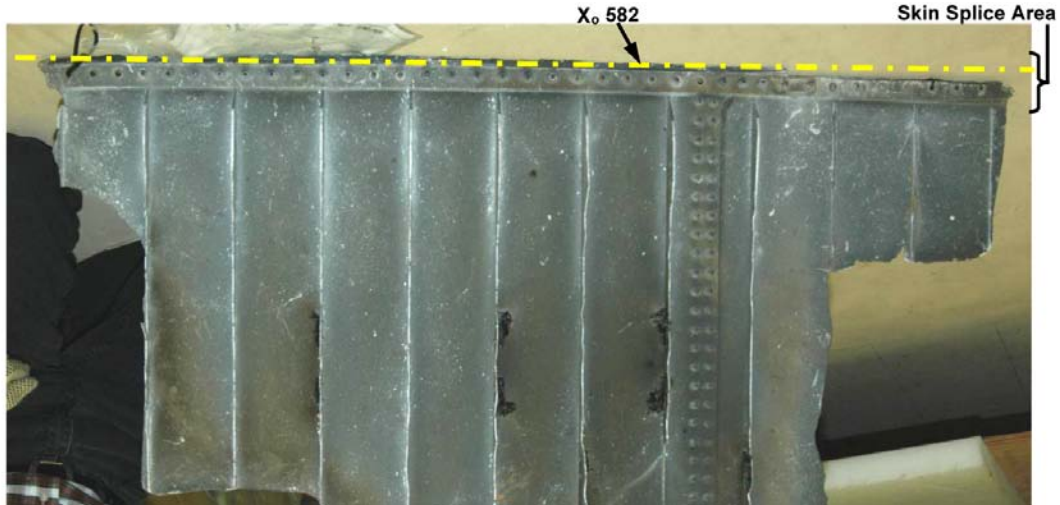
The recovered midbody bottom skin pieces from Bay 1 (the most forward bay in the midbody, immediately aft of the X<sub>0</sub> 582 ring frame bulkhead (figures 2.2-35, 2.2-36, and 2.2-37)) show little or no heat damage to the skin at the splice aft of the X<sub>0</sub> 582 ring frame bulkhead. The damage is mainly mechanical breakup of the frame to skin splice.

Figure 2.2-35. Bay 1 midbody bottom skin, Columbia Reconstruction Database debris item nos. 2429 and 33852.

Figure 2.2-36. Bay 1 midbody skin, Columbia Reconstruction Database debris item no. 88290.

Figure 2.2-37. Bay 1 midbody skin, Columbia Reconstruction Database debris item no. 14908.

The *Columbia* Reconstruction Team noted that thermal damage to the midbody was not generally severe.<sup>10</sup> The thin skin and stringers of Bay 1 experienced some heating but not sufficient to melt the material. One scenario that may explain this is that this bay corresponded to the X location of the structural failure and disintegrated quickly during or immediately after the CE. Even if the bay skin remained with the midbody at the CE, without the X<sub>o</sub> 582 ring frame bulkhead frame aerodynamic loads would peel off the Bay 1 skin quickly. This is consistent with the interpretation that the forebody and midbody separated in this area.

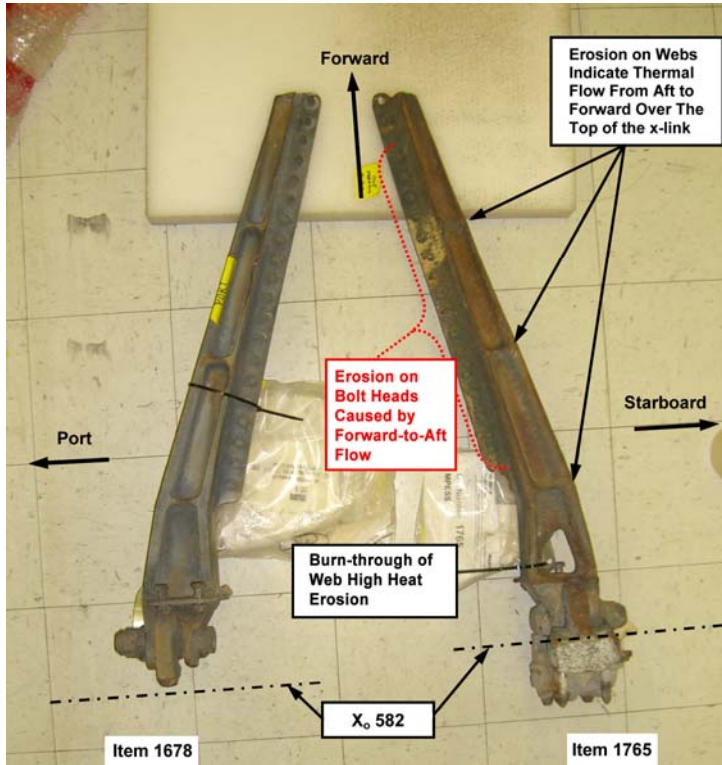
Comparison of the recovered port and starboard x-links (figure 2.2-38) shows two important differences. First, the starboard x-link was recovered with a portion of the X<sub>o</sub> 582 ring frame bulkhead and starboard sill attached, while the port x-link failed forward of the X<sub>o</sub> 582 ring frame bulkhead. Second, the starboard x-link experienced much more thermal erosion than the port x-link. It is clear that the directionality of the thermal damage (aft to forward flows above the x-links, and forward to aft flows along the bolt heads) is the same on both links. This orientation was shown to be unlikely due to a common trim attitude when free-flying (see Section 2.1). This strongly suggests that they were in the same relative orientation (still attached to forebody structure) when exposed to heating. The common thermal pattern on the x-link body is discussed in Section 2.4.

Figure 2.2-38. Port and starboard x-links.

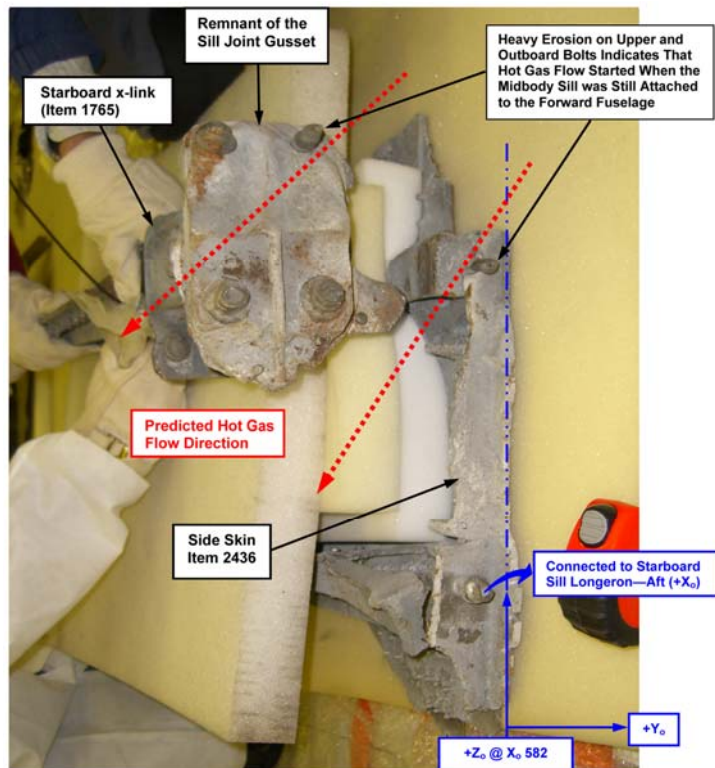
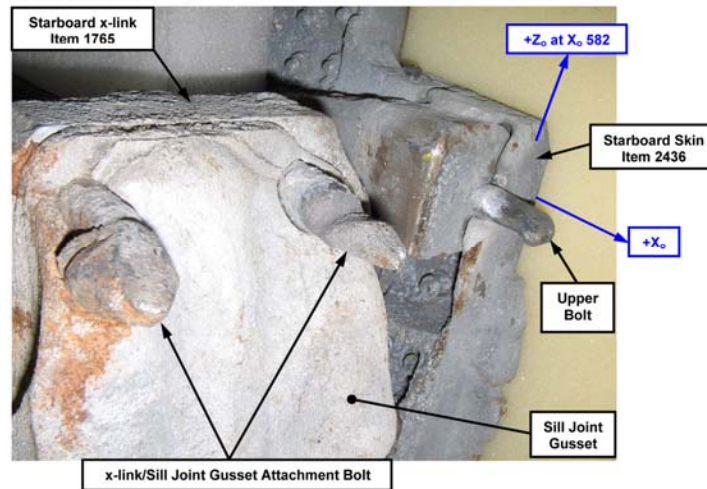
Figures 2.2-39 and 2.2-40 show the heavy thermal erosion on the sill joint gusset that is attached to the starboard x-link. The portion of side skin splice from just outboard of the starboard x-link was also recovered. Heavy heat erosion was noted on the midbody side (aft side of X<sub>o</sub> 582 ring frame bulkhead), but was not significant elsewhere on the debris. This skin panel was recovered near the center of the forebody debris field. Together, this confirms that the CM stayed inside the FF shell until the forebody breakup, and suggests that the trailing edge (midbody side) was exposed to heating.

The structure aft of the X<sub>o</sub> 582 ring frame bulkhead on both the starboard covering side skin and the starboard x-link was heavily damaged by heat. The heat erosion pattern on bolt heads on the aft side shows that the higher (+Z) and outboard (+Y) bolts experienced more heat erosion than the lower/inboard bolts. The resulting shape of eroded bolt heads indicates

Figure 2.2-39. View looking forward at the starboard x-link and side skin.

that hot gas flowed down and inboard (figures 2.2-39 and 2.2-40). This suggests that the aft side of the starboard x-link area was exposed to hot gas while the starboard midbody sidewall/sill was still attached to the X<sub>o</sub> 582 ring frame bulkhead and FF.

Figure 2.2-40. Detail of thermal erosion on the upper bolts at the starboard x-link and skin.

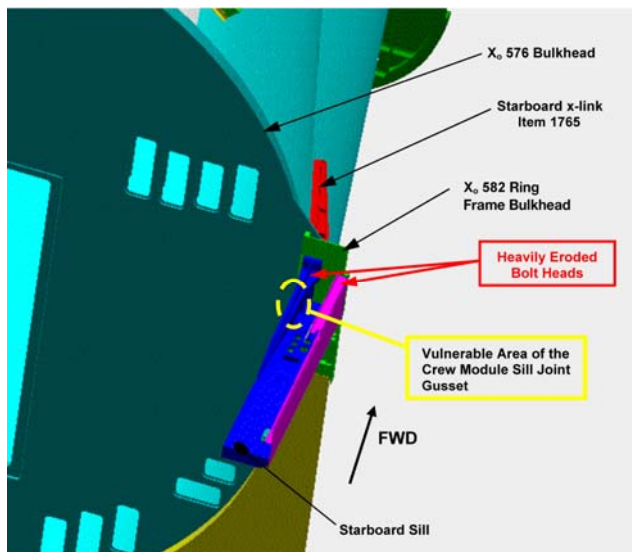
To summarize the assessment, the point of the orbiter that was weakest under dynamic rotational loading was likely to be the sill gusset immediately aft of the x-link and the X<sub>o</sub> 582 ring frame bulkhead. Debris shows that for the starboard sill, the failure of the midbody sill joint occurred at a location aft of the X<sub>o</sub> 582 ring frame bulkhead, perhaps near the middle of the gusset (figures 2.2-41 and 2.2-42). Since orbiter load limits were apparently not exceeded, this implies that thermal degradation was required.

Figure 2.2-41. Weak links – sill joint gusset, starboard side.

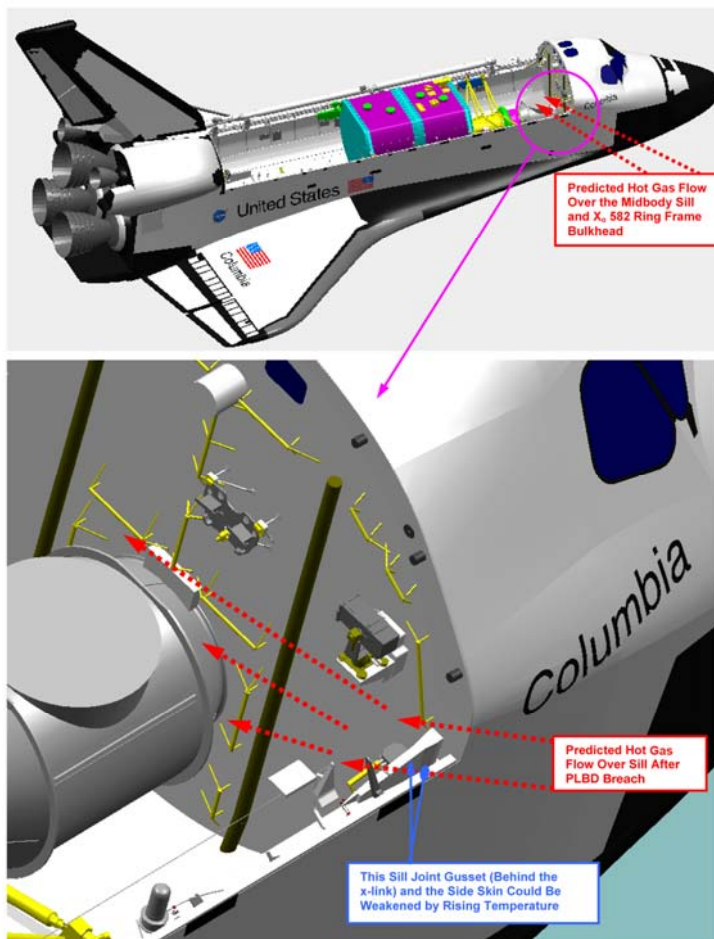
This thermal degradation could have occurred prior to the CE if the PLBDs departed or were compromised in that area (figure 2.2-43). Debris evidence shows that the starboard sill joint experienced more thermal damage than the port sill joint. This suggests the possibility that rising temperature on the starboard sill area weakened the sill joint until it failed mechanically. Although orbiter motion generally resulted in “belly-into-the-wind” orientation (see Section 2.1), with the large pitch and roll oscillations hot gas could flow beyond the belly of the orbiter, up and over the sill. However, hot gas exposure to the sill area could only be short and intermittent (<3 seconds at a time). Debris field and ballistic assessment of PLBD debris is inconclusive. However, a local failure or compromise on the starboard PLBD near the sill could have resulted in this scenario without evidence being apparent in these assessments.

Figure 2.2-43. Hot gas flow heats up starboard sill and the adjacent x-link.

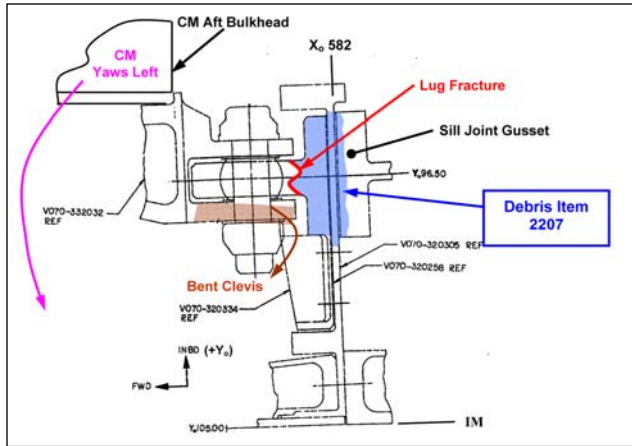
A portion of the X<sub>o</sub> 582 ring frame bulkhead and portside sill fitting, which has a lug that supports the port x-link, was recovered and inspected. The lug broke near its base mainly because of a bending load caused by the x-link and the forebody yawing to the left (figure 2.2-45). This yawing motion was identified by the yielding on the outboard flange of the clevis on the aft end of the port x-link (figure 2.2-46).

Figure 2.2-45. How the port x-link failed, cross-section view looking down.

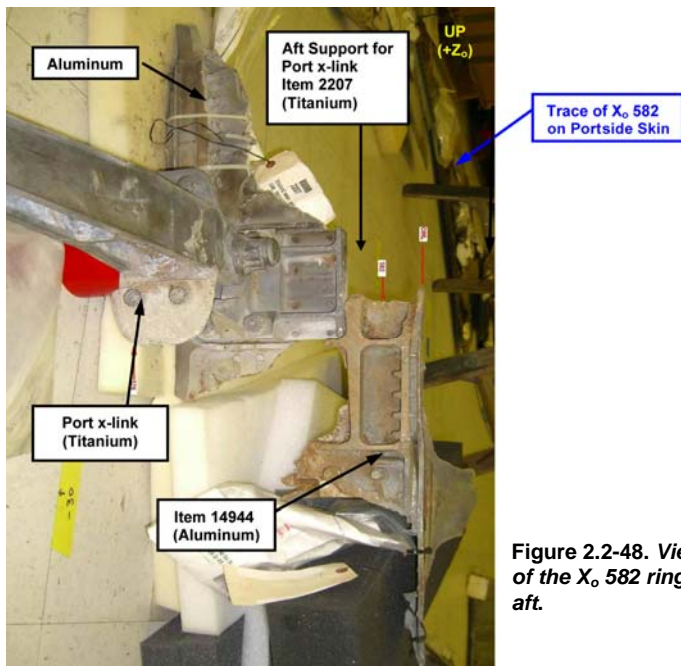
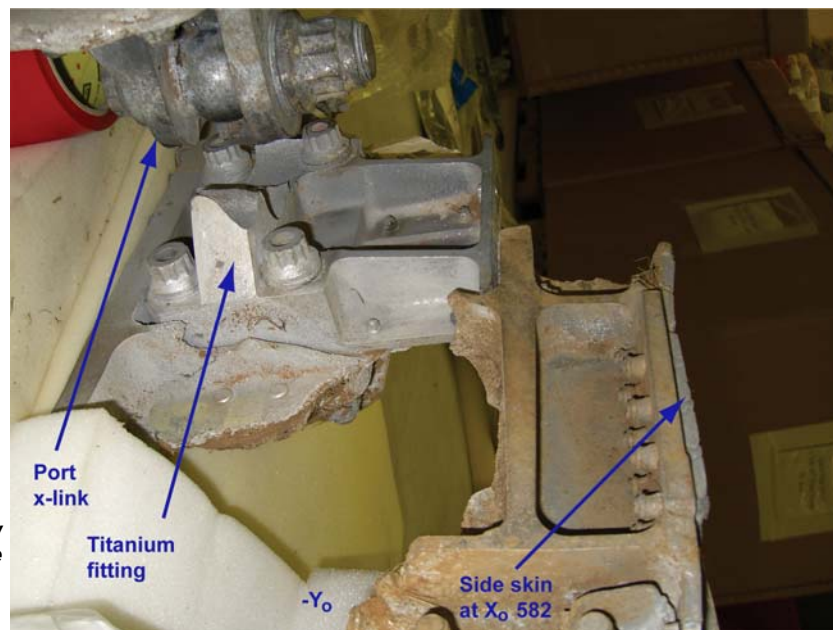
Figure 2.2-48. View of the port x-link and a portion of the X<sub>0</sub> 582 ring frame bulkhead debris items, looking aft.

Figure 2.2-49. View looking up and aft at the port x-link.

These pieces provided a more subtle understanding of the separation event between the forebody and the midbody.

The conclusion was that the forebody separation started *aft* of the X<sub>0</sub> 582 ring frame bulkhead on the starboard-side sill area, and then spread across the fuselage along the aft portion of the X<sub>0</sub> 582 lower ring frame bulkhead. The breakup progressed toward the portside sill while the forebody yawed to the left and pitched down, causing the portside lug fitting to fail by bending to the portside. This resulted in failure at the X<sub>0</sub> 582 ring frame bulkhead on the portside of the bulkhead, leaving a portion of the bulkhead with the midbody.

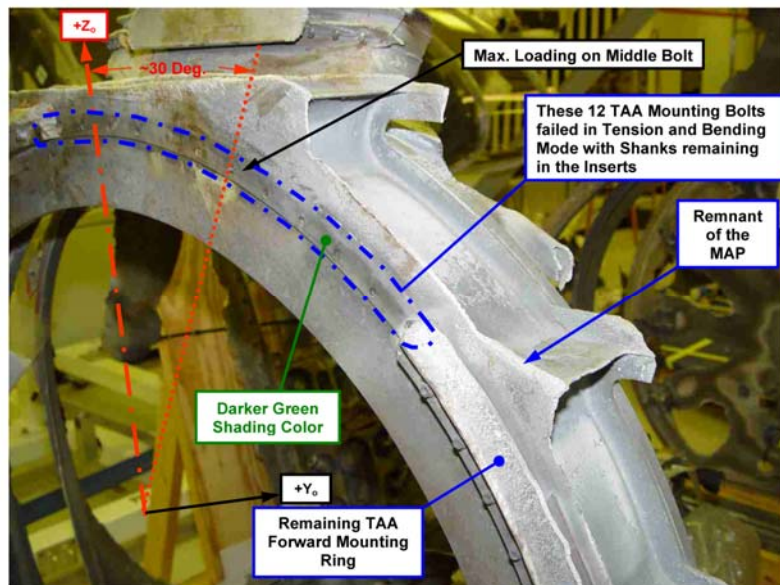
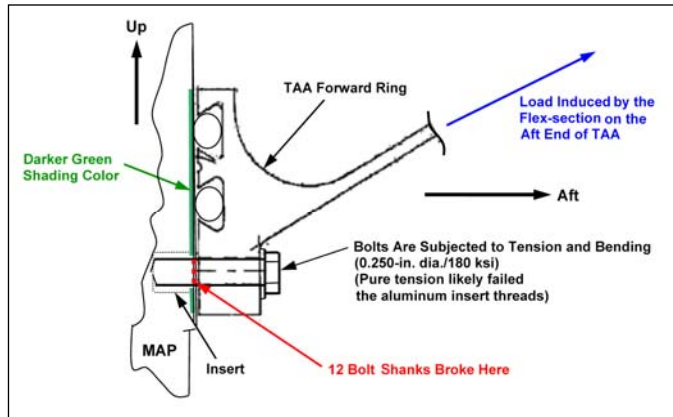
As shown in figures 2.2-51 through 2.2-54, the 12 high-strength bolts (180,000 pounds per square inch (psi)) that attached the forward ring of the TAA to the MAP failed with shanks still remaining in the inserts. This suggests that this area was subjected to high tension and bending while the remaining bolts were not subjected to the same loading. It implies that this TAA joint reacted to a bending moment ( $M_{TAA}$ ) plus aft tension loading (figure 2.2-54). When the aft end of the TAA was restrained by the SPACEHAB tunnel to the midbody, the forebody yawing left and pitching down relative to the midbody could create the same bending effects. This suggests that the TAA broke away from the MAP when the forebody separated from the midbody at the CE or shortly afterwards.

Figure 2.2-51. Tunnel adapter assembly and the manufacturing access panel debris, view looking forward at "B" hatch opening.

Figure 2.2-52. Tunnel adapter assembly debris showing that the bolt shanks failed mainly by tension and bending.

Figure 2.2-53. Cross section through tunnel adapter assembly mounting bolt.

Darker shading color on the surface of the MAP, as was noted on figures 2.2-51 and 2.2-52, indicates that this area was shielded by the missing portion of the TAA ring and suggests that the MAP surface outside of the TAA ring was subjected to thermal flow before the TAA departure. If the TAA departed at the CE, the MAP or the aft bulkhead of the CM was exposed to the thermal flow for some period of time prior to the CE (figure 2.2-44). This would agree with the theory that the PLBDs were compromised prior to the CE.

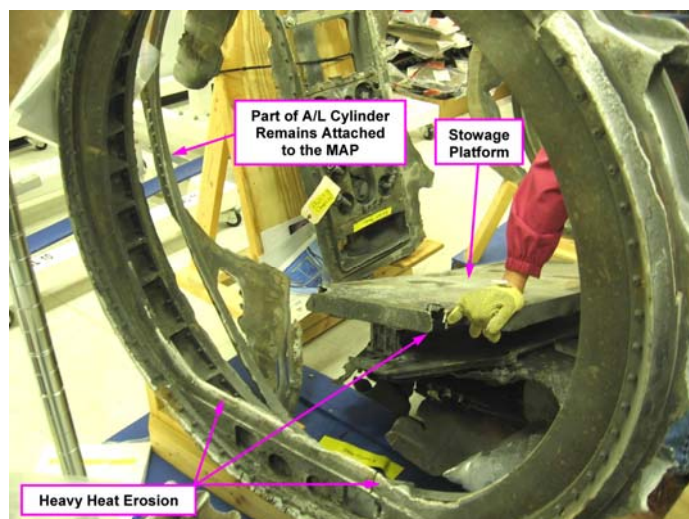
Extreme thermal erosion at the lower edge opening on the MAP where the forward end of the TAA is attached indicates that after the TAA broke away from the MAP, hot gas flowed in over the lower edge of the “B” opening in the MAP. This thermal flow also caused heat erosion to the two aft corners of the stowage platform, which was mounted to the airlock floor (figure 2.2-56). This is consistent with the rotational motion of the forebody post-CE, when such an exposure could have occurred.

Figure 2.2-56. View looking forward at the “B” hatch opening on the X<sub>0</sub> 576 bulkhead.
