# ***Columbia* Crew Survival Investigation Report**

NASA/SP-2008-565

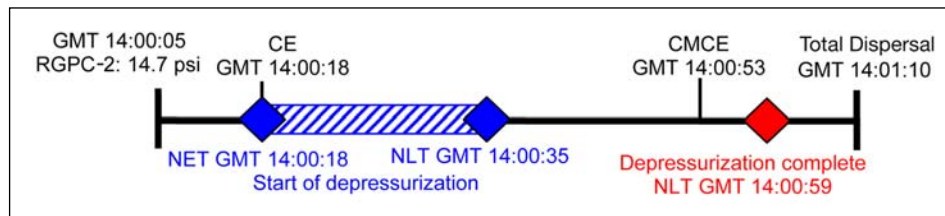
Debris field analysis, ballistics analysis, and video evidence were used to provide the NLT time for when the depressurization completed. The presence of significant CM structural debris items in the debris field indicated a loss of structural integrity of the CM and, therefore, the inability to maintain cabin pressure. Ballistic analysis on a middeck floor panel indicates a release time of GMT 14:01:02 ± 5 seconds. More than 200 pieces of CM structure were recovered west of this item, strongly suggesting that the CM lost structural integrity prior to this time. Video evidence indicated that major changes in the appearance of the CM and significant debris shedding occurred from GMT 14:00:58 to GMT 14:00:59. It is probable that the CM lost structural integrity and was fully depressurized NLT GMT 14:00:59. The CM was estimated to be over 135,000 feet altitude at GMT 14:00:59, so the crew was exposed to a high-altitude environment. Figure 2.3-1 shows the depressurization timeline with the start of depressurization NET and NLT times and the NLT time for when the cabin depressurization was complete.

Figure 2.3-1. Cabin depressurization timeline.

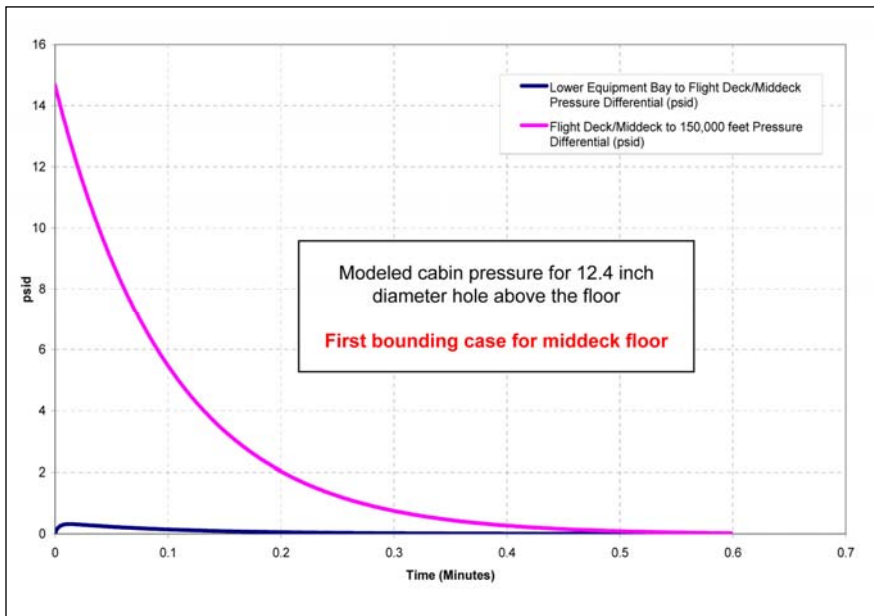
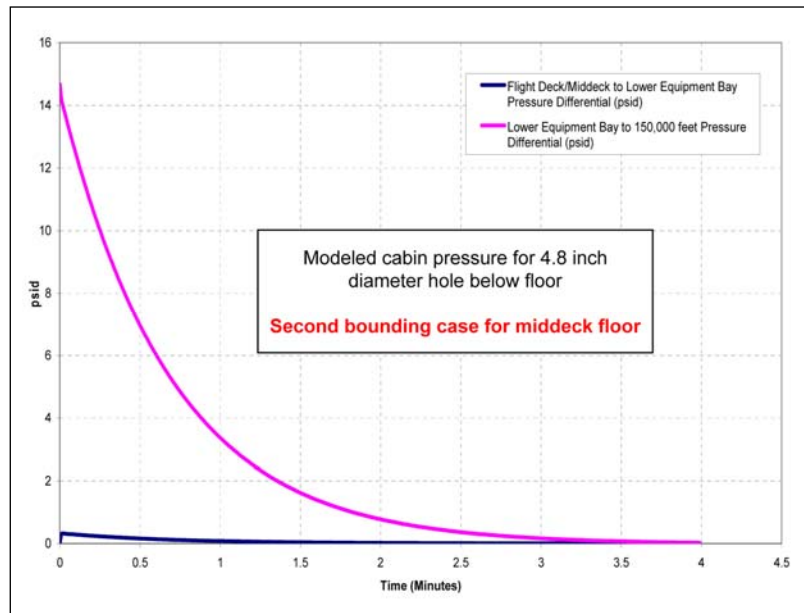
capability of the floor.<sup>10</sup> This model predicted that a hole larger than 12.4 in. diameter (or several smaller holes equivalent to 12.4 in.) *above* the middeck floor, or a hole larger than 4.8 in. in diameter *below* the middeck floor would result in a differential pressure across the floor greater than 0.32 psi (figures 2.3-2 and 2.3-3).

**Figure 2.3-2. Plot from a cabin depressurization model showing a 12.4-inch-diameter hole above the middeck floor. The maximum differential pressure across the middeck floor is 0.317 pounds per square inch (within middeck floor capability).**

**Figure 2.3-3. Plot from a cabin depressurization model showing a 4.8-inch-diameter hole below the middeck floor. The maximum differential pressure across the middeck floor is 0.319 pounds per square inch (within middeck floor capability).**

More than 65% of the middeck floor was recovered, and there was no evidence of buckling due to differential pressure. This indicates that the CM depressurization rate did not exceed the structural capability of the middeck floor.<sup>11</sup> Therefore, the cabin depressurization was not caused by an instantaneous hole above the middeck floor larger than 12.4 in. diameter (or several holes, all above the middeck floor, with a combined effective hole size of 12.4 in. diameter). Additionally, the depressurization was not due to an instantaneous hole (or several holes combined) below the middeck floor larger than 4.8 in. diameter. However, holes on both sides of the floor could cause cabin depressurization to occur more quickly and still not cause differential pressures sufficient to damage the floor. The analyses assumed that the hole sizes remained constant; if the holes were to enlarge gradually, a depressurization could occur faster without exceeding the middeck floor's 0.32 pounds per square inch differential (psid) capability.

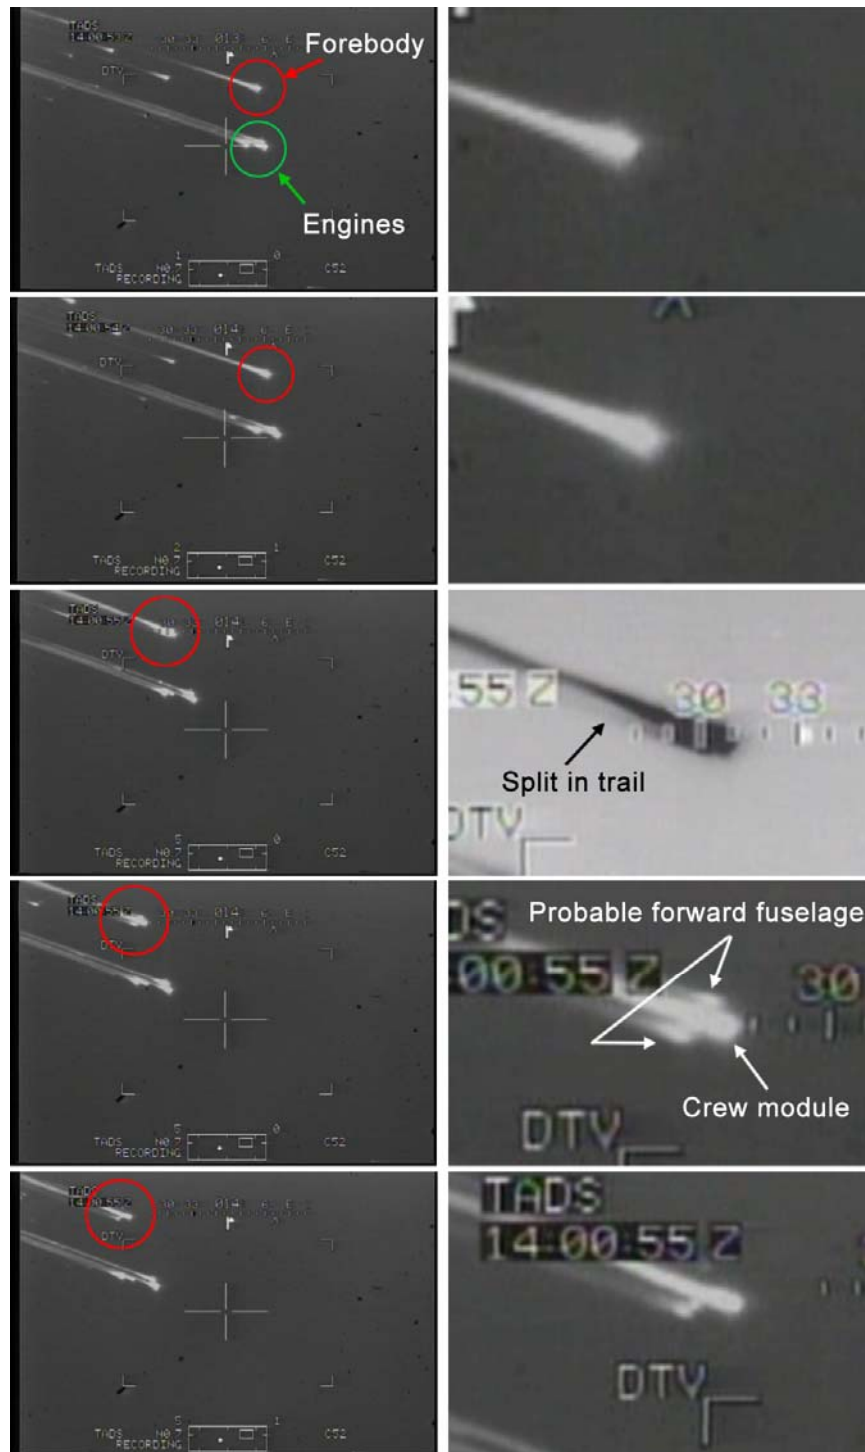
Figure 2.4-1 shows a set of five paired images covering less than 2 seconds of time. On the left is the original image and on the right is a close-up of the forebody and CM. The first frame shows when the forebody begins to brighten. The second frame, which was taken one-third of a second later, shows the slight increase in apparent size of the envelope of gases of the orbiter. The third image, almost 1 second later than the previous image, shows the first definitive indication (although it can be recognized a few frames earlier) that the forebody is beginning to fail. The magnified image has been inverted to emphasize the split in the trail of the forebody. The next frame, which occurs about one-third of a second later, shows what are believed to be two significant portions of the FF separating from the CM. The last image, taken one-fifth of a second later, shows how quickly the FF is breaking into pieces that are too small to be seen by the camera. The CM breaks up over the next 16 seconds.

Figure 2.4-1. Five time-paired images covering under 2 seconds of time showing the Crew Module Catastrophic Event. Image on the left is the full frame, image on the right is an enlarged view.

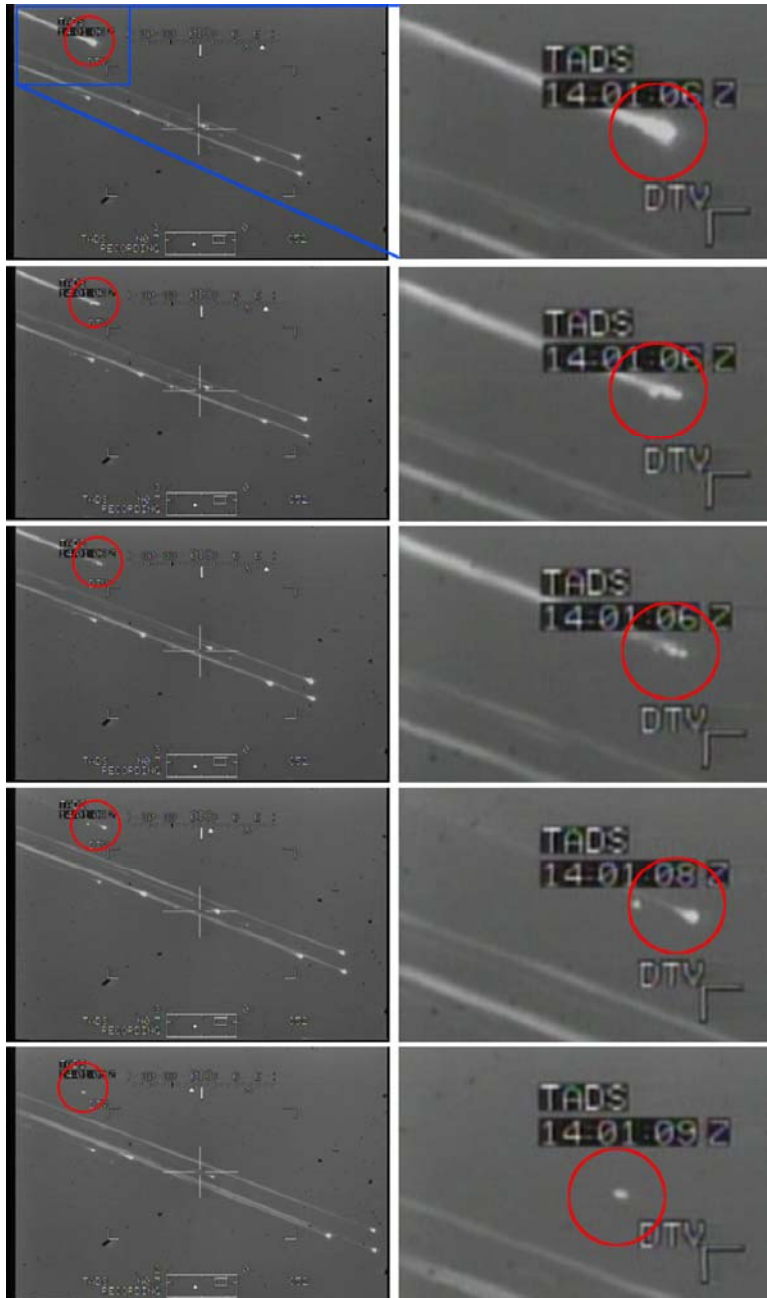
Figure 2.4-2 shows the last few seconds of the CM as seen in the Apache video, ranging from GMT 14:01:06 through GMT 14:01:09. The images on the right side are a magnified view of the original images on the left. The CM has been circled in red.

As the images illustrate, when structural integrity of the CM completely failed, it did so in a fraction of a second. The times for the images (figure 2.4-2), from top to bottom, are GMT 14:01:06.73, GMT 14:01:06.87, GMT 14:01:06.97, GMT 14.01.08.3, and GMT 14:01:09.67. In the next frame, the CM is no longer visible.

Figure 2.4-2. Apache video of the Total Dispersal, spanning from GMT 14:01:06.73 to GMT 14:01:09.67. The forebody/crew module is circled in red.

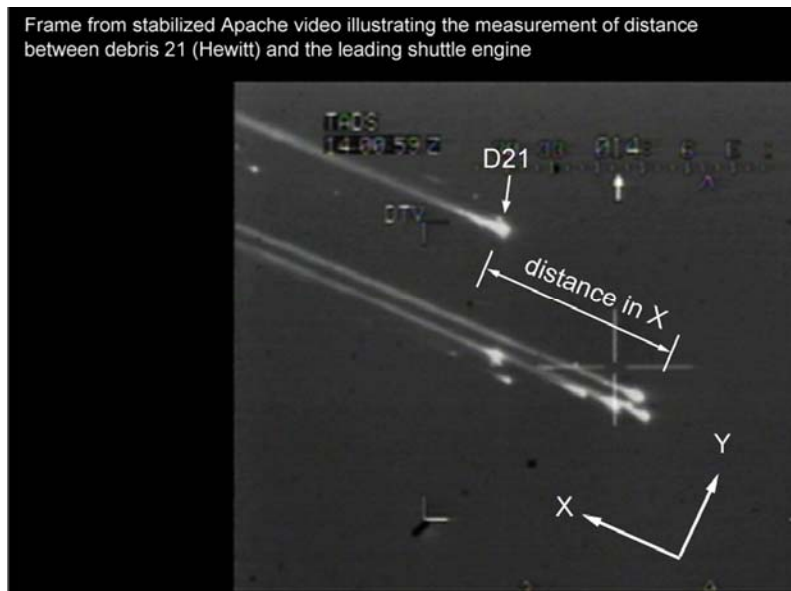
The second relative motion analysis was performed on the CM (identified as D21) and the aft engines post-CMCE in a stabilized Apache video (figure 2.4-3).

Figure 2.4-3. An analyzed frame from the Apache video.

The relative motion of the CM to the engines appears to suggest a high deceleration event occurred during the breakup of the forebody (between the CMCE and the TD). Later understanding of the breakup sequence revealed that this deceleration was related to the disintegration of the CM and the resulting cloud of debris. Rather than a specific high-G event that was experienced by an intact CM, it represents the cloud of individual items separating and rapidly decelerating. Heating was sufficient to keep the individual objects visible for a short period of time, and these items were close enough together that they could not be distinguished as separate items. This also explains why the CM's visible disappearance occurred in a fraction of a second, as the deceleration passed the threshold of sufficient heat generation for visibility in the video.

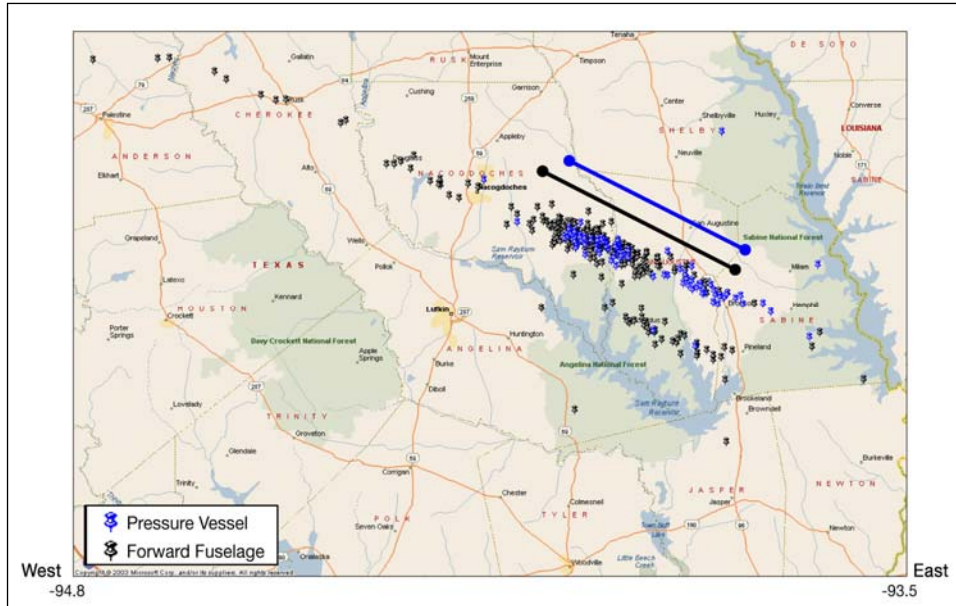
The most significant finding from debris field analysis showed that the FF and CM appeared to remain relatively intact from the CE to the CMCE, a period of 35 seconds (see Section 2.2.3). Small amounts of forebody structure, such as some nose landing gear door tile and small structure, were released earlier. However, 87% of the FF structure and all of the CM pressure vessel structure debris clusters overlap completely (figure 2.4-4), strongly suggesting a relationship between their structural failure. The western end of the main portion of the forebody structure debris field is at a longitude of 94.5W.

Figure 2.4-4. Debris field of the forward fuselage and crew module pressure vessel.

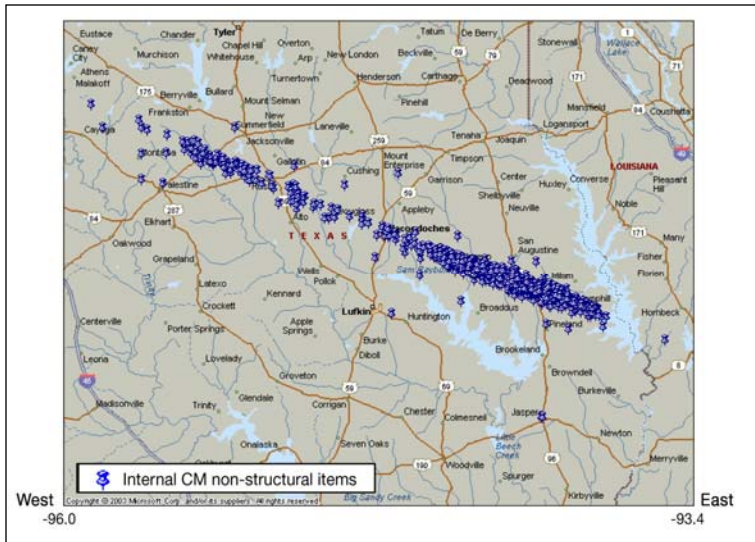
In general, small and light items did not travel downrange significant distances due to the ballistic properties of the object. Some paper/lightweight items were offset slightly northeast of the main debris footprints, probably due to the prevailing winds at the time of the accident. Figure 2.4-5 shows the debris field for nonstructural internal CM debris.

Many of the westernmost debris items came from internal stowage volumes. This implies that internal structural damage occurred at the CE. A full description of cabin depressurization is contained in Section 2.3. The integrated assessment concluded that depressurization occurred NET GMT 14:00:18 (CE) and NLT GMT 14:00:35. It ended NLT GMT 14:00:59, and most likely earlier.

Figure 2.4-5. Debris field of the nonstructural items from inside the crew module pressure vessel.

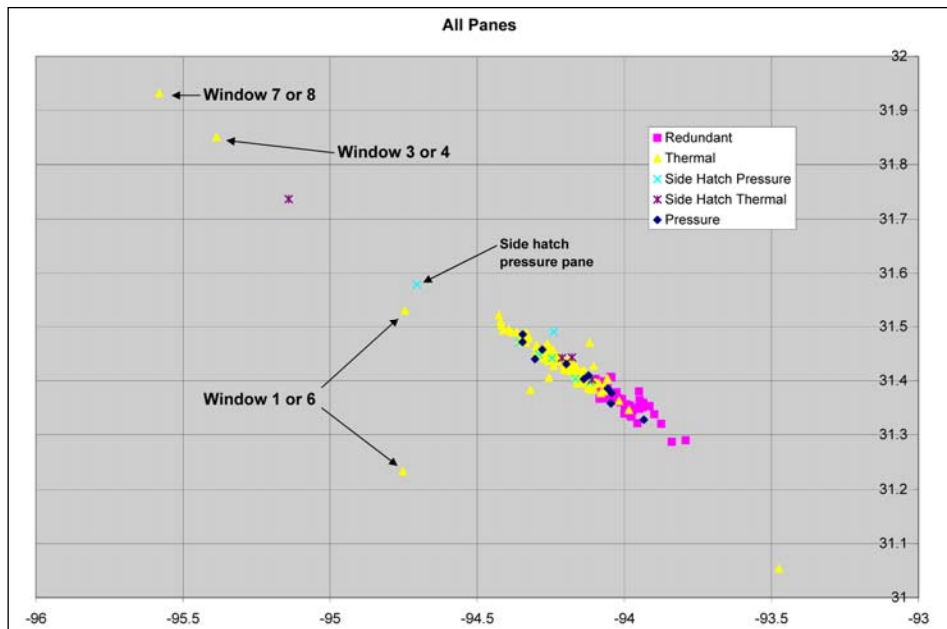
A different concern was whether the flexing of the structure under the varying loads at the LOC and the CE would cause the glass to shatter. The debris field analysis refuted that theory as well. Figure 2.4-8 shows the debris field coordinates for recovered glass.

Figure 2.4-8. Recovered debris field for window glass.

Of the 201 recovered glass fragments, only six pieces of loose glass that are confidently believed to be from the orbiter were found west of the main forebody debris field. All were thermal (outer) panes with the exception of one piece of probable side hatch pressure pane. However, a piece of pressure pane that was recovered in the western end of the debris field does not alone indicate a source of depressurization. Pressure panes may be damaged due to objects moving around inside the CM as it rotated, impacting the windows. If the cabin is depressurized from a different source, these pieces can evacuate through other breaches.

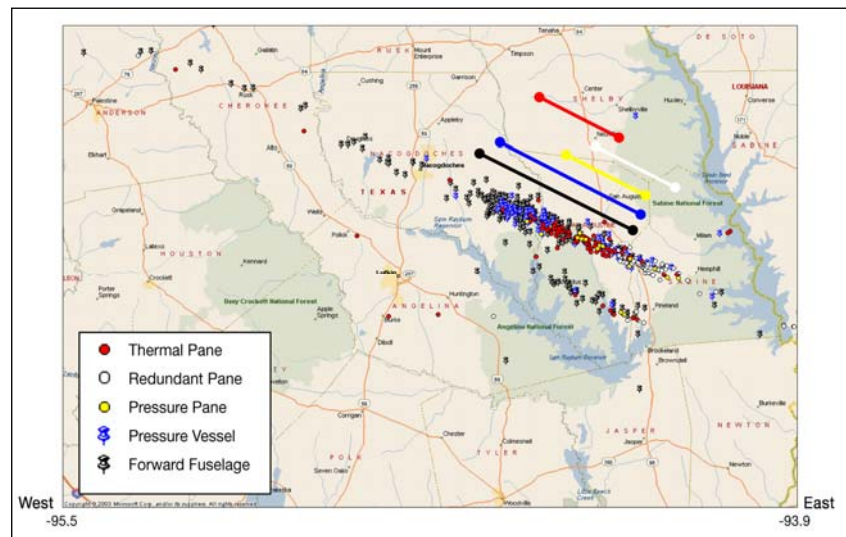
Figure 2.4-9. Debris field of the window panes, forward fuselage, and crew module pressure vessel.

If the source of the cabin depressurization had been a window, both the pressure pane and the redundant pane would have to have failed. However, redundant pane is not seen until the far eastern end in the forebody debris field. Also, in such a case, the pressure from inside the CM would likely blow the entire pane out and result in significant amounts of glass that were not seen west of the main forebody debris field.

Figure 2.4-9 shows that thermal pane debris was recovered east of the beginning of the main forebody debris, suggesting that the windows broke at or after the CMCE. Pressure panes were recovered west of the bulk of the redundant panes, possibly because the redundant panes were extraordinarily thick and heavy and may have traveled farther east because their ballistic number was higher. Determining the failure sequence of the windows based on ground plots alone was somewhat suspect because some of the window frames remained attached to other window frames as a unit, and the shape of the windows can potentially generate lift. Regardless, because the debris field does not contain significant pane debris west of the main CM debris field, it is concluded that the windows were not the source of a CM breach or a part of the initiating event of the forebody breakup.

**Finding.** The *Columbia* windows remained largely intact up until the CMCE and were not a cause of cabin depressurization.

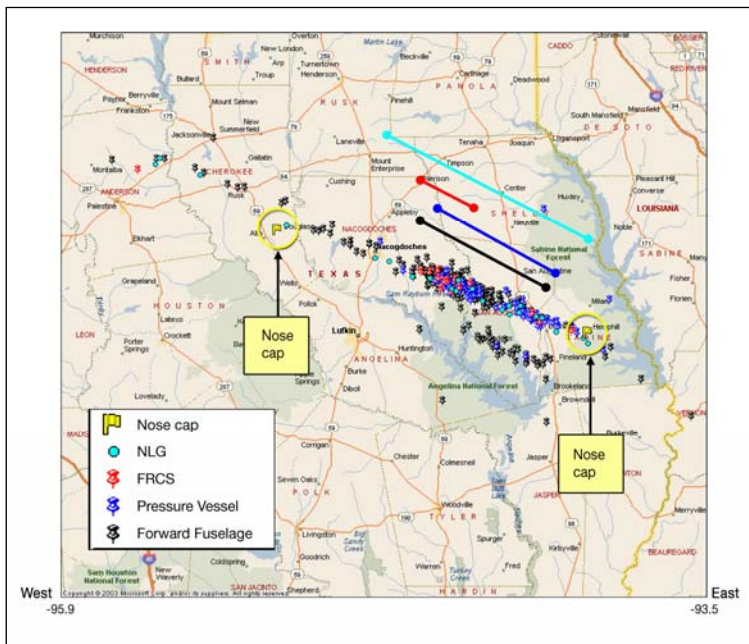
Figure 2.4-10. Debris field of the forebody components.

This section discusses the debris field clusters related to the CMCE and the breakup of the forebody. Figure 2.4-10 shows the major elements of the forebody including the CM pressure vessel, FF, forward RCS, nose, and nose landing gear debris. Figure 2.4-11 shows greater detail regarding specific items and highlights the scarcity of items recovered prior to the main FF/CM debris field.

The debris field analysis suggests that the order of separation was as follows: nose landing gear structure and nose cap, FF, and forward RCS, followed by the CM pressure vessel. This is consistent with the video that appeared to show FF separating, followed very quickly by failure of the CM.

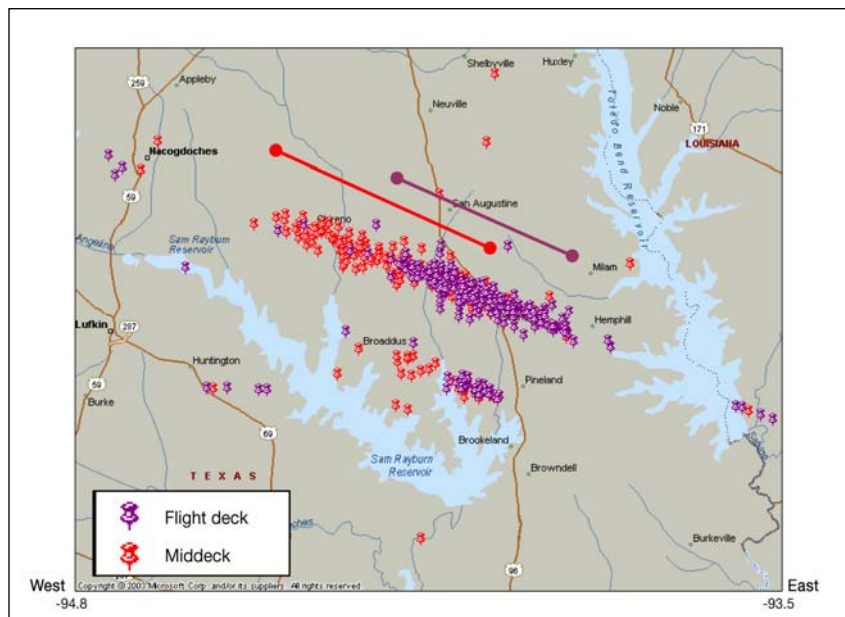
Figure 2.4-12 shows the distribution of middeck and flight deck structure. The middeck structure appears farther west in the debris field, while the flight deck debris cluster is concentrated at the eastern end. This suggests that the flight deck remained intact longer and traveled farther downrange than the middeck.

Figure 2.4-12. Debris field of the middeck and the flight deck.

This conclusion is supported by the fact that almost all of the middeck floor debris was in fair to very good condition. However, very little of the structurally stronger flight deck floor was recovered. Furthermore, the flight deck items that were recovered were heavily thermally eroded. This would be the case if the flight deck stayed together and received more thermal damage as a result of having a higher ballistic number than the individual middeck components.

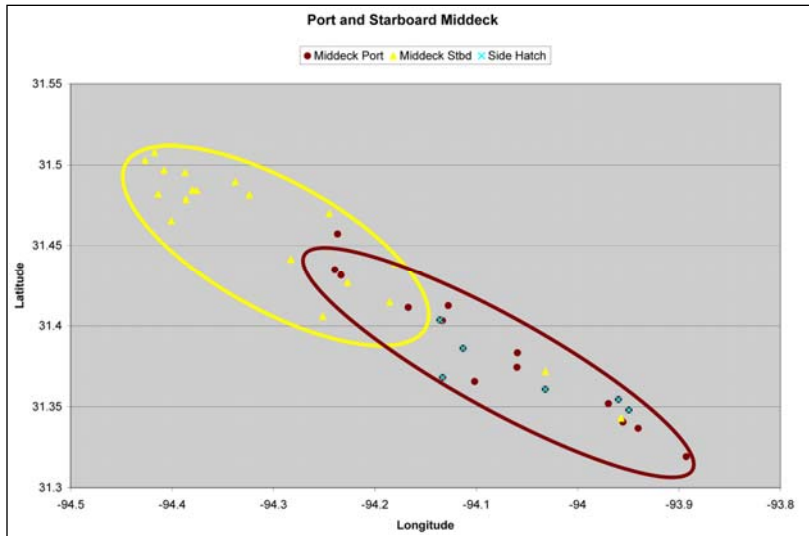
Figure 2.4-13. Middeck structural debris port vs. starboard.

There was a substantial amount of debris for the middeck analysis. Middeck starboard debris was recovered west of the middeck port debris, suggesting that the starboard side failed before the portside. Many of the items from the starboard side were lightweight items from the sleep station with low ballistic numbers, which may also affect this debris field. The debris field is consistent with a yaw to the portside, exposing the starboard side to greater thermal and aerodynamic loads. However, the flight deck panels appear inconclusive relative to a specific failure sequence of forward to aft or port vs. starboard. Not many panels were recovered from port or starboard, which makes interpretations risky.

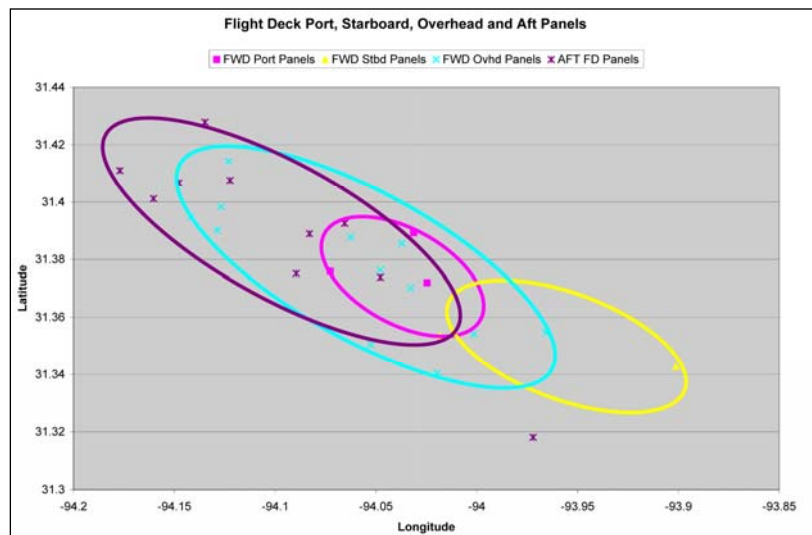
Figure 2.4-14. Flight deck panels by overhead, port, and starboard.

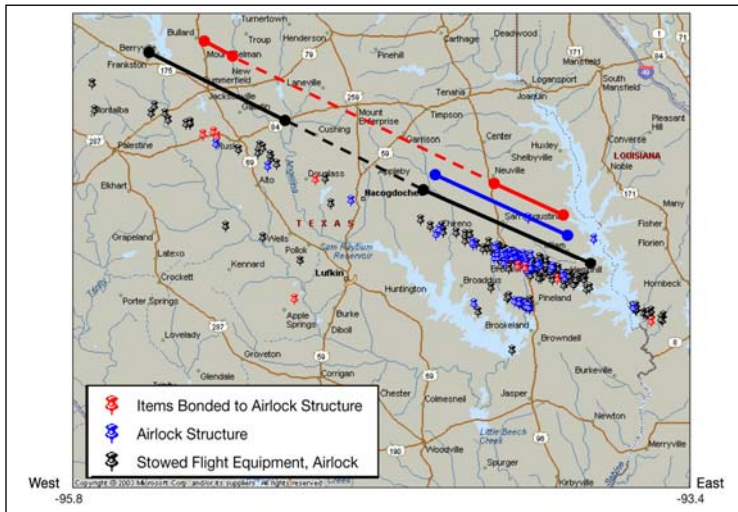
A few “loose” items, as well as a few items that were adhesively bonded to structure and a few pieces of secondary structure, were recovered in the western end of the debris field, indicating that these items were evacuated from the airlock when the TAA departed (figure 2.4-15). However, almost 80% of the airlock structure was recovered in the eastern portion of the forebody debris field (figure 2.4-16).

Figure 2.4-15. Debris field of the airlock structure, flight crew equipment stowed in the airlock, and items bonded to airlock structure.

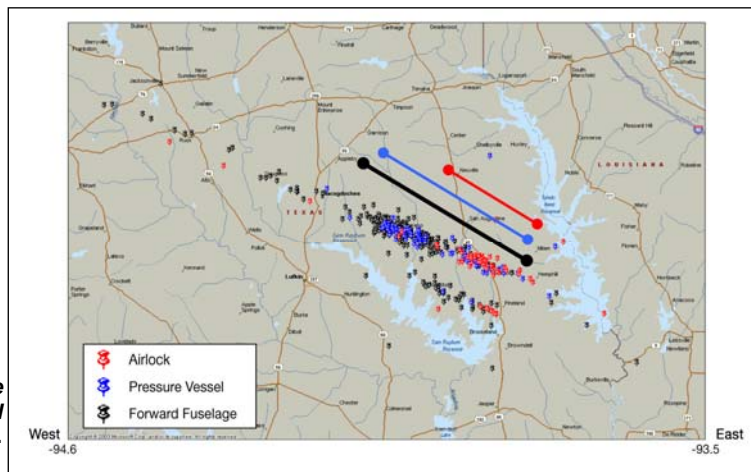
Figure 2.4-16. Debris field of the forward fuselage, pressure vessel, and airlock structure.

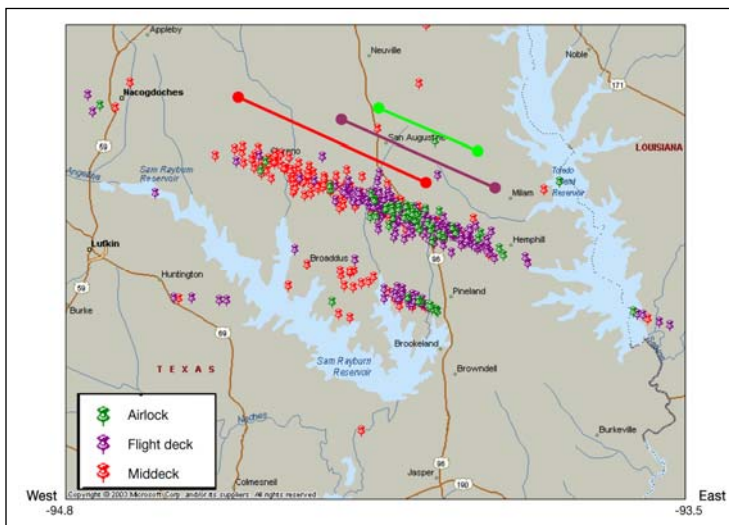
Figure 2.4-17. Debris field of the middeck, flight deck, and airlock.

The internal airlock is structurally attached to the CM aft of the X<sub>0</sub> 576 bulkhead. It likely stayed with the aft bulkhead after the middeck departed. Figure 2.4-17 indicates that the airlock structural debris is also squarely in the middle of the flight deck structural debris. This suggests that the flight deck and airlock remained connected to each other by the aft bulkhead.

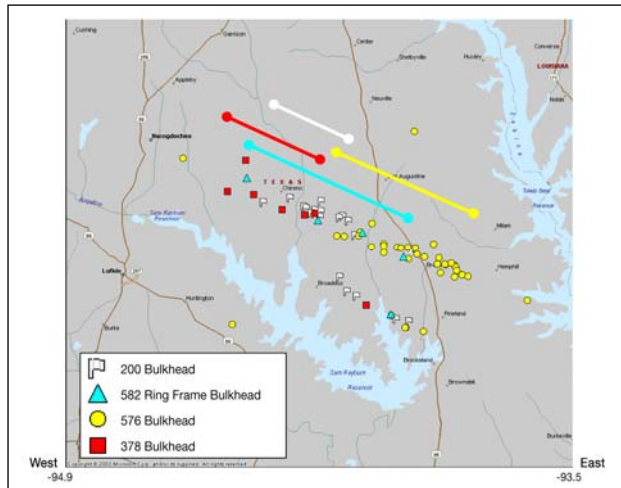
Figure 2.4-19. Debris field of the key forebody bulkheads.

The debris field clusters suggest that the two forward bulkheads appeared to fail earlier than the aft bulkheads. Also, the outer (fuselage) bulkheads failed prior to their corresponding inner (CM pressure vessel) bulkheads. The debris footprint for the CM forward bulkhead ( $X_{cm} 200$ ) coincides with the center of the middeck debris field, suggesting that the  $X_{cm} 200$  departed with the middeck. The CM aft bulkhead ( $X_o 576$ ) appears to have remained with the flight deck until it disintegrated, likely also connected to the airlock since that debris field coincides as well.

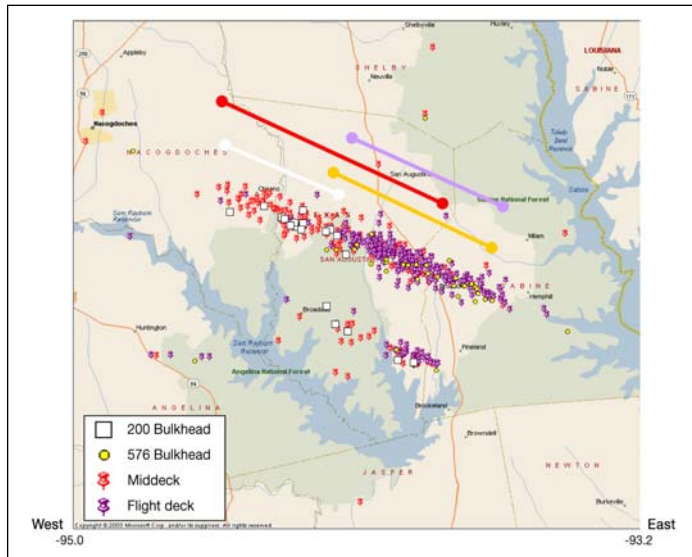
Figure 2.4-20. Debris field of the crew module bulkheads, middeck, and flight deck.

This agrees with the general conclusion that the FF failed followed by the CM pressure vessel failure.

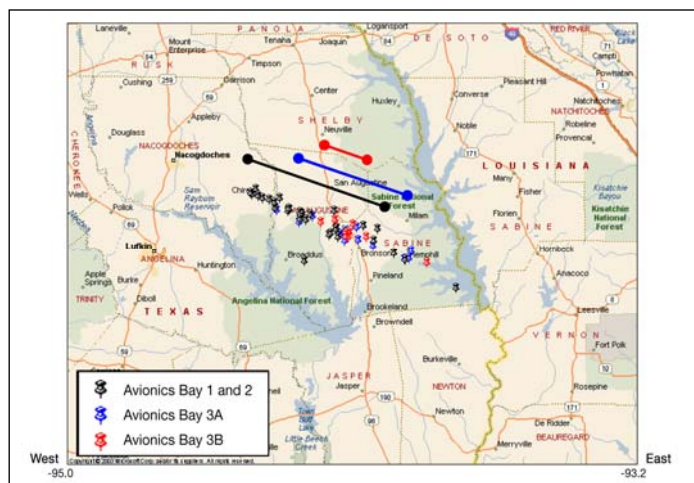
Figure 2.4-21. Debris field of the avionics bays.

Debris from Bays 1 and 2 was recovered west of Bays 3A and 3B. This order matches the CM bulkhead order, supporting that the front ( $X_{cm} 200$ ) bulkhead departed before the aft ( $X_o 576$ ) bulkhead.

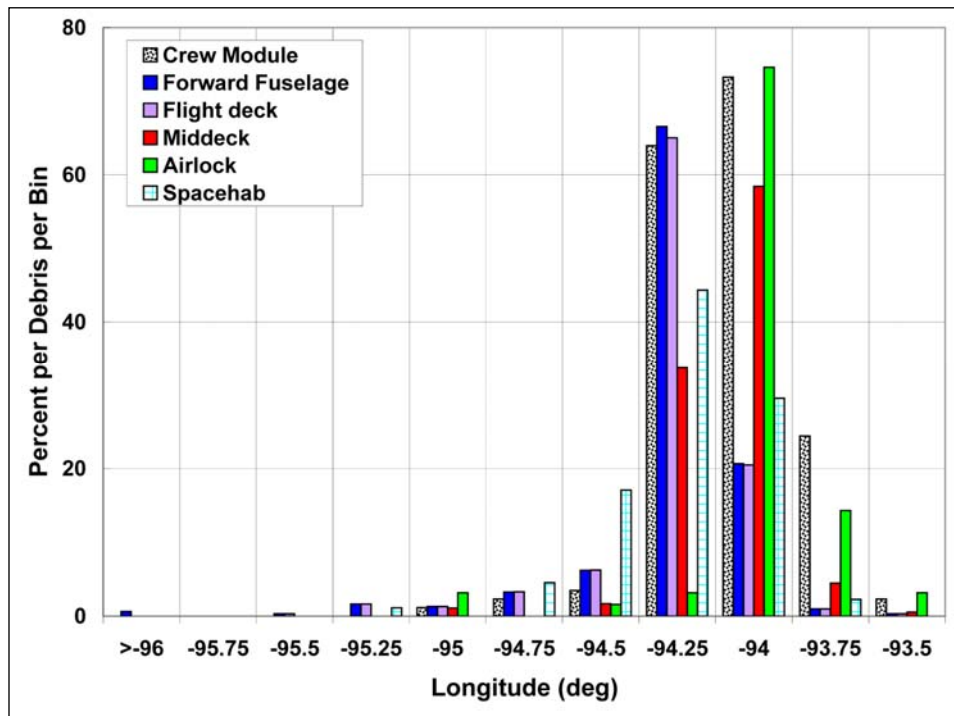
Figure 2.4-22. Histogram of the forebody structural components, plus SPACEHAB.

To summarize the video and debris field findings, at the CE the CM was contained within the FF structure. The CM began to depressurize through a series of small breaches, with small amounts of FF debris being shed. Eventually, the FF structure failed, and the CM itself failed within a few seconds afterwards. The middeck and forward bulkhead (X<sub>cm</sub> 200) of the CM departed, while the airlock, flight deck, and aft bulkhead (X<sub>o</sub> 576) remained together for a short period longer until all elements separated and the TD occurred.

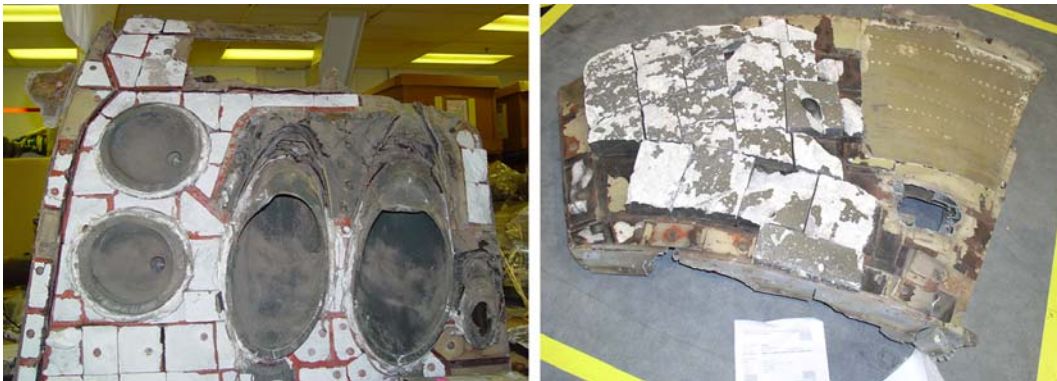
Some large pieces of the forward RCS were recovered (figure 2.4-24). These exhibit evidence of mechanical overload as the primary failure mechanism. Heating did not appear to play a significant role in the component degradation and appears to have occurred during or subsequent to the mechanical breakup.

**Figure 2.4-24. Two large forward Reaction Control System debris pieces, Columbia Reconstruction Database debris item nos. 792 (left) and 82061 (right).**

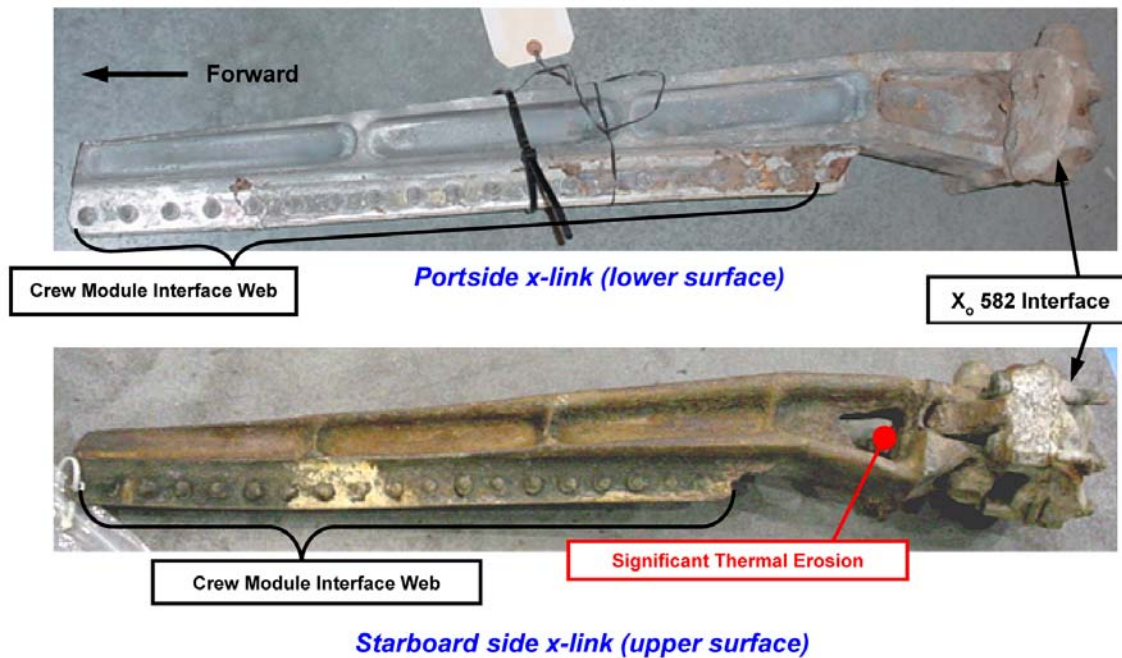
Both the port and the starboard x-links (figure 2.4-25) were recovered nearly intact with evidence of high heating. The titanium fittings on both links experienced significant thermal exposure/melting, predominantly on the upper surfaces. Additionally, the starboard side fitting experienced significantly greater heating and erosion than the portside.

**Figure 2.4-25. Crew module x-links, Columbia Reconstruction Database debris item nos. 1678 (top) and 1765 (bottom).**

The titanium x-link components did not fail. The attach area on the CM side of the x-link is stronger than the FF side since it is reinforced by the flight deck floor and the X<sub>o</sub> 576 bulkhead. The failures occurred at the weaker X<sub>o</sub> 582 ring frame bulkhead connection points. The port x-link experienced a mechanical lug failure at the X<sub>o</sub> 582 ring frame bulkhead interface, while the starboard side fittings pulled through the X<sub>o</sub> 582 ring frame bulkhead at the CE. The starboard x-link retained some of the sill and X<sub>o</sub> 582 ring frame bulkhead while the portside did not. Furthermore, it was concluded that at the CE, the forebody rotated left and pitched down, separating from the midbody (see Section 2.2.4).

Heat damage patterns on the webs of both x-links indicates that, at some point, there was hot gas flow from aft to forward above both x-links. The starboard x-link has more damage than the port x-link. Thermal analysis (see Section 2.1.6.7) of the x-links shows that entry heating alone was not capable of causing such heavy erosion. Additionally, because the surrounding structure was aluminum with a much lower melting temperature, entry heating alone would have resulted in the weakening of the surrounding structure first and release of the x-links. Section 2.1.7 discusses the other thermal mechanisms that were likely involved, shock-shock interactions and combustion. Both of these mechanisms are possible with the forebody geometry as understood from the debris.

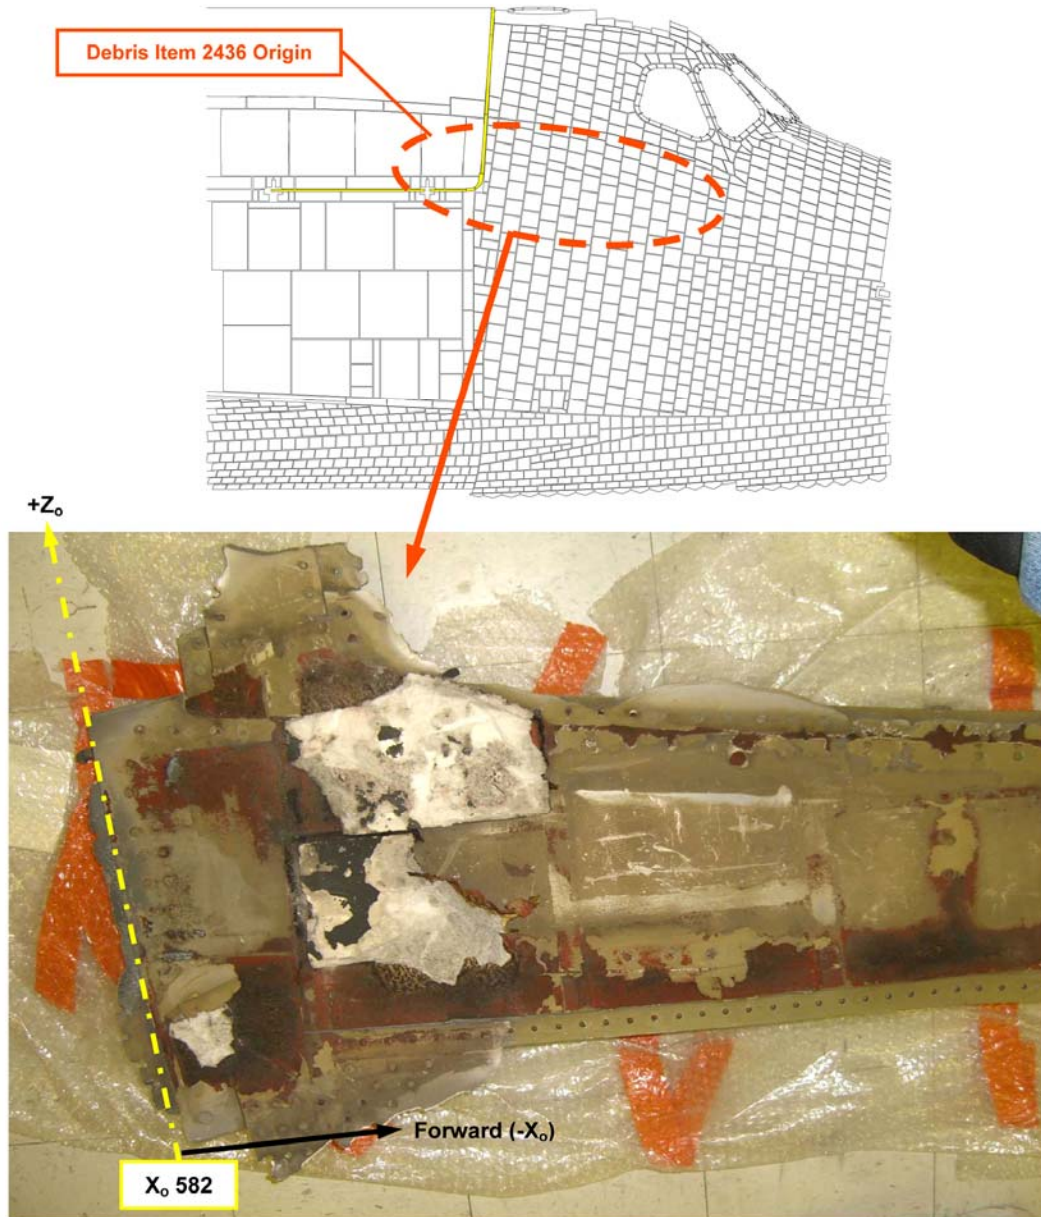
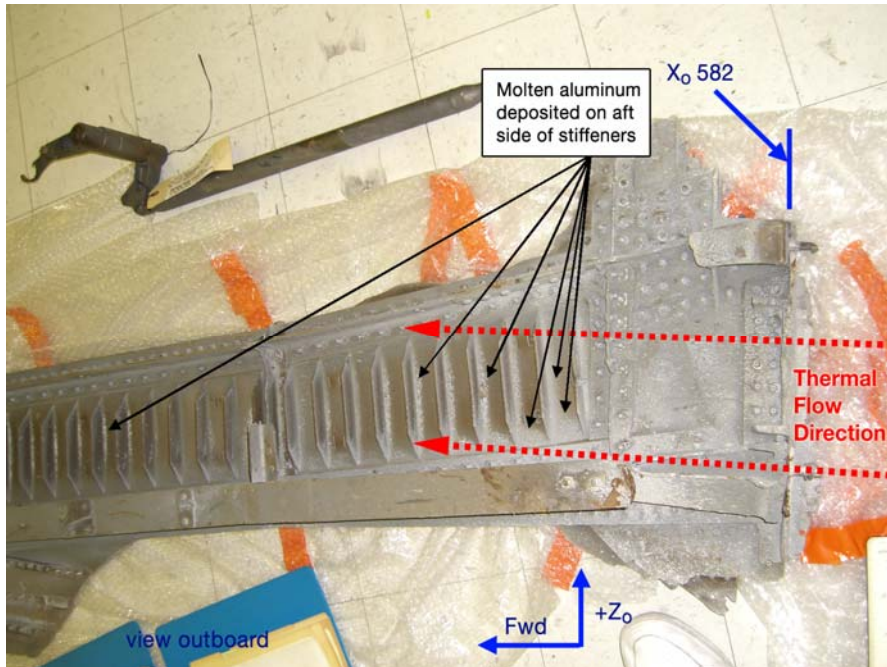
Debris item no. 2436 is a piece of FF skin panel outside of the starboard x-link (figure 2.4-26). It was subjected to heat erosion mainly at the aft edge (along the  $X_0$  582 ring frame bulkhead) (figure 2.4-27). The pattern of deposited molten aluminum on the inboard side indicates that it was subjected to thermal flow aft to forward over the x-link (see arrows, figure 2.4-27).

Figure 2.4-26. Starboard-side skin, view looking inboard, Columbia Reconstruction Database debris item no. 2436.

Figure 2.4-27. Inboard side of the starboard-side skin, Columbia Reconstruction Database debris item no. 2436.

This debris shows high heat erosion at the aft end while the remaining edges failed mechanically. The pattern of molten aluminum deposition indicates that the hot gas flowed mainly from aft to forward. If the thermal event happened after this panel broke away from the FF shell, all edges should experience a similar level of thermal damage, and the deposition of molten aluminum on the inside surface of the skin should have a random pattern instead of a directional pattern (figure 2.4-27). This suggests that this piece of FF skin was in place when the thermal event occurred. It is not known when this thermal event occurred. Since the forebody was rotating, the aft portion of the forebody may have periodically been presented to thermal flow for brief periods between the CE and the CMCE. The thermal event may also have happened around the CMCE, when the FF pulled away and exposed the area to thermal flow.

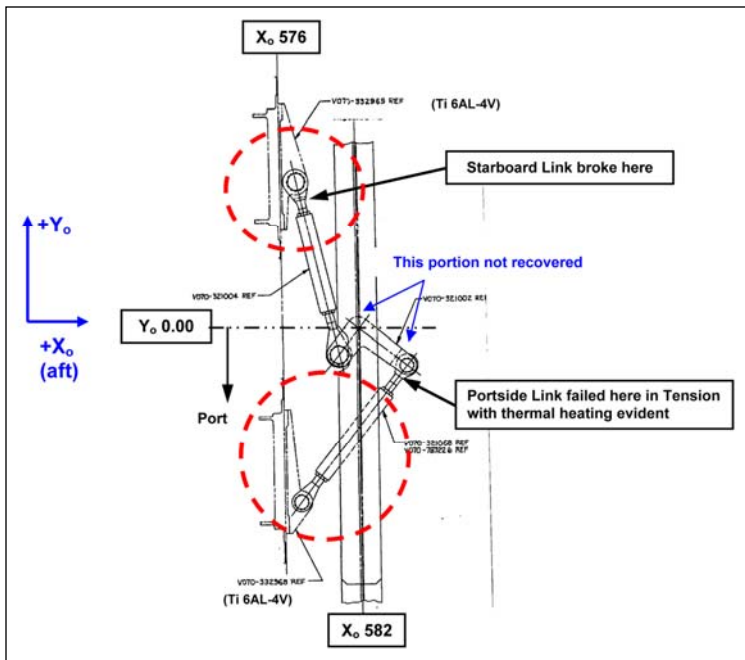
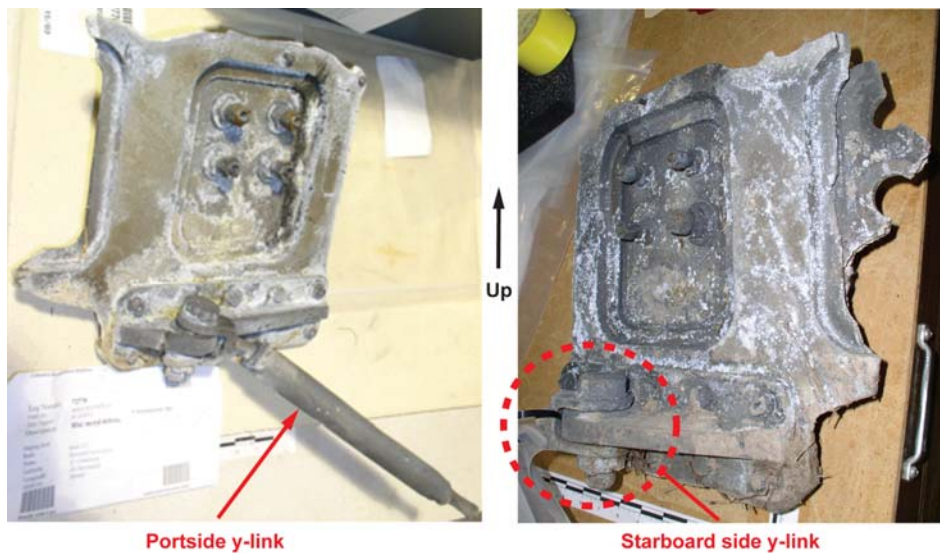
The y-links attach the aft bulkhead of the CM ( $X_o$  576) to the  $X_o$  582 ring frame bulkhead at the lower central portion of the bulkhead. It is possible that the two y-links remained intact at the CE, since most of the  $X_o$  582 ring frame bulkhead is believed to have stayed with the FF. After the CE, any Y-direction movement of the CM relative to the  $X_o$  582 ring frame bulkhead would exert high tension or compression loads on these links. Failure by tension is evident on the recovered debris of these links. The portside y-link shows that it also was softened by thermal exposure along with the tension failure. This portion protrudes beyond the  $X_o$  582 ring frame bulkhead, which would have been exposed periodically to hot gas flow following the CE as the forebody rotated (figures 2.4-28 and 2.4-29).

Figure 2.4-28. View looking from the top at the y-links.

Figure 2.4-29. The y-link debris, still attached to the mounting on the  $X_o$  576 bulkhead, Columbia Reconstruction Database debris item nos. 72770 (left) and 9280 (right).

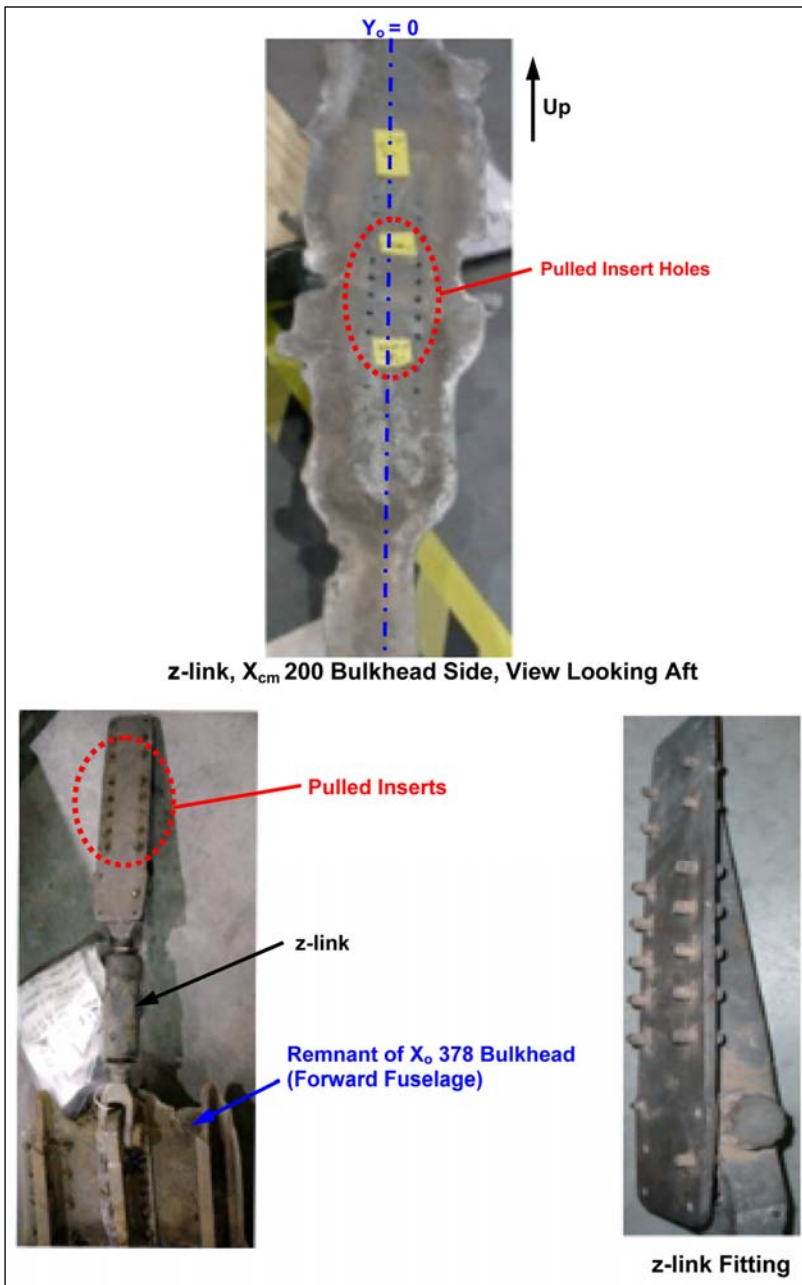
The z-link failed at the attach point to the  $X_{cm}$  200 bulkhead (figure 2.4-30). The joint failed by a combination of fastener tensile failure and fastener insert pullout. Insert pullout requires thermal weakening of parent material because, by design, the insert is stronger than the fastener (under normal temperatures, the fastener should fail before the insert pulls out). Heating may have been occurring as the forebody rotated, allowing hot gas into the plenum between the CM and the FF. Failure resulted at the CMCE.

Alternately, after the FF separated, the  $X_o$  378 bulkhead may have remained in place attached to the  $X_{cm}$  200 bulkhead, connected by the z-link, and exposed to entry heating flow. The two bulkhead debris fields support this conjecture because the  $X_o$  378 bulkhead and the  $X_{cm}$  200 bulkhead debris fields overlap, with the  $X_o$  378 debris field being slightly west of the  $X_{cm}$  200 debris field. No ballistic analysis was done on either bulkhead elements to support or refute this conjecture.

Figure 2.4-30. The z-link debris photographs, Columbia Reconstruction Database debris item no. 53828 (top).

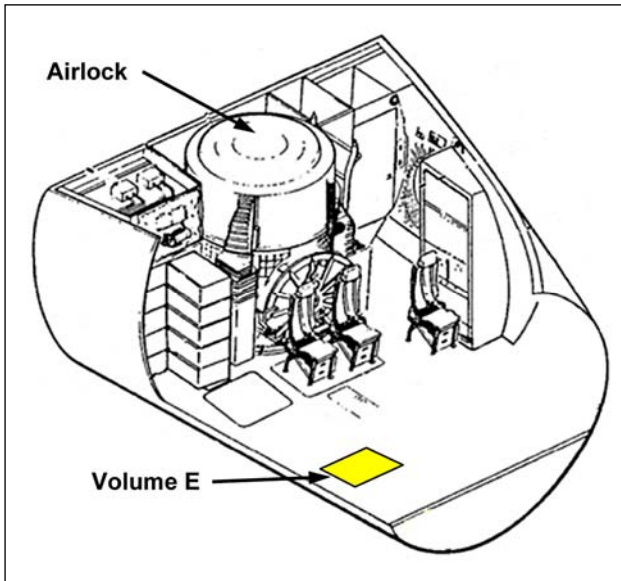
Items that originated from inside the CM and were recovered in the western portion of the debris field were reviewed to determine a potential breach area. These items included multiple STS-107 mission patches. Most of the mission patches were stowed in a middeck sub-floor stowage volume called Volume E. In-flight access to Volume E was not possible in the *Columbia* cabin configuration, so the crew could not have accessed the patches and stowed them elsewhere. Review of the stowage configuration documents for this compartment revealed that the patches were stowed near the bottom of Volume E. Therefore, the bottom portion of the Volume E structure had to be compromised to release the patches.

Figure 2.4-31. View of middeck floor and Volume E, looking down and aft.
