# ***Columbia* Crew Survival Investigation Report**

NASA/SP-2008-565

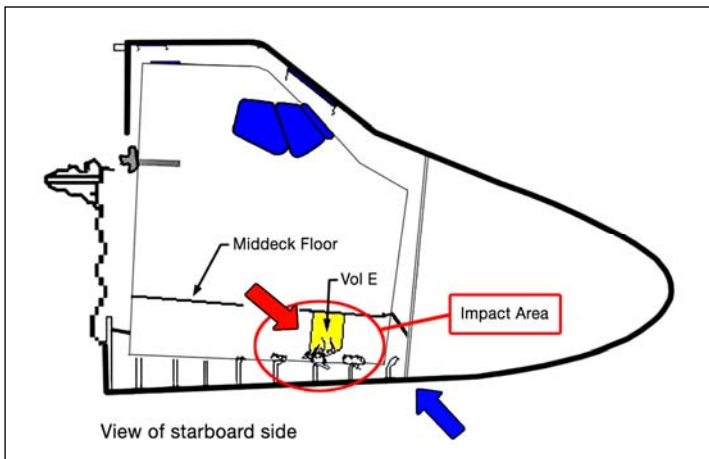
Detailed inspection of Volume E debris indicates that it was subjected to mechanical damage prior to thermal damage. The outer perimeter “picture frame” of the bottom panel was recovered and shows evidence of impact from below. Impact from the CM skin below Volume E would push the aft/outboard corner of the volume upward and then split the edge of the upper frame, as seen in the debris (figures 2.4-32 and 2.4-33).

**Figure 2.4-33. Scenario showing how the crew module pressure vessel could impact the forward fuselage, and the middeck Volume E could impact the crew module pressure vessel, with resultant damage.**

It is likely that at or shortly after the CE, the FF structure impacted the CM skin below Volume E and, in turn, caused an impact between the CM skin and Volume E. The impact was severe enough to crack open the Volume E box, possibly near the lower portion, spilling some of its contents, including the patches. The patches then escaped the CM during CM depressurization.

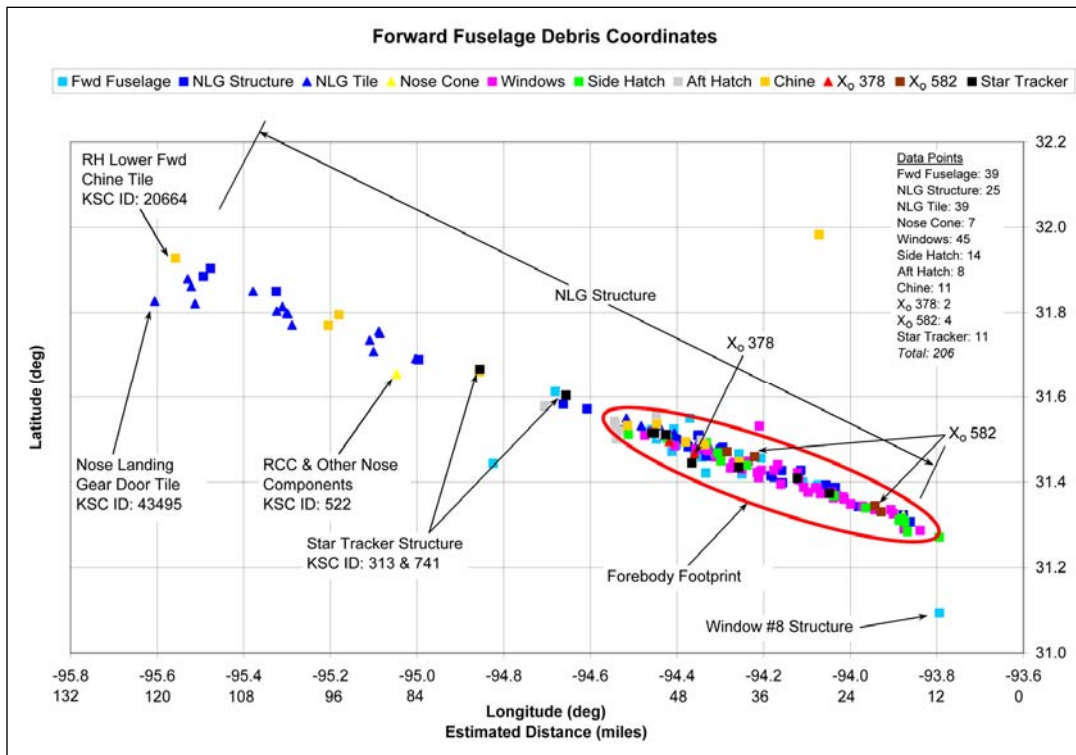
More impacts likely occurred as the forebody continued to rotate. From the CE to the CMCE, it is likely that the CM swung back and forth inside the FF, with both the CM and the FF experiencing impacts at multiple locations. The FF structures would have received damage, possibly creating paths for thermal inflow, as the forebody rotated. Impacts from the relative motion between the CM and the FF would damage the forward bulkheads (X<sub>o</sub> 378 and X<sub>cm</sub> 200), the fuselage frames, and the thinner areas of CM aluminum skin, star tracker well area, etc., depending on the attitude and the rotational movement. Recovered crew equipment debris also came from the forward lockers on the portside, not far from the star tracker wells, lending credence to this. Frame and bulkhead damage would destabilize the FF structures, perhaps popping open numerous items, including the star tracker panels, the TPS around the forward windows, the forward RCS module, the nose gear doors, and the side hatch outer layer. Review of forebody items found in the debris field prior to the main debris field support this conclusion, as portions of the nose gear, star tracker, and multiple tiles and portions of TPS made up this early released debris (figure 2.4-34).

**Figure 2.4-34. Forward fuselage debris field showing tile, nose landing gear door structure, and star tracker door structure west of the main forebody debris field.**

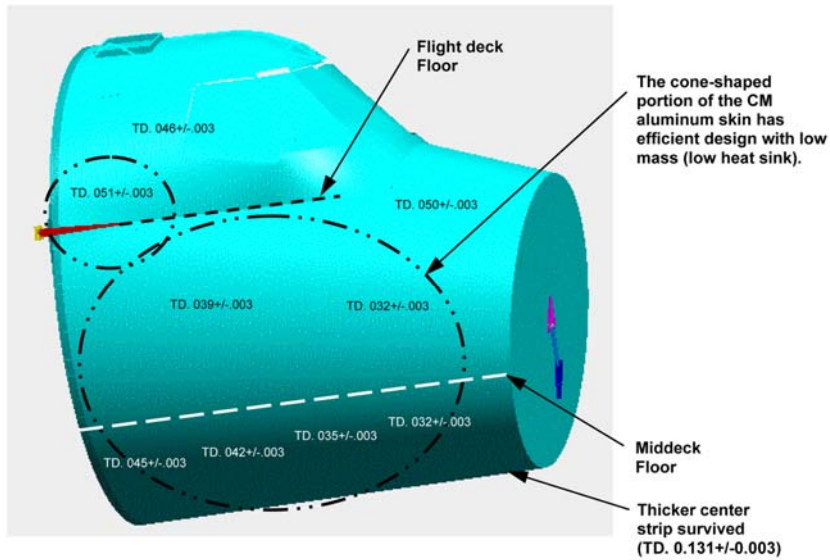
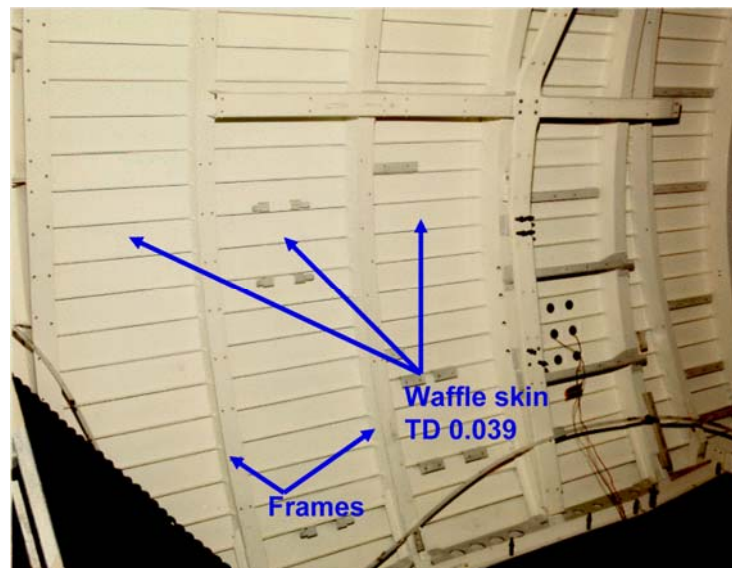
The CM pressure vessel skin was designed with a main cone shape that has low thickness and minimized integral stringers to save weight (figures 2.4-35 and 2.4-36). Many large areas of the cone shape have uniform low thickness—as thin as 0.039 in. Skin thickness was controlled tightly by a chemical milling process during manufacturing. Because of low and uniform thickness, a large area of skin can be heated up quickly and uniformly. This can result in rapid thermal failure of the skin panel, and heat erosion can propagate rapidly.

Figure 2.4-35. Crew module pressure vessel skin lightweight design. The thickness dimension (TD) is represented in inches.

Figure 2.4-36. Typical crew module pressure vessel skin in middeck, looking outboard.

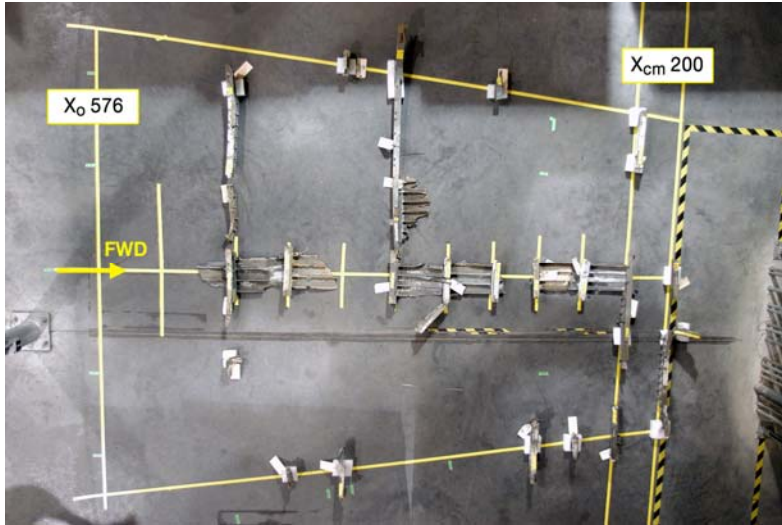
Very little CM skin structure survived. It is very thin, and probably melted quickly after breakup when exposed to entry heating. Only a relatively thicker region of skin strip (0.131-in. thick) along the bottom at the centerline was recovered in multiple pieces (figure 2.4-37).

Figure 2.4-37. Recovered crew module pressure vessel base skin.

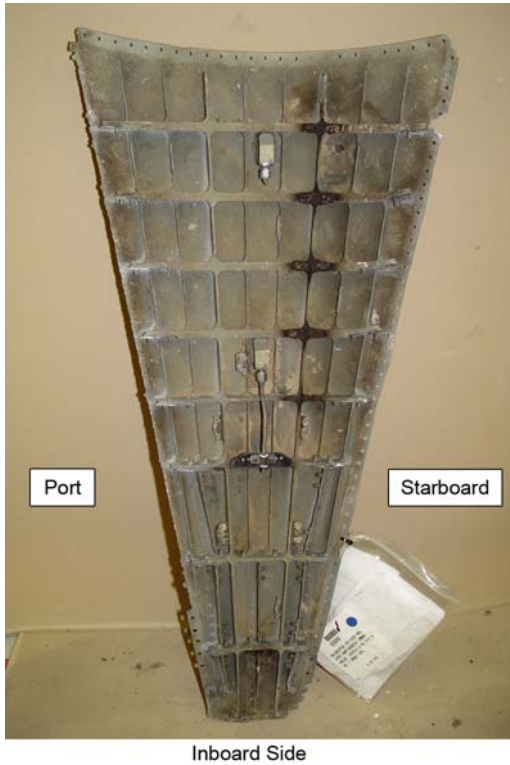
The “arrowhead” skin/TPS panel between Windows 3 and 4 (debris item no. 65049) (figures 2.4-38 and 2.4-39) on the front of the forebody was recovered near the middle of the forebody debris field. It appears to have been torn on the portside and pulled through on the starboard side by mechanical loading, probably initiated by a relative movement between the port Windows 1 through 3 and the starboard Windows 4 through 6.

Figure 2.4-38. Forward fuselage arrowhead panel and the forward two windows, facing in.

**Figure 2.4-39. Low-heat damage on the forward fuselage arrowhead panel, facing out, Columbia Reconstruction Database debris item no. 65049.**

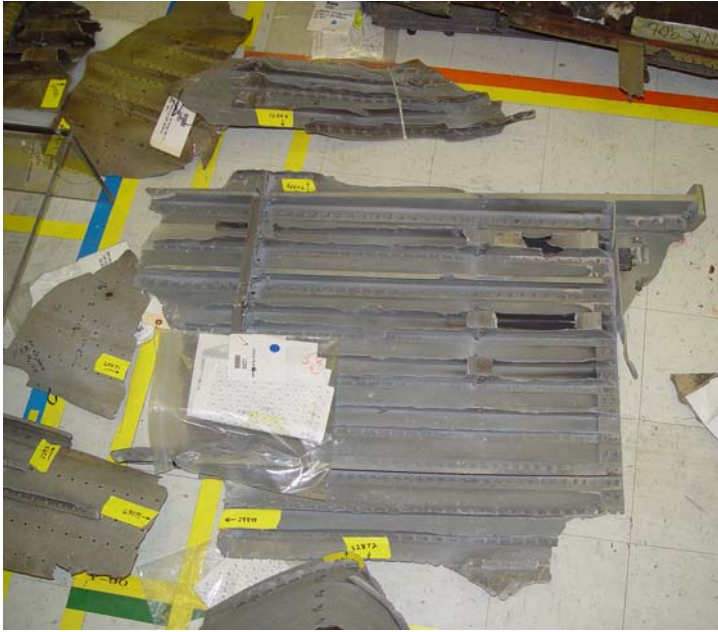
Figures 2.4-40 and 2.4-41 are of the FF skin debris items that lie below the CM. Many panels have little molten metal deposition on the inside surfaces. Broken edges show little thermal damage, and some still have intact primer. This indicates that the plenum behind these areas was not exposed to long durations of thermal flow. Some skin pieces even had stringers that were removed mechanically. Most of the recovered skin debris appears to have mechanically fractured edges. Many forward RCS structural items were recovered; it appears that the forward RCS was pulled away mechanically and broke up into pieces with low thermal effects. The conclusion was that it is likely that the FF skin panel peeled away and broke up quickly.

**Figure 2.4-41. Lower forward fuselage skin panel near external tank attachment.**

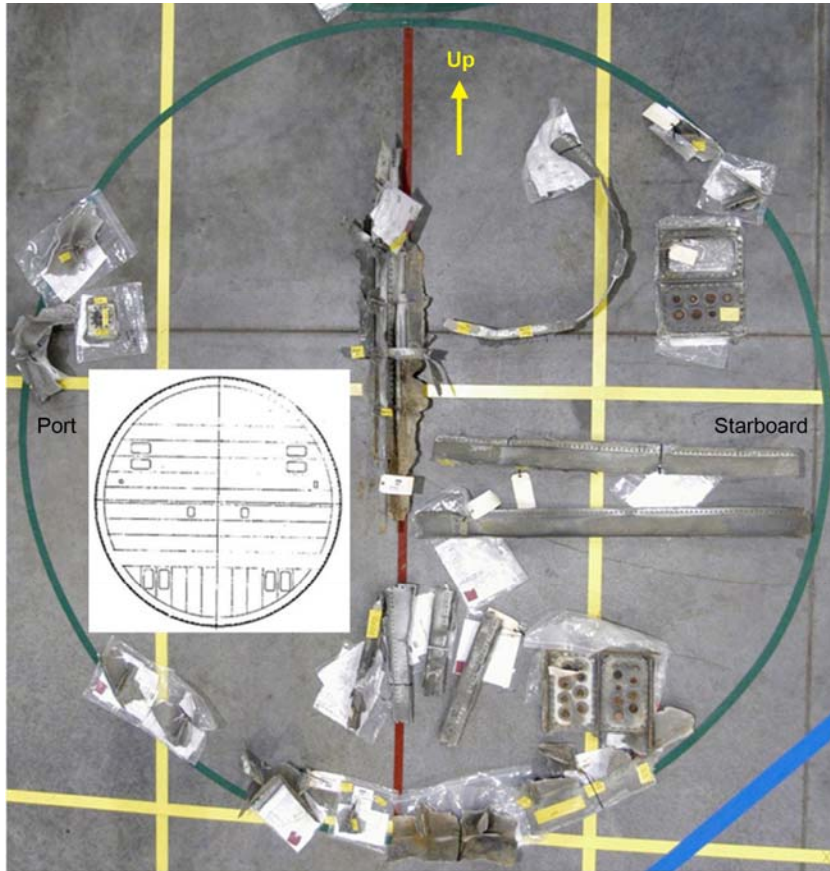
Figure 2.4-42 shows recovered CM forward bulkhead ( $X_{cm}$  200) debris on a grid that is the size of the original bulkhead. As described in the debris field cluster analysis, the CM forward bulkhead debris was recovered west of the aft bulkhead debris, and the middeck starboard debris was recovered west of the port debris. This suggests that the CM middeck starboard/forward was shed first and that the starboard and forward CM areas were exposed to higher heating first and/or faced the velocity vector at the time of the CM major breakup. The main CM breakup involved the departure of the middeck area, including the middeck floor and everything that was attached to that floor. Anything not firmly attached to the flight deck floor also came out with the middeck. Most equipment that was above and below the middeck floor was supported by the middeck floor; avionics bays are also supported by the side skins and bulkheads.

**Figure 2.4-42. View looking forward of the recovered crew module  $X_{cm}$  200 bulkhead debris.**

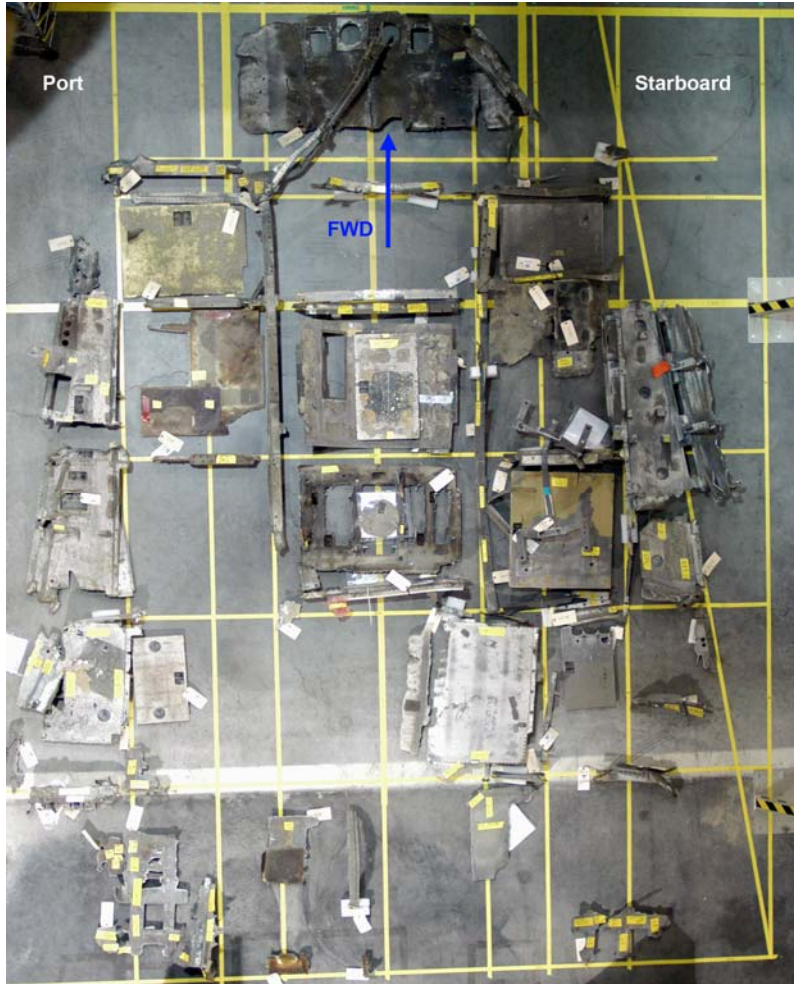
Structurally, the flight deck section is connected to the middeck section and the lower equipment bay is mainly connected by the CM side skin, avionics bay partitions, and the aft and forward bulkheads. The side skin and the forward bulkhead could be easily damaged by aerodynamic heating after the CM lost the protection from the FF shell. Therefore, as soon as the middeck side skin and forward bulkhead were compromised structurally, the lower half of the CM could have swung away from the flight deck portion by the effects of aerodynamic drag. It is likely that the whole middeck floor assembly came out together with the lower equipment bay. The hinge line appears to be at or near where the middeck floor attaches to the aft bulkhead. This motion would expand the middeck compartment (similar to opening a clam shell) and release all items attached to the middeck floor as well as other items stowed beneath that floor. Because the middeck floor disintegrated into many smaller parts without being significantly heated, it appears that the middeck floor failed as a result of structural loading. This may help to explain why more than 65% of the middeck floor was recovered without significant thermal erosion (figures 2.4-43 and 2.4-44).

Figure 2.4-43. Top view of the crew module middeck floor debris.

The middeck floor and the lower equipment bay quickly disintegrated, with middeck floor panels, crew escape pole, MAR, and other crew equipment items (window shade bag, middeck lockers, sub-floor components, MADS/OEX recorder, etc.) departing quickly from the CM.

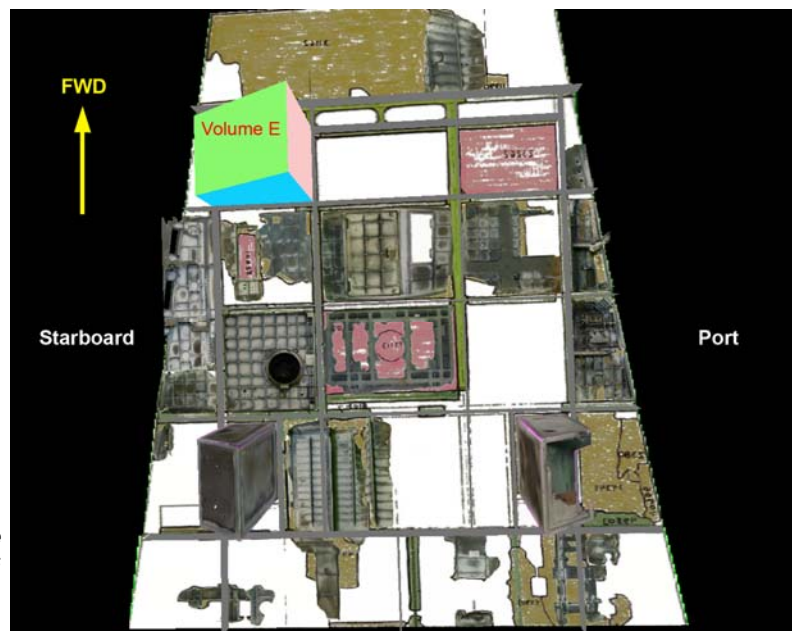
Figure 2.4-44. Bottom view of the recovered middeck floor items from virtual reconstruction.

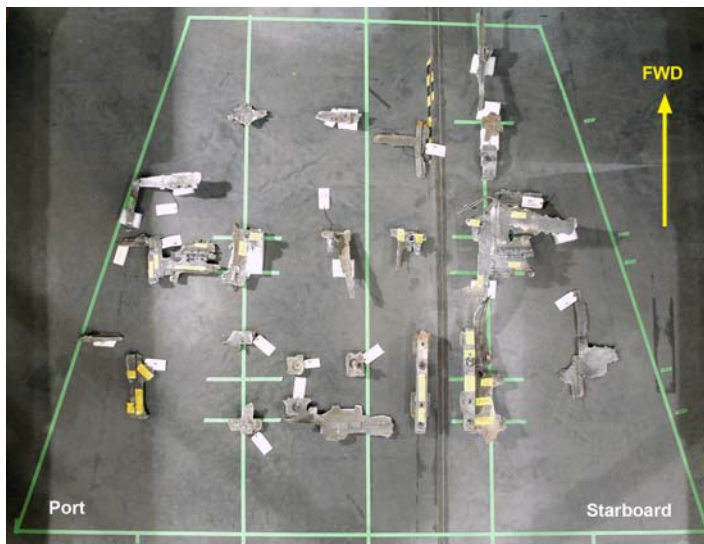
The CM debris field suggests that after the forward bulkhead and the middeck floor departed, it was followed by the airlock, the flight deck, and the aft bulkhead. The flight deck floor debris exhibited much more thermal damage than the middeck floor debris.

Figure 2.4-45. Top view of the crew module flight deck debris.

From the thermally eroded state of the flight deck debris, it appears that the flight deck stayed nearly intact for a period of time following the departure of the middeck area. This explains why so little of the flight deck floor was recovered (figure 2.4-45). Based on debris field evidence, the internal airlock, which was supported by the MAP (which is part of the X<sub>o</sub> 576 bulkhead), likely stayed together with the bulkhead and the flight deck.

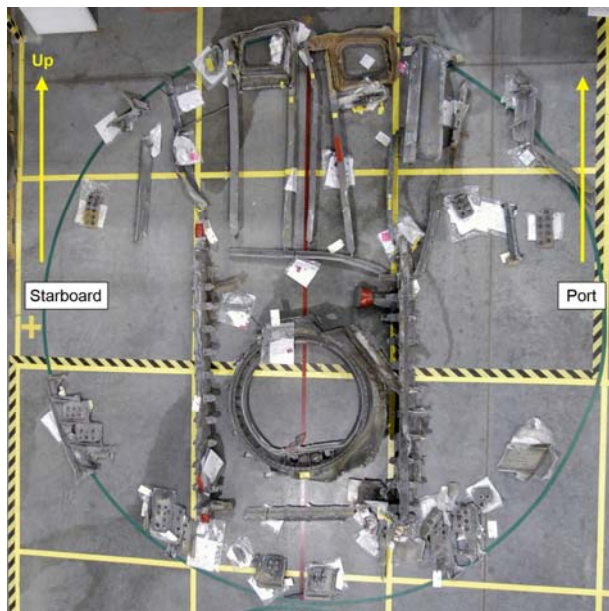
In general, heavy portions of the X<sub>o</sub> 576 bulkhead (including the MAP) survived the entry heating (figure 2.4-46). This is possibly due to the high heat absorption property of the aluminum bulkhead.

Some “T”-section stiffeners survived with little heat damage, possibly because of the early departure of these elements before the high thermal event that consumed the bulkhead.

Figure 2.4-46. View looking aft of the recovered X<sub>o</sub> 576 bulkhead debris.

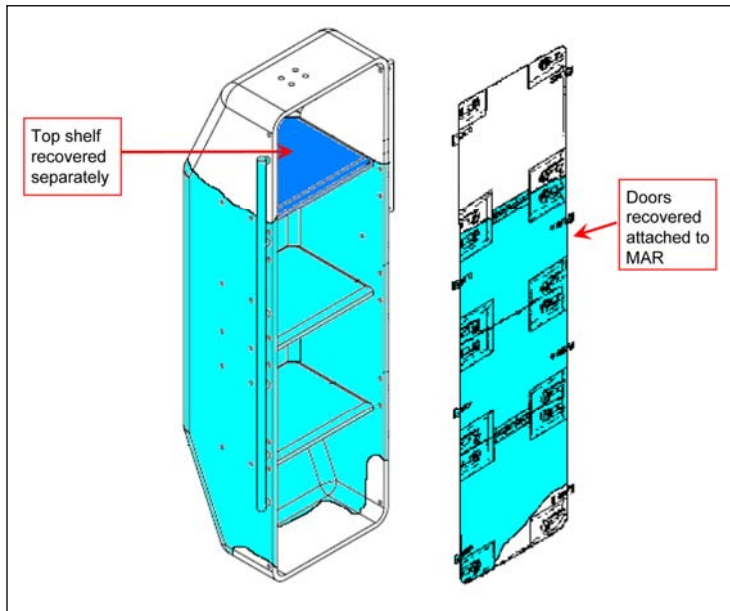
Approximately 75% of the MAR structure was recovered, mostly intact. The blue areas in figure 2.4-48 represent the MAR structure that was recovered. The portions that were not recovered included the upper one-fourth of the MAR structure (including the upper attachment bracket), the top half of the upper door, a portion of the bottom half of the lower door, and the bottom surface of the MAR structure (including floor attachment brackets).

Figure 2.4-48. Recovered middeck accommodations rack structure (shown in blue).

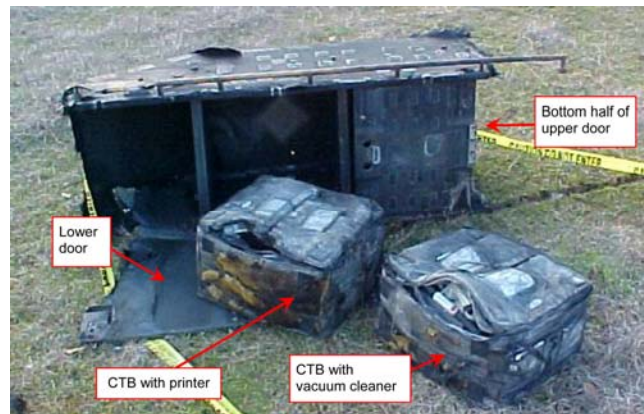
The MAR was recovered with the middle and bottom shelves still attached. The top shelf was recovered separately. The lower door and the bottom half of the upper door were recovered with the MAR structure, as were the contents of the compartment between the middle and bottom shelves (CTBs with the printer and the vacuum cleaner (figure 2.4-49)). The contents of the compartment between the middle and top shelves and the contents of the compartment below the bottom shelf were recovered separately from the MAR structure and were highly fragmented.

Figure 2.4-49. Main middeck accommodations rack structure, as found.

The lack of impact witness marks on the MAR aft handle and the aft wall upper surface indicates that the MAR did not impact the CES pole, which is mounted just inches aft of the MAR. The lack of impact witness marks on the MAR starboard surfaces indicates that the MAR did not impact the seat 5 structure, which is mounted inches starboard of the MAR. Ballistic analysis indicates that the MAR separated from the CM shortly after the CMCE. Based on the failure of the fasteners securing the MAR attachment bracket to the middeck floor, it is concluded that the MAR separated from the middeck floor mostly to fully intact. These conclusions support the general findings that the middeck breakup was rapid and expansive, with very little interaction between major structures, and occurred at the onset of the CMCE.

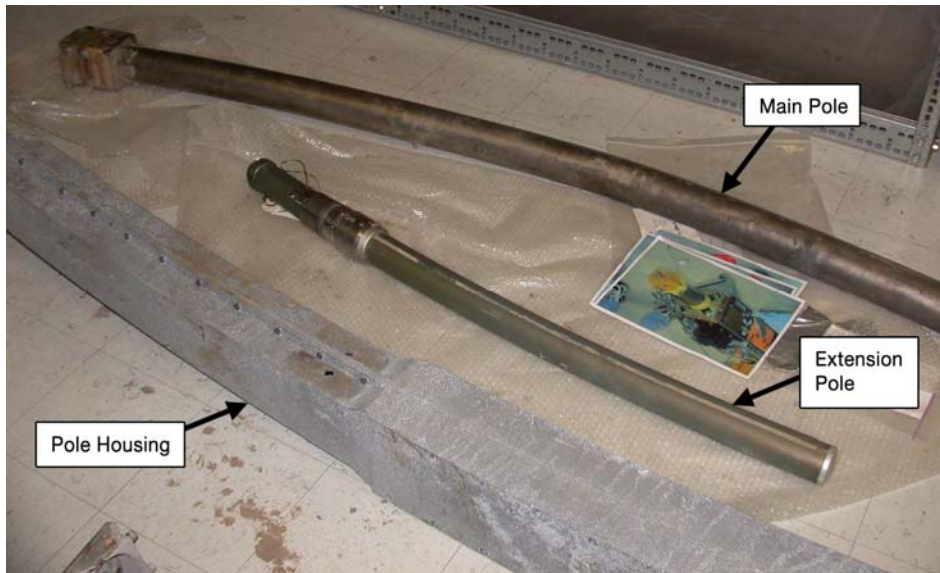
The debris indicates that the pole was installed in the launch/landing position. There is no evidence to suggest that the pole had been deployed (or that the side hatch had been jettisoned<sup>3</sup>). The pole housing, the main pole, and the extension pole (figure 2.4-52) were recovered separately. The starboard end of the housing, including the middeck ceiling mounting bracket, shows evidence of thermal damage. The main pole and extension pole (figure 2.4-53) were recovered in relatively good condition, showing little mechanical or thermal damage. The main pole deployment spring was recovered separately from the housing, with the starboard end cap of the pole housing attached to the spring. Additionally, the portion of the CM port wall to which the pole attaches was recovered and analyzed. Several lanyards were recovered separately, but the lanyard magazine was not recovered.

Figure 2.4-52. Pole housing, main and extension poles.

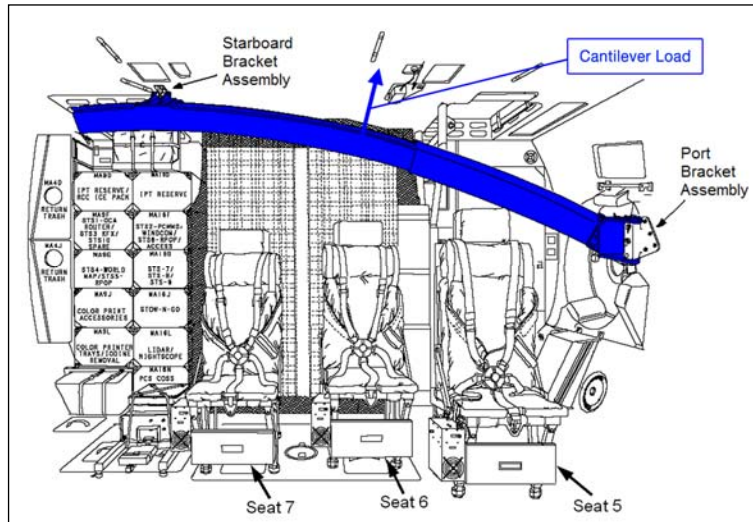
Deformation of the upper portion of the knuckle that attaches to the CM indicates that it experienced an upward cantilever load (figure 2.4-54). This could be caused by the starboard end of the pole moving upward. This suggests that the flight deck separated from the middeck roughly at the flight deck floor/ middeck ceiling level.

**Figure 2.4-54. Crew escape pole in launch/landing position, middeck, looking aft, with direction of cantilever load noted from debris.**

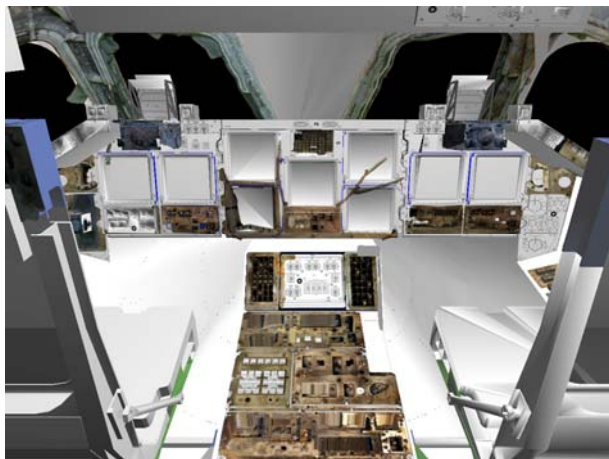
**Figure 2.4-56. Virtual reconstruction of the recovered Columbia flight deck panels.**

This virtual reconstruction was studied to investigate whether there were clear indications of a thermal or structural breach. However, adjacent panels were seen to have received significantly different amounts of thermal damage. This indicated that some panels broke off earlier than other panels, or were temporarily shielded from the thermal flow during the breakup. The damage varied greatly from one panel to the next, indicating a chaotic breakup sequence. No clear evidence of the initial breach location could be determined.

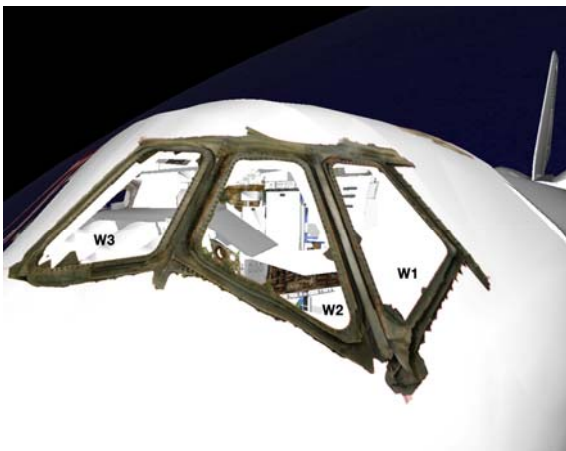
At least one window frame (CM or FF) was recovered from every window. Two large debris assemblies were recovered (figures 2.4-57 and 2.4-58). Each large piece is a complete assembly of three CM forward window frames (Windows 1, 2, and 3 and Windows 4, 5, and 6) with some broken glass pieces still captured in their retainers. Three CM window frames of Windows 7, 9, and 10 were recovered in separate pieces since they were not connected to each other by heavy CM skin structures (figure 2.4-59). Five thermal frames (FF) were also recovered.

**Figure 2.4-57. Port view looking aft, recovered Columbia crew module Windows 1, 2, and 3.**

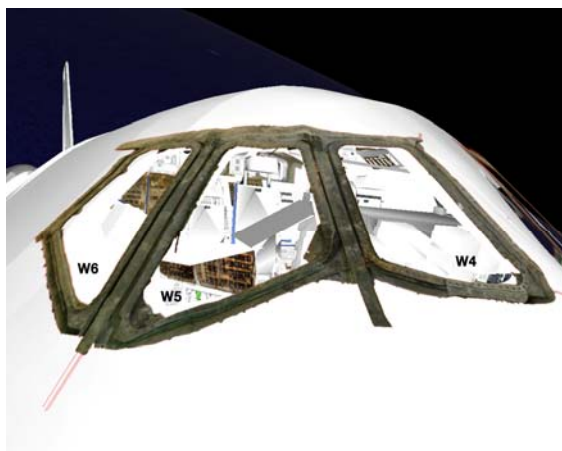
**Figure 2.4-58. Starboard view looking aft, recovered Columbia crew module Windows 4, 5, and 6.**

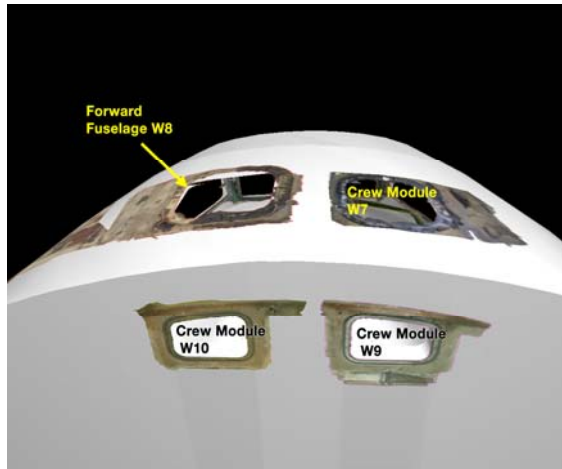
**Figure 2.4-59. View looking forward, recovered Columbia crew module Windows 7, 9, and 10 and forward fuselage Window 8.**

Debris evidence suggests that most of the CM skin structures surrounding the CM flight deck windows had been melted away during the event. One exception is the upper edge of CM aft Windows 9 and 10, which shows mechanical fracture edges.

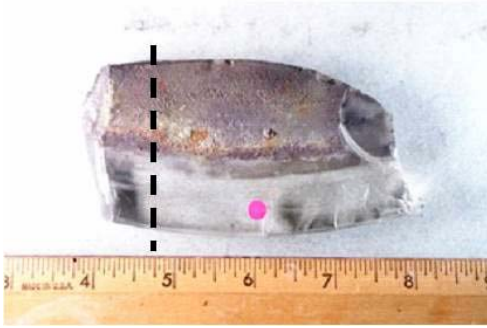
**Figure 2.4-60. Window fragment removed from the thermal pane frame from Window 8. The black dashed line denotes the sectioning plane. The red dot was used to indicate the outward face of the pane.**

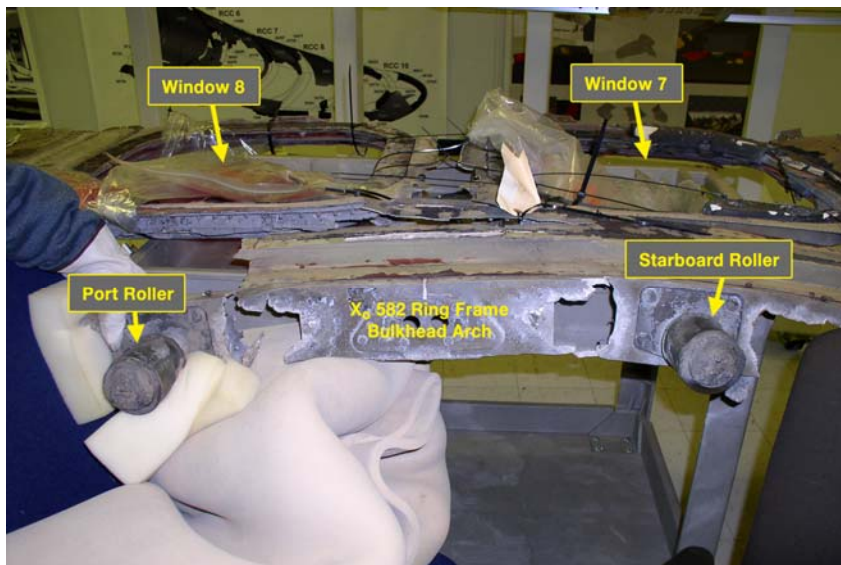
Figure 2.4-63. Columbia debris for same location. Note eroded rollers and eroded region of the X, 582 ring frame bulkhead arch between the rollers.

The recovered rollers for the location closest to the overhead windows both showed significant signs of erosion. While these rollers were not the only components made of titanium, they were the only ones recovered that possessed the proper material, proximity, and thermal indications and were, therefore, concluded as the source location. Given these findings, the rollers were the most probable source of titanium causing the deposition on the windows.

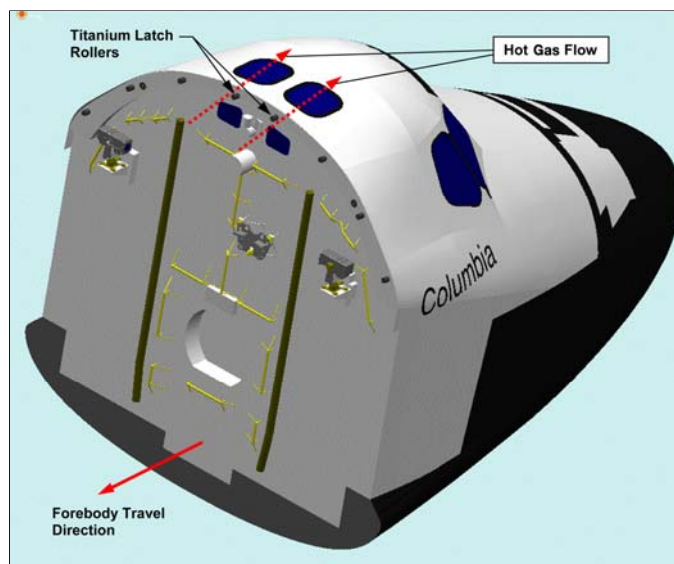
Since the rollers are located on the X<sub>0</sub> 582 ring frame bulkhead arch aft and below these two windows, and protected by the PLBDs, the PLBDs must have been compromised or fully departed while the bulkhead arch was still attached to the CM. Additionally, the forebody must have been traveling aft-end forward for some period of time to have the directional thermal flow that caused the titanium to “vaporize” flow over the glass external surface of the thermal panes or on the external surface of the Windows 7 and 8 redundant panes, it can be concluded that the thermal panes were intact at the time of this event. This is consistent with other findings showing that the FF remained with the CM until breakup of both elements.

Figure 2.4-64. Titanium deposit on windows indicates forebody traveled backwards.

**Finding.** Windows 7 and 8 experienced a titanium deposition event that occurred prior to window breakup.

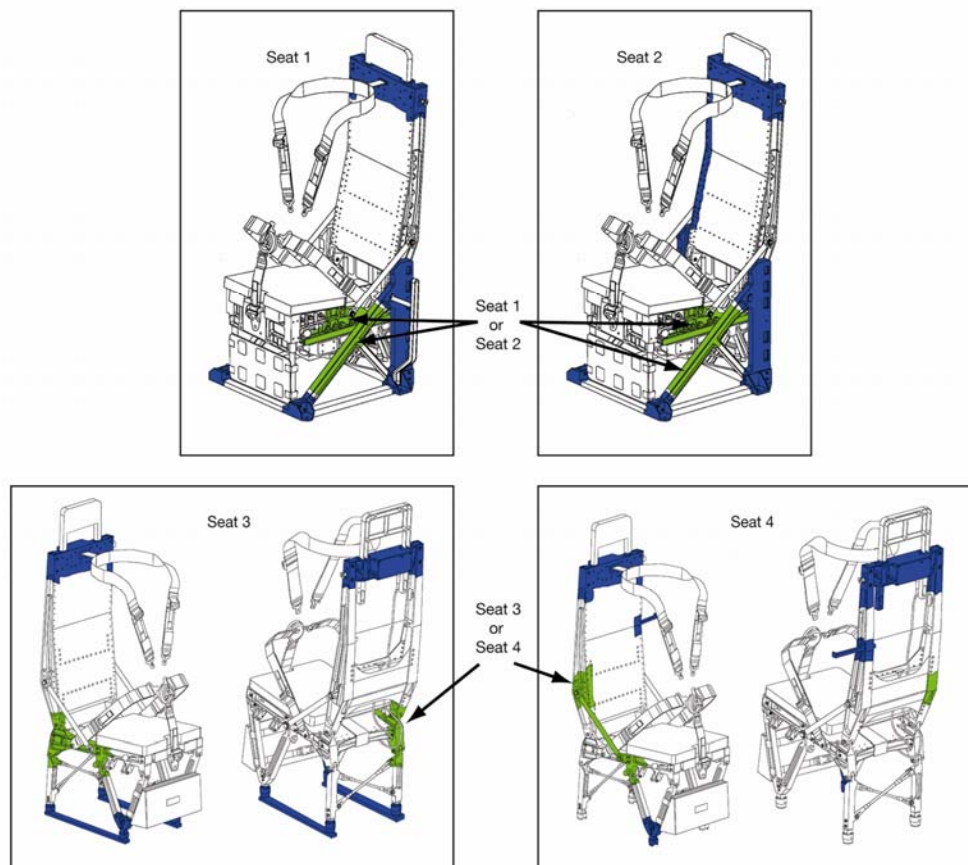
**Figure 3.1-6. Identified debris from the flight deck seats. [Adapted from the Space Shuttle Systems Handbook]**

Figures 3.1-6 and 3.1-7 show seat structure pieces that were identified to each seat location. The blue items in these figures represent items that were positively identified to a seat location. The green items are those items that could be from one of two seats. Figure 3.1-8 shows the major seat structure debris pieces that could not be identified to a specific seat location (the colors in this figure distinguish the different pieces and are otherwise inconsequential). Although represented in figure 3.1-8 on just two seats, the seatback and seat restraint items could be from any of the seven seats. However, the seat pan items could only be from the Mission Specialist seats.

Blue items are positively identified to a specific seat;  
green items could be from either one of the two indicated seats.

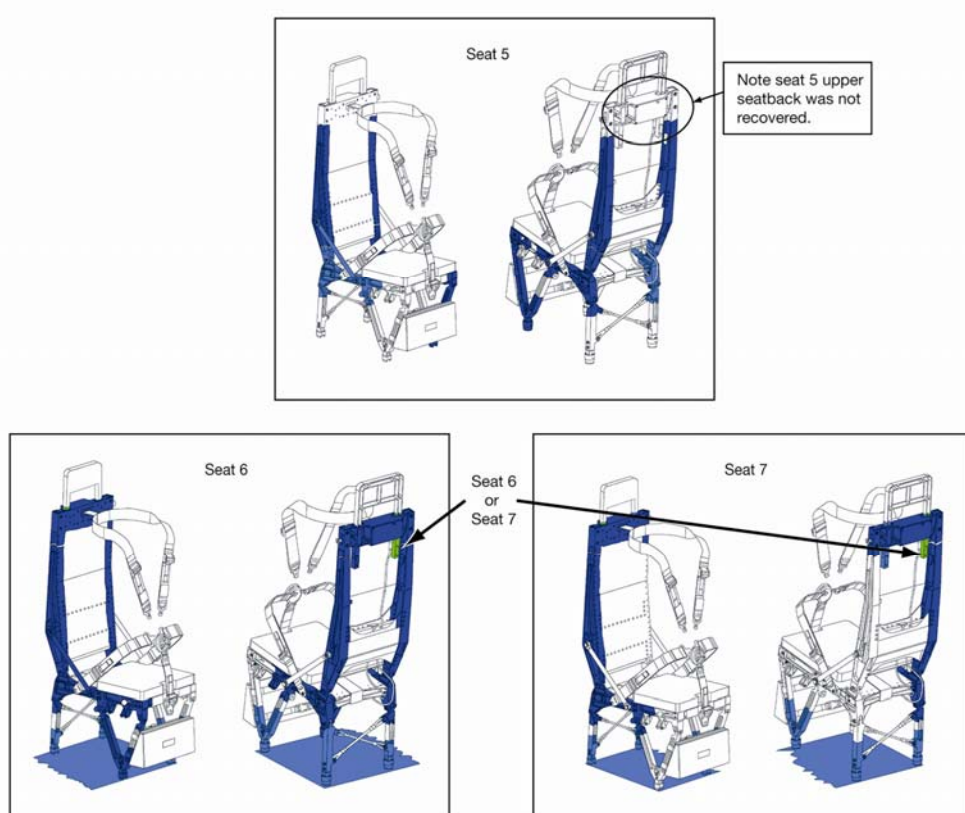
**Figure 3.1-7. Identified debris from the middeck seats. [Adapted from the Space Shuttle Systems Handbook]**

Blue items are positively identified to a specific seat;  
green items could be from either one of the two indicated seats.

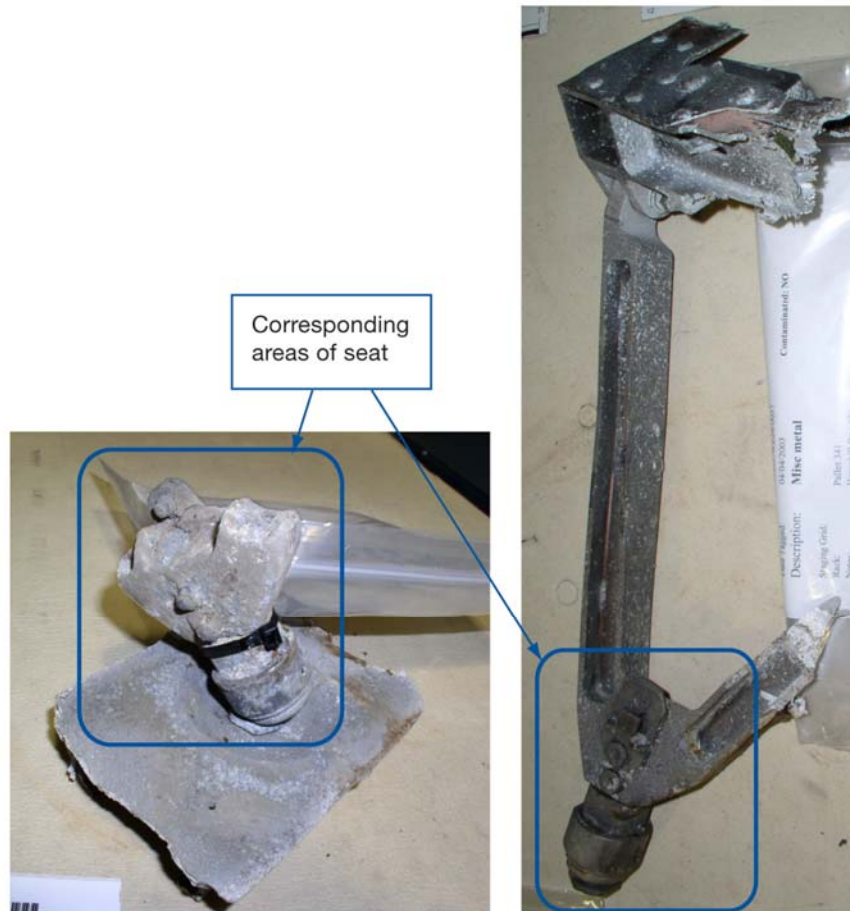
**Figure 3.1-10. Comparison of seat debris from a flight deck Mission Specialist seat (left) and a middeck Mission Specialist seat (right).**

The magnitude and distribution of heating of flight deck seat components indicates a prolonged attachment to other crew module (CM) structure during exposure to heating. This indicates that the flight deck seat components were released from the CM later in the breakup sequence than the middeck seat components. Ground plots of debris recovery locations also support this conclusion (figure 3.1-9). Figure 3.1-10 compares a portion of the seat leg from a flight deck Mission Specialist seat component with a similar component from a middeck seat.

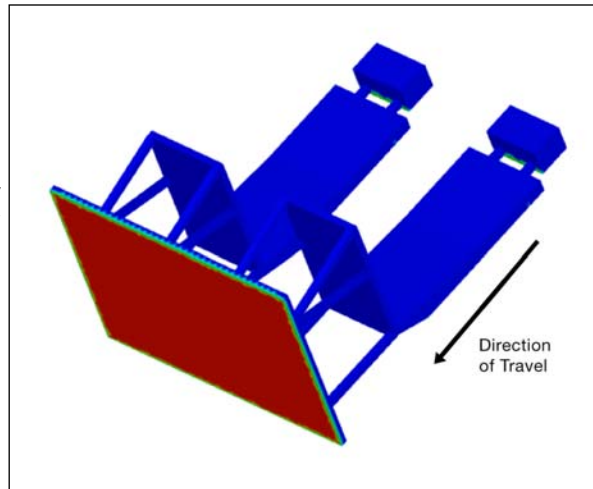
**Figure 3.1-11. Stable attitude of the lithium hydroxide door/seat 6/seat 7 combination, as indicated by deposition.**

Although all seat components experienced significant heating, the middeck seats were less eroded and fragmented when compared to the flight deck seats. Material analysis revealed that the seat 6 and 7 components collected significant deposits of melted aluminum from the lithium hydroxide (LiOH) door to which they were attached. Unlike the flight deck seat components, analysis revealed no materials consistent with the pressure shell deposited on the middeck seats. The CAIB Report concluded,<sup>5</sup> and this report concurs, that seats 6 and 7 remained attached only to the LiOH door during a period of significant thermal exposure and material deposition. The highly directional nature of the deposition indicates that the LiOH door/seat 6/seat 7 combination attained a stable attitude (figure 3.1-11) during thermal exposure. The close proximity of debris recovery locations indicates that the seat 6 and 7 components separated from the LiOH door shortly before ground impact.

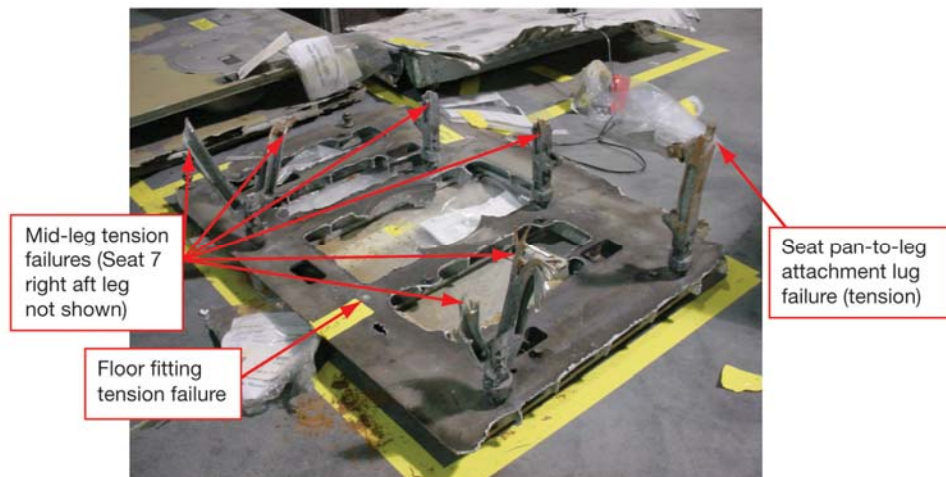
Figure 3.1-14. Recovered lithium hydroxide door with seats 6 and 7 legs attached.

Seats 6 and 7 leg failures occurred with the legs in tension. The lowest strength margin (and, therefore, the expected failure point) at room temperature is at the leg attachment lug at the top of the leg. Analysis indicates that the leg attachment lug should fail at around 12,000 lbs. at room temperature, but only the left aft leg of seat 6 failed at the attachment lug (figure 3.1-14). Another expected leg failure point is the seat attachment floor fitting. At room temperature, the floor fitting should fail at around 21,400 lbs., but only the right forward leg from seat 6 failed at the floor fitting.

Five of the eight seat legs failed at mid-leg locations. The room temperature failure load for mid-leg fractures of the forward leg is 45,000 lbs. and the aft leg failure load is 24,000 lbs.

The seat 7 right forward leg floor fitting is present, but the corresponding seat 7 leg was not recovered; therefore, the failure location was not the floor fitting. Because this leg is very close to the edge of the LiOH door, it is possible that the failure occurred because the locking collar<sup>7</sup> was thermally damaged as the LiOH door/seat 6/seat 7 complex experienced entry heating.

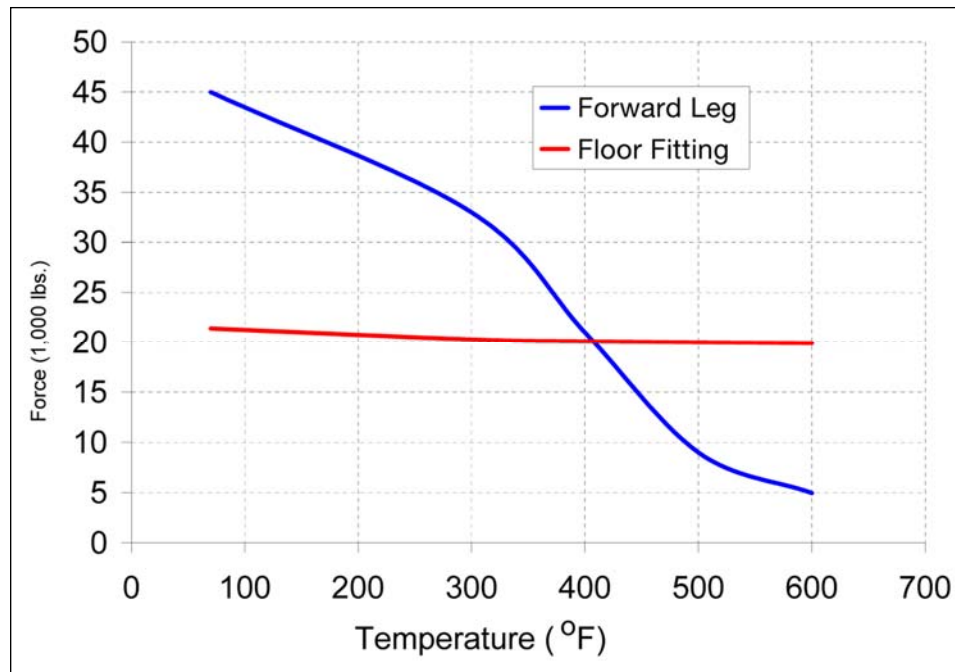
Figure 3.1-15. Failure force of seat forward leg and floor fitting vs. temperature.

Structural assessments were performed on the legs (which are made of 7075 aluminum, with a melting point between 890°F (477°C) and 1,175°F (635°C)) and the floor fitting (which is made of Inconel 718, with a melting point between 2,300°F (1,260°C) and 2,440°F (1,338°C)) to evaluate materials strengths with respect to temperature. As mentioned above, a force of 45,000 lbs. is required to cause a mid-leg tension fracture of the forward leg at room temperature. The required fracturing force decreases to 33,000 lbs. (~75% of room temperature strength) at 300°F (149°C), 21,000 lbs. (~45%) at 400°F (204°C), 9,000 lbs. (~20%) at 500°F (260°C), and 4,950 lbs. (~11%) at 600°F (316°C).

A force of 21,400 lbs. is required to fracture the floor fitting at room temperature. This force decreases to 20,300 lbs. (~95% of room temperature strength) at 300°F (149°C), 20,100 lbs. (~94%) at 400°F (204°C), and 19,900 lbs. (~93%) at 600°F (316°C). These values are plotted in figure 3.1-15.

This plot reveals that heating greater than 400°F (204°C) is needed to weaken the materials such that the leg failure would occur at the mid-leg location. Otherwise, the forward legs should have failed at the floor fitting, which did not occur.

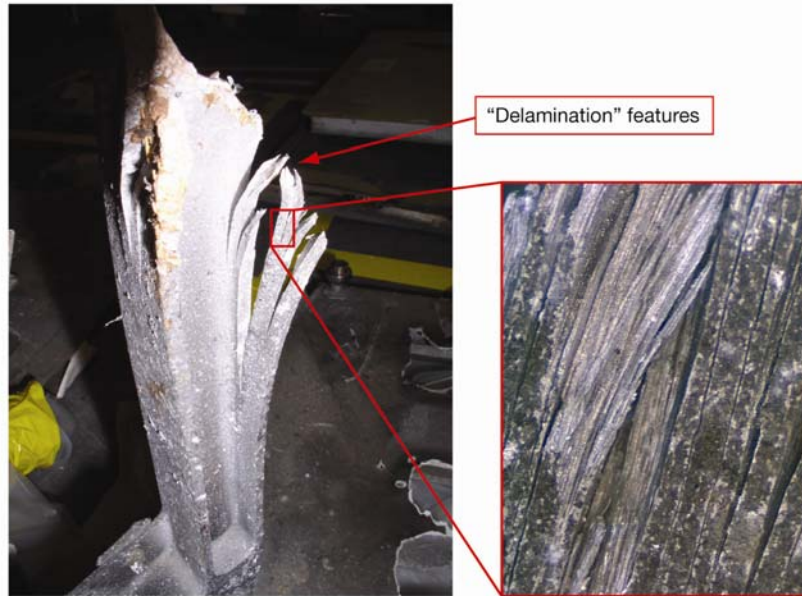
Figure 3.1-16. Example of a “broom-straw” fracture on a Columbia seat leg.

Inspection of the seat structure fracture surfaces revealed a “delamination” fracture pattern that is consistent throughout the seat debris items. The most drastic of the fractures makes it appear almost as if the 7075 aluminum material is constructed of a laminate material (figure 3.1-16). This phenomenon is termed a “broom-straw” fracture.

In all cases, seat failure occurred as a result of thermal exposure (resulting in material property degradation) followed by mechanical overload. The additional thermal degradation on the flight deck seat components is accounted for by a longer period of heating as a result of the higher ballistic number associated with an intact, free-flying flight deck.

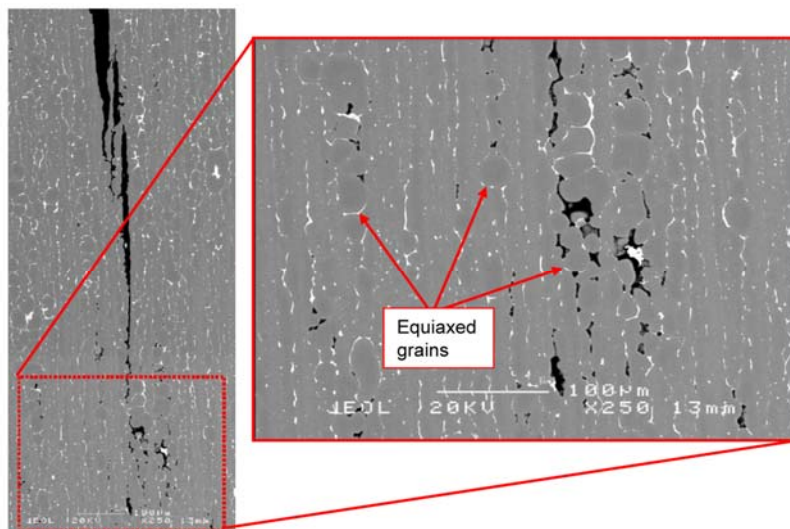
Figure 3.1-17. Scanning electron microscope image of broom-straw fracture surface cross sections.

Scanning electron microscope analysis of the seat broom-straw fracture surface cross sections revealed fully intergranular fractures and equiaxed grain<sup>8</sup> microstructure. This finding is consistent with exposure to elevated temperatures and high strain rates. Equiaxed grains were discovered both along and away from the crack surfaces (figure 3.1-17).

Metallurgical evaluation was completed in proximity to, and away from, the crack surfaces using energy dispersive X-ray spectroscopy. This revealed heavy grain boundary precipitation that is consistent with the aluminum alloy experiencing temperatures greater than 900°F (482°C).

All of these features are consistent with material that is exposed to high temperatures. Significant lack of ductility surrounding the fracture areas indicates that the failures occurred at relatively high strain rates.

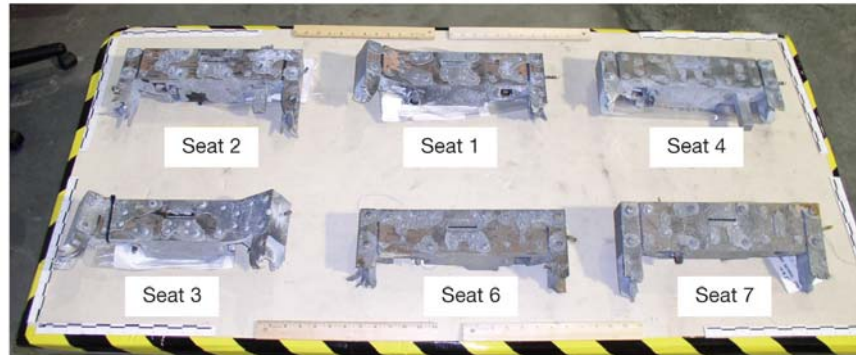
Figure 3.1-19. Upper seatbacks (front view).

As with the general seat failures that were described previously, all of the fractures at the upper seatback location occurred at the minimum thermal cross section, away from heat sinks on either side. Fracture surfaces did not exhibit melting or materials deposition, indicating that the upper seatback fractures occurred near the end of the period of heating and material deposition. Figure 3.1-19 shows all six recovered upper seatback items. Table 3.1-1 summarizes the upper seatback findings.

Seat	Deformation	Fractures	Thermal Effects
Seat 1	Right frame member is bent forward, about the headrest bushing.	Tensile/bending fractures (with “broom-straw” features) are present on both the left and the right seatback frame members, just below the lower surface of the upper seatback/inertial reel assembly.	A moderate amount of splattered aluminum is present throughout, primarily deposited on the upper and lower surfaces (the upper surfaces more than the lower). No melting of fracture surfaces is noted.
Seat 2	Deformation is limited to the areas local to the fractures.	Tensile/bending fractures (with “broom-straw” features) are present on both the left and the right seatback frame members, just below the lower surface of the upper seatback/inertial reel assembly.	A moderate amount of splattered aluminum is present throughout, primarily deposited on the upper and lower surfaces (the upper surfaces more than the lower). No melting of fracture surfaces is noted.

Seat 3	Left and right frame members bent forward. Left side is bent about the headrest bushing; right side is bent just out-board of the bushing.	Tensile/bending fractures (with “broom-straw” features) are present on both the left and the right seatback frame members, just below the lower surface of the upper seatback/inertial reel assembly.	A large amount of splattered aluminum is present throughout, primarily deposited on the upper and lower surfaces. Noted the absence of deposited material on the portside bushing. No melting of fracture surfaces is noted.
Seat 4	Deformation is limited to the areas local to the fractures.	Tensile/bending fractures (with “broom-straw” features) are present on both the left and the right seatback frame members, just below the lower surface of the upper seatback/inertial reel assembly.	A large amount of splattered aluminum is present throughout, primarily deposited on the upper and lower surfaces. No melting of fracture surfaces is noted.

Seat 6	Slight deformation in the right frame member, bent about the headrest bushing.	Tensile/bending fractures (with “broom-straw” features) are present on both the left and the right seatback frame members, just below the lower surface of the upper seatback/inertial reel assembly.	A large amount of splattered aluminum material is deposited primarily on the lower surface. Noted a near complete absence of deposition on the upper surface. No melting of fracture surfaces is noted.

Seat	Deformation	Fractures	Thermal Effects
Seat 7	Deformation is limited to the areas local to the fractures.	Tensile/bending fractures (with “broom-straw” features) are present on both the left and the right seatback frame members, just below the lower surface of the upper seatback/inertial reel assembly.	A large amount of splattered aluminum material is deposited on the lower surface. Noted a complete absence of deposition on the upper surface. No melting of fracture surfaces is noted.
Interpretations		Seat fractures occur at minimum thermal cross section, away from heat sinks on either side.	Middeck items appear to have experienced significant splatter initiating from below. Flight deck items appear to have experienced significant splatter initiating from above and below. Lack of melting on the fracture surfaces indicates that the fractures occurred after the period of heating.
Conclusions	Observed deformations are affiliated with seat breakup fractures.	Fractures are consistent with general seat failure mechanism (thermal heating followed by mechanical overload).	Flight deck items experienced significant splattering initiating from above and below. Middeck items experienced significant splattering initiating from below <i>only</i> . Upper seatback fractures occurred after the period of heating.
