# ***Columbia* Crew Survival Investigation Report**

NASA/SP-2008-565

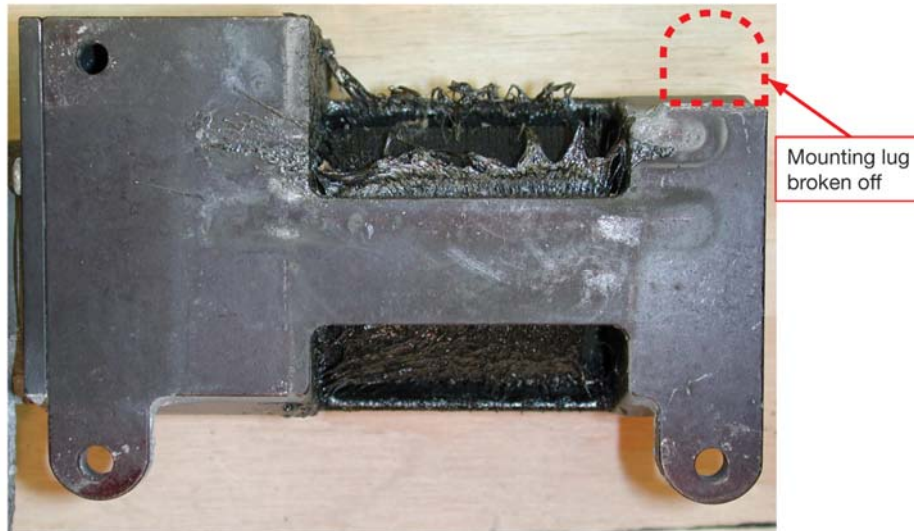
Figure 3.1-21. Seat 3 inertial reel, looking aft.

Only seat 3 showed deformation of the inertial reel housing mounting hardware. All four mounting bolts were bent slightly. One inertial reel housing mounting lug was broken with melted metal deposits on both fracture surfaces; i.e., the fracture surface of the lug and the fracture surface of the inertial reel housing (figure 3.1-21). The inertial reel mounting hardware for the other five recovered upper seatbacks exhibited no deformations.

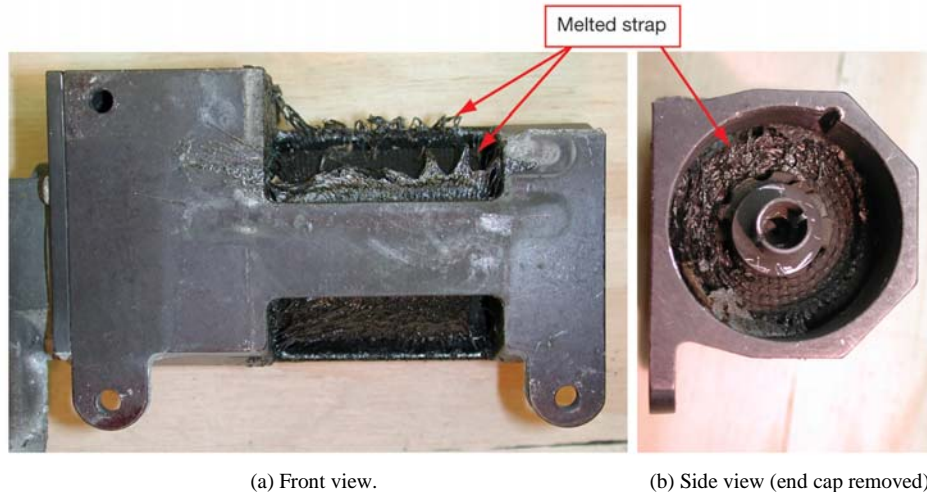
Figure 3.1-23. *Inertial reel melted strap material.*

In all cases, the inertial reel straps were melted only in areas that were immediately adjacent to the strap pass-through openings and along the lateral edges of the strap (figure 3.1-23). The strap material in other areas was not melted and appears normal.

The inertial reel straps failed primarily due to mechanical overload. Limited melting of the straps (and only in distinct areas that were unprotected by the inertial reel housing) indicates that melting was not a significant factor in the inertial reel strap failure. The mechanical overload may have been affected by elevated temperatures that weakened the straps, but these temperatures were not sufficient to cause obvious thermal damage to the strap. Significant strap melting occurred after the inertial reel straps failed and recoiled into the housing. Therefore, the inertial reel straps failed (and the *Columbia* crew members were, at most, partially restrained in their seats) prior to the end of the period of thermal exposure.

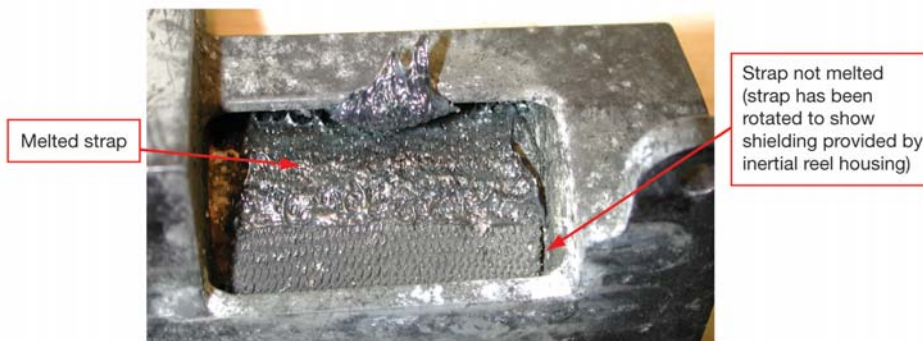
Five of the six recovered strap ends terminated along a straight line. The exception was the strap for seat 2, which terminated in a jagged line. Away from, but in close proximity to, the melted areas, the residual strap material remains flexible. This is consistent with melting that occurred after the strap recoiled into the housing (the straight lines correspond to where the straps were exposed at the pass-through slot). If the whole strap was exposed to significant heating/melting, a definite thermal gradient (varying degrees of melting) and some melting and “pulling” at the broken end of the strap would be seen. However, none of the straps exhibited a thermal gradient along the strap or melting and pulling at the broken end. The demarcation between melted and non-melted areas is very distinct (figure 3.1-24), indicating that the straps were protected inside the inertial reel housings during the period of high heating.

Figure 3.1-24. *Close-up of strap melt pattern.*

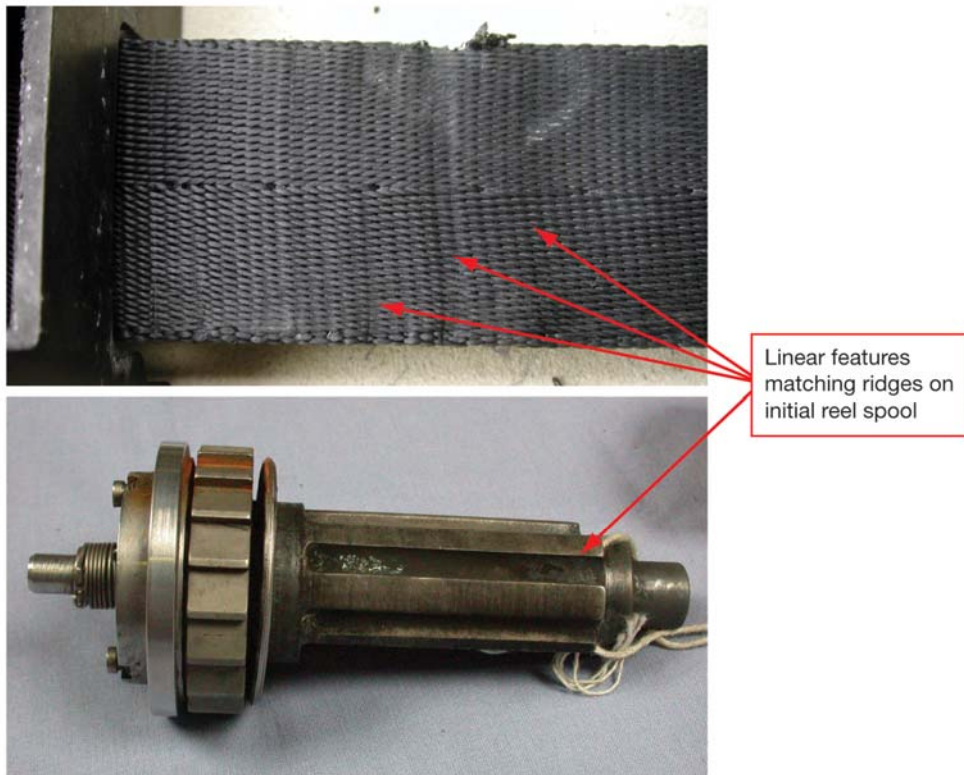
Indentations matching the linear ridges on the inertial reel spool were observed 0 to 4 in. from the strap attach location (figure 3.1-25). These linear indentations near the inertial reel, were present on all the straps (except the seat 1 strap, which failed next to the inertial reel attachment). Inertial reel straps for 11 other shuttle flight seats in inventory (not *Columbia* debris) and training seats were inspected for similar linear features. The inertial reel straps for all seats exhibited the same waves that were found on the *Columbia* inertial reel straps. Therefore, the waves are a result of strap stowage, not an indication of loading on the strap.

**Figure 3.1-25.** Example of linear waves on inertial reel straps.

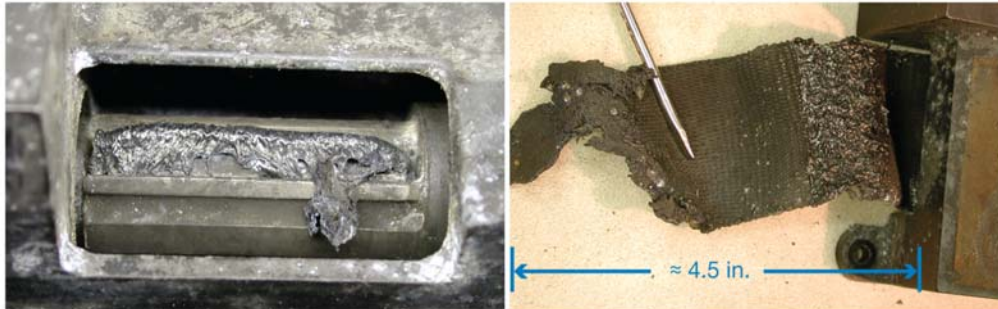
Seat 1 experienced strap failure at the end of the strap next to the inertial reel, and seat 2 experienced strap failure near the end of the strap next to the inertial reel. The seat 1 strap failure (figure 3.1-26) occurred in a straight line along the strap attach point shear plane (the expected failure point if the strap is fully extended).

The seat 2 strap failed at an approximate 45-degree angle, over a 1- to 2-in. length, approximately 4.5 in. from the inertial reel (figure 3.1-26). The way in which the seat 2 belt failed is unique among the

six recovered inertial reel straps. This failure is similar to a failure mode known as strap “dumping.”<sup>12</sup> It is theorized that loading of the inertial reel strap laterally against the pass-through slot (figure 3.1-27) resulted in damage to the strap and, eventually, strap failure.

Figure 3.1-26. Seat strap failures: seat 1 (left) and seat 2 (right).

**Finding.** The seat 2 inertial reel strap exhibits “strap dumping” failure features. The strap failed progressively, possibly due to damage to the lateral edge of the strap from contact with the sharp edge of the strap pass-through slot.

**Recommendation L2-5.** Incorporate features into the pass-through slots on the seats such that the slot will not damage the strap.

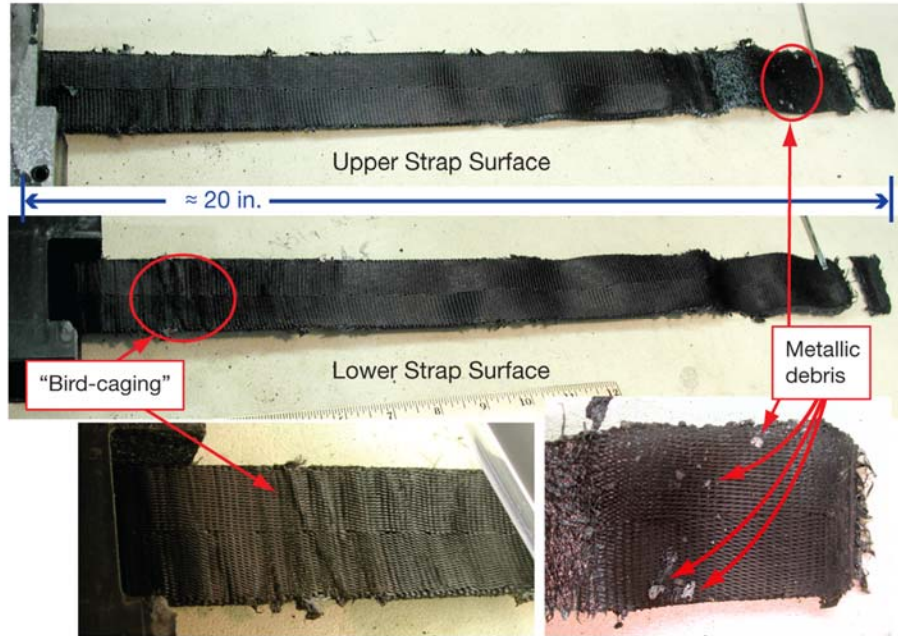
Figure 3.1-28. Seat 3 inertial reel strap.

The seat 3 inertial reel strap (figure 3.1-28) failed at approximately 90% of the extended length (~20 in. away from the inertial reel). This strap failure occurred in close proximity to the shoulder harness y-split attachment, which is the expected failure point if a strap is not fully extended (the inertial reel strap will fail at around 5,200 to 5,300 lbs.). Wave features, which were observed approximately 2 to 4 in. from the strap attach location at a slight angle (~20 degrees) from perpendicular to the strap axis, were similar to the “birdcaging”<sup>13</sup> features found in dynamic failures of cable/cord. Because these birdcage features are close to the inertial reel end of the strap, the strap failure occurred with the strap mostly extended (retracted only 2 to 4 in.). Approximately 10 small metallic bits of debris, the larger of which are approximately 1/8 in. in diameter, were located approximately 16.5 to 18 in. away from the inertial reel attachment.

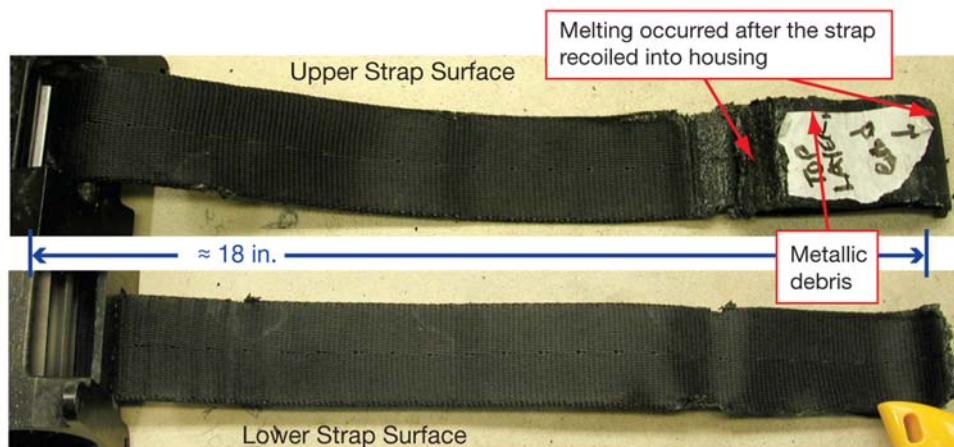
Figure 3.1-29. Seat 4 inertial reel strap.

The seat 4 inertial reel strap (figure 3.1-29) failed at approximately 80% of the extended length, which is in proximity to the attachment at the shoulder harness y-split (~18 in. away from the inertial reel). One very small ball of melted metallic material (< 1/16 in.) was located approximately 14 in. from the inertial reel attachment on the lateral edge of the upper strap surface (the debris came off during inspection.). No witness marks were observed along the entire strap length.

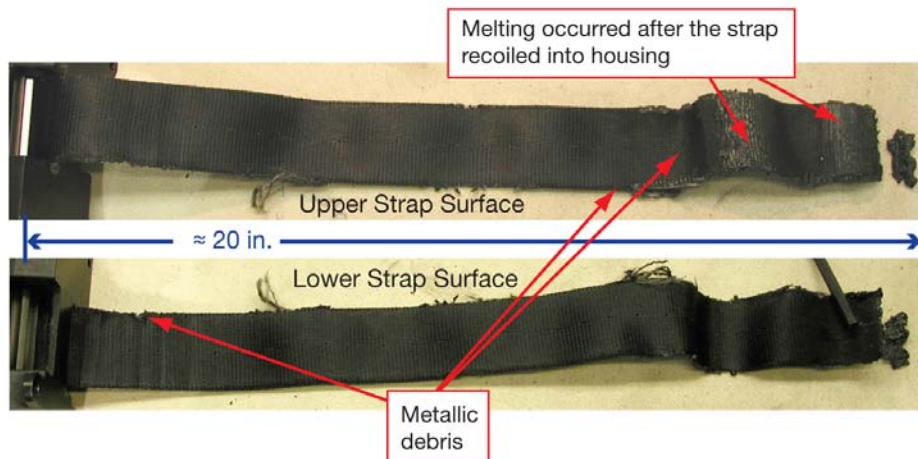
Figure 3.1-30. Seat 6 inertial reel strap.

The seat 6 inertial reel strap (figure 3.1-30) failed at approximately 90% of the extended length (~20 in. away from the inertial reel). Strap failure occurred in close proximity to the shoulder harness y-split attachment (the expected failure point if the strap was not fully extended). No witness marks were observed along the entire strap length. Three pieces of metallic debris were deposited on the strap surfaces: a small ball of melted material (< 1/32-in. dia.) deposited on the upper surface, approximately 16 in. from the reel

attachment (debris came off during inspection); a small fragment of melted material (< 1/32-in. dia.) deposited on the lateral strap edge located approximately 13 in. from the reel attachment; and a small fragment of melted material (< 1/32 in. dia.), which was deposited on the lateral strap edge located approximately 1.75 in. from the reel attachment. The strap was melted completely through one layer near the strap pass-through opening.

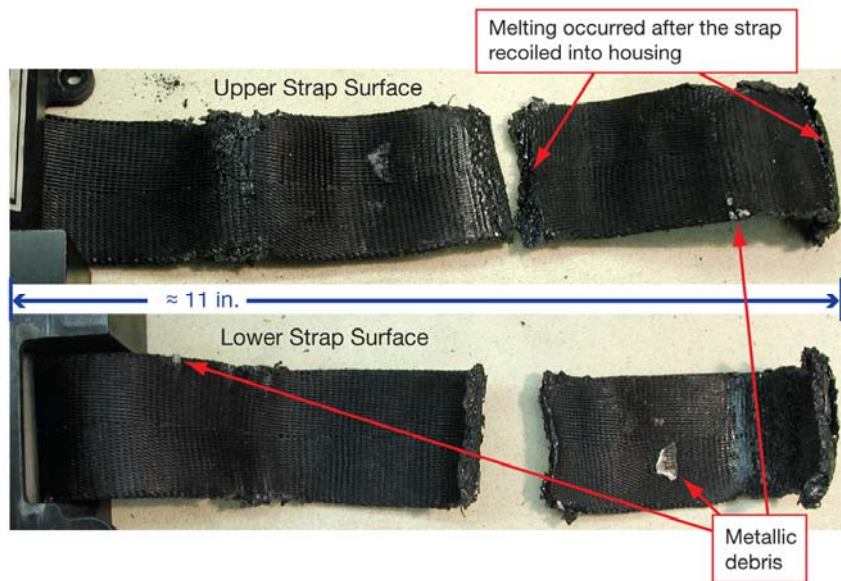
Figure 3.1-31. Seat 7 inertial reel strap.

The seat 7 inertial reel strap (figure 3.1-31) failed at approximately 50% of its length (~11 in. away from the inertial reel). No witness marks were observed along the entire strap length. Three areas of metallic debris deposits were noted on the strap: one approximately 1/10-in.-diameter, roughly spherical piece of metal debris stuck to the edge (the right side of seat) of the lower surface of the strap, approximately 1.5 in. from the inertial reel; one 0.5-by-0.3-in. roughly triangular (~0.05-in.-thick) piece of metal debris stuck to the lower surface of the strap, approximately 8 in. from the inertial reel; and several small, roughly spherical metal debris items stuck to the upper side of the strap fragment, along the edge, approximately 2 in. from the end. Localized melting caused the strap to separate into two pieces after the strap had recoiled into the housing.

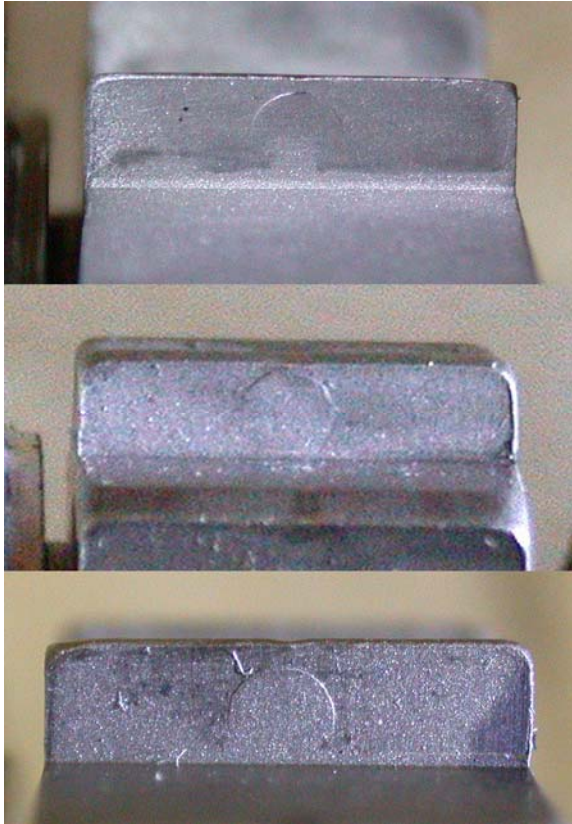
It was initially thought that the witness marks were an indication of inertial reel strap loading during the accident. However, extensive investigation of inertial reels from training seats and other flown shuttle seats as well as a new inertial reel revealed identical circular witness marks (figure 3.1-34).

Figure 3.1-34. Circular witness marks on inertial reels from a training seat (top), a flight (non-Columbia) seat (middle), and a new (unused) flight-qualified inertial reel (bottom).

All inertial reels/straps of this type are proof-tested by the manufacturer with a 3,350-lb. static load prior to delivery to the customer. Because these inertial reels (and the *Columbia* inertial reels) were proof-tested, the investigation concluded that the witness marks on all of the inertial reels are a result of proof-testing. The absence of a second witness mark on the inertial reel led to the conclusion that the inertial reel straps failed at forces below the equivalent of a 3,350-lb. static load. However, it is probable that the straps failed under dynamic loading. As discussed above, the straps' load-carrying capabilities under dynamic loading are unknown.

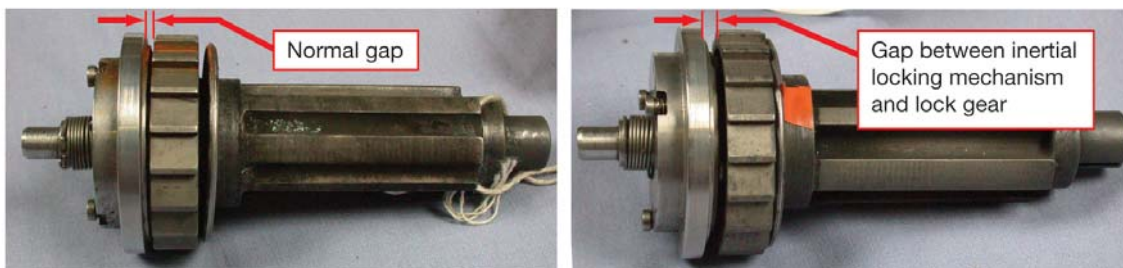
A relatively large gap was discovered between the inertial locking mechanism and the lock gear on the seat 4 inertial reel (figure 3.1-35).

Figure 3.1-35. Separation gap on the seat 4 inertial reel.

Upon further inspection, it was noted that the locking mechanism had permanently “jumped” out of the normal track position, creating a gap between the inertial mechanism and the locking gear. Because this configuration would not function nominally, it is concluded that this “jump” occurred during the accident.

The observed gap between the inertial reel locking mechanism and the locking gear on seat 4 is consistent with information in the manufacturer’s experience base and occurs in crash events resulting in accelerations above 100 G at the strap input. However, the inertial reel locking mechanism can also be moved away from the locking gear by an impact along the axis of the inertial reel spool. Therefore, the observed failure (and resulting gap) could have been caused by impacts during the breakup dynamics, ground impact, or actual loads on the inertial reel strap. Because the cause of failure cannot be determined positively, no conclusions are possible regarding seat 4 inertial reel strap loads/accelerations.

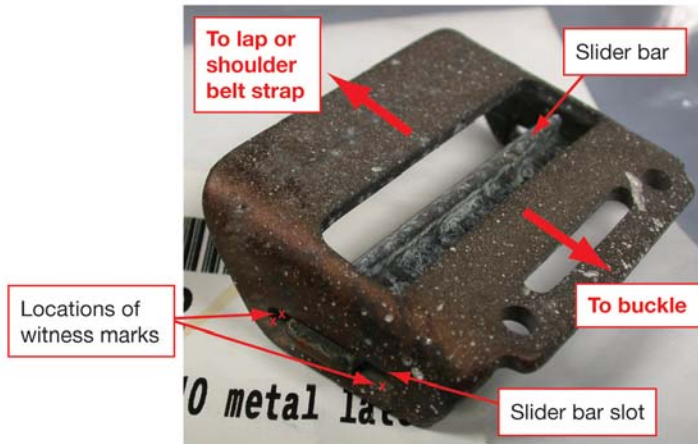
Three of the four adjusters exhibited witness marks within the slider bar slot surface (figure 3.1-37). Tension on the belt will cause the slider bar to contact the slider bar slot as the bar rotates and slides within the slot. The witness marks in the adjusters are a result of significant loading on an intact restraint belt.

Figure 3.1-37. Recovered belt adjuster rear view.

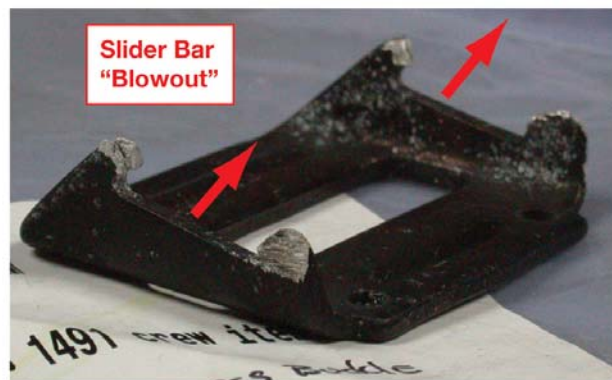
The fourth adjuster was missing the slider bar, and experienced fractures on both the left and the right slider bar slots. These fractures were apparently caused by the slider bar “blowing out” away from the body surface (figure 3.1-38).

Figure 3.1-38. Fractured belt adjuster.

The fracture surfaces exhibited delamination fractures (the “broom-straw” fractures described in section 3.1.3), indicating material property degradation due to elevated temperature exposure combined with high strain rate loading. The heating occurred quickly and allowed material degradation of the metallic belt adjuster to occur without compromising the material properties of the nylon restraint belt to the point that the belt could not transmit forces to the adjuster.

The slider bar “blowout” on one of the four strap adjusters was the result of significant loading on an intact restraint belt. It cannot be determined positively when this strap adjuster failure occurred.

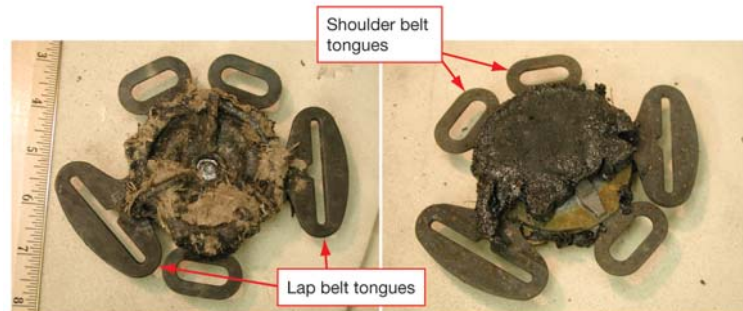
One of the seven 5-point seatbelt buckles on board *Columbia* was recovered (figure 3.1-40). Positive identification to a seat position was not possible. Although the buckle experienced significant entry heating, resulting in substantial melting of the outer plastic housing, the structure remained intact with all five belt tongues still in place.

Figure 3.1-40. *Recovered five-point seatbelt buckle (front and back).*

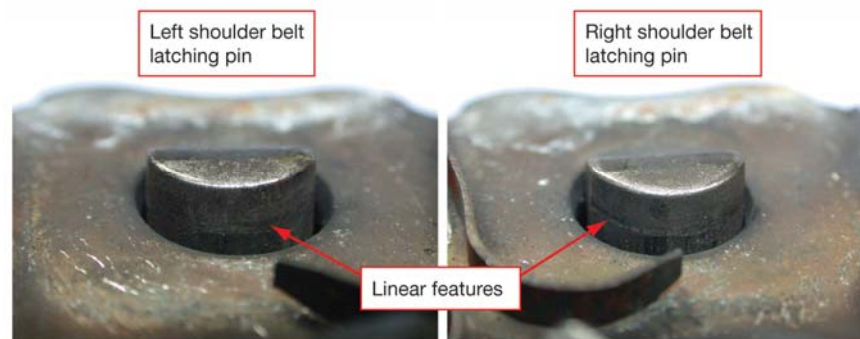
The buckle assembly was disassembled for analysis. The two shoulder belt tongues and the two lap belt tongues were bent outward slightly (i.e., away from the crew member). Both of the shoulder belt tongue latching pins had very shallow linear features corresponding to the mating surfaces of the belt tongue (figure 3.1-41). These features may be witness marks as a result of dynamic loading events that were experienced in flight by the restraint system or of forces imparted to the five-point attach buckle during disassembly by the CAIB investigation team. A definitive conclusion cannot be made based on these witness marks alone. The other latching pins did not exhibit any noticeable marks or deformations.

Figure 3.1-41. *Indentations on latching pins, looking from center of buckle towards outer edge.*

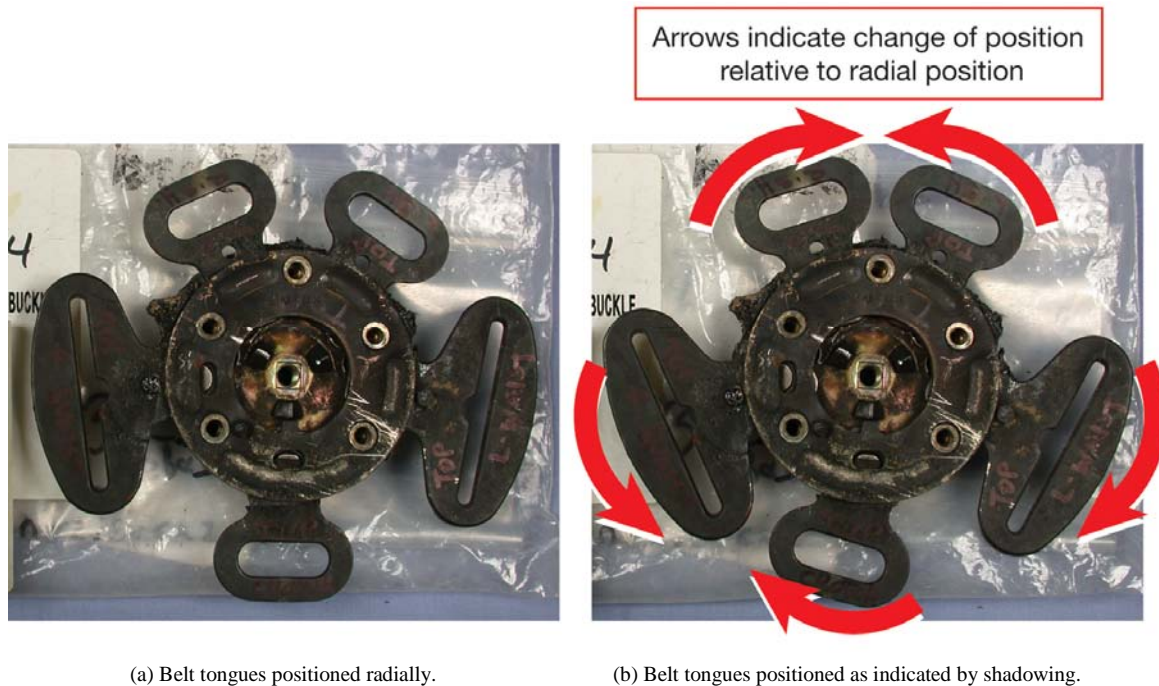
**Figure 3.1-42. Belt tongue positions.**

Shadowing<sup>14</sup> on the belt tongues indicates that the belt tongues were in the position shown in figure 3.1-42(b). These positions, when compared to the positions of the tongues being straight out from center of buckle (radially, figure 3.1-42(a)), are: the shoulder belt tongues are moved toward the centerline (medially), the crotch belt tongue is moved toward the right side of the seat, and the lap belt tongues are moved down. It cannot be determined positively when the deposition (and shadowing) occurred, so no conclusions can be made relative to timing.

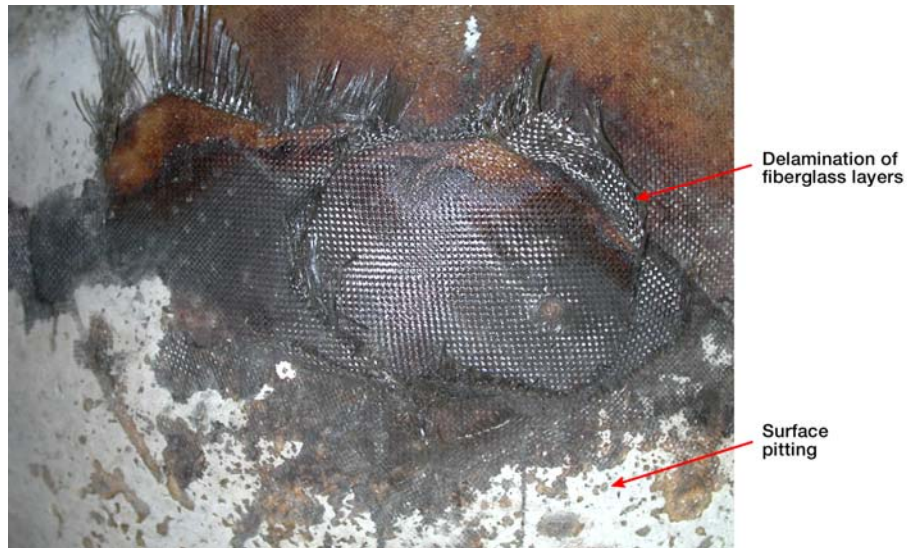
Thermal effects were apparent throughout all helmet surfaces. Significant variations in thermal conditions were noted from helmet to helmet (both interior and exterior helmet surfaces). The reflective tape was missing from all of the helmets, and fiberglass delaminations of various sizes and depths were observed. Some white paint remained, except in the areas removed via fiberglass delamination. Residual paint on the exterior helmet surfaces shows signs of damage (pitting) that are consistent with impacts with many small debris items. Figure 3.2-22 shows examples of delaminations and pitting damage.

Figure 3.2-22. Delamination and pitting damage.

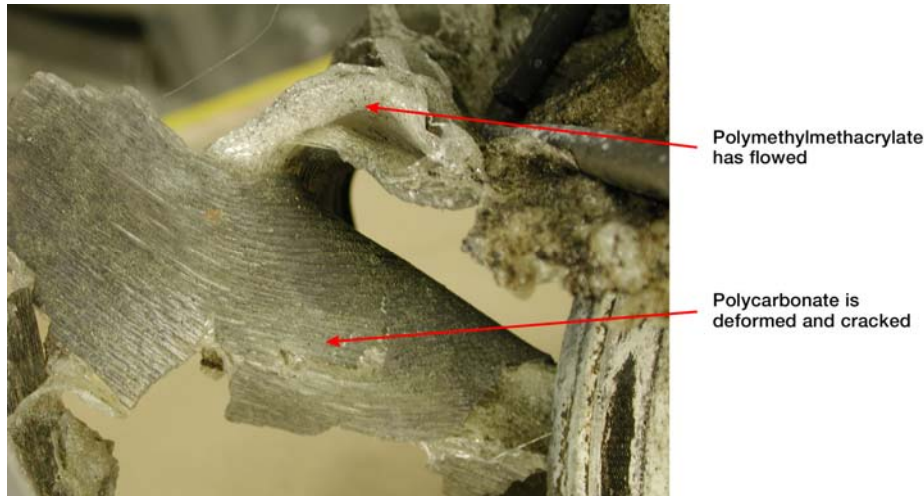
On all three helmets that have remaining pressure visor material, the polymethylmethacrylate flowed and pyrolyzed and the polycarbonate flowed in some places but did not pyrolyze (figure 3.2-23). Therefore, helmet visor materials experienced at least 300°F (149°C), which is the glass transition temperature of polycarbonate, to over 572°F (300°C), the pyrolysis temperature of polymethylmethacrylate, but certainly less than 752°F (400°C), which is the pyrolysis temperature of polycarbonate. Although there were small localized areas of fiberglass pyrolysis, in no case was there global pyrolysis of the helmet fiberglass material, indicating that the helmets did not experience temperatures globally above 735°F (391°C).

Figure 3.2-23. *Helmet pressure visor thermal effects.*

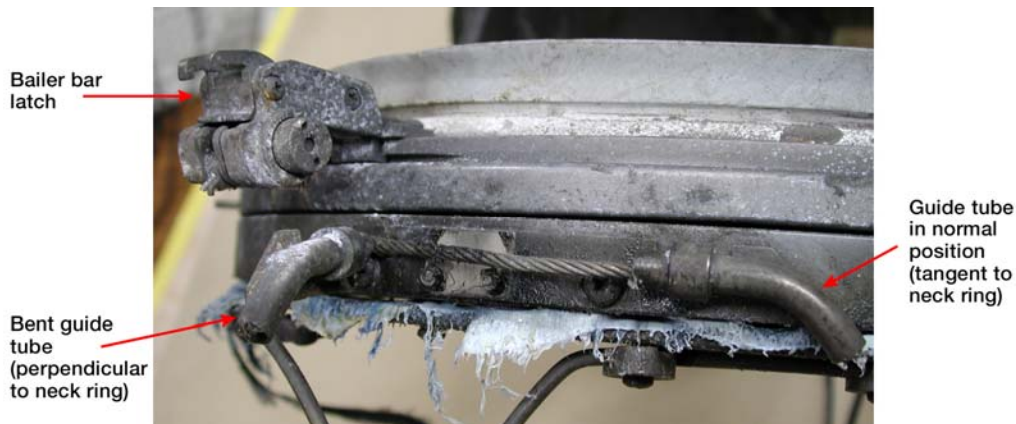
The hold-down cables on each neck ring were severed at the attach points to the cable guide tubes due to mechanical overload (figure 3.2-24). Most cable guide tubes experienced significant plastic deformation. The guide tubes display evidence of external contaminants (i.e., melted metal and suit material) and thermal effects on top of the fractures and localized deformation. This indicates that mechanical loading preceded exposure to the thermal environment. Rotation of the helmet relative to the normal forward position was observed on all neck rings varying from 90 to 180 degrees. Major cable guide tube deformation and helmet rotation indicates that a significant loading event occurred where helmets were removed via a mechanical (nonthermal) mechanism.

Figure 3.2-24. Hold-down cable guide tube.

The bailer bar latch mechanisms on five of the seven helmets remained attached to the helmets in good condition (figure 3.2-24). This would not be expected if the crew members had lowered and locked their visors. Mechanical separation of the bailer bar would be accompanied by fracture of the latch assembly if the visor was down and the bailer bar was locked. The other two helmets experienced latch mechanism separation due to failure of the fasteners that attach the latch mechanism to the helmet before subsequent deposition of melted suit materials. This suggests that latch separation was followed by suit melting. Neither of the two helmets shows evidence of the indentation or deformation that would be associated with forces expected if the bailer bar ripped the latch from the neck ring. Combined with the absence of melted visor material on the visor seal, this confirmed the conclusion that none of the crew members lowered and locked visors.

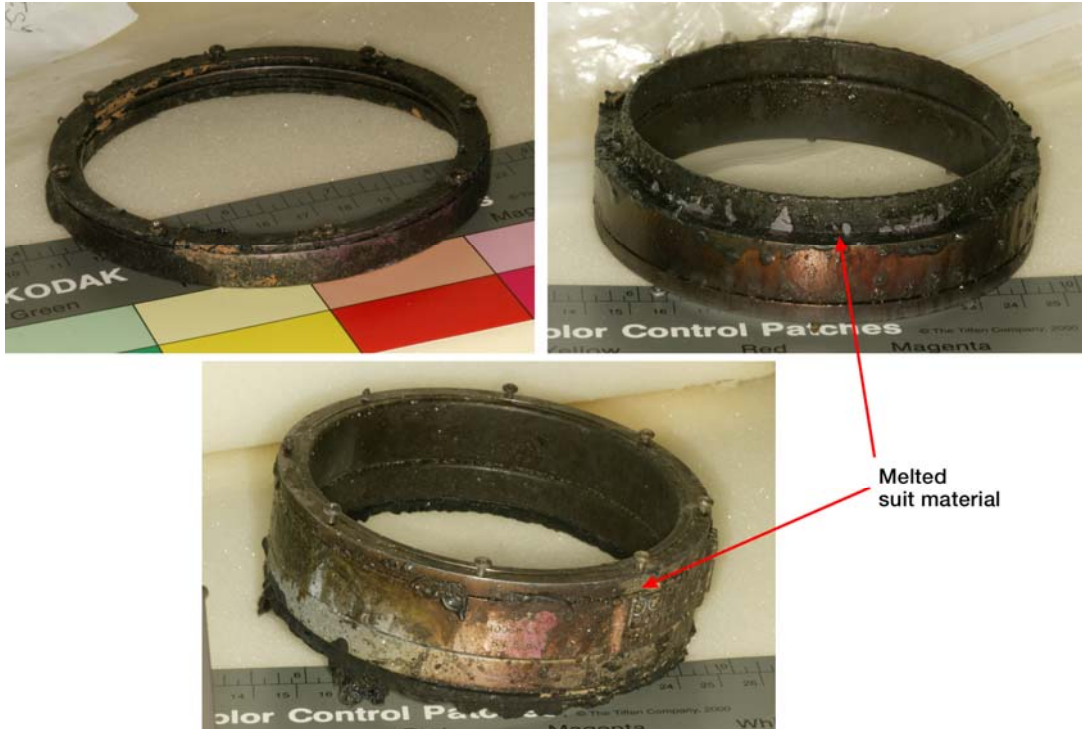
Melted aluminum deposits and/or tiny craters were observed on most of the glove and suit rings. Melted suit material (figure 3.2-26) was discovered on all recovered disconnect rings. Close inspection of the suit bladder clamp interface on the suit-side disconnect rings revealed mainly nylon and Teflon materials. In all cases, minimal amounts of Nomex remained clamped to the interface. Overall, the amount of residual melted suit material seems to correlate with the general magnitude of heating; that is, higher-magnitude heating resulted in the pyrolysis of residual suit material. As with the helmets, deposition of melted suit material on the glove disconnect areas occurred after mechanical separation. Small fragments of suit material were still clamped in the disconnect after mechanical separation. The failure modes at the disconnect ring (the ring-to-suit material interface) were similar to those observed in the suit-side helmet disconnect rings (see Section 3.2.5).

Figure 3.2-26. Recovered suit-side (upper left), glove-side (upper right), and mated (bottom) glove disconnects.

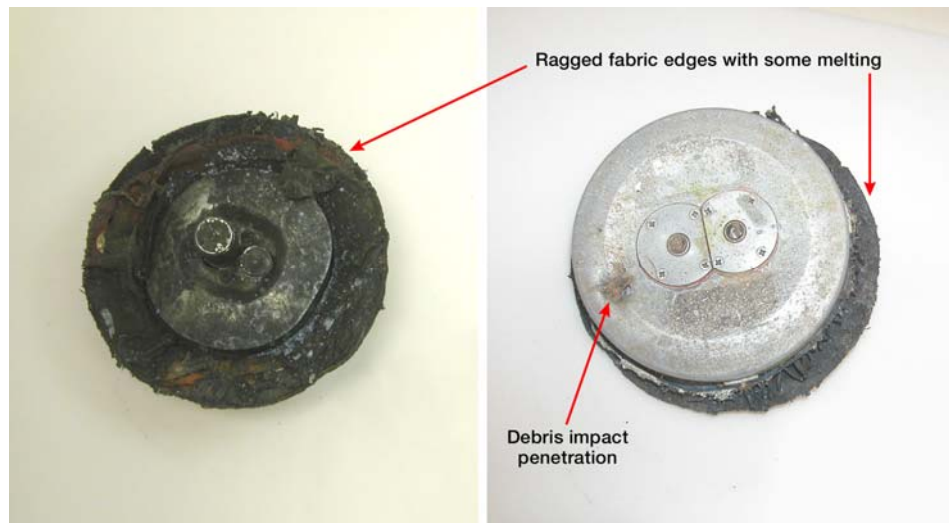
Four DSCs were recovered, all from flight deck crew members and all presenting similar appearances. One DSC (figure 3.2-28) was disassembled and inspected to determine the thermal environment exposure. The suit material edges were ragged with some localized melting around the edges, indicating that there was a mechanical disruption of the suit followed by thermal exposure to the suit fabric that was still attached to the DSC body. The DSC body back surface (i.e., the surface inside the suit) had many craters and one penetration (~0.5 in. × 0.25 in.). This indicates a rapid disruption of the suit, releasing the DSC while it was still in close proximity to the CM debris cloud. Some melting of the suit material to the DSC body caused the suit flange to adhere to the DSC body. All internal soft goods (O-rings, seals, diaphragms) were intact and showed no signs of mechanical or thermal damage. Both of the aneroids<sup>7</sup> were still hermetically sealed with the sealing solder intact. The suit cover-layer Velcro was melted to the suit restraint-layer Velcro in some

areas. Although melting of the torn fabric edges and the Velcro® indicates thermal exposure, the complete lack of thermal damage to any of the internal soft goods suggests that the thermal exposure was limited in intensity and/or duration.

Figure 3.2-28. Recovered dual suit controller front (left) and back (right).

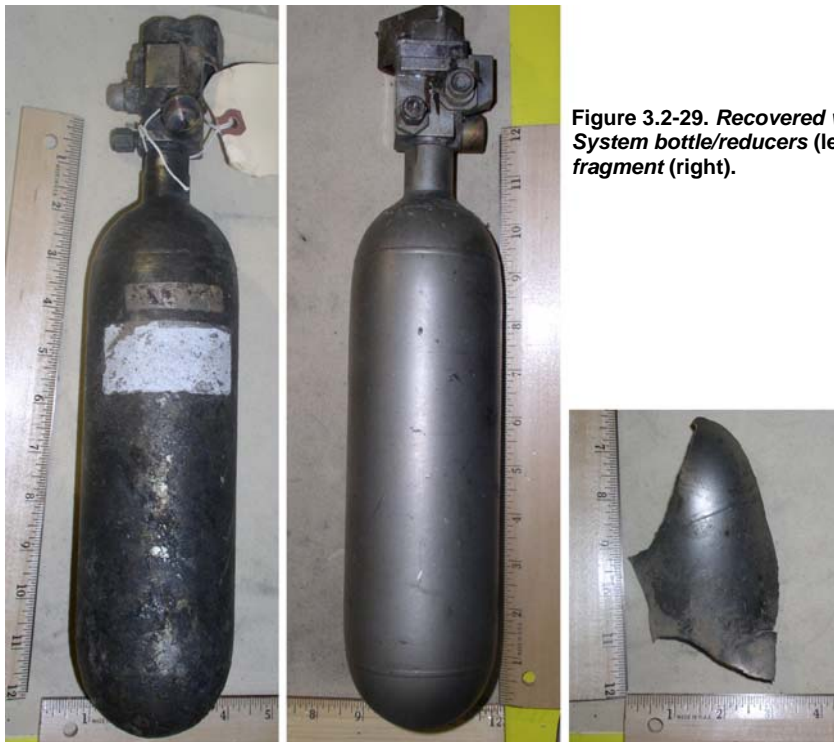
Ten whole EOS bottle/reducers were recovered (eight were ascribed to specific crew members), each with no O<sub>2</sub> remaining. All 10 of the recovered EOS bottle/reducers have similar appearances, with some variance in the amounts of material deposition. Additionally, three fragments of bottles were also recovered (figure 3.2-29).

Figure 3.2-29. Recovered whole Emergency Oxygen System bottle/reducers (left and center) and a bottle fragment (right).

No nylon material from the parachute harness adhered to the bottle/regulator assemblies. Minor evidence of elevated temperatures, directional burn marks, and discrete external impacts are visible. As with most of the *Columbia* hardware, corrosion that occurred while the debris was on the ground is also evident. X ray revealed that all of the EOSs were activated. However, the crew members were trained not to activate them unless their visors were down. Therefore, activation of the EOS (achieved by applying tension to the activation cables) probably occurred as the bottles separated from the harnesses rather than by crew action.

The EOS bottle fragments exhibited irregular edges along the fracture surfaces, some outward bent edges, evidence of heating on the inner surfaces, and some deposited/flowed black material along a fracture surface.

Heating on the inner surfaces indicates that the bottle failure occurred before the end of entry heating. Neither the cause of the bottle failures nor the status of the bottles at the time of failure (pressurized or unpressurized) could be determined.

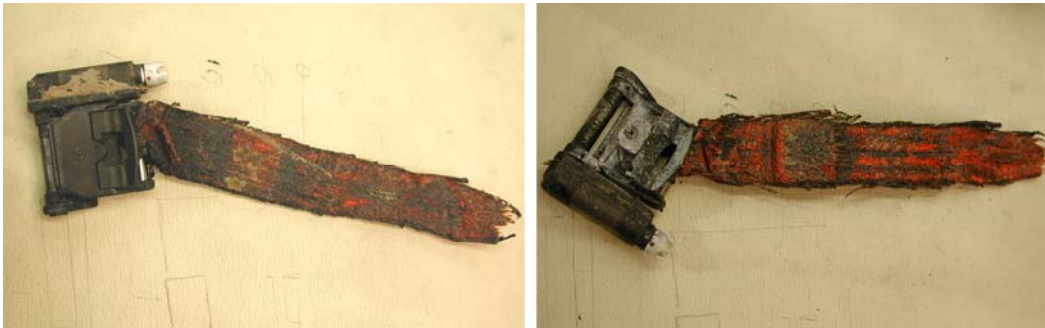
Six SEAWARS were recovered. None had automatically ignited, and all had both of the Frost fitting male and female halves still mated. All SEAWARS had similar appearances (figure 3.2-30), consisting of the SEAWARS assembly still attached to approximately 12 in. of nylon parachute harness strap. None had any parachute riser material attached.

**Figure 3.2-30. Seawater Activated Release System with Frost fittings (male/female) still mated, with a segment of harness strap attached (two different SEAWARS are shown).**

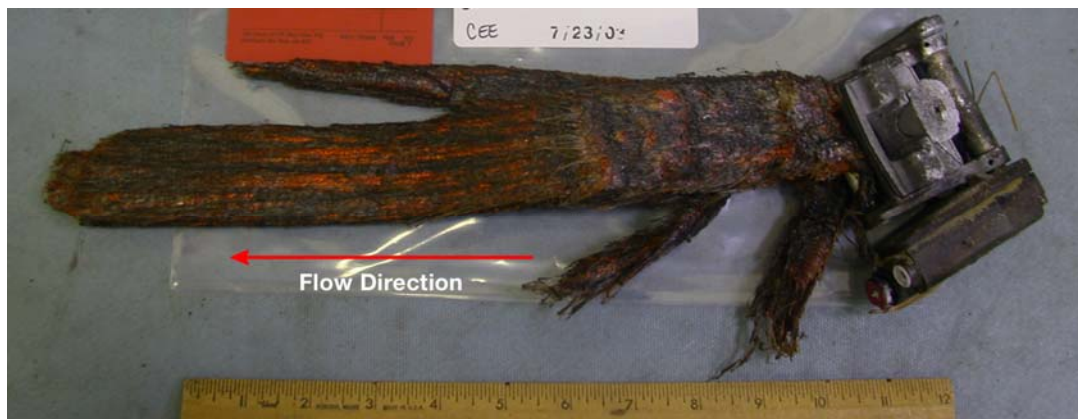
Each SEAWARS/strap item shows evidence of directional melting, burning, and mechanical loading. The surviving length of parachute harness strap is consistent with a harness strap failure at the waist. While the terminating ends show evidence of melting on the top layer of fabric, these ends appear to have failed primarily due to mechanical overload, not melting. Some surface melting occurred along the length of the straps, with distinct directionality away from the SEAWARS towards the broken end of the strap, corresponding to a head-to-foot direction when the harness is on a crew member. These directional heating/melting features are present on both sides of the straps, with little difference between the front and the back of the straps. Because both sides of the straps show signs of heating, the heating and melting must have occurred after the straps had separated from the crew member. Localized heating on the metallic SEAWARS Frost fitting buckle suggests intense, short-duration heat exposure. Each SEAWARS and strap was mechanically extracted from the harness webbing before experiencing this short-duration heating. Directionality suggests that each piece of riser trimmed with the SEAWARS into the airflow (figure 3.2-31).

**Figure 3.2-31. Directional melting on Seawater Activated Release System/parachute harness strap.**

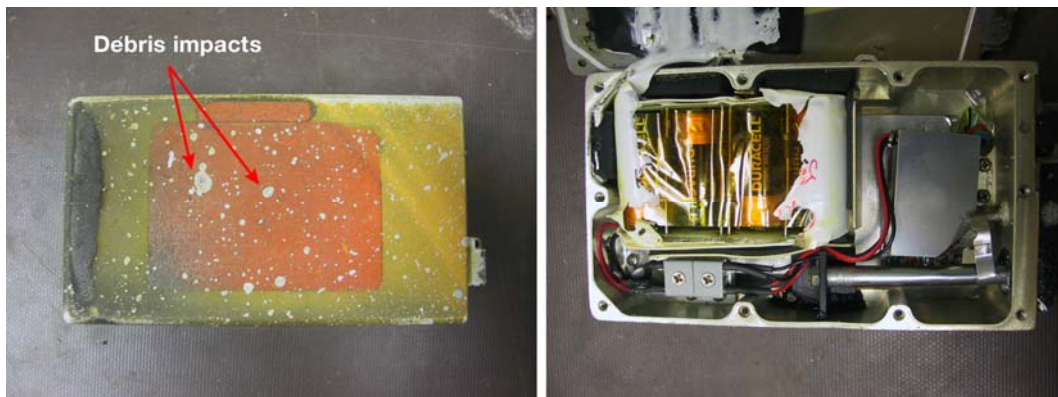
One TSUB-A SARSAT beacon is flown per crew member; it is located in the survival raft packed in the PPA. Six SARSAT beacons were recovered; none of them were activated during the accident. All six recovered SARSAT beacons show similar thermal and mechanical damage (figure 3.2-32).

**Figure 3.2-32. External (left) and internal (right) views of a recovered search and rescue satellite-aided tracking beacon.**

No material from the raft or the PPA was adhered to the outer aluminum casing. Various amounts of paint remained, displaying evidence of impacts with small, hot metal pellets. Corrosion was also present. All external plastic was melted. Internal inspection of the beacons revealed minor solder re-flow, with most of the components mechanically and electrically intact. Two SARSAT beacons were tested and, when externally powered, functioned properly. For each of the six SARSAT beacons, the processing module was extracted and interfaced with ground support equipment to read the beacon's unique identifier, thereby allowing all six beacons to be ascribed to individual crew members. Each SARSAT beacon was mechanically extracted from the PPA as temperatures were rising; then for a short duration and nearly simultaneously, it experienced high heating and a hot metal pellet-like shower. This indicates a rapid disruption of the parachute packs and release of the SARSAT beacons while they were still in close proximity to the CM debris cloud.

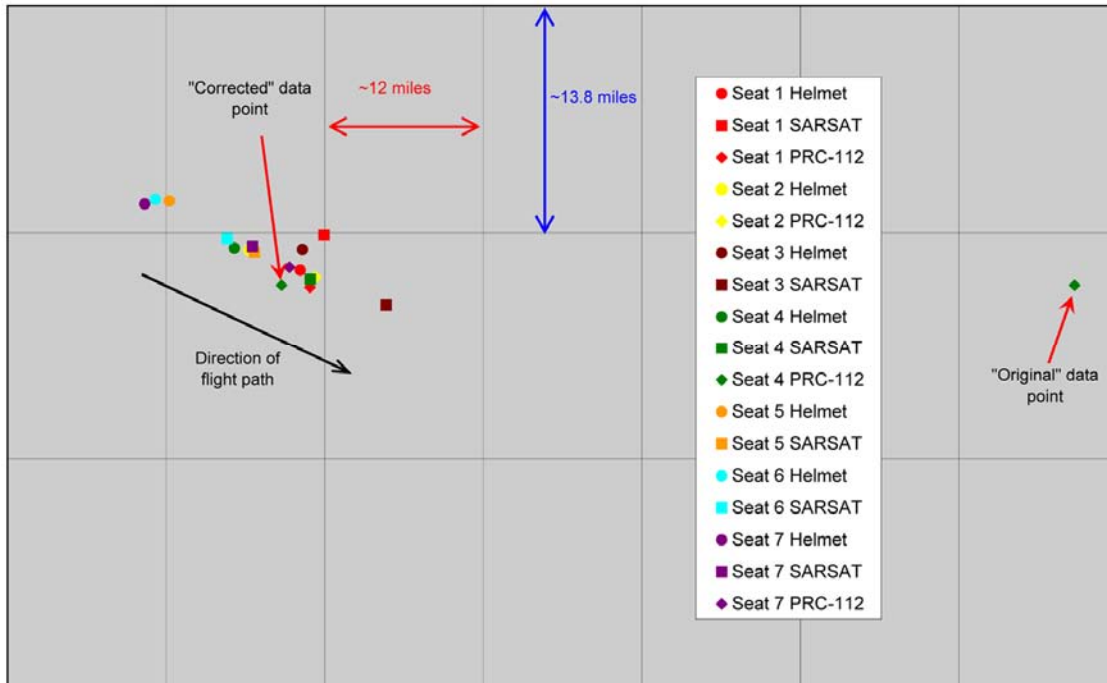
**Figure 3.2-34. Relative location of helmets, search and rescue satellite-aided tracking beacons, and Army/Navy personal radio communications-112 radios.**

The investigation team concluded that the middeck crew members separated from the CM before the flight deck crew members. Orders within the middeck/flight deck groups cannot be determined conclusively, but it appears that seat 6 and seat 7 equipment items were first out of the middeck and seat 4 equipment was first out of the flight deck. All CEE associated with specific crew members was plotted by crew member. Analysis looking at the relative centers of the areas of recovered items for each crew member supports this conclusion. Figure 3.2-35 shows the locations of the recovered items for each crew member. The upper plot shows items for the flight deck crew members; the lower plot show items for the middeck crew members. Both plots are the same scale and represent the same geographic area.

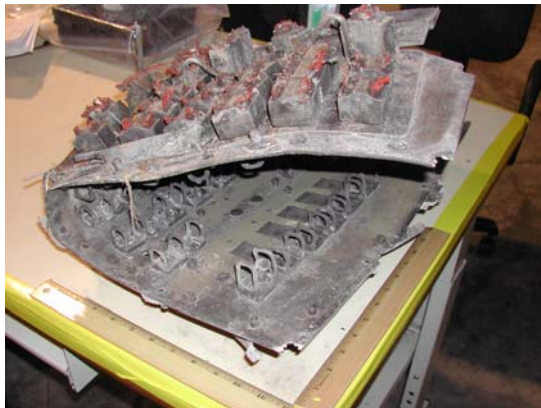
Figure 3.3-3. Recovered R2 panel from Columbia.

When recovered, the R2 panel was folded back in on itself (figure 3.3-3), protecting the innermost switches from manipulation during recovery operations. The switch positions were considered to be unaltered by external factors, making the switches valuable in determining crew actions.

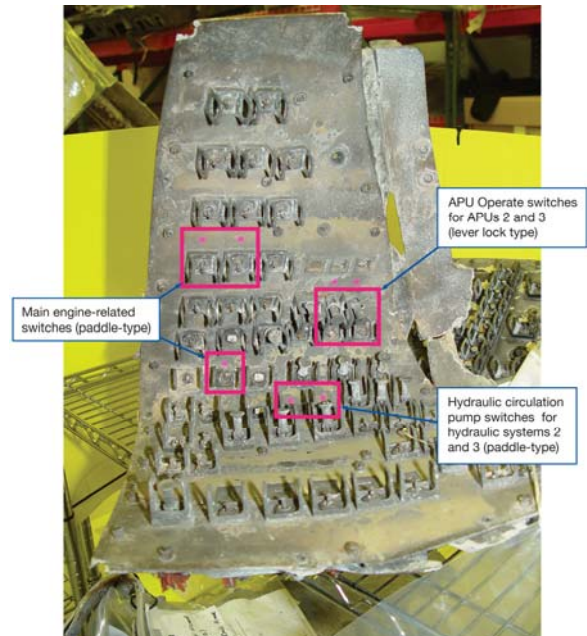
The panel was pried open during the investigation and switch positions were reviewed. In figure 3.3-4, all out-of-position switches are outlined with a pink box and noted with a pink dot.

Figure 3.3-4. Recovered R2 panel from Columbia (after it was unfolded). Pink dots are above the out-of-configuration switches.

The APU 2 and APU 3 Operate switches (“lever lock” switches that require two independent actions to change the switch position) were found in the “injector cool” position as opposed to the nominal “start/run” position. These switches are used when starting and stopping the APU. The “injector cool” position is used to cool down the APU after a shutdown prior to restarting it.

entry.<sup>5</sup> The two paddle-type switches in the lower center of the panel are the circulation pump switches for hydraulic systems 2 and 3. These were found in the “on” position as opposed to the normal “off” position. The circulation pump is used for thermal conditioning of the hydraulic fluid while the orbiter is on orbit. The pump also is used to keep the hydraulic reservoir pressurized. This pump is not powerful enough to deploy the landing gear, but it can provide some hydraulic pressure if activated. The pump is neither used nominally on entry nor is it used in off-nominal procedures.

In response to a hydraulic system failure, the procedures require shutting down the APUs by placing the APU Operate switches in the “off” position, then moving the APU Operate switches into the “injector cool” position to cool down the APUs before attempting a restart of the APUs. RGPC-2 data indicate that the APU Operate and hydraulic circulation pump switches were in their nominal, expected positions.<sup>6</sup> Therefore, these switches changed position after GMT 14:00:05, 13 seconds prior to the Catastrophic Event (CE).

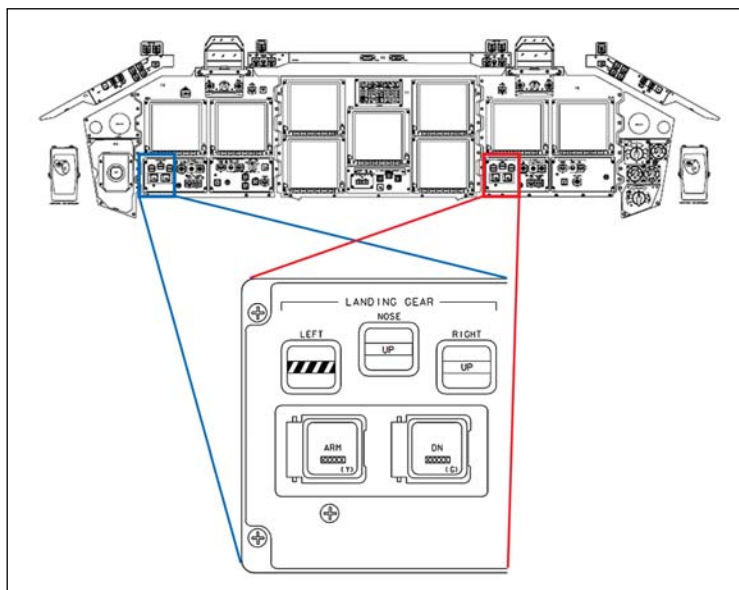
At GMT 13:59:06, 10 seconds after the fourth of four tire pressure fault messages, telemetry indicated that the “LEFT MAIN GEAR DOWN” lock sensor transferred to “ON.” Other sensors indicated that the landing gear door was still closed and the landing gear was locked in the “up” (stowed) position. These mixed signals caused the left landing gear position indicator to display a “barber pole” (figure 3.4-6), which indicates an indeterminate landing gear position. Post-accident analysis of the data and recovered debris indicates that the left landing gear was locked in the “up” position and the landing gear door was closed. The signal indicating that the gear was down was a false signal that was likely triggered by damage to the sensor system (sensor, wiring harness, etc.). Based on training experience, the crew was probably attempting to diagnose the situation given that it involved the same landing gear as the tire pressure messages and indicated a potential landing gear deployment problem.

**Figure 3.4-6. Landing gear indicator panel, identical on both sides of the flight deck forward display panels. Left indicator showing “barber pole” (indeterminate position). [Adapted from the Space Shuttle Systems Handbook]**

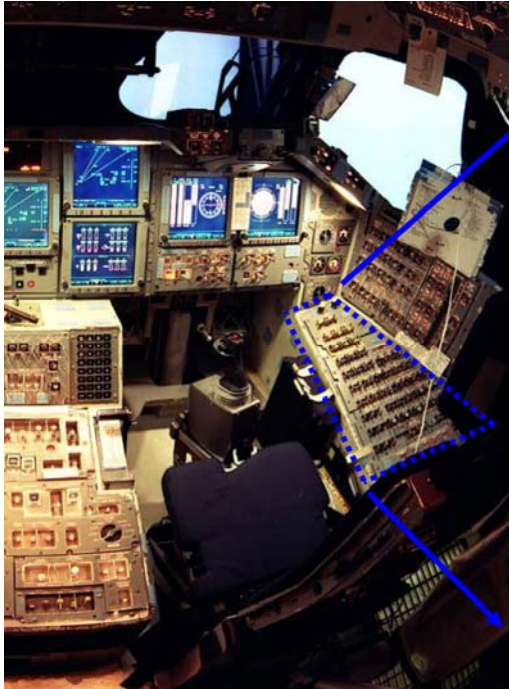
Figure 3.4-10. Location of the R2 panel.  
[Picture from the Shuttle Training Simulator]

Recovered debris revealed that the APU Operate switches on flight deck panel R2 were in positions that were consistent with an attempted restart of two of the three APUs<sup>11</sup> (figures 3.4-10 and 3.4-11). The hydraulic circulation pump paddle switches for the two hydraulic systems corresponding to the two APUs were also turned on. While turning on the hydraulic circulation pump is not in any crew emergency checklist, the pump can provide some hydraulic pressure, and this action shows good systems knowledge by the crew members as they responded to the limited information presented to them and worked to restore orbiter control. The APU Operate switches are “lever-lock” switches that require three actions to change the position. They must be (1) pulled outwards to disengage the switch lever from the lock, (2) moved to the desired position, and (3) released (figure 3.4-12). The switches are spring-loaded to hold them in the detents. The RGPC data indicate that all of these switches were in the nominal configuration up to GMT 14:00:04.826. These findings strongly suggest that despite the very dynamic vehicle motion, the PLT was still capable of taking appropriate actions to attempt a recovery of the hydraulic pressure by performing an APU restart at some time after GMT 14:00:04.826. Based on the panel R2 switch throws and the lack of visors being lowered, it is probable that the crew never realized that the vehicle LOC situation was unrecoverable and had become a survival situation.

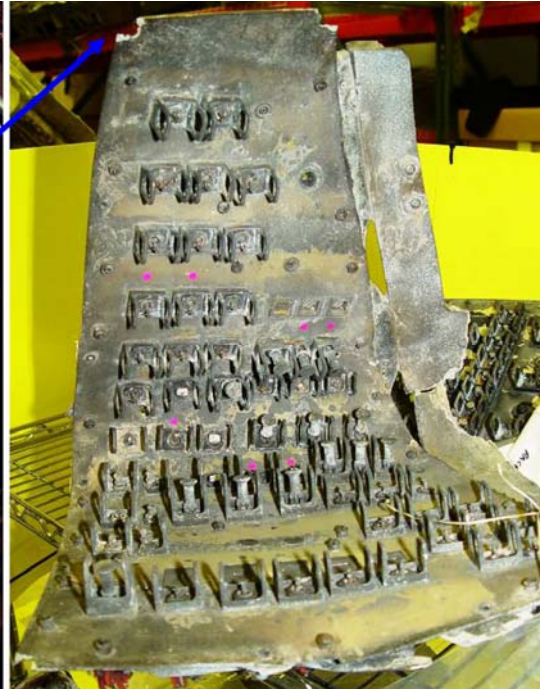
Figure 3.4-11. Recovered R2 panel from Columbia (after it was unfolded). Pink dots are above the out-of-configuration switches.
