# ***Columbia* Crew Survival Investigation Report**

NASA/SP-2008-565

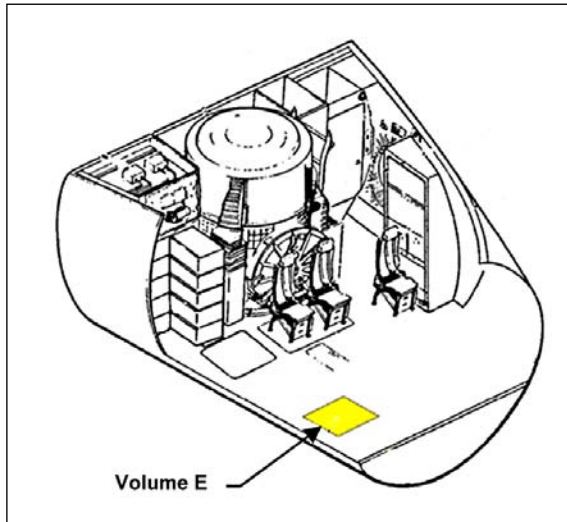
Analysis of several sources of information indicates that the forebody separated from the midbody at or shortly after GMT 14:00:18. It is unknown what accelerations occurred during separation of the orbiter forebody from the midbody; however, ballistic analysis estimates that the translational G that was experienced by the orbiter forebody at the CE decreased from approximately 3.5 G to 1 G. It is also likely that there were additional translational and rotational loads acting on the crew at this time. Analysis of structural debris supports that multiple small impacts occurred between the forward fuselage (FF) and the CM, including in the area of middeck Volume E (figures 3.4-13a and 3.3-13b).

Figure 3.4-13a. View of middeck floor and Volume E, looking aft.

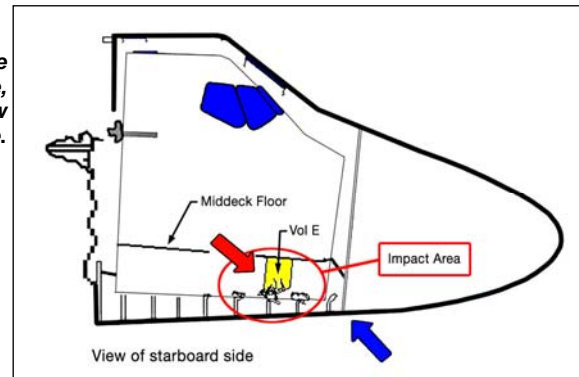
Figure 3.4-13b. Scenario showing how the crew module pressure vessel could impact the forward fuselage, and the middeck Volume E could impact the crew module pressure vessel, with resultant damage.

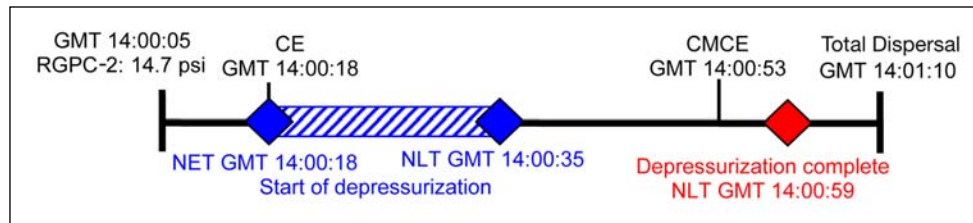
Figure 3.4-15. Cabin depressurization timeline.

However, additional research discussed in *Joint Aerospace Physiology, Air Education and Training Command/Bureau of Medicine and Surgery* shows that the physiological response to hypoxia during a rapid depressurization event at this extreme altitude (181,000 feet) would have reduced the conventional TUC interval by 50% (i.e., 12 seconds would have been reduced to 6 seconds). In addition to the depressurization effects, the physical exertion against the G-forces that the crew experienced at this time would further reduce the available metabolic O<sub>2</sub> reserves<sup>14</sup> and increase the CO<sub>2</sub> partial pressure. Also, NASA research data indicate that de-conditioned crews have a reduced tolerance to G-loads.<sup>15</sup> Further, anecdotal reports from accidental exposure to vacuum confirm much shorter periods of awareness as reported by survivors.<sup>16</sup>

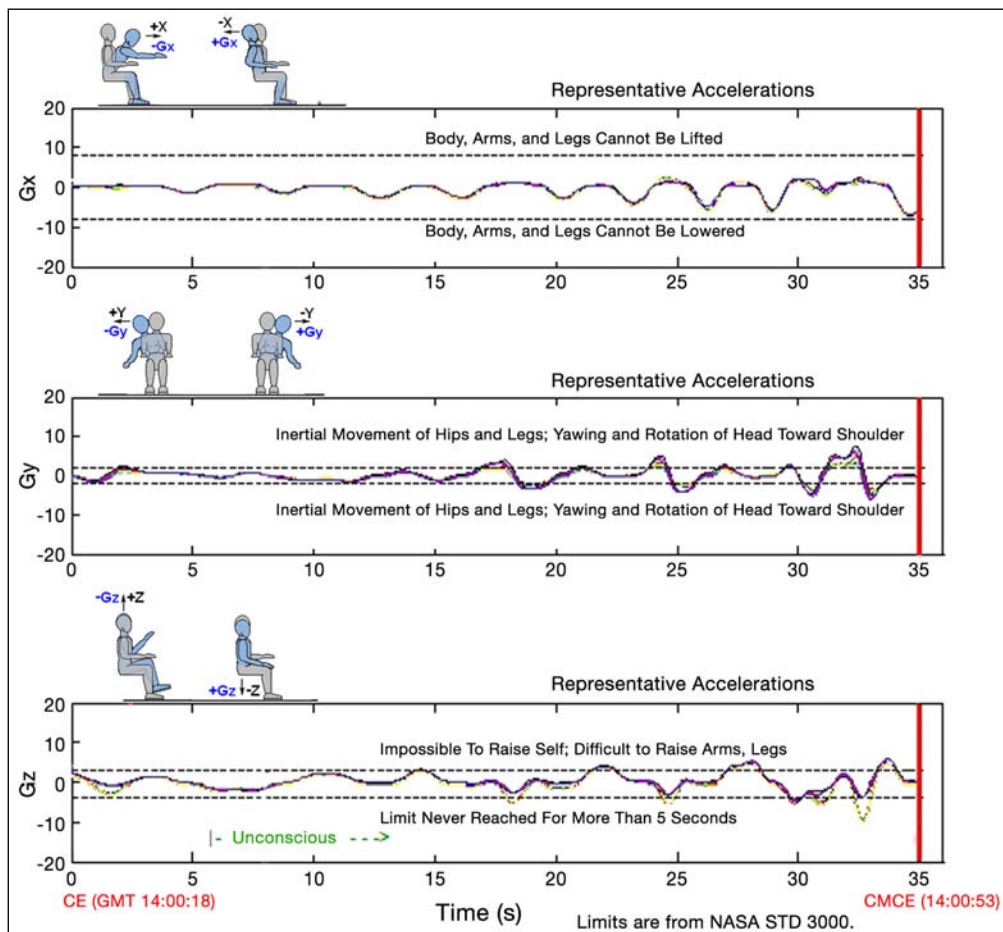
A very dynamic motion environment existed after the CE (GMT 14:00:18); this environment became more intense as the CMCE (the breakup of the forebody) approached at GMT 14:00:53. Figure 3.4-16 shows representative loads on the unconscious or deceased crew members based on aerodynamic modeling of the forebody dynamics post-CE. The black dashed lines showing human performance limits<sup>20</sup> are for conscious crew members. Based on the conclusion that the rapid depressurization occurred at or close to the time of the orbiter forebody separation, the crew was unconscious or deceased and unable to brace against these loads.

**Figure 3.4-16. Representative acceleration profiles from the orbiter breakup (Catastrophic Event) to the orbiter forebody breakup (Crew Module Catastrophic Event) based on aerodynamic modeling. Black dashed lines show human performance limits.**

For the first 15 to 20 seconds, the modeled loads would not cause serious injuries to a conscious crew member who was capable of active bracing. An unconscious or deceased crew member would have been more susceptible to injury.

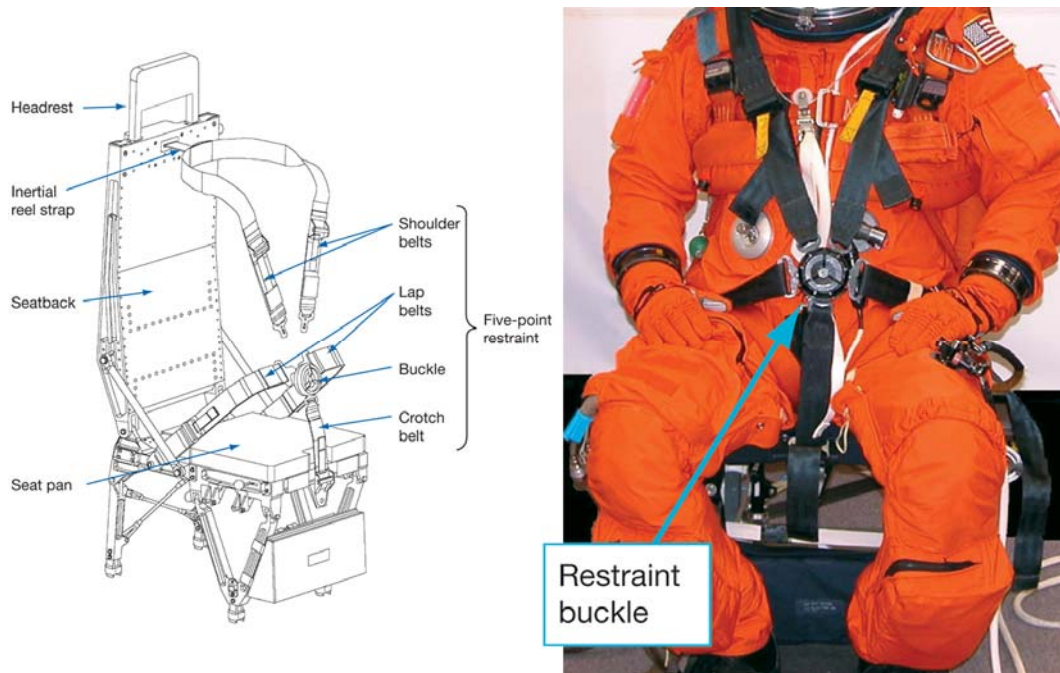
Figure 3.4-17. Detail of the five-point harness.

Engineering analysis of the STS-107 restraints indicates that most of the inertial reel straps were extended and did not lock or retract prior to failure of the straps. The inertial reels are normally unlocked to allow the crew to access displays and controls with a full range of motion. With the inertial reels unlocked, the crew members’ upper bodies were left unrestrained during the forebody dynamics. [REDACTED.]

**Finding.** Injuries were consistent with the crew’s upper bodies not being securely held to the seatbacks and with the evidence indicating that the inertial reel straps were extended at the time of failure.

**Conclusion L2-3.** Lethal injuries resulted from inadequate upper body restraint and protection during rotational motion.

**Recommendation L2-8.** The current shuttle inertial reels should be manually locked at the first sign of an off-nominal situation.

**Recommendation L2-9.** The use of inertial reels in future restraint systems should be evaluated to ensure that they are capable of protecting the crew during nominal and off-nominal situations without active crew intervention.

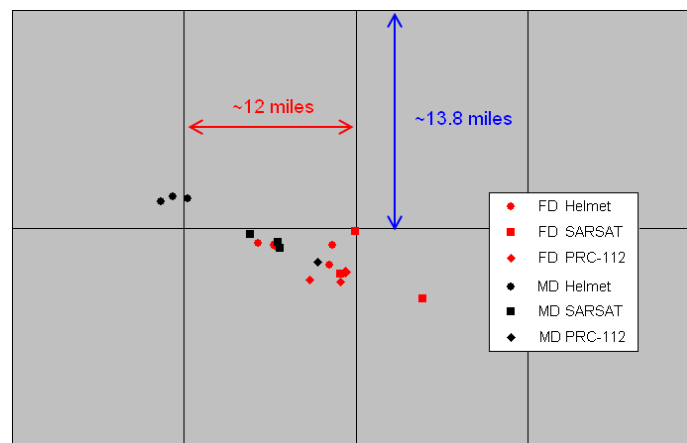
[REDACTED.] Engineering and ballistic analyses of the orbiter forebody failure indicate that the mid-deck separated prior to the flight deck. Crew members on the middeck separated along with the middeck accommodations rack, middeck lockers, sub-floor components, and Modular Auxiliary Data System/orbiter experiment data recorder – a scenario that is supported by debris plots (see Section 2.2). Based on structural design analysis, thermal damage, and position in the debris field, the flight deck “pod” and the CM aft bulkhead stayed intact for a longer time. The location of the recovered flight crew equipment, which is plotted in figure 3.4-21, supports the middeck departing prior to the flight deck.

Figure 3.4-21. Ground location of the recovered flight crew equipment.

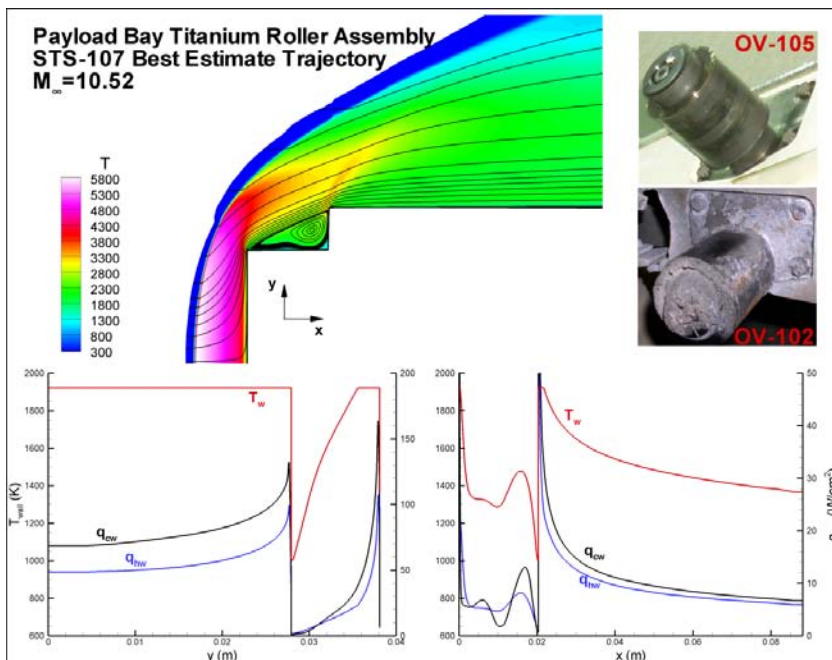
A computational fluid dynamics (CFD) thermal analysis of the payload bay door rollers was performed by the JSC Applied Aerosciences & CFD Branch. Various Mach numbers, from  $M = 7.5$  to  $M = 15$ , were used to determine the flow field environment and temperature at the face of a roller for an orientation with the front of the roller facing directly into the direction of travel. Figure 4-10 shows the predicted heating rate and temperature distribution along the payload bay door roller at  $M = 10.5$ . The notations  $q_{cw}$  refers to "cold wall" and  $q_{hw}$  refers to "hot wall." In this figure, the CFD solution assumes a steady-state solution, meaning that given enough time, the flow will develop into the calculated results. This is a reasonable assumption for high-speed entry because the flow field will form very quickly. The wall temperature is calculated by assuming radiation equilibrium. This means that the amount of heat that is being absorbed by convective heating is the same amount of heat that is being expelled through re-radiation. Also seen in the upper right of figure 4-10 are two photographs of payload bay door rollers. The photograph for OV-105 shows an intact roller, and the photograph for OV-102 (*Columbia*) clearly shows the erosion of the exposed titanium surface on the front face of the roller.

Figure 4-10. Computational fluid dynamics analysis of heating at the tip of the payload bay door roller for orthogonal geometry into the direction of travel at  $M = 10.5$ .

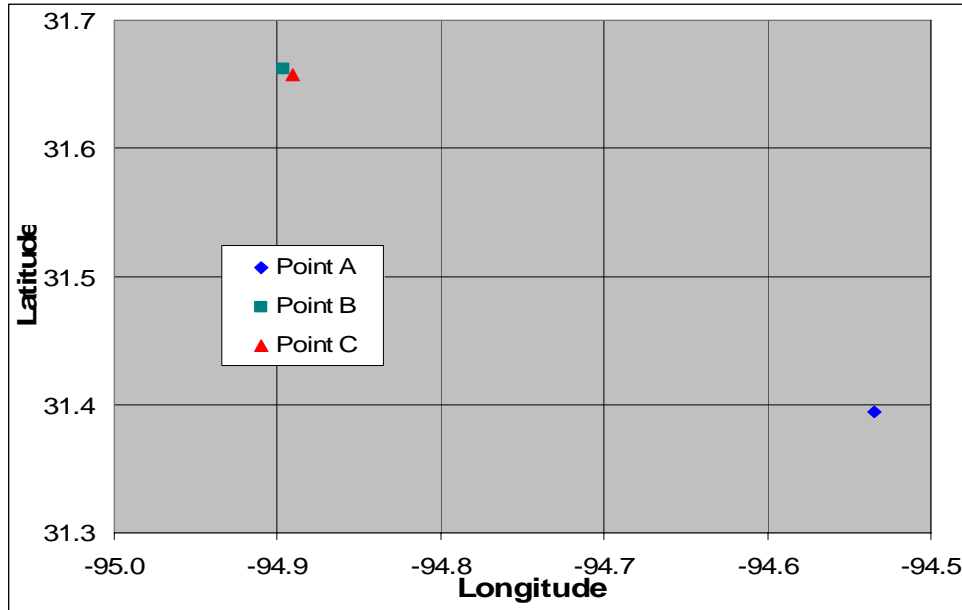
**Finding.** The lack of a single, standard data format for latitude/longitude data and the potential ambiguity that is associated with the need to convert data of different formats resulted in possible data errors.

Figure 4-11 shows a plot for a pair of number strings (31 39439 and 94 53462) that is interpreted for three different latitude/longitude formats. Point A shows the numbers interpreted as the DD.ddddd format (31.39439° N, 94.53462° W). Point B shows the numbers as a DD MM SS.sss format (31° 39' 43.9" N, 94° 53' 46.2" W). Point C shows the numbers as a DD MM.mmm format (31° 39.439' N, 94° 53.462' W).

Figure 4-11. Plot for a pair of number strings that was interpreted for three different latitude/longitude formats.

In this example, Point A is approximately 28 miles from Points B and C; while Points B and C are less than six-tenths of a mile apart. This example demonstrates the magnitude of error that can occur if the wrong data format is assumed and a necessary conversion does not occur (or an *unnecessary* conversion is performed).

**Recommendation A10.** Global Positioning System receivers used for recording the latitude/longitude of recovered debris must all be calibrated the same way (i.e., using the same reference system), and the latitude/longitude data should be recorded in a standardized format.
