**DEPARTMENT OF TRANSPORTATION**

01-262004  
MEN-101-R69.4/R78.9KP  
CONSTRUCT WILLITS BYPASS  
Sent via E-mail

**RE: Letter of Response to NCRWQCB April 2, 2014 Inspection Report**

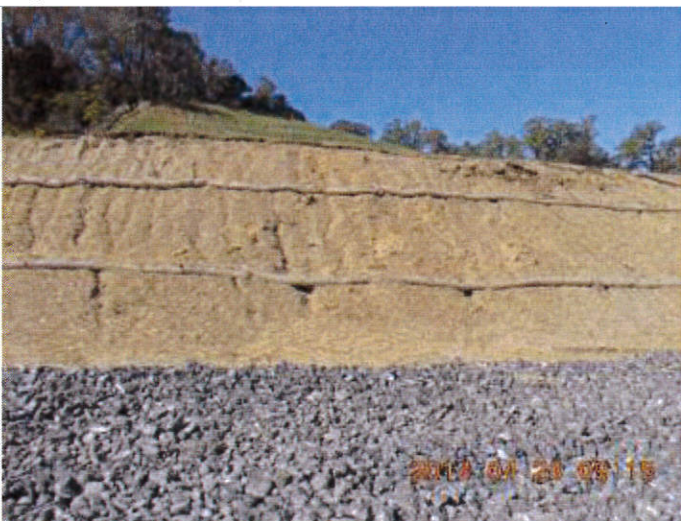
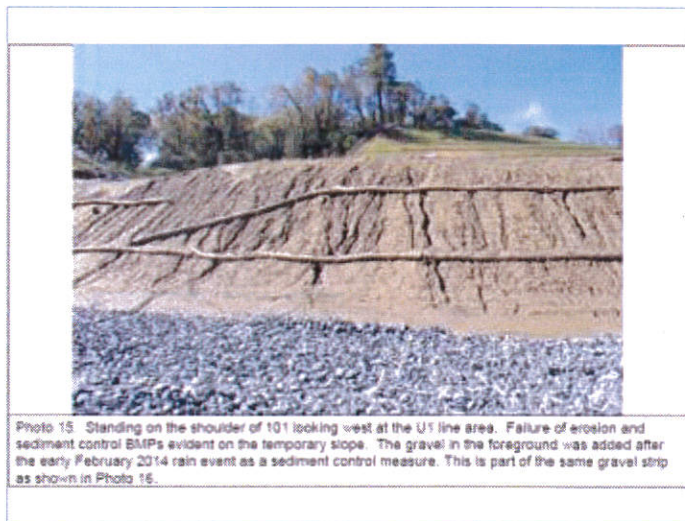
16

"U1, Line," Photo 1 through Photo 19, West of Hwy 101, Southern-Most Project Limits, South Haehl Creek Watershed, Water Quality Monitoring Stations WQ01 and WQ03

Description: Straw mulch applied. Fiber rolls repaired.

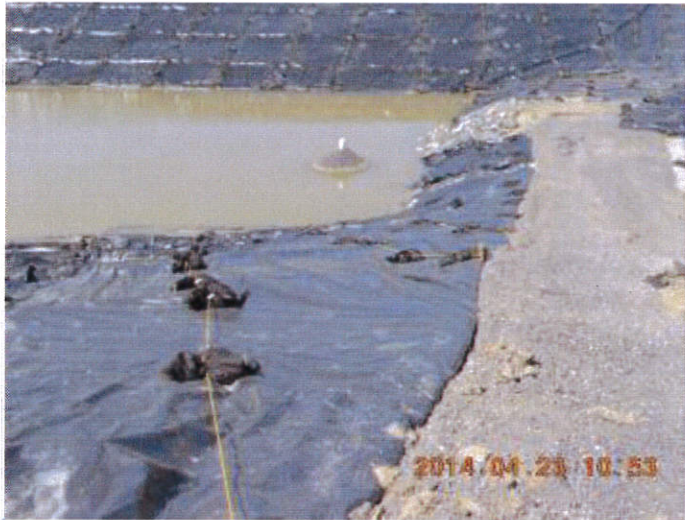
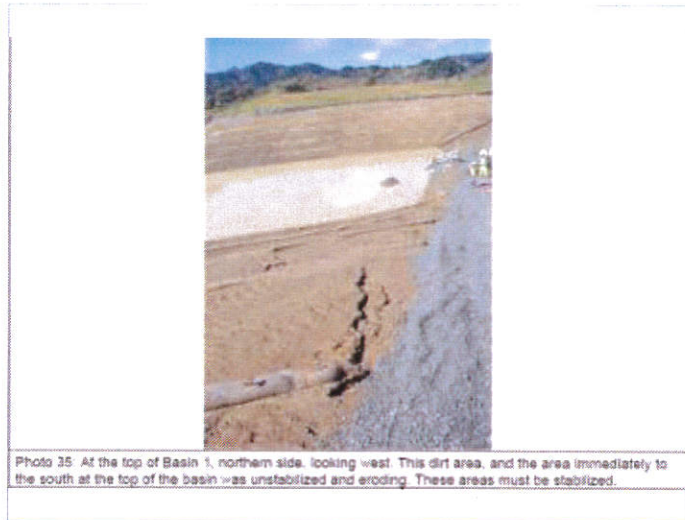
36

Water Board Comment:  
Inadequate erosion and sediment control

Description: TC-2 installed including linear barrier edge of AB.

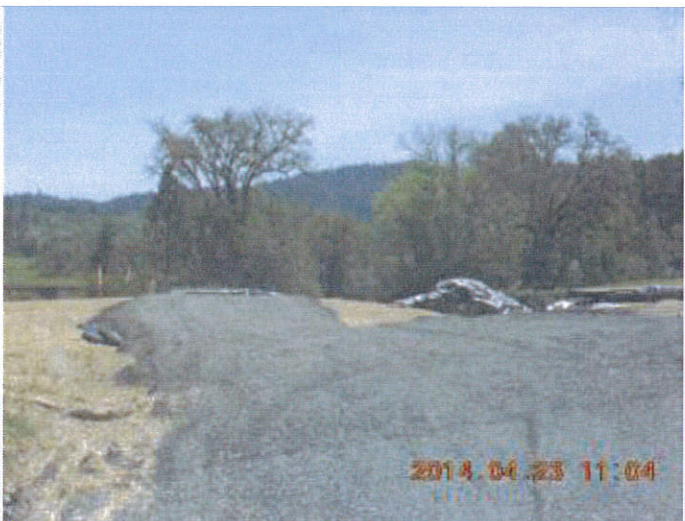
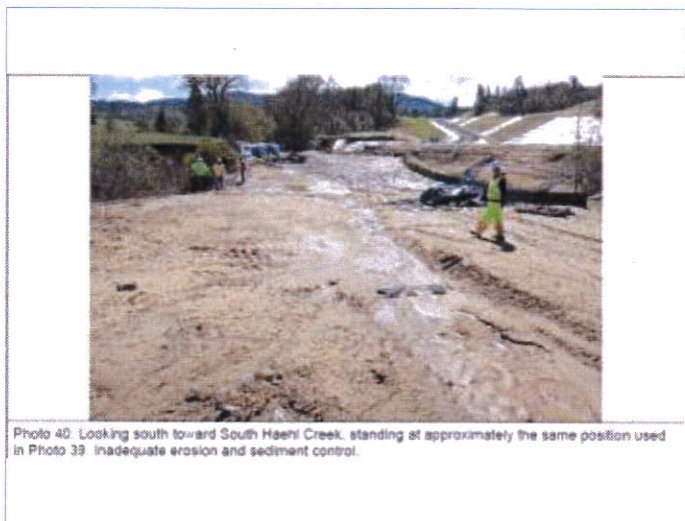
Inadequate erosion and sediment control. This area must be stabilized.

Photo 41 Looking south at Drainage System 24 before it enters a culvert and discharges to South Haehi Creek. There was inadequate erosion and sediment control in this area. This area must be stabilized.

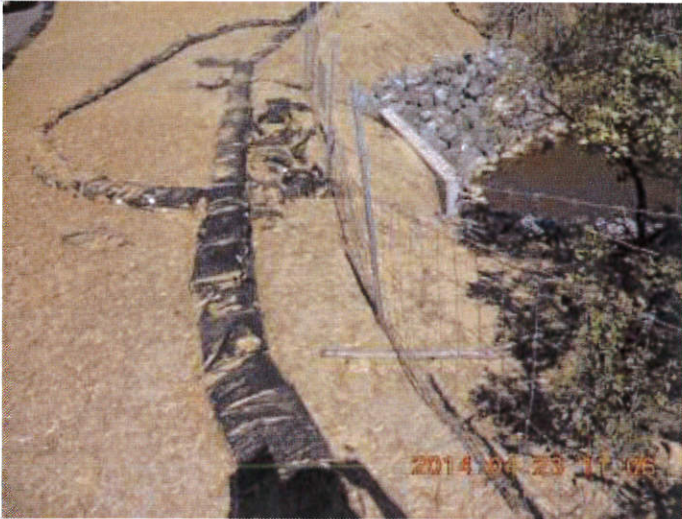
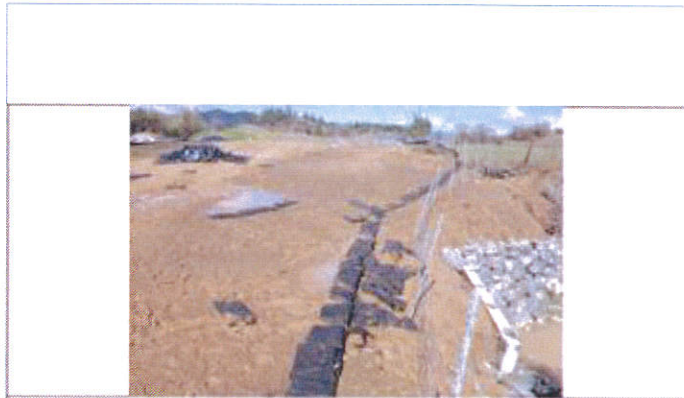
Photo 43. Looking north at Drainage System 24

Water Board Comment:  
Provide soil stabilization.

Description: Straw mulch applied. Rilling inside temporary construction easement will be hand raked and temp cover placed. Work will be performed only while Water Quality Monitor on site.

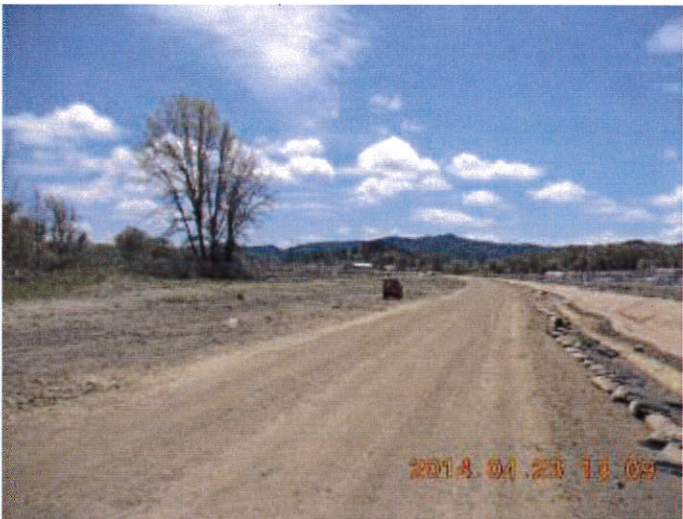
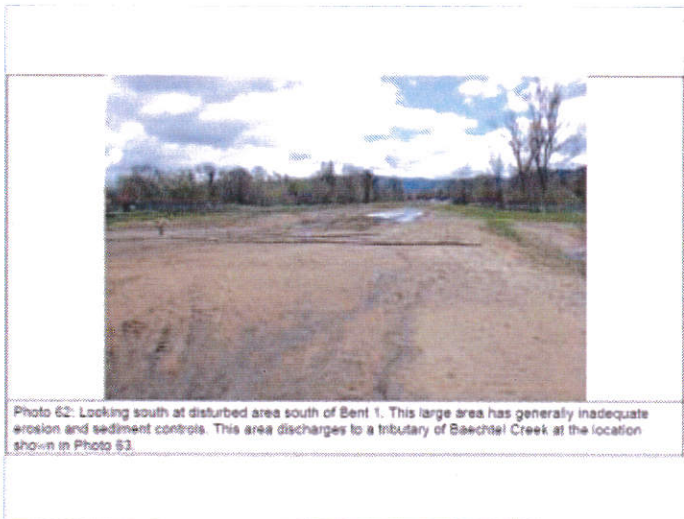
63

Move sampling point upstream of the confluence with water unaffected by construction activities.

Photo 62: Looking south at disturbed area south of Bent 1. This large area has generally inadequate erosion and sediment controls. This area discharges to a tributary of Beechdale Creek at the location shown in Photo 63.

Description: New RECP and check dams installed in ditch line adjacent to Sparetime Supply Property. Straw mulch to be applied per 2035, corrective action summary form.

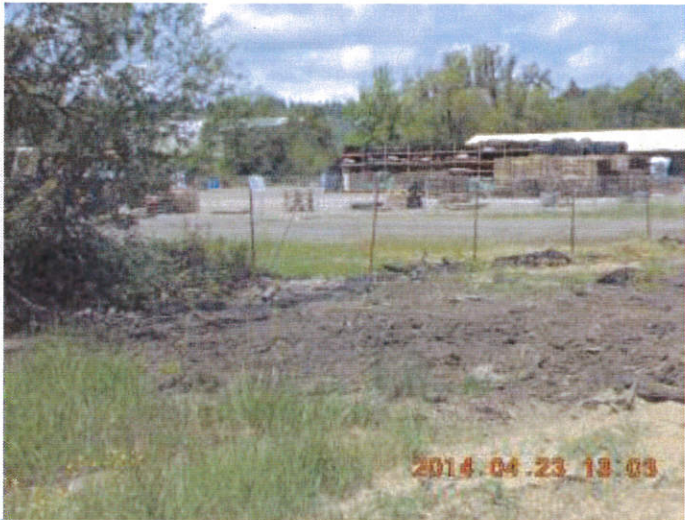
68

Photo 68: Looking northeast at Rutledge Pond. No sediment control at the boundary of Rutledge Pond. Construction storm water has flowed uncontrolled into the pond all rainy season. Perimeter control must be installed.

Install perimeter control.

Description: Silt fence installed. Straw mulch applied to exposed soil area between pond and DS 48.

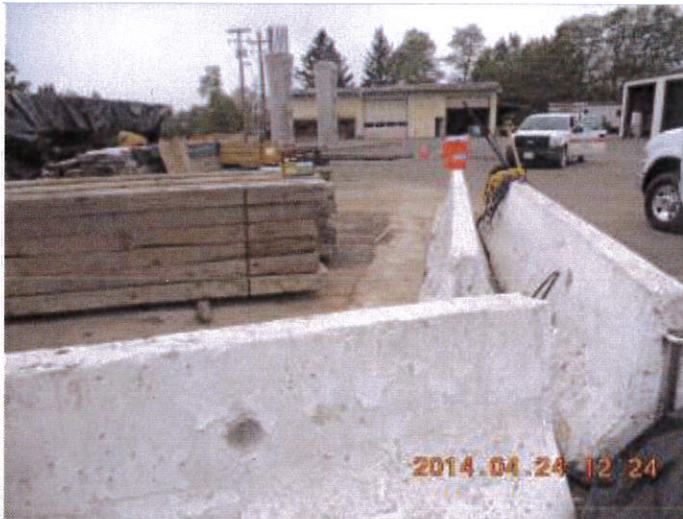
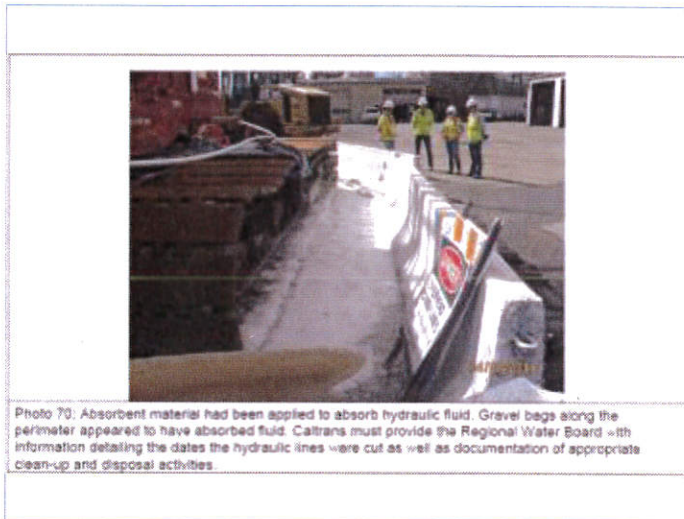
File Name	Oil Spill Schuesters_Photos 70 and 71		
Photo Date	4/23/2014	By Int	N/A

Provide details on hydraulic line damage and clean-up efforts.

Photo 71: It appeared that fluid had drained from the spill area as indicated by the water mark on the asphalt. We communicated that the material, including the gravel bags must be disposed of immediately subject to appropriate hazardous waste disposal protocol. Caltrans had not been notified of the incident and potential discharge.

Description: Clean up method provided by WPCM, Jim Montgomery. Area of oil spill was covered with absorbent, swept up and then vacuumed to remove as much of the contaminated absorbent as possible. All contaminated absorbent, pads, and gravel bags were disposed of in 55 gallon hazmat barrels provided by Safety Kleen, Inc. JV continuing to monitor location. Additional information on notifications, clean-up timelines is provided in Enclosure 1.
