GHOST SHIP FIRE STARTED IN ADJACENT BUILDING

Was Ghost Ship fire caused by inadequate Utility Wiring?

1305 – 31st Avenue, Oakland, CA 94601

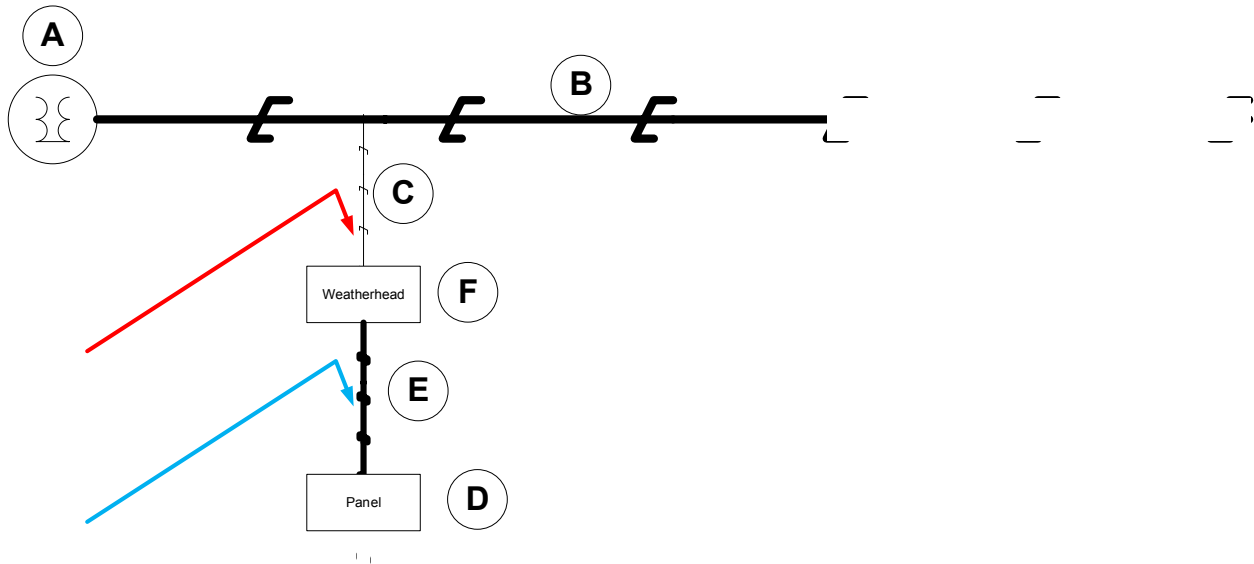
A is the Utility Transformer.

B is the wire from the transformer feeding multiple customers (Distribution Line)

C is the drop line from the Utility to the entry point to the building. Typically a Weatherhead (F) which protects the conduit from accumulating water inside the pipes which feed the wires (E) to the distribution panel.

D is the actual point at which the power is then distributed to different end customer points. This may or may not have a meter in the panel or the customer meters may be remote.

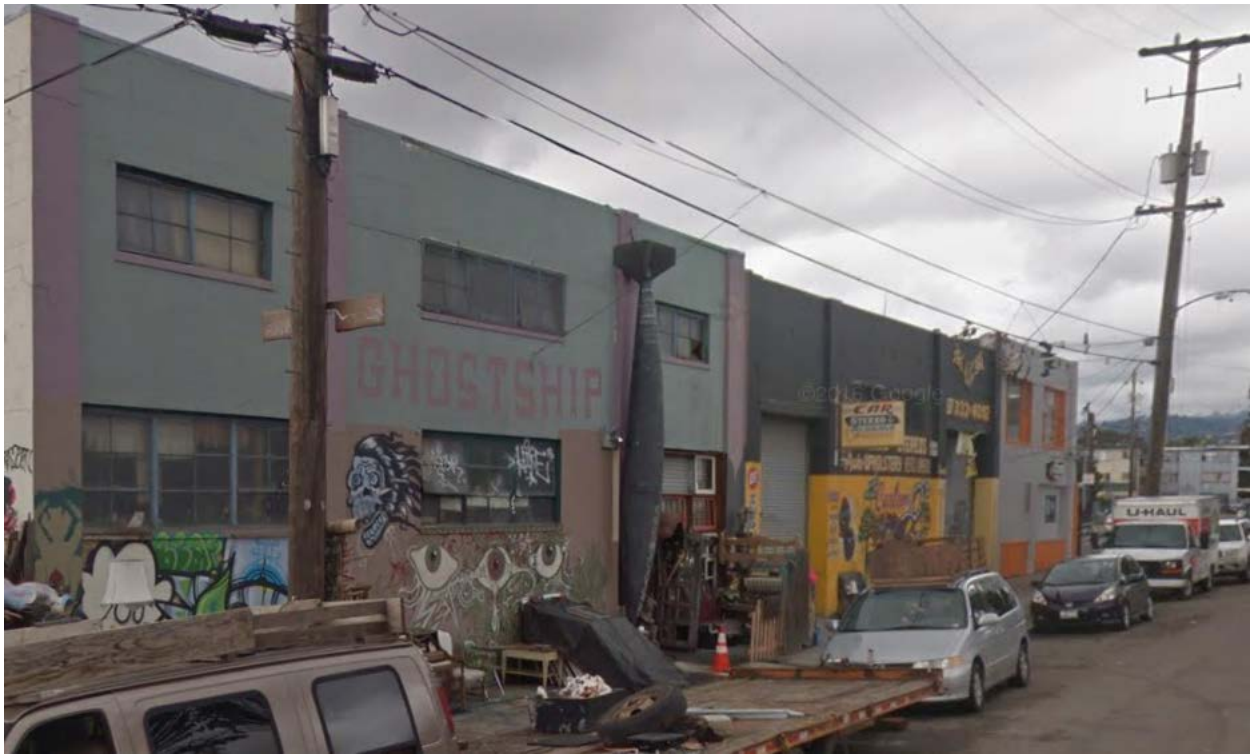
Observations:

- 1) No apparent direct utility drop to the building segment (Ghost Ship Unit) in question.
- 2) There are TWO apparent Utility drops to the complex as the buildings are adjacent and abutting to each other.
 - a. One at the Boost Mobile entrance
