Caltrans State Route 101 Willits Bypass April 2, 2014 Inspection Findings
Inspected by Brendan Thompson and Kason Grady, North Coast Regional Water Quality Control Board
Time of Inspection: ~9:00 a.m. to 3:30 p.m., clear weather, one day after rain
Caltrans EA No.: 01-262004, Risk Level 3, WDID No. 1B12045WNME
See "Willits Map" at end of document for Area locations.

Area 1, "U1 Line," Photo 1 through Photo 19, West of Hwy 101, Southern-Most Project Limits, South Haehl Creek Watershed, Water Quality Monitoring Stations WQ01 and WQ03

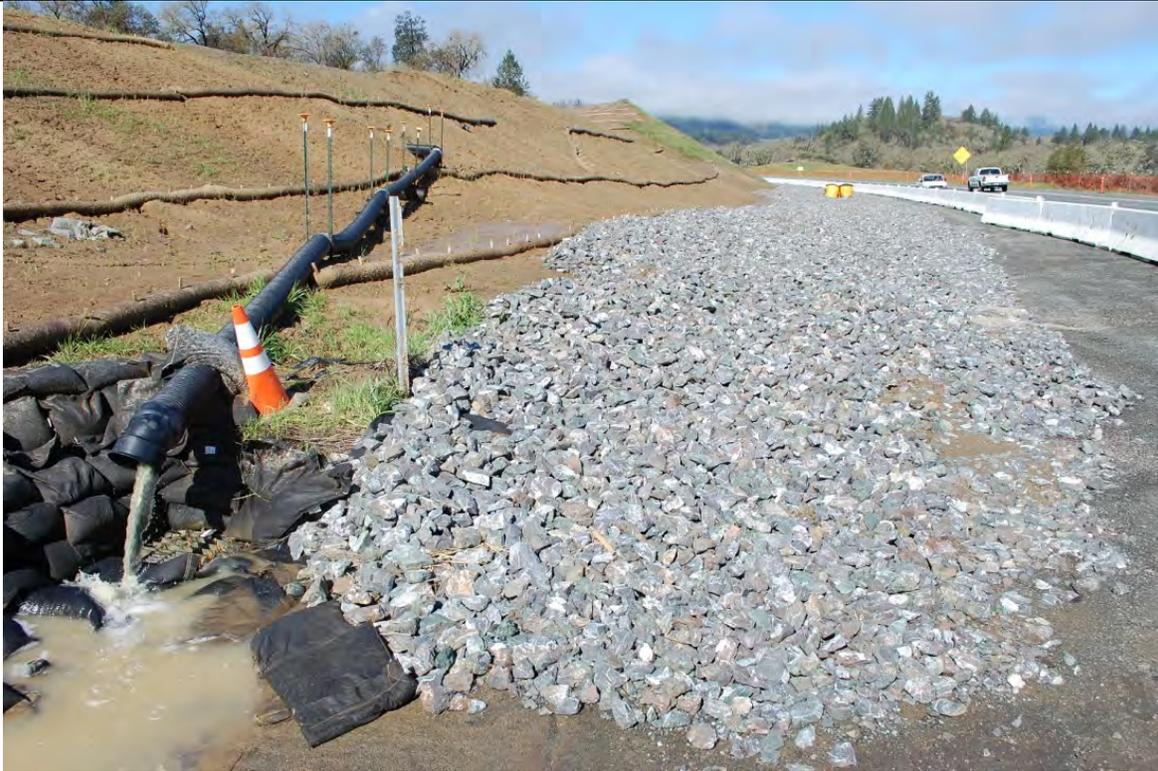
Photo 15: Standing on the shoulder of 101 looking west at the U1 line area. Failure of erosion and sediment control BMPs evident on the temporary slope. The gravel in the foreground was added after the early February 2014 rain event as a sediment control measure. This is part of the same gravel strip as shown in Photo 16.

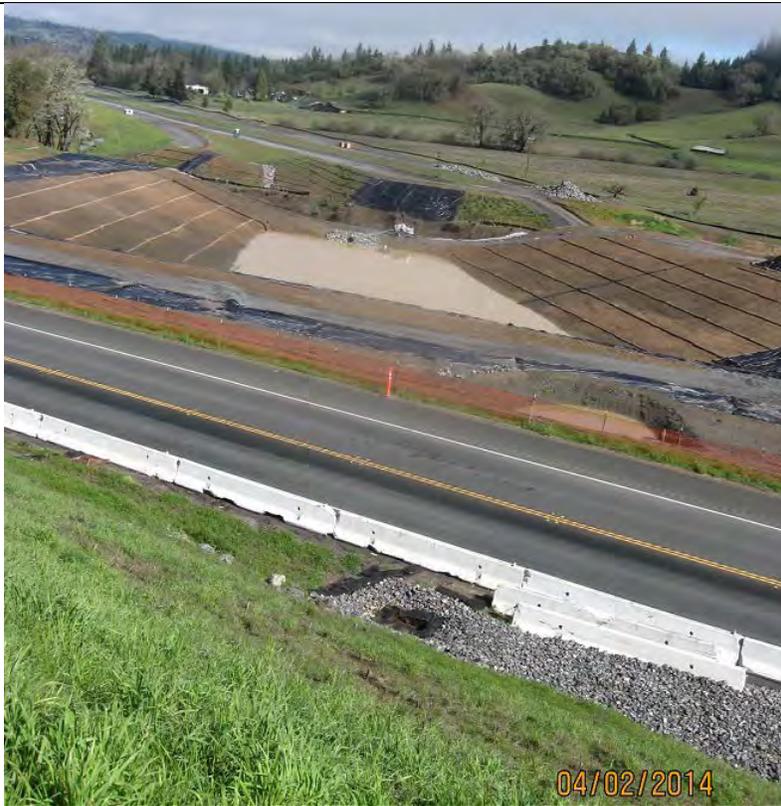
Photo 16: Looking north along the shoulder of Hwy 101 where gravel was placed as a sediment control. The road slopes downward and the gravel extends to the location of a drain inlet (see Photo 17) that transports stormwater under the freeway to the basin shown in Photo 28.

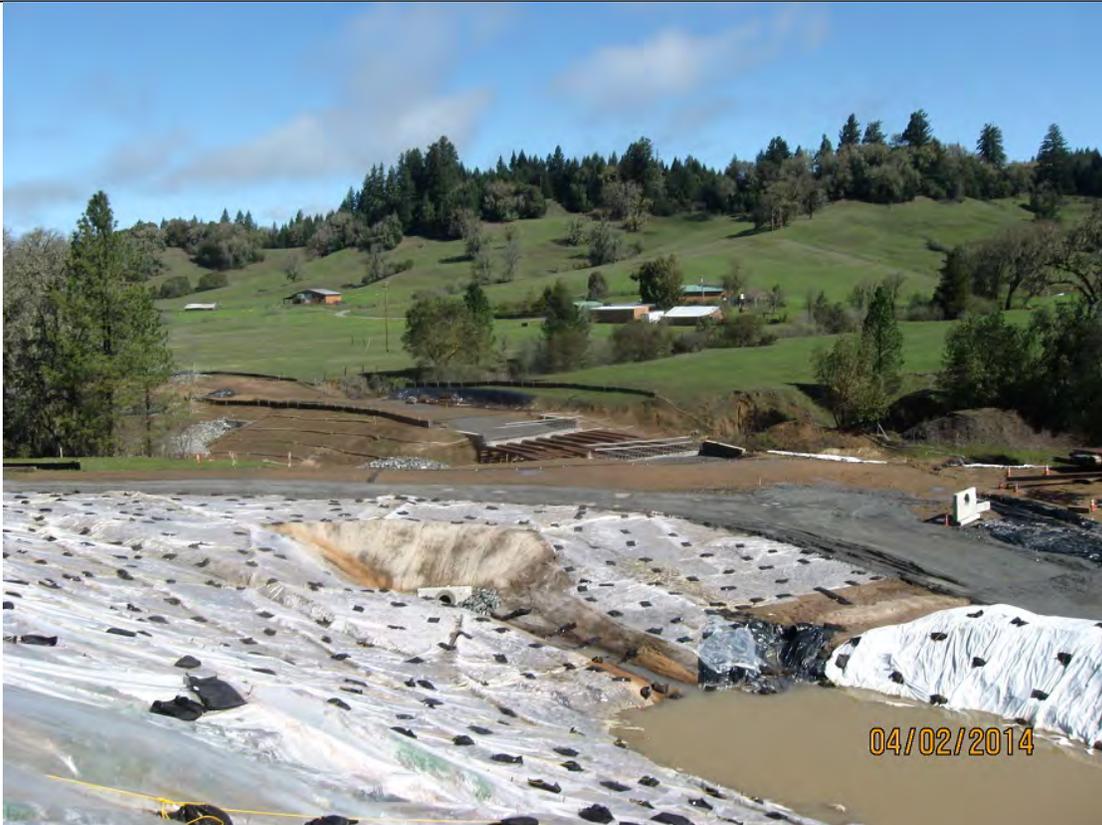
Photo 24: Looking northeast at the “U2” fill area, just east of main entrance to Area 2. Sediment transport was evident throughout the area despite the recently placed straw erosion control.

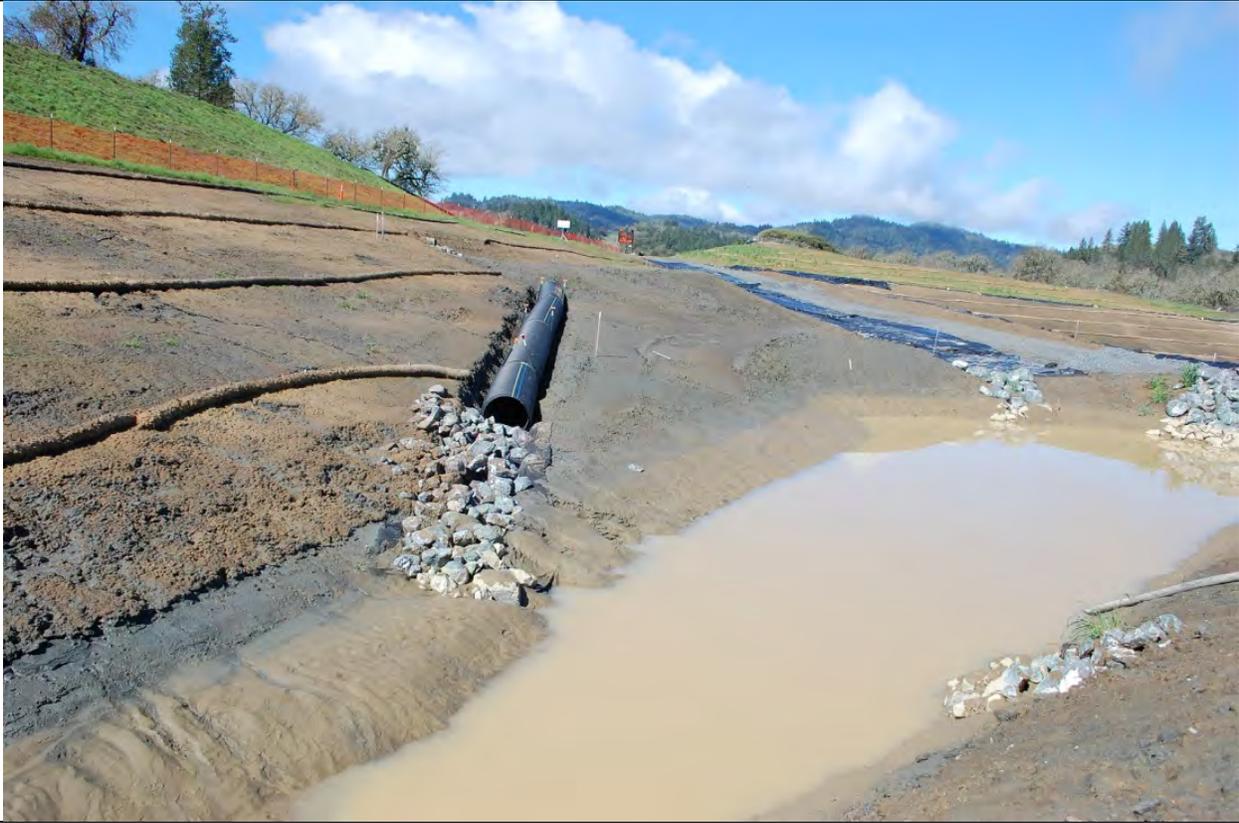
Photo 27: West side of U2 line, looking north toward the storm water basin shown in Photo 26. An attempt had been made to intercept drainage from the ditch shown in Photo 26, by installing the smaller black plastic pipe, but storm water scoured beneath the pipe and eroded the earthen ditch immediately downstream.

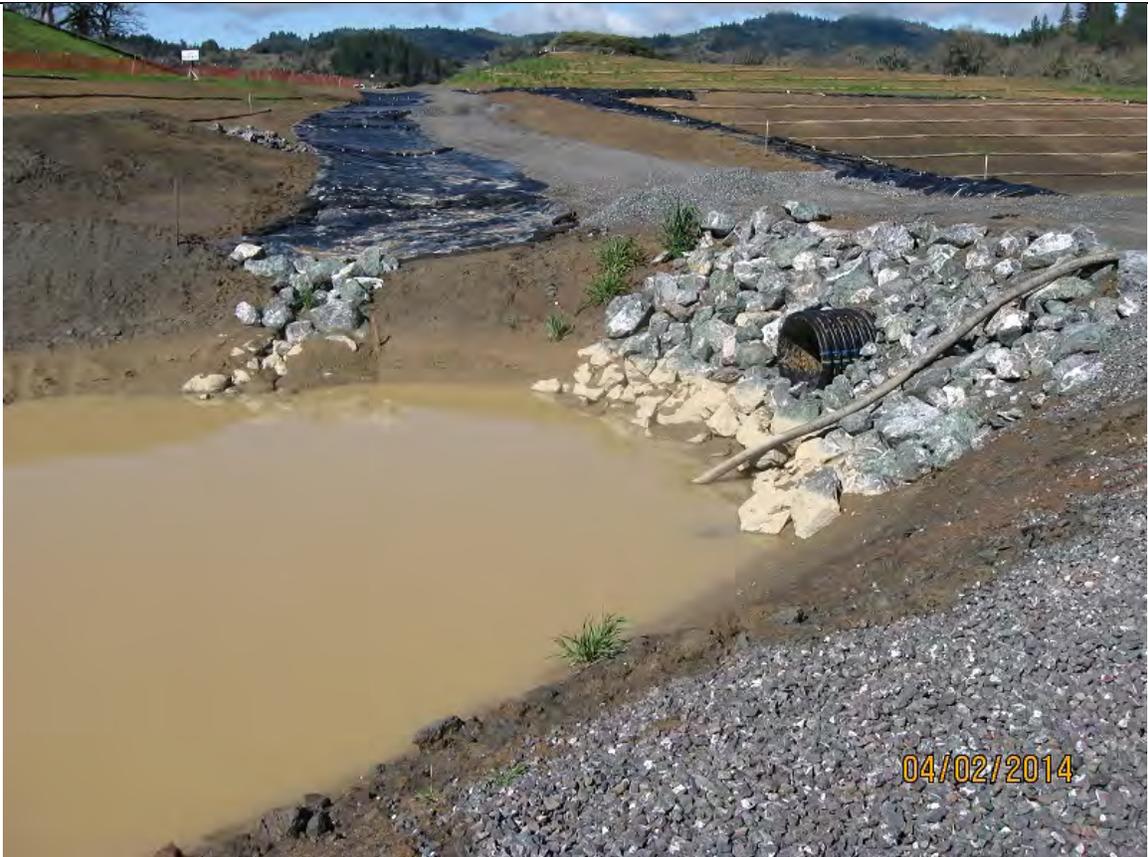
Photo 28: This basin receives flow from the disturbed area west of Hwy 101, the basin in Photo 21 and discharges to Basin 1.

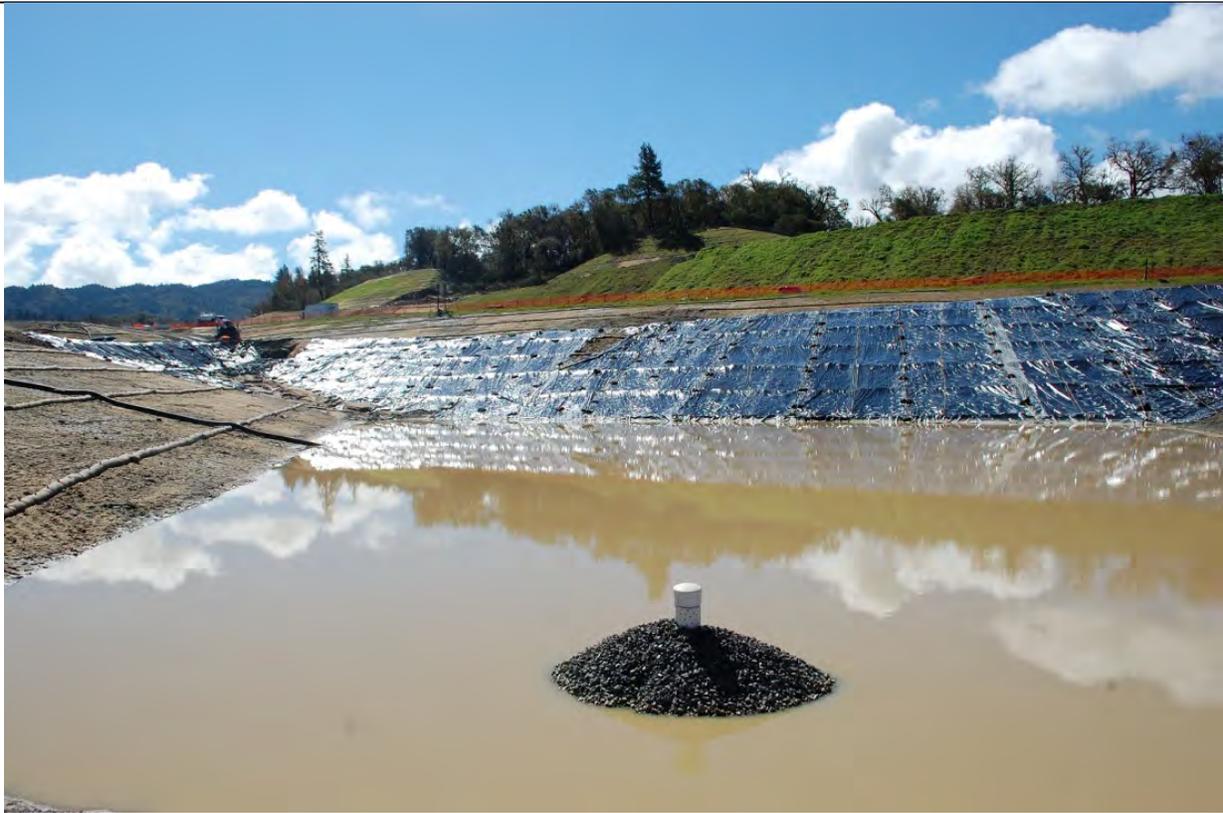
Photo 31: A view of Basin 1, looking north. The channel was eroding/eroded below the outlet seen in the foreground. This channel must be appropriately stabilized to accommodate concentrated flow.

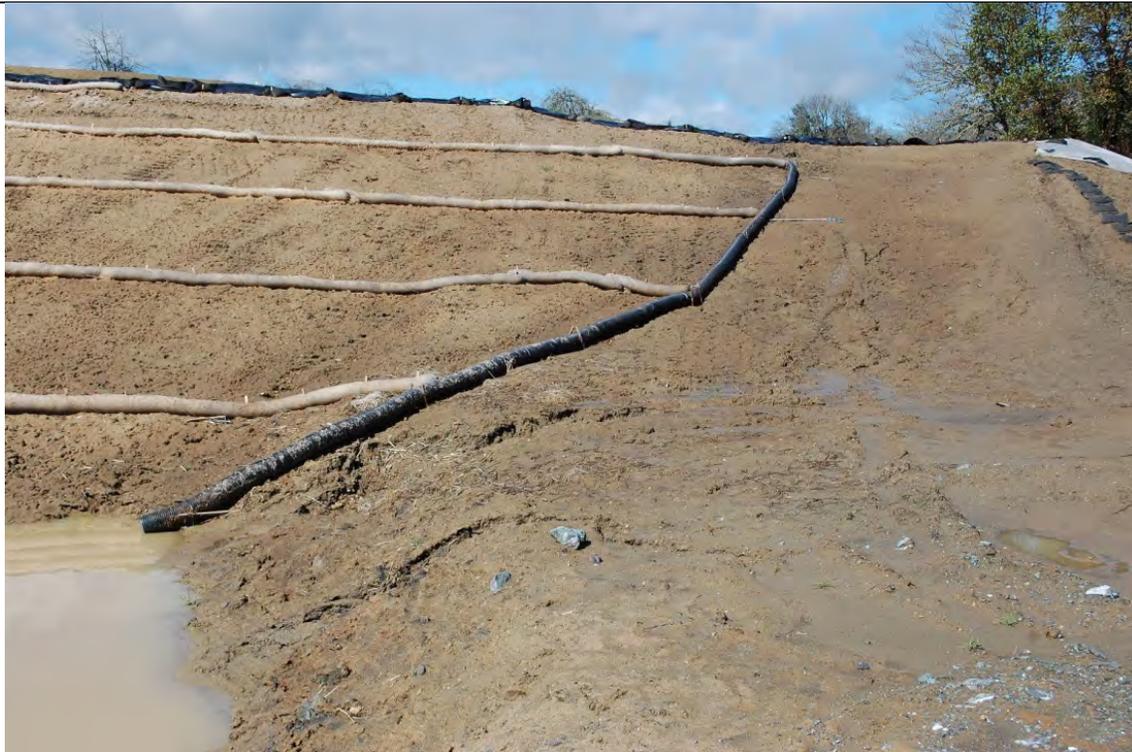
Photo 33: At the top of Basin 1, southern side, looking west. This dirt area was unstabilized and eroding. This area and others around the basin must be stabilized.

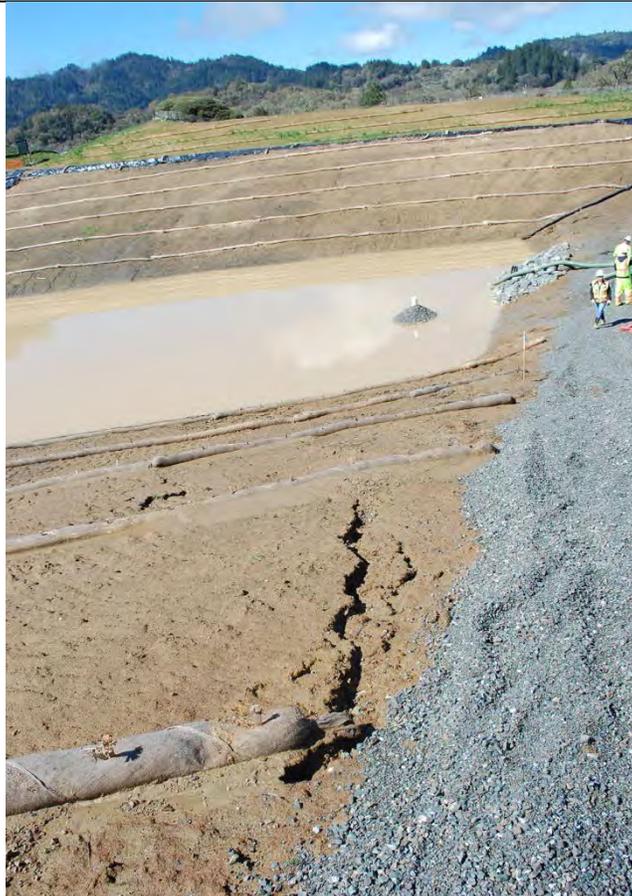
Photo 34: At the northern end of Basin 1, looking west. This dirt area was unstabilized and eroding. This area must be stabilized.

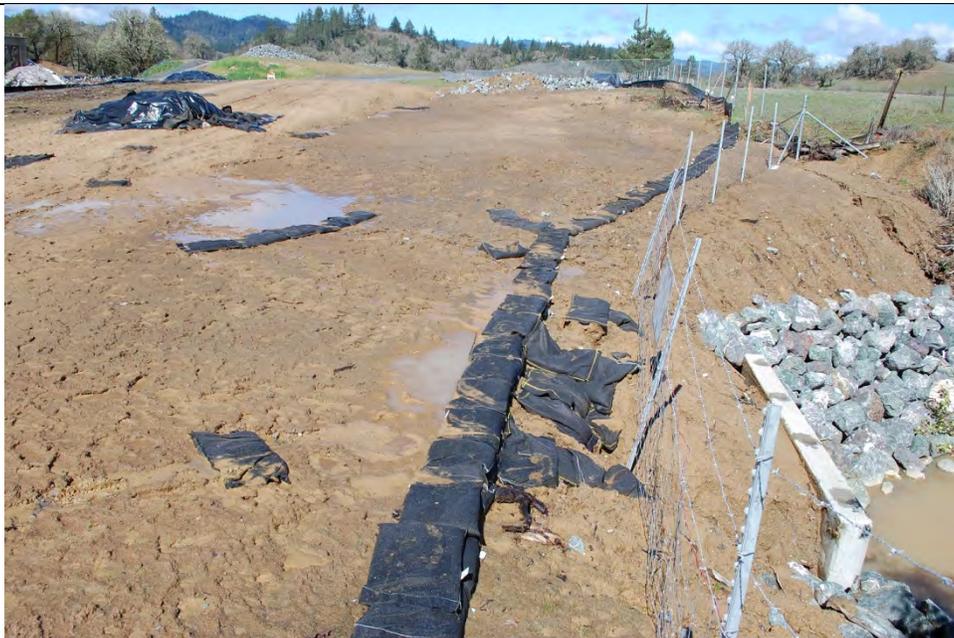
Photo 42: Looking southeast at Drainage System 24 before it enters a culvert and discharges to South Haehl Creek. A large gully has formed developed into the channel, as seen in the center of the photo. The steel fence is the Caltrans right-of-way fence. Caltrans staff said they were limited to fixes within their right-of-way, however, the disturbance on the other side of the fence was created by Caltrans and is Caltrans's responsibility to stabilize.

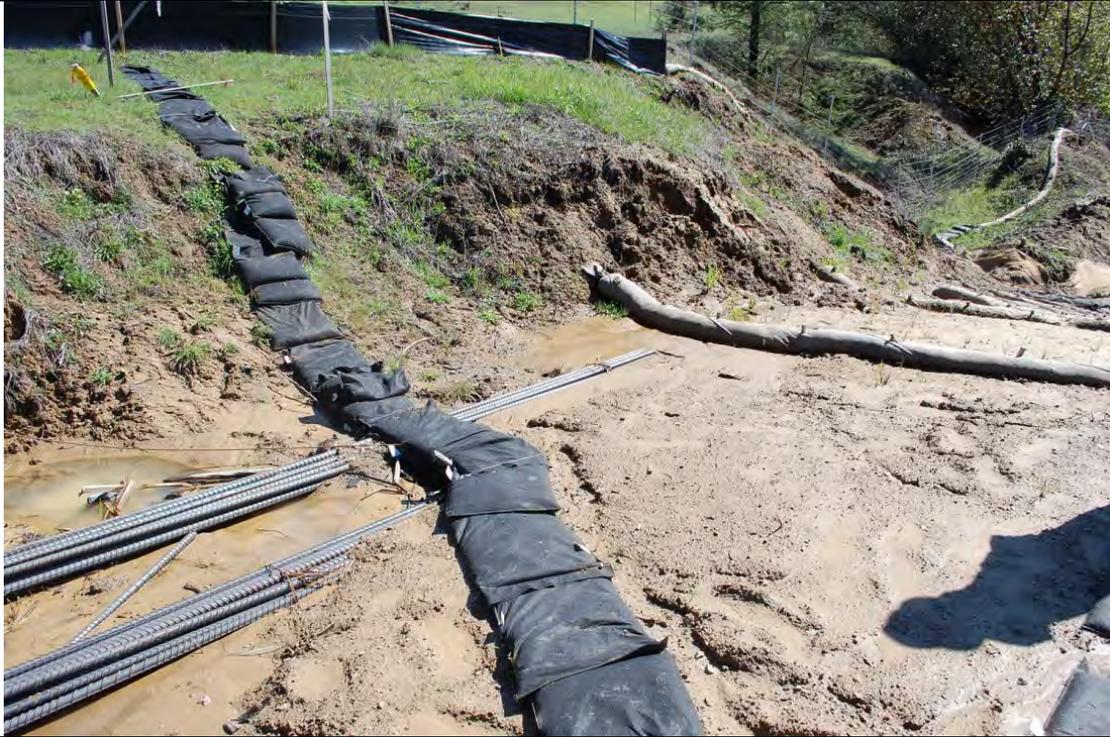
Photo 43: Looking north at Drainage System 24.

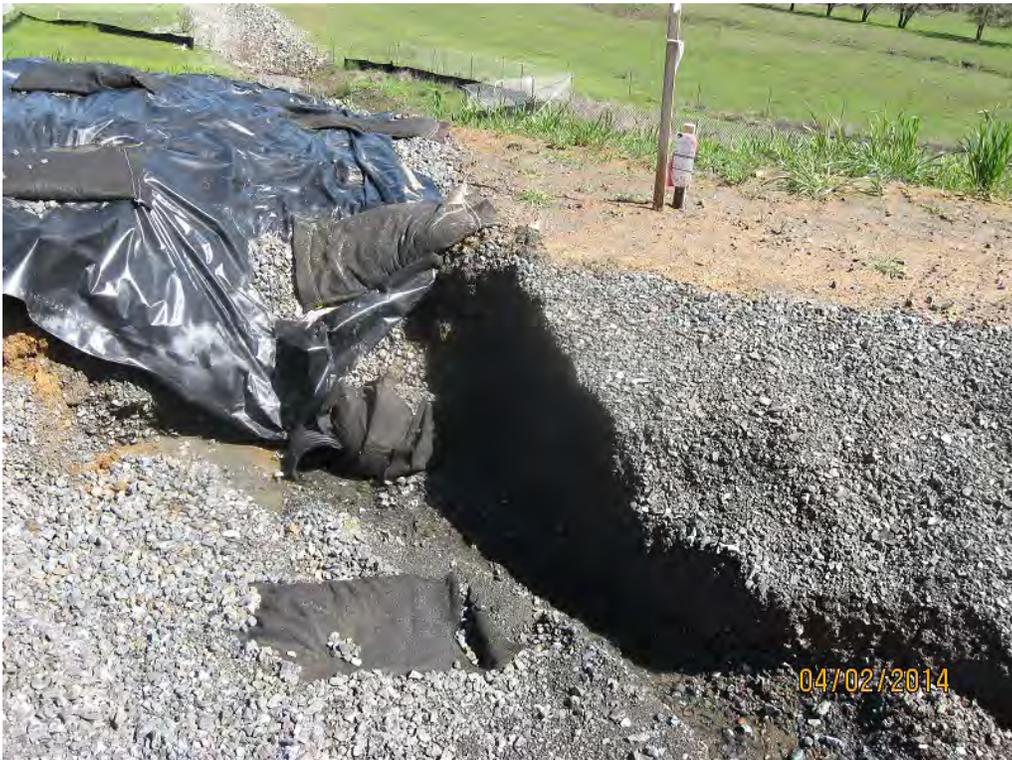
Photo 51: Looking north at the U2 line, south and upgradient of the area shown in Photo 50. The gravel road was significantly incised and sediment had been transported downstream to South Haehl Creek. The inlet is beneath the black plastic, shown in the lower left of the photo (see Photo 52).

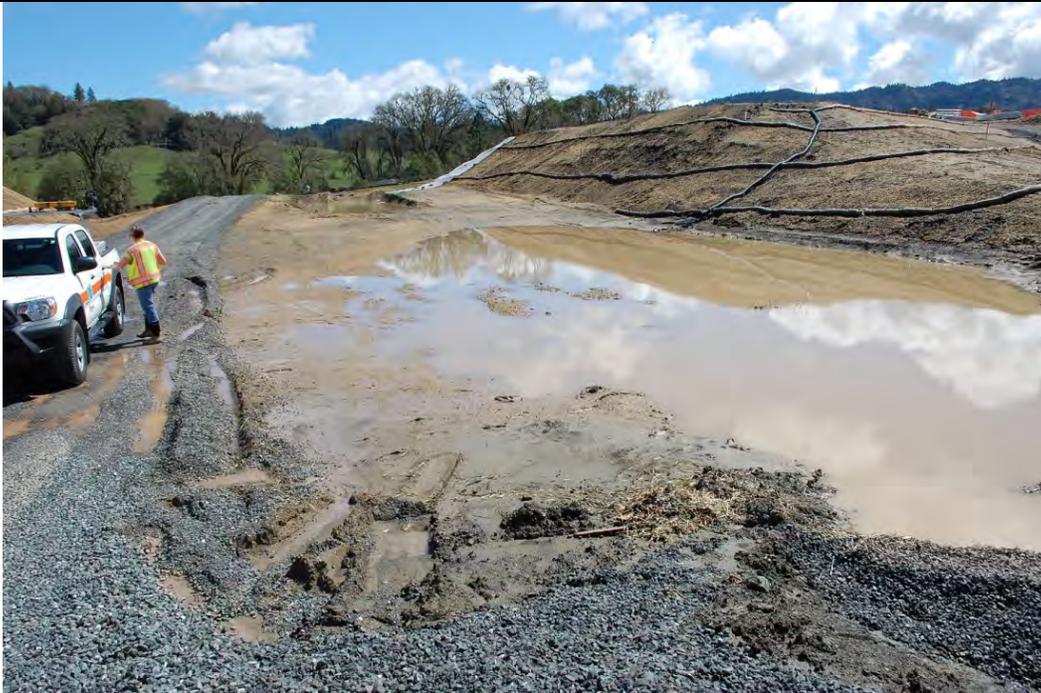
Photo 54: There was evidence that the basin shown in Photo 19 and Photo 55 overflowed down this slope, through the silt fence, and into South Haehl Creek. Erosion can be seen in the center-right of the photo. The silt fence shown in the distance was worn and requires replacement.

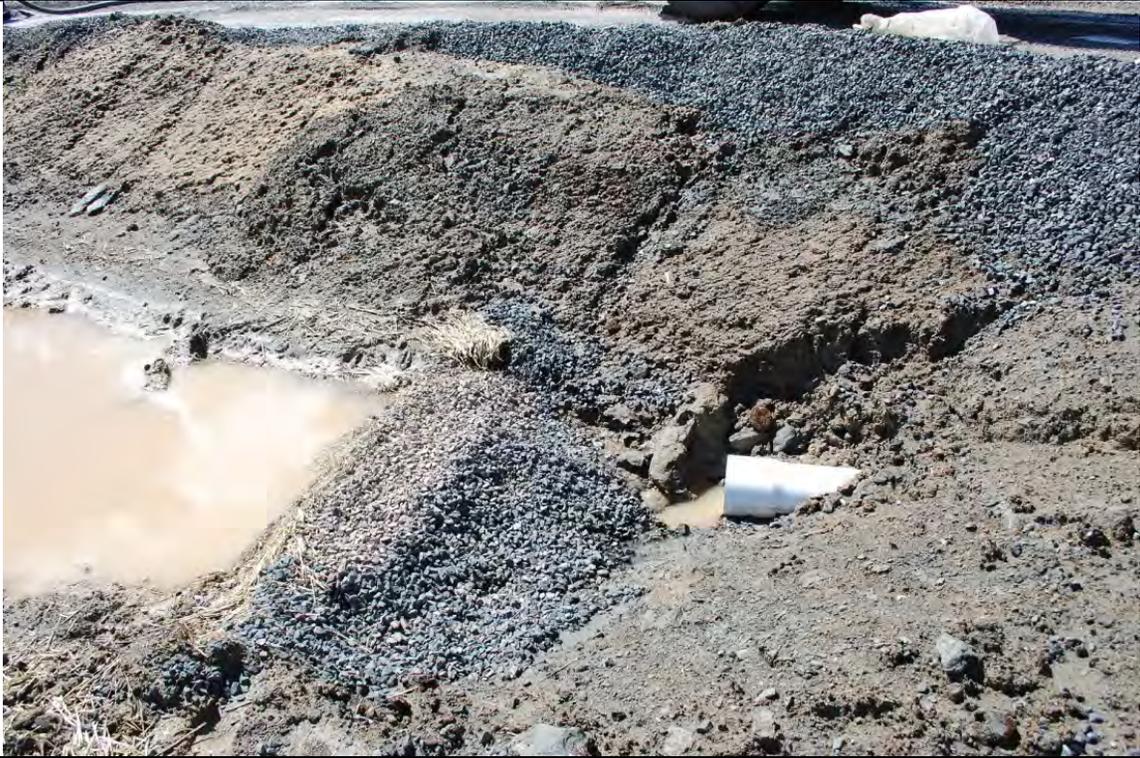
Photo 55: This basin primarily drains to Basin 1 through an inlet just to the lower right of the photo (see Photo 56), but will overflow directly to South Haehl Creek at the location in the upper left of the photo and as shown in Photo 54.
