## Inspection Overview

**Organization:** Wake County School District  
**Site:** Timber Drive Elem  
**Type:** Low Frequency  
**Status:** Complete  
**Inspector:** Bill Marrs  
**CPSI Number:** 32333-1018  
**Phone Number:** (133) 690-9093  
**Completed on:** 2/25/2016

**Organization:** Wake County Public Schools  
**Site:** Timber Drive Elem  
**Type:** Low Frequency  
**Status:** Scheduled  
**Inspector:** Bill Marrs  
**Completed on:** 4/11/2017

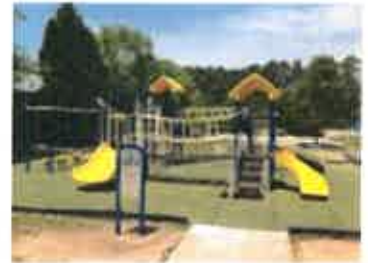
#### Inventory

**Item:** Asset 66566 wo19734852  
**Equipment Category:** Playground Equipment  
**Equipment Type:** Climbing Equipment  
**Equipment Item:** Composite structure  
**Manufacturer:** Playworld  
**AgeGroup:** All  
**Status:** Okay  
**Priority:** None (1=High - 5=Low)

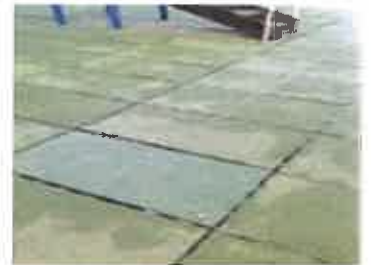
#### Inventory

**Item:** Protective surfacing  
**Equipment Category:** Surface  
**Equipment Type:** Surface  
**Equipment Item:** Rubber Tile  
**Manufacturer:** Unknown/None  
**AgeGroup:** All  
**Status:** Okay  
**Priority:** None (1=High - 5=Low)

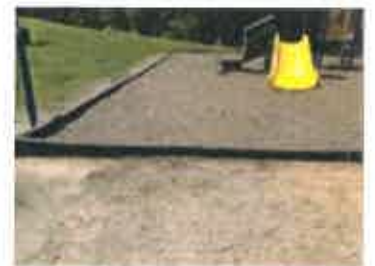
#### Inventory

**Item:** Safety surface 56611  
**Equipment Category:** Surface  
**Equipment Type:** Surface  
**Equipment Item:** Eng. Wood Fiber  
**Manufacturer:** Unknown/None  
**AgeGroup:** All  
**Status:** Okay  
**Priority:** None (1=High - 5=Low)

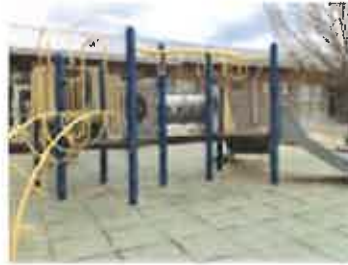
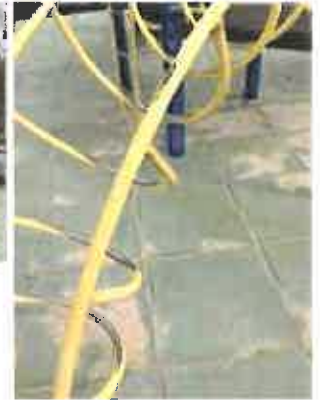
**Issue**

**Item:** Asset 56372 wo19734836  
**Equipment Category:** Playground Equipment  
**Equipment Type:** Climbing Equipment  
**Equipment Item:** Composite Structure, Climber  
**Manufacturer:** GameTime  
**AgeGroup:** All  
**Status:** Needs Maintenance  
**Part:** Entire unit  
**Problem:** Corrosion  
**Action:** Paint  
**Priority:** 5  
**Repair Notes:** N/A  
**Comments:** N/A

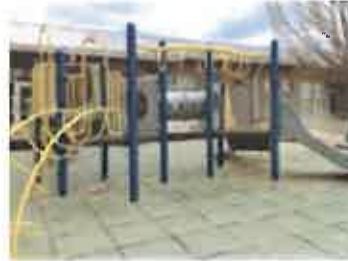
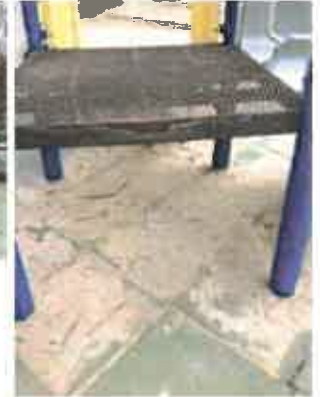
**Issue**

**Item:** Asset 56372 wo19734836  
**Equipment Category:** Playground Equipment  
**Equipment Type:** Climbing Equipment  
**Equipment Item:** Composite Structure, Climber  
**Manufacturer:** GameTime  
**AgeGroup:** All  
**Status:** Needs Maintenance  
**Part:** Deck  
**Problem:** Cracked  
**Action:** Repair  
**Priority:** 3  
**Repair Notes:** N/A  
**Comments:** N/A

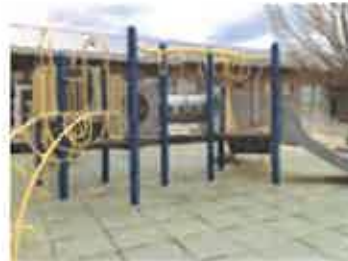
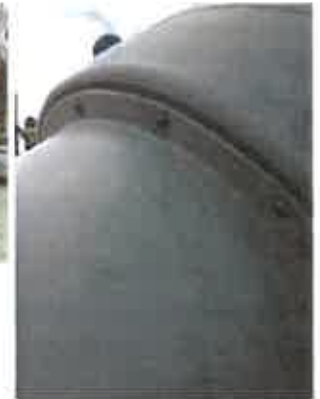
**Issue**

**Item:** Asset 56372 wo19734836  
**Equipment Category:** Playground Equipment  
**Equipment Type:** Climbing Equipment  
**Equipment Item:** Composite Structure, Climber  
**Manufacturer:** GameTime  
**AgeGroup:** All  
**Status:** Needs Maintenance  
**Part:** Plastic slide  
**Problem:** Cracked  
**Action:** Replace  
**Priority:** 3  
**Repair Notes:** N/A  
**Comments:** N/A

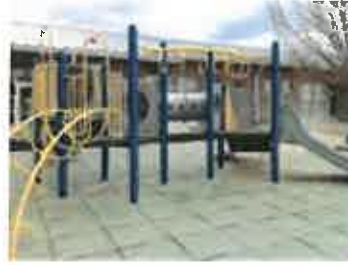
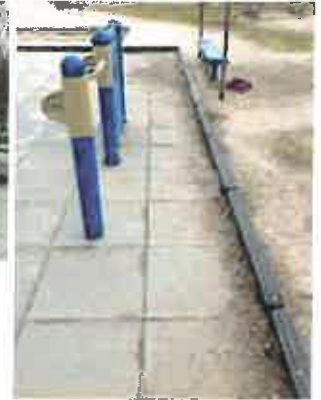
**Issue**

**Item:** Asset 56372 wo19734836  
**Equipment Category:** Playground Equipment  
**Equipment Type:** Climbing Equipment  
**Equipment Item:** Composite Structure, Climber  
**Manufacturer:** GameTime  
**AgeGroup:** All  
**Status:** Needs Maintenance  
**Part:** Handrail  
**Problem:** Insufficient area  
**Action:** Repair  
**Priority:** 2  
**Repair Notes:** N/A  
**Comments:** N/A

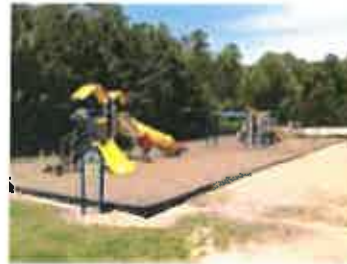
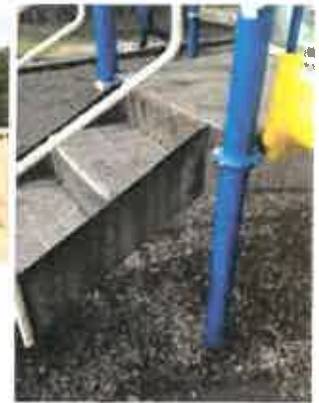
**Issue**

**Item:** Asset 56611 wo19734851  
**Equipment Category:** Playground Equipment  
**Equipment Type:** Climbing Equipment  
**Equipment Item:** Composite structure  
**Manufacturer:** Playworld  
**AgeGroup:** All  
**Status:** Needs Maintenance  
**Part:** Deck  
**Problem:** Cracked  
**Action:** Repair  
**Priority:** 4  
**Repair Notes:** N/A  
**Comments:** N/A

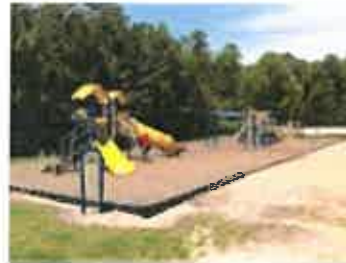
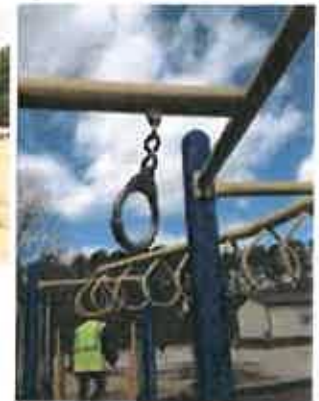
**Issue**

**Item:** Asset 56611 wo19734851  
**Equipment Category:** Playground Equipment  
**Equipment Type:** Climbing Equipment  
**Equipment Item:** Composite structure  
**Manufacturer:** Playworld  
**AgeGroup:** All  
**Status:** Needs Maintenance  
**Part:** Not applicable  
**Problem:** Non Compliant  
**Action:** Replace  
**Priority:** 3  
**Repair Notes:** N/A  
**Comments:** N/A

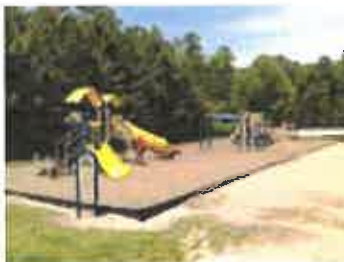
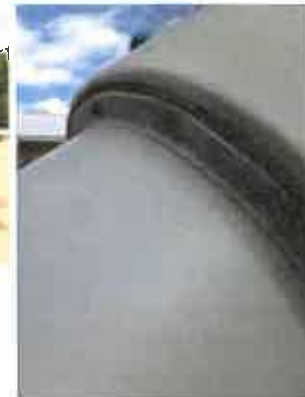
**Issue**

**Item:** Asset 56611 wo19734851  
**Equipment Category:** Playground Equipment  
**Equipment Type:** Climbing Equipment  
**Equipment Item:** Composite structure  
**Manufacturer:** Playworld  
**AgeGroup:** All  
**Status:** Needs Maintenance  
**Part:** Plastic slide  
**Problem:** Cracked  
**Action:** Replace  
**Priority:** 3  
**Repair Notes:** N/A  
**Comments:** N/A

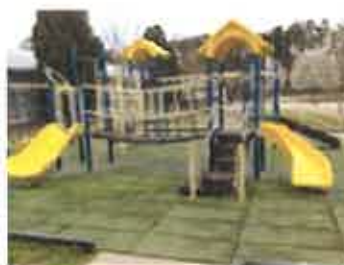
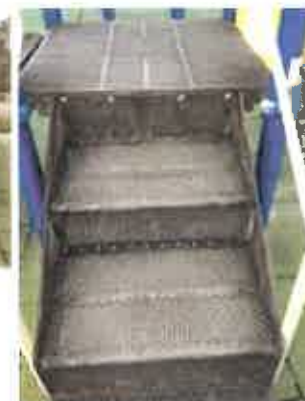
**Issue**

**Item:** Asset-66566  
**Equipment Category:** Playground Equipment  
**Equipment Type:** Climbing Equipment  
**Equipment Item:** Composite structure  
**Manufacturer:** Playworld  
**AgeGroup:** All  
**Status:** Needs Maintenance  
**Part:** Deck  
**Problem:** Cracked  
**Action:** Repair  
**Priority:** 4  
**Repair Notes:** N/A  
**Comments:** N/A

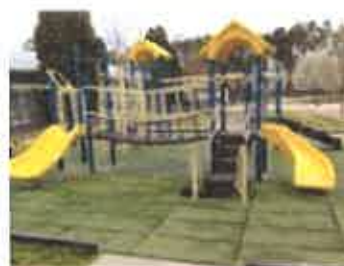
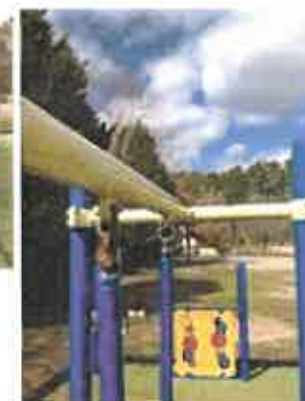
**Issue**

**Item:** Asset-66566  
**Equipment Category:** Playground Equipment  
**Equipment Type:** Climbing Equipment  
**Equipment Item:** Composite structure  
**Manufacturer:** Playworld  
**AgeGroup:** All  
**Status:** Needs Maintenance  
**Part:** Hardware  
**Problem:** Non Compliant  
**Action:** Repair  
**Priority:** 2  
**Repair Notes:** N/A  
**Comments:** N/A

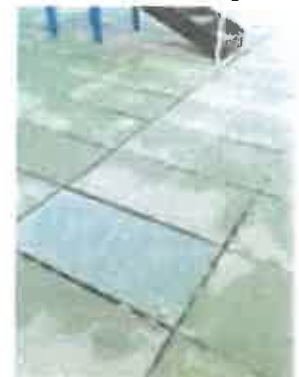
#### Inventory

**Manufacturer:** Unknown/None  
**AgeGroup:** All  
**Status:** Okay  
**Priority:** None

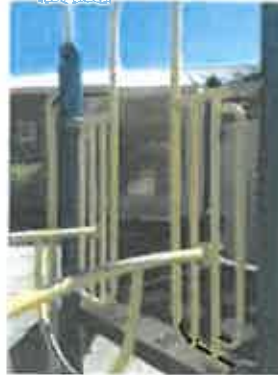
**Issue**

**Item:** Asset 56372 wo17153994  
**Equipment Category:** Playground Equipment  
**Equipment Type:** Climbing Equipment  
**Equipment Item:** Composite Structure, Climber  
**Manufacturer:** GameTime  
**AgeGroup:** All  
**Repair Notes:** N/A  
**Comments:** N/A

**Status:** Needs Maintenance  
**Part:** Entire unit  
**Problem:** Corrosion  
**Action:** Paint  
**Priority:** 4

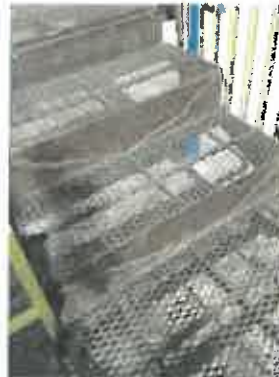
**Issue**

**Item:** Asset 56372 wo17153994  
**Equipment Category:** Playground Equipment  
**Equipment Type:** Climbing Equipment  
**Equipment Item:** Composite Structure, Climber  
**Manufacturer:** GameTime  
**AgeGroup:** All

**Status:** Needs Maintenance  
**Part:** Deck  
**Problem:** Cracked  
**Action:** Replace  
**Priority:** 3 - Medium

**Repair Notes:** N/A  
**Comments:** PVC coatings are starting to peel

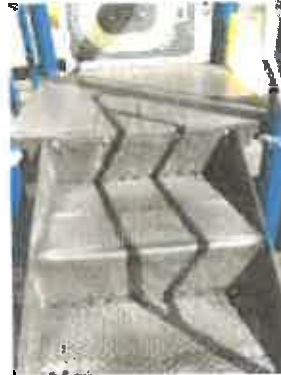
**Issue**

**Item:** Asset 56611 wo17154038  
**Equipment Category:** Playground Equipment  
**Equipment Type:** Climbing Equipment  
**Equipment Item:** Composite structure  
**Manufacturer:** Playworld  
**AgeGroup:** All

**Repair Notes:** N/A  
**Comments:** PVC coatings are starting to peel

**Status:** Needs Maintenance  
**Part:** Deck  
**Problem:** Cracked  
**Action:** Replace  
**Priority:** 3 - Medium

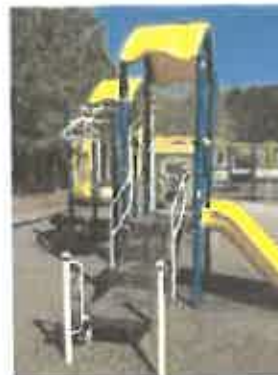
**Issue**

**Item:** Asset 56611 wo17154038  
**Equipment Category:** Playground Equipment  
**Equipment Type:** Climbing Equipment  
**Equipment Item:** Composite structure  
**Manufacturer:** Playworld  
**AgeGroup:** All

**Repair Notes:** N/A  
**Comments:** Entire unit needs painting

**Status:** Needs Maintenance  
**Part:** Entire unit  
**Problem:** Corrosion  
**Action:** Paint  
**Priority:** 4

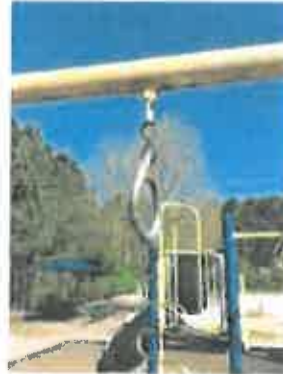
**Issue**

**Item:** Asset 56611 wo17154038  
**Equipment Category:** Playground Equipment  
**Equipment Type:** Climbing Equipment  
**Equipment Item:** Composite structure  
**Manufacturer:** Playworld  
**AgeGroup:** All

**Repair Notes:** N/A  
**Comments:** All S hooks are improperly closed

**Status:** Needs Maintenance  
**Part:** Not applicable  
**Problem:** Entanglement  
**Action:** Replace  
**Priority:** 2

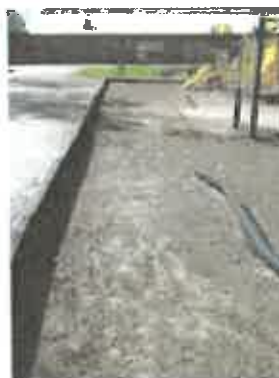
**Issue**

**Item:** Asset 56611 wo17154038  
**Equipment Category:** Playground Equipment  
**Equipment Type:** Climbing Equipment  
**Equipment Item:** Composite structure  
**Manufacturer:** Playworld  
**AgeGroup:** All

**Repair Notes:** N/A  
**Comments:** Must have a minimum 6' fall zone

**Status:** Needs Maintenance  
**Part:** Ladder  
**Problem:** Insufficient area  
**Action:** Increase surface size  
**Priority:** 3 - Medium

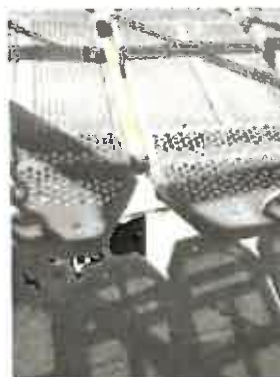
**Issue**

**Item:** Asset-66566  
**Equipment Category:** Playground Equipment  
**Equipment Type:** Climbing Equipment  
**Equipment Item:** Composite structure  
**Manufacturer:** Playworld  
**AgeGroup:** All

**Status:** Needs Maintenance  
**Part:** Deck  
**Problem:** Crush & Shear  
**Action:** Replace  
**Priority:** 3 - Medium

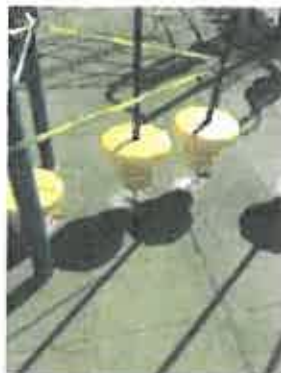
**Issue**

**Item:** Asset-66566  
**Equipment Category:** Playground Equipment  
**Equipment Type:** Climbing Equipment  
**Equipment Item:** Composite structure  
**Manufacturer:** Playworld  
**AgeGroup:** All

**Repair Notes:** N/A  
**Comments:** Chains are broken

**Status:** Needs Maintenance  
**Part:** Stepping Stones  
**Problem:** Broken  
**Action:** Replace  
**Priority:** 3 - Medium

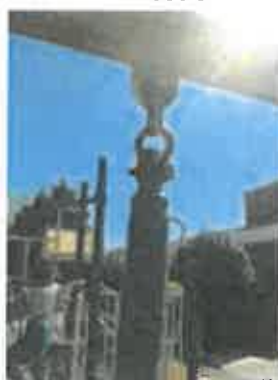
**Issue**

**Item:** Asset-66566  
**Equipment Category:** Playground Equipment  
**Equipment Type:** Climbing Equipment  
**Equipment Item:** Composite structure  
**Manufacturer:** Playworld  
**AgeGroup:** All

**Repair Notes:** N/A  
**Comments:** More than two threads

**Status:** Needs Maintenance  
**Part:** Hardware  
**Problem:** Entanglement  
**Action:** Repair  
**Priority:** 2

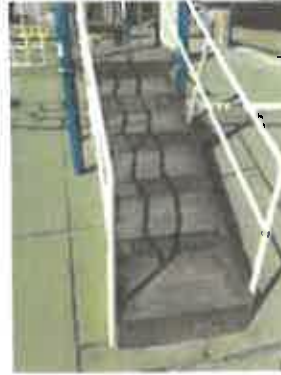
**Issue**

**Item:** Asset-66566  
**Equipment Category:** Playground Equipment  
**Equipment Type:** Climbing Equipment  
**Equipment Item:** Composite structure  
**Manufacturer:** Playworld  
**AgeGroup:** All

**Repair Notes:** N/A  
**Comments:** PVC coatings are starting to peel

**Needs Maintenance**  
Deck  
Cracked  
Replace  
3 - Medium
